air barrier  
**abaa**  
association of  
america  
**CONFERENCE  
& TRADE SHOW**  
MARCH 26-27  
**2019**  
NORFOLK  
**VA**  
AIR BARRIER EDUCATION TRACKS FOR  
THE CONSTRUCTION INDUSTRY

# Avoiding Building Enclosure System Failures

Len Anastasi

*EXO-TEC Consulting, Inc.*

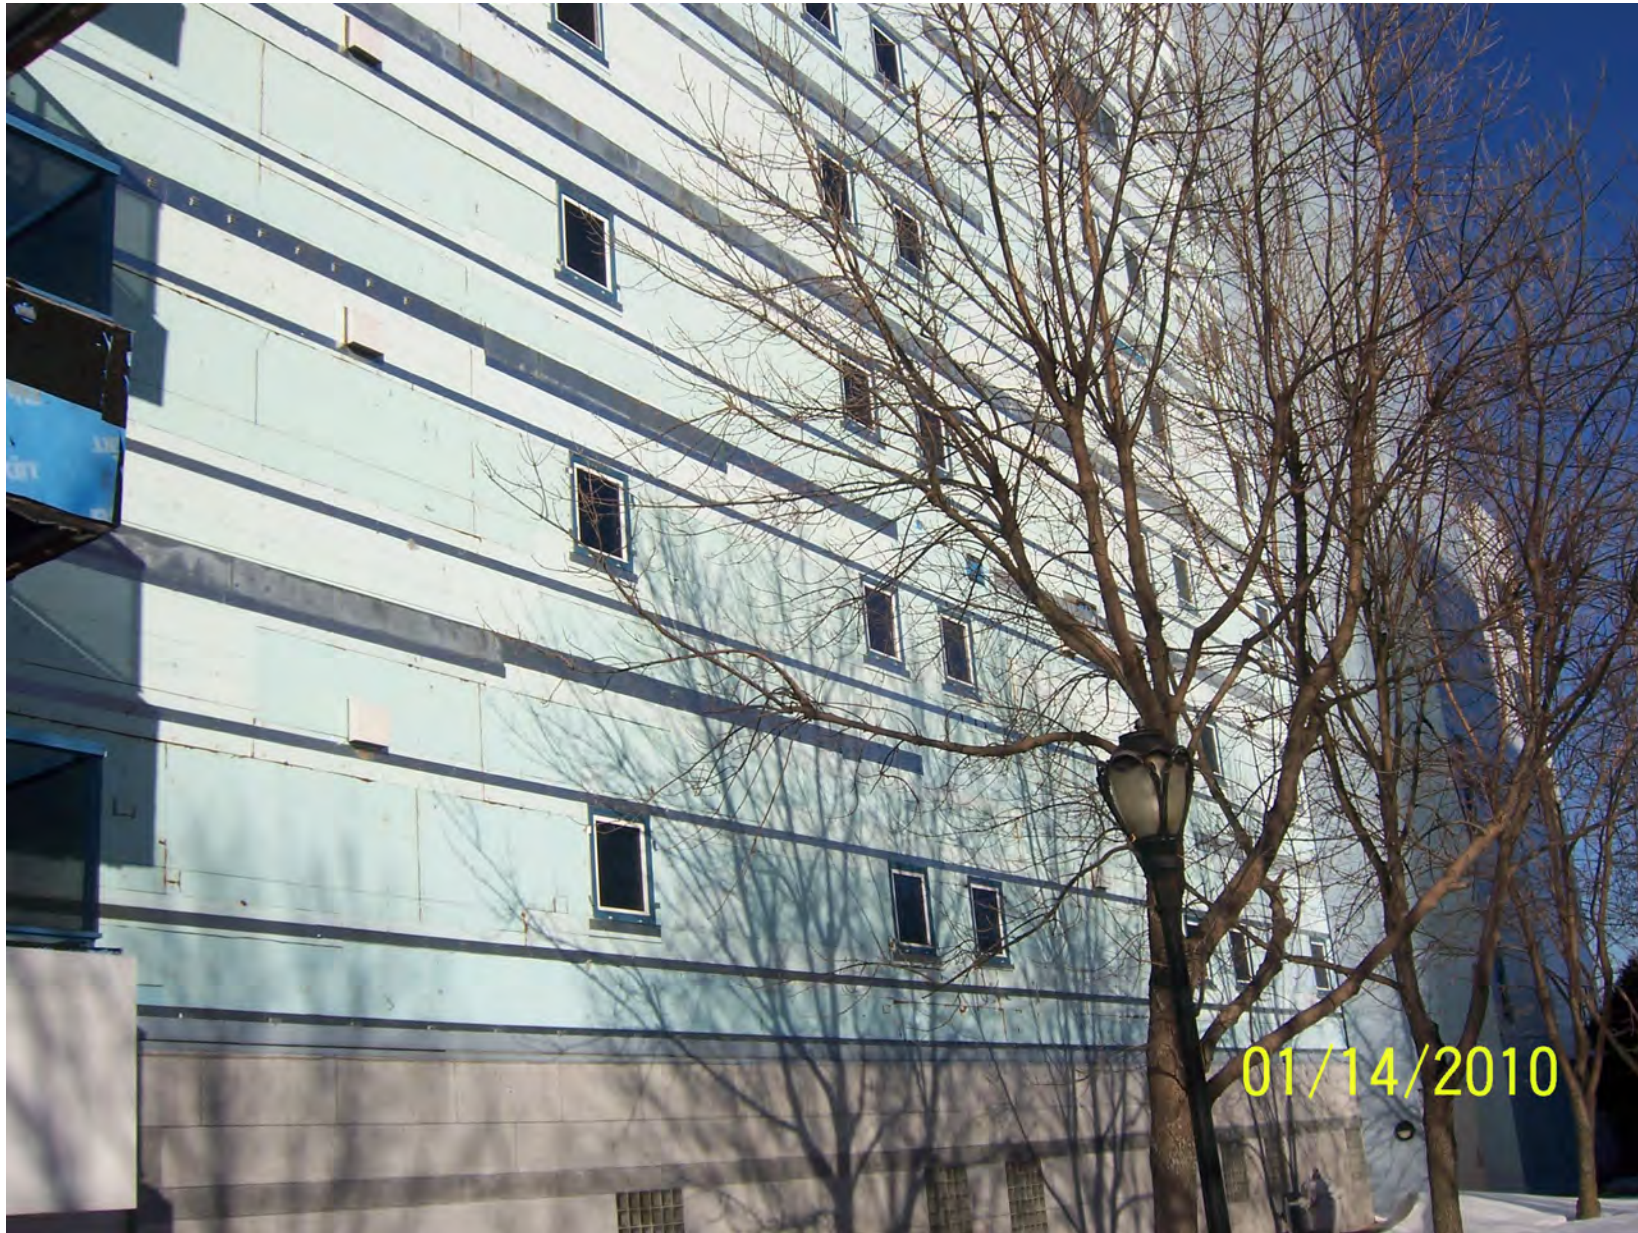
The ACM cladding attachment hardware was surface mounted to the rigid insulation.

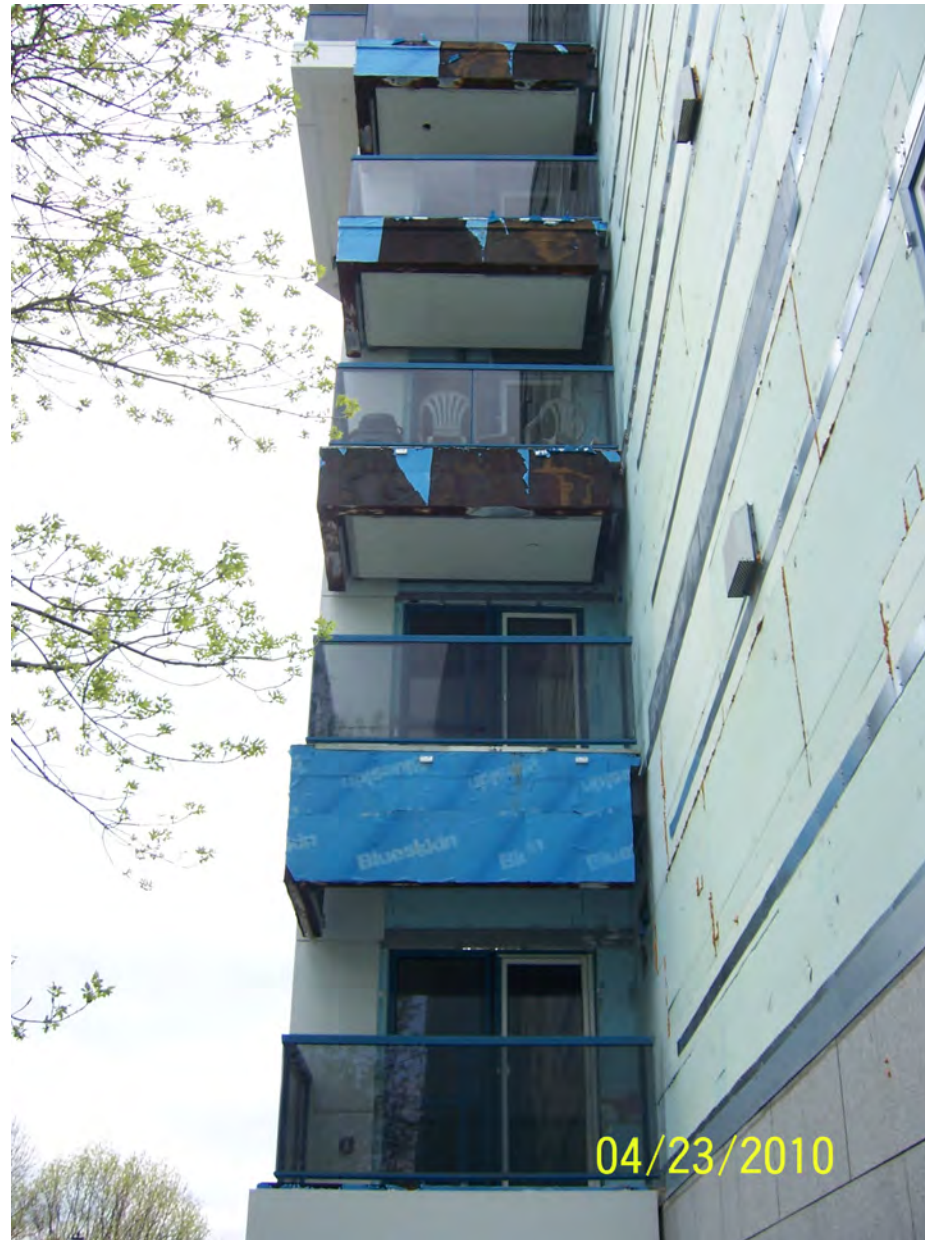
The joints of the rigid insulation were sealed.

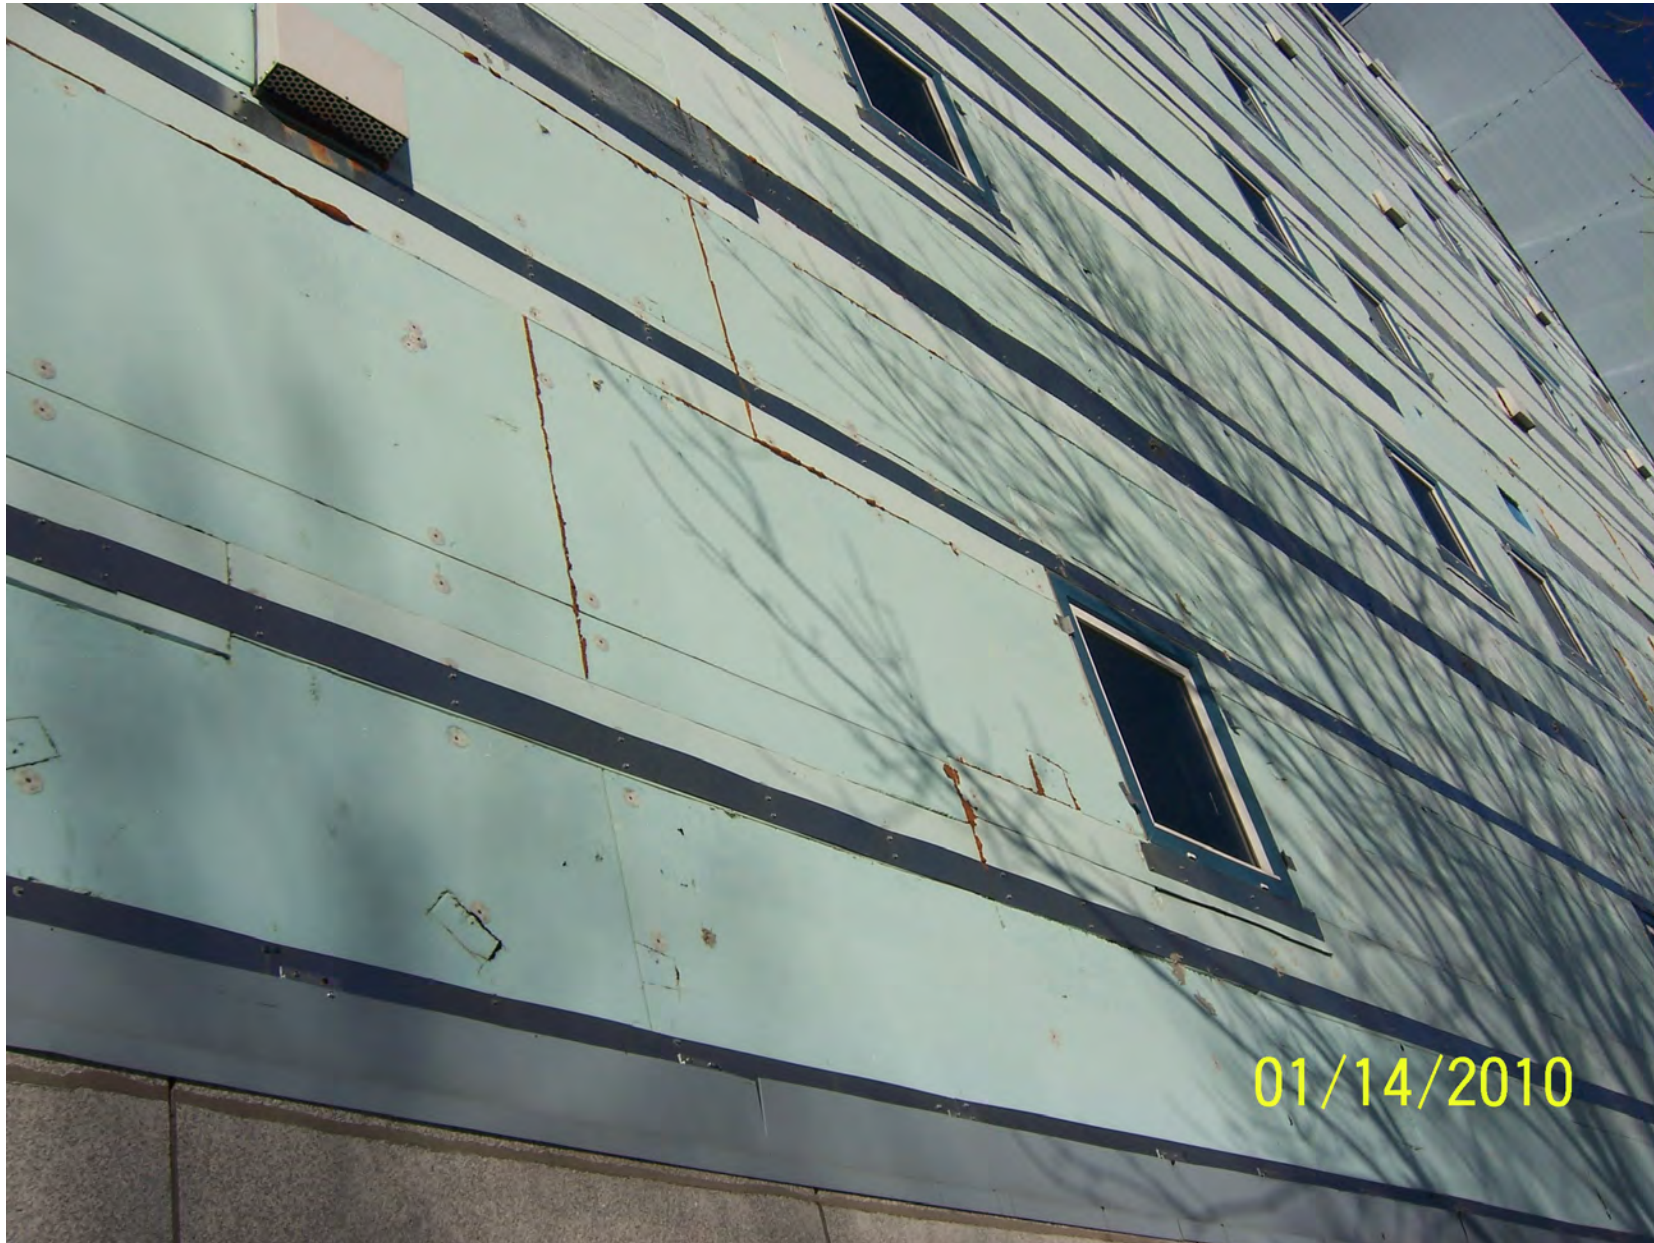
The structural engineer for the metal panel contractor determined that the gage of the existing LGMF studs was not sufficient to withstand the eccentric load imposed on them if conventional z-furring was used as the ACM cladding mounting hardware. So he designed flat stock galvanized steel plates to be fastened to the studs through the extruded polystyrene insulation thus turning the insulation into a load bearing element.

Materials that burn are not allowed to be load bearing elements in the exterior walls in non-combustible construction classified buildings per the building code.

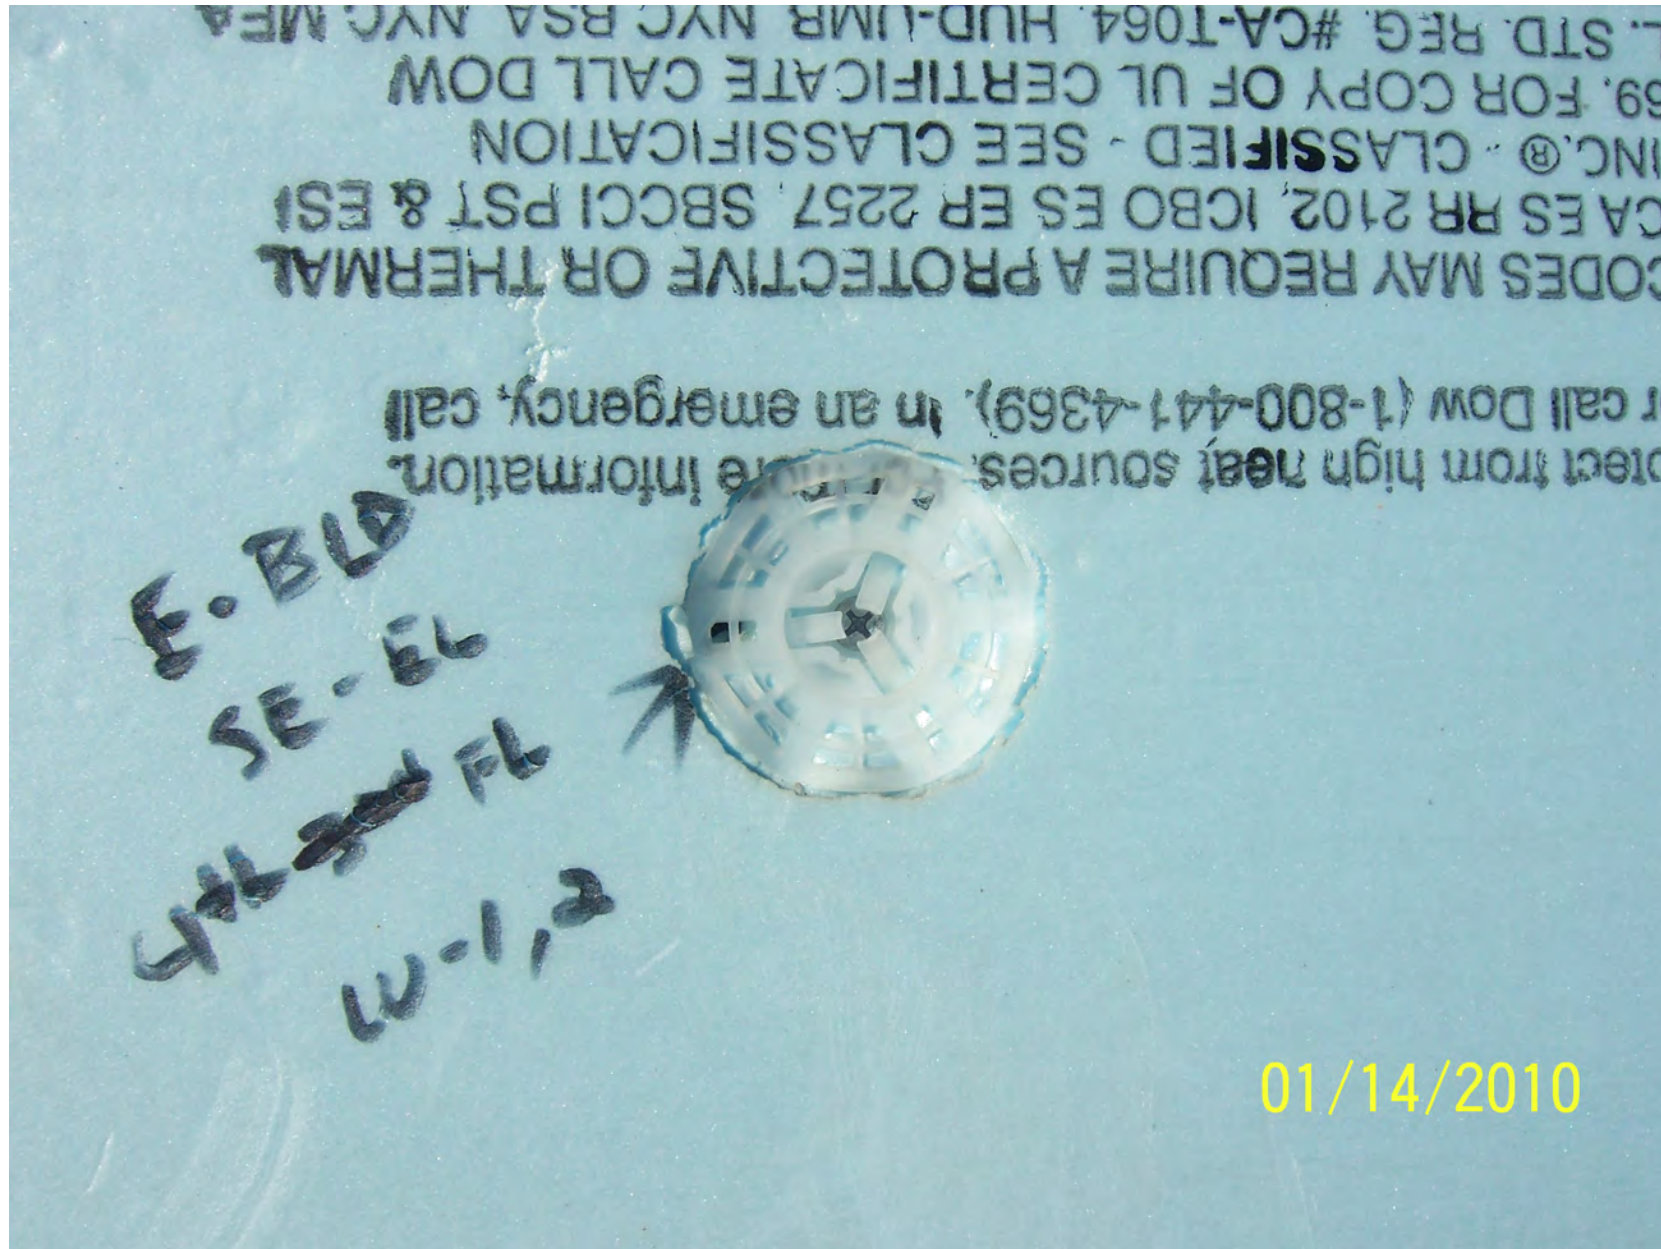
Insulation fastener penetrations that missed the studs

4. Holes through the air and water barrier created by fastener penetrations where the studs were missed created a path of water infiltration in the the LGMF stud cavity but the infiltration would have been insignificant if the building was not under significant negative pressure.

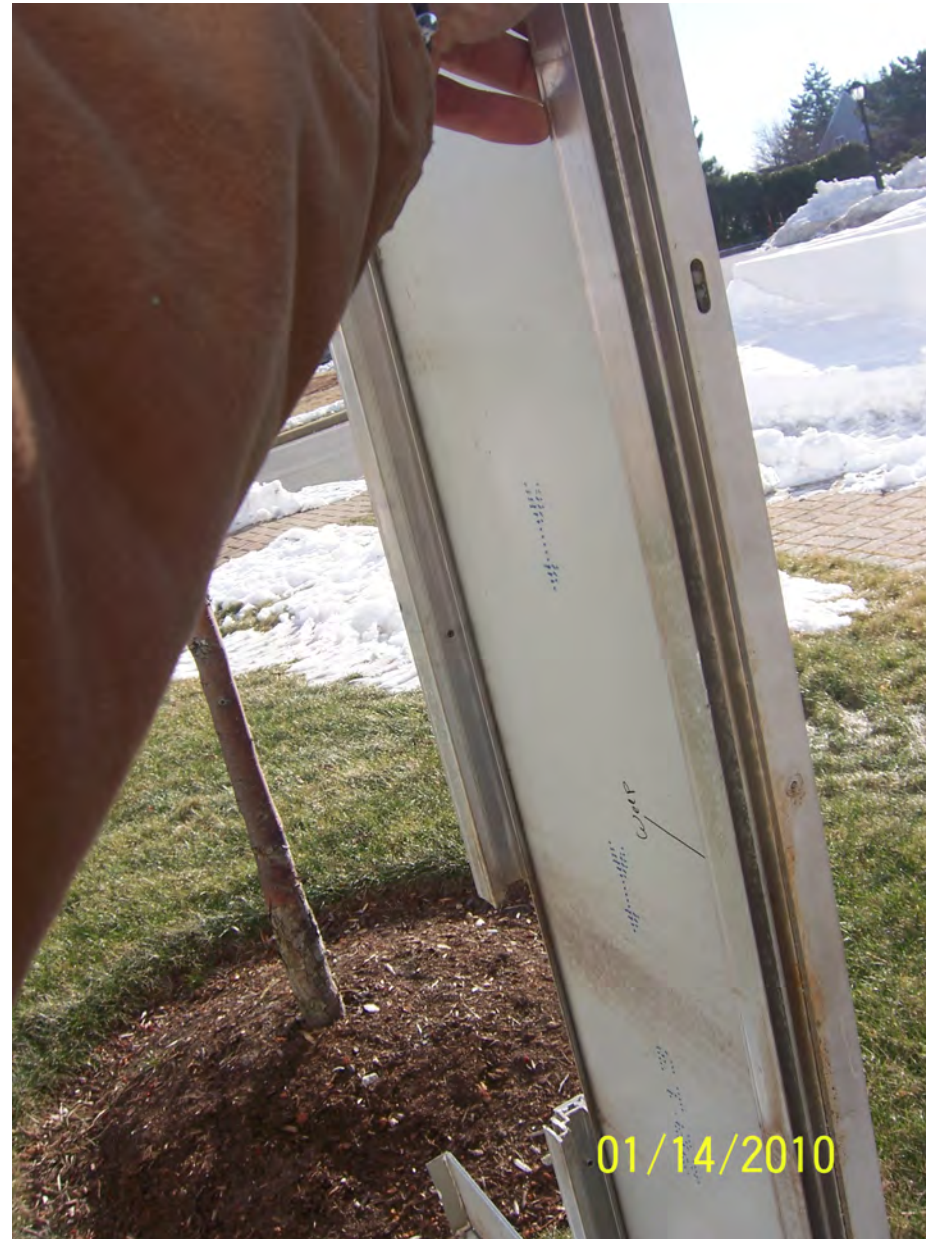
**There were weeps / vents in the ACM cladding, but....**

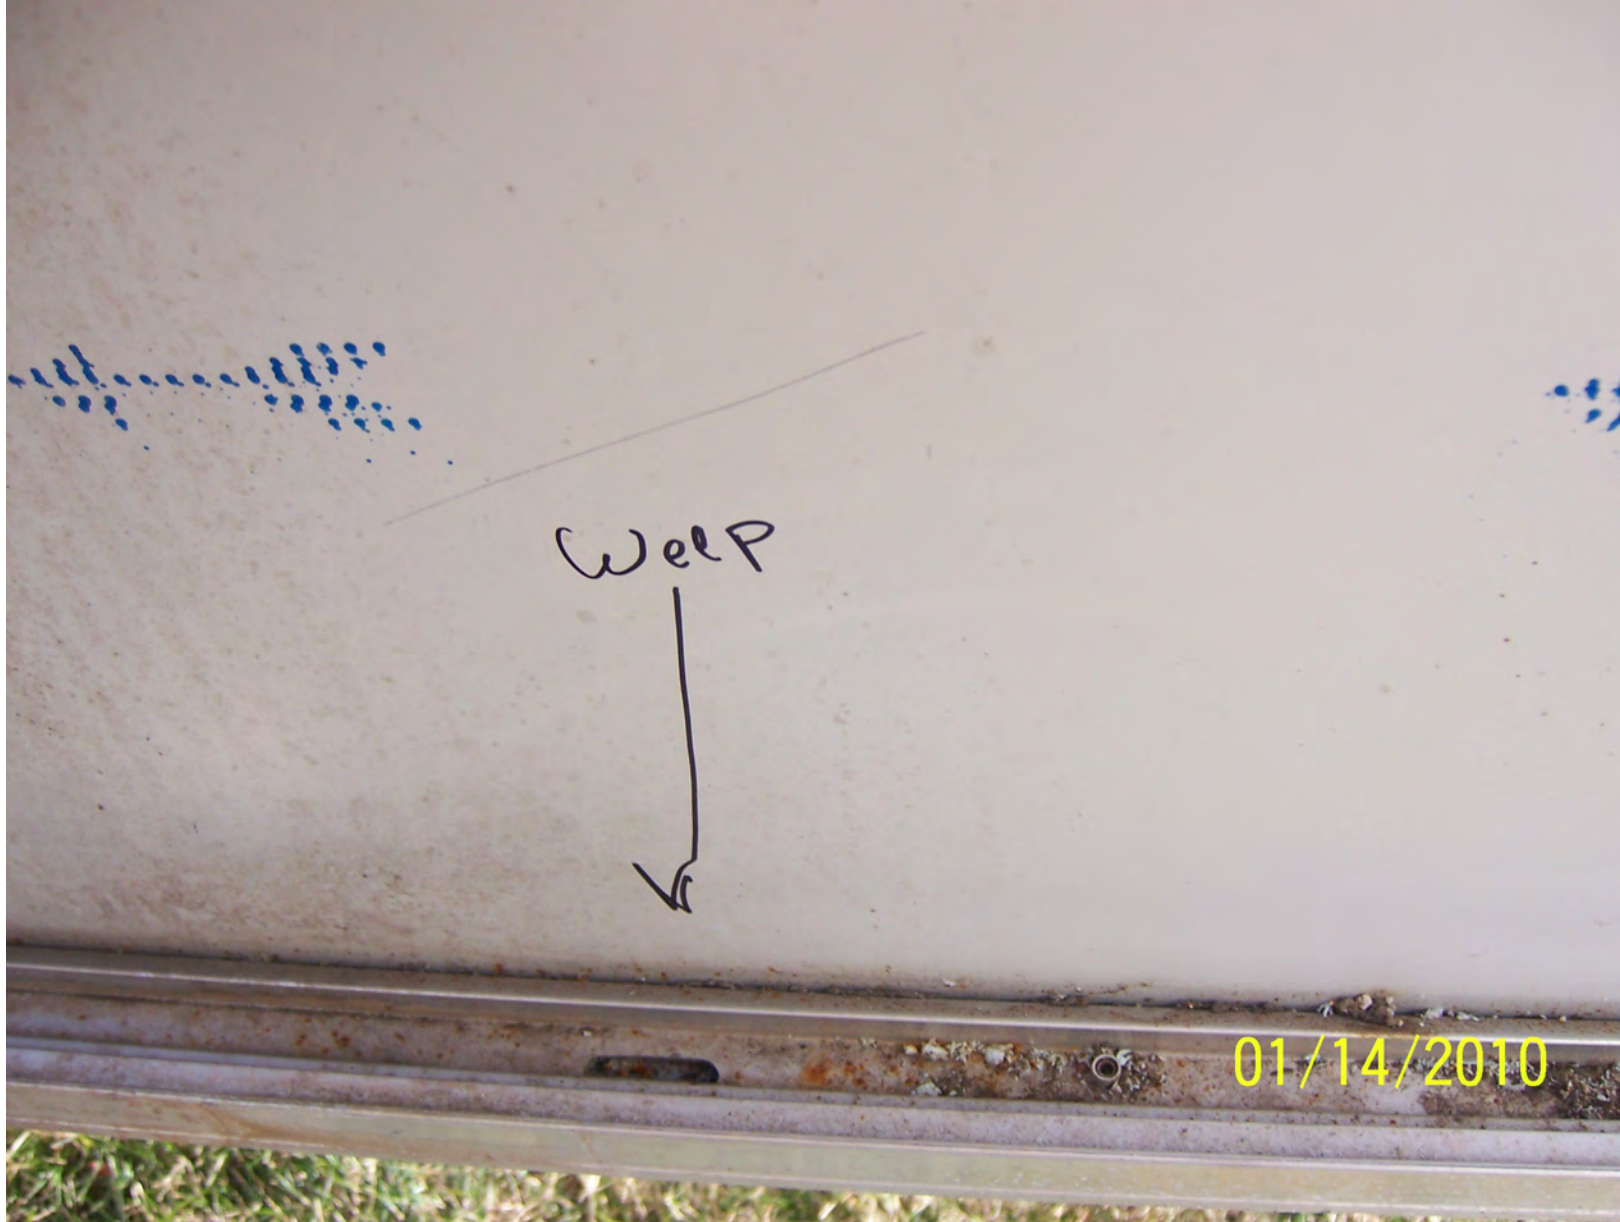
...they did not line up with the weeps in the stiffener plates.

**6. The un-aligned weep holes in the ACM cladding and the ACM cladding stiffeners took away the ability of the cladding system to vent the space behind it adding to the RH of that space and thus creating humidity levels in that space conducive to the accelerated corrosion of the metal items in that space.**

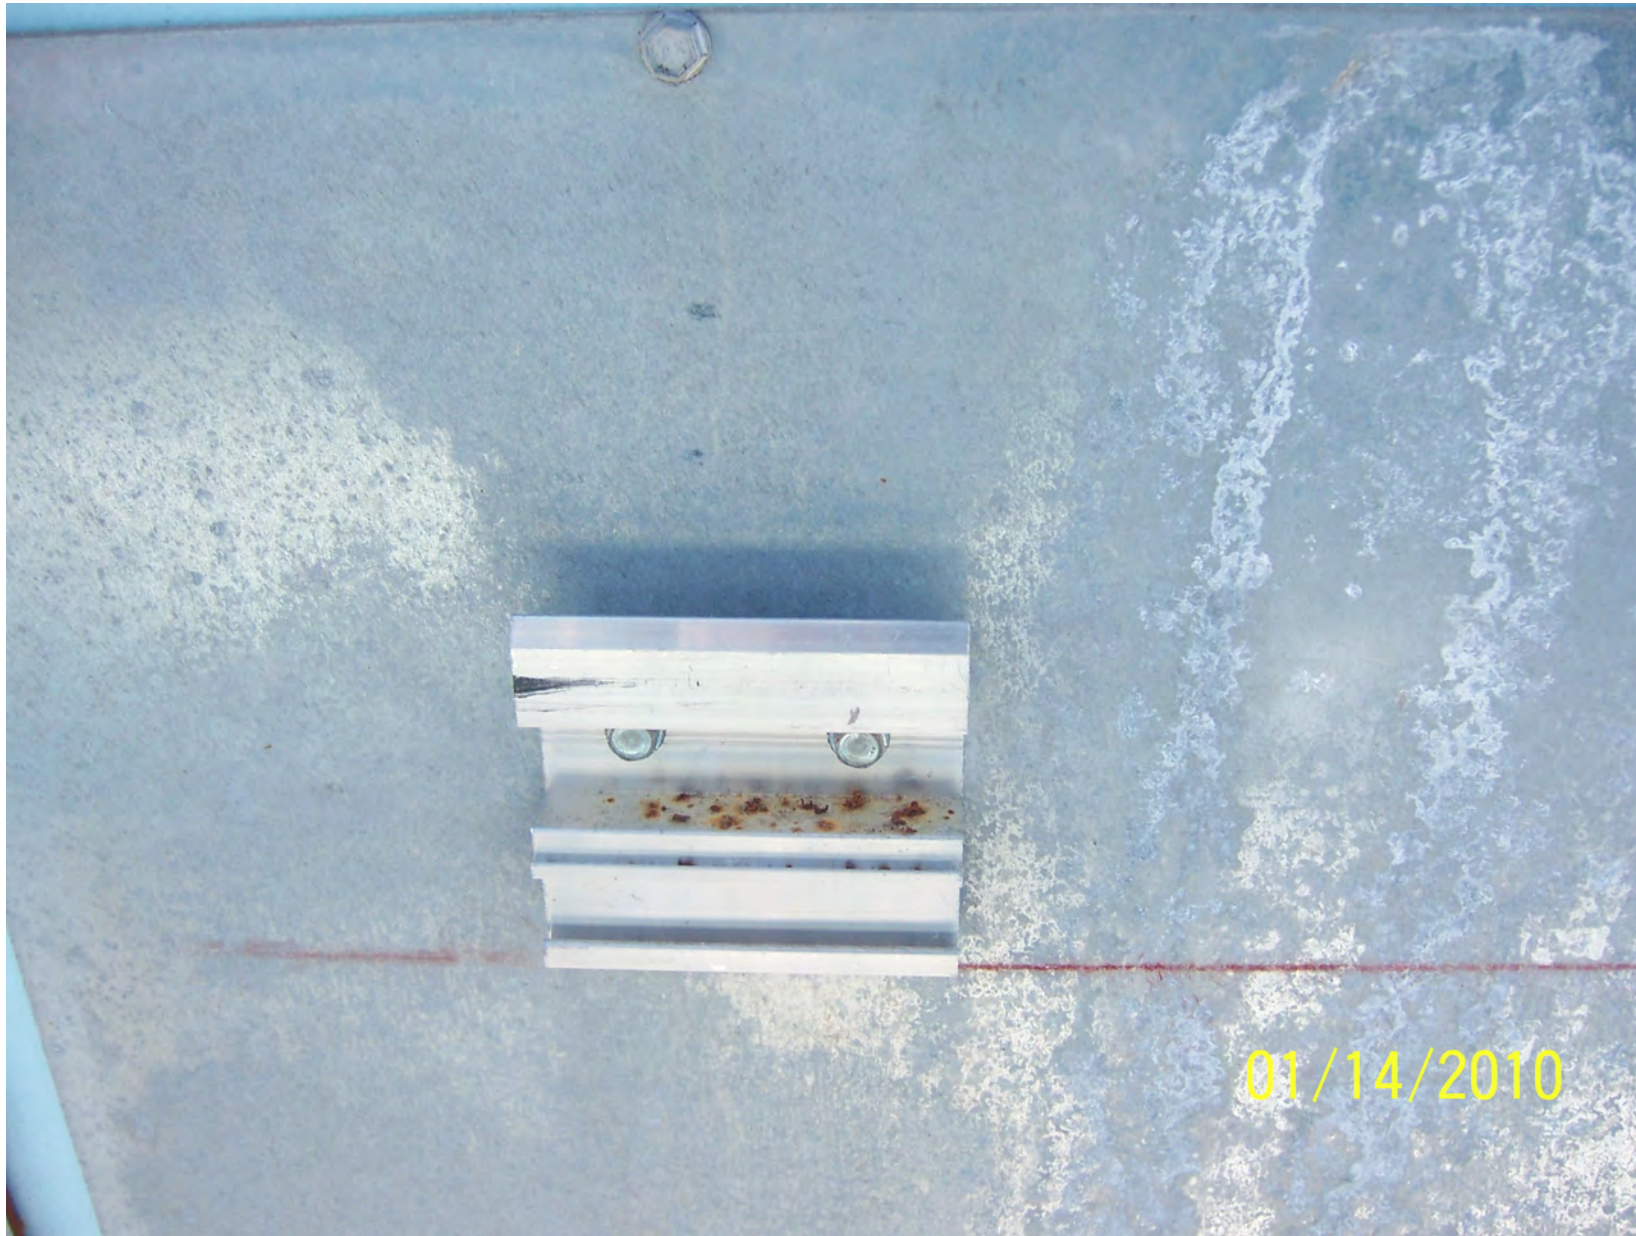
The corrosion of the mounting hardware seemed fairly significant based on its age.

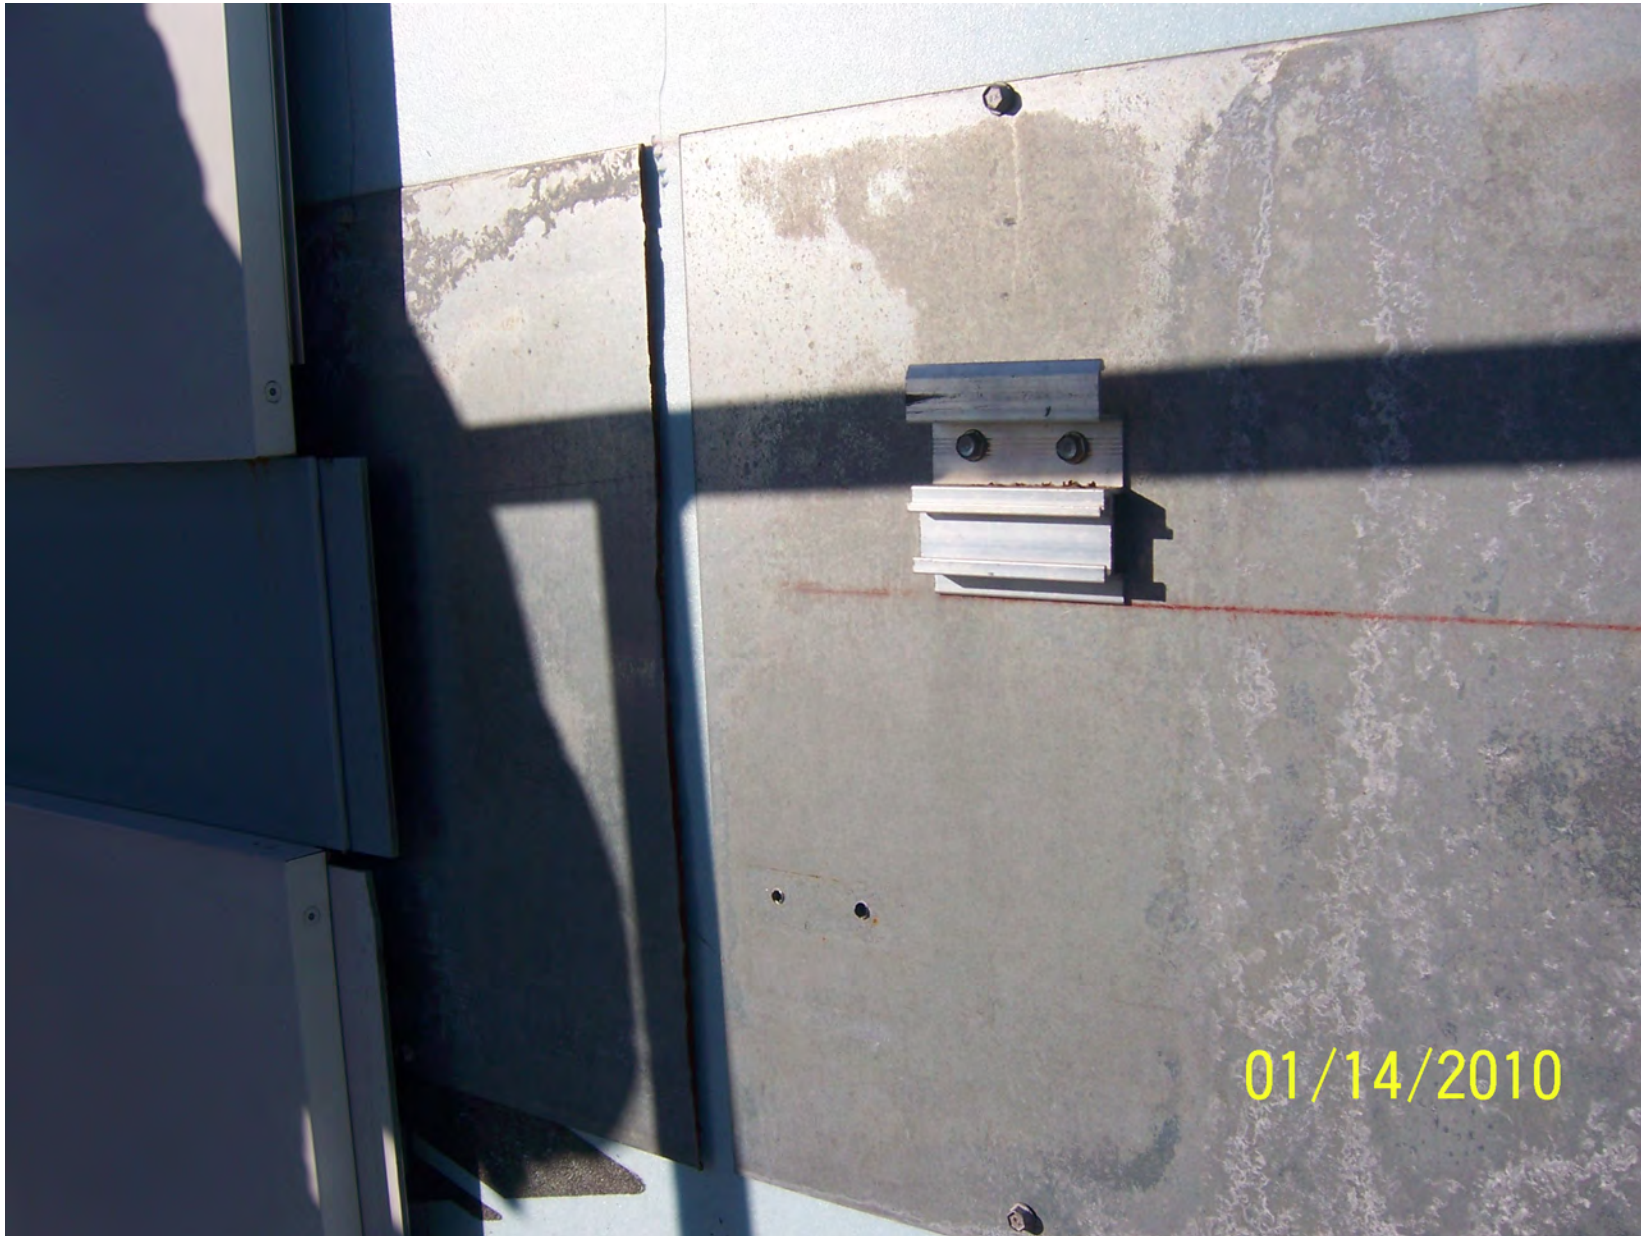
**High RH levels in the rainscreen cavity are the most likely cause of the premature corrosion of the metal items in the rainscreen cavity.**

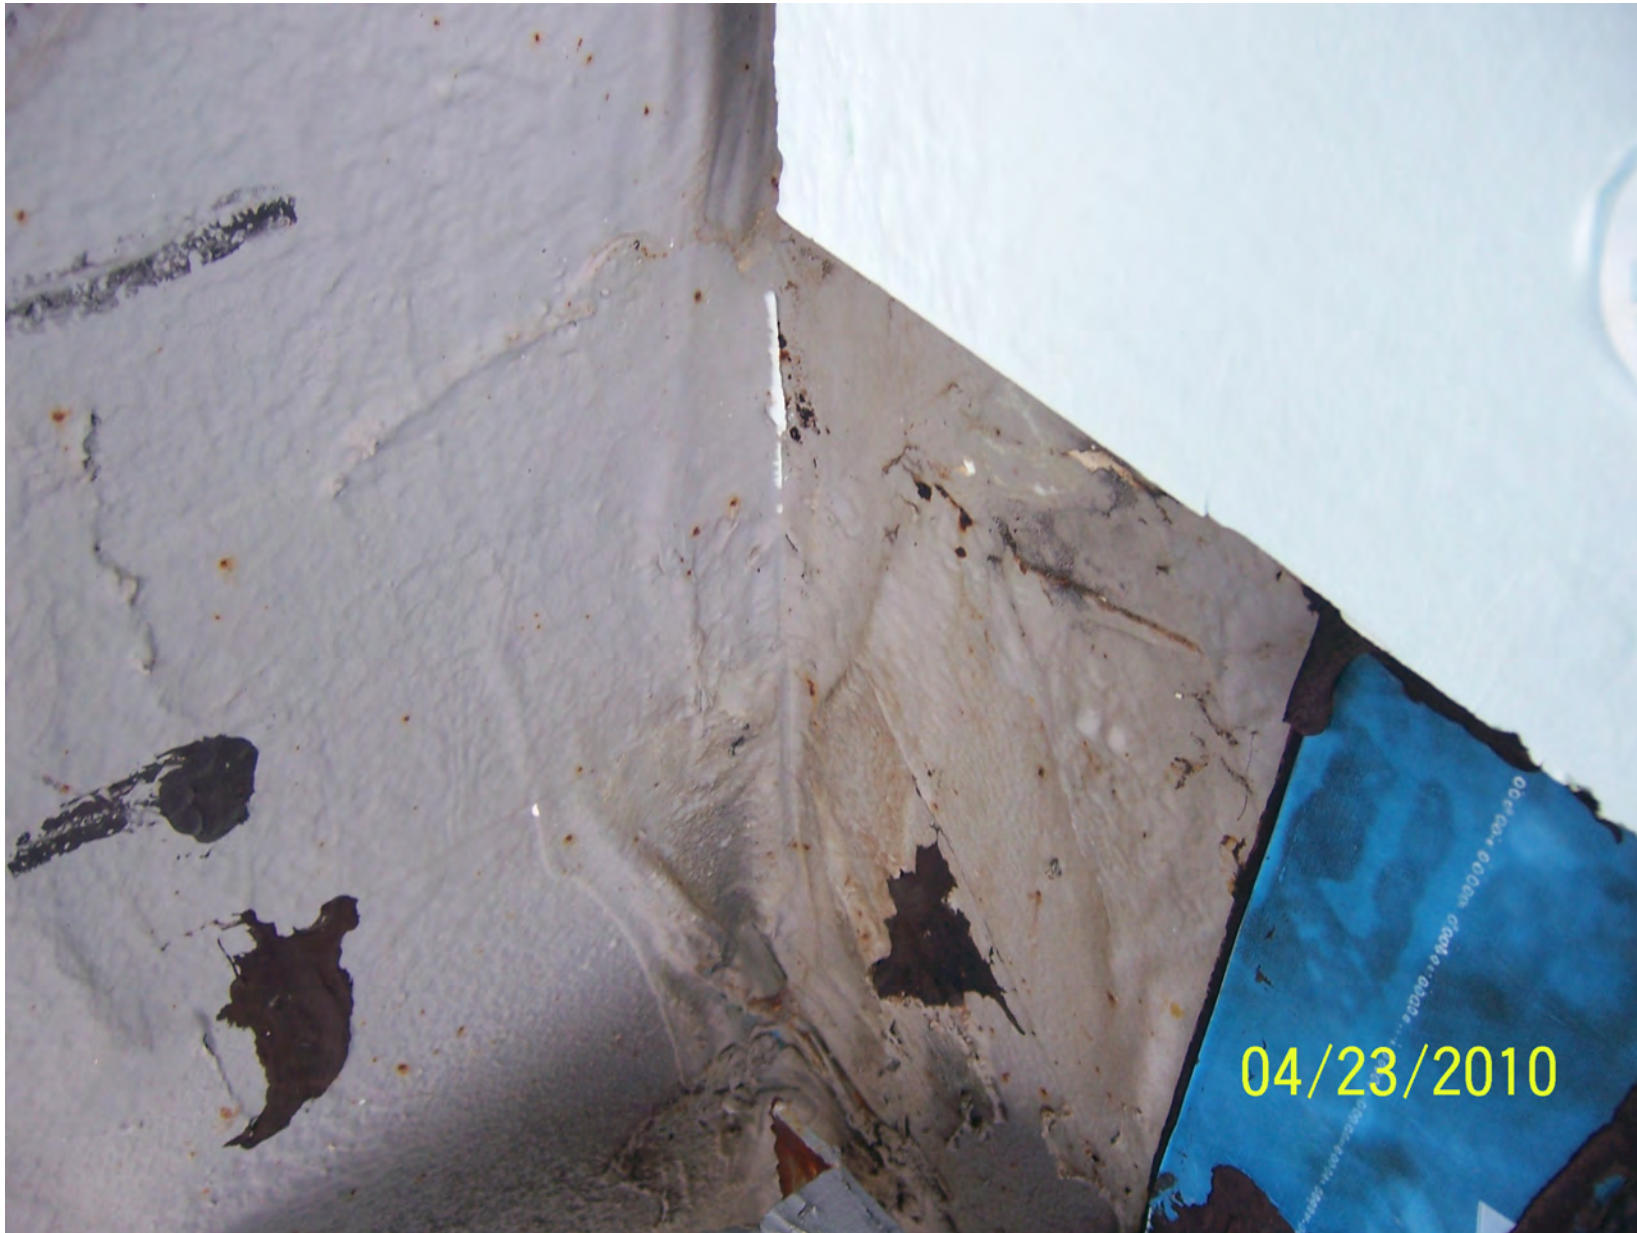
The adhesion of the S/A detail membrane was failing at many locations

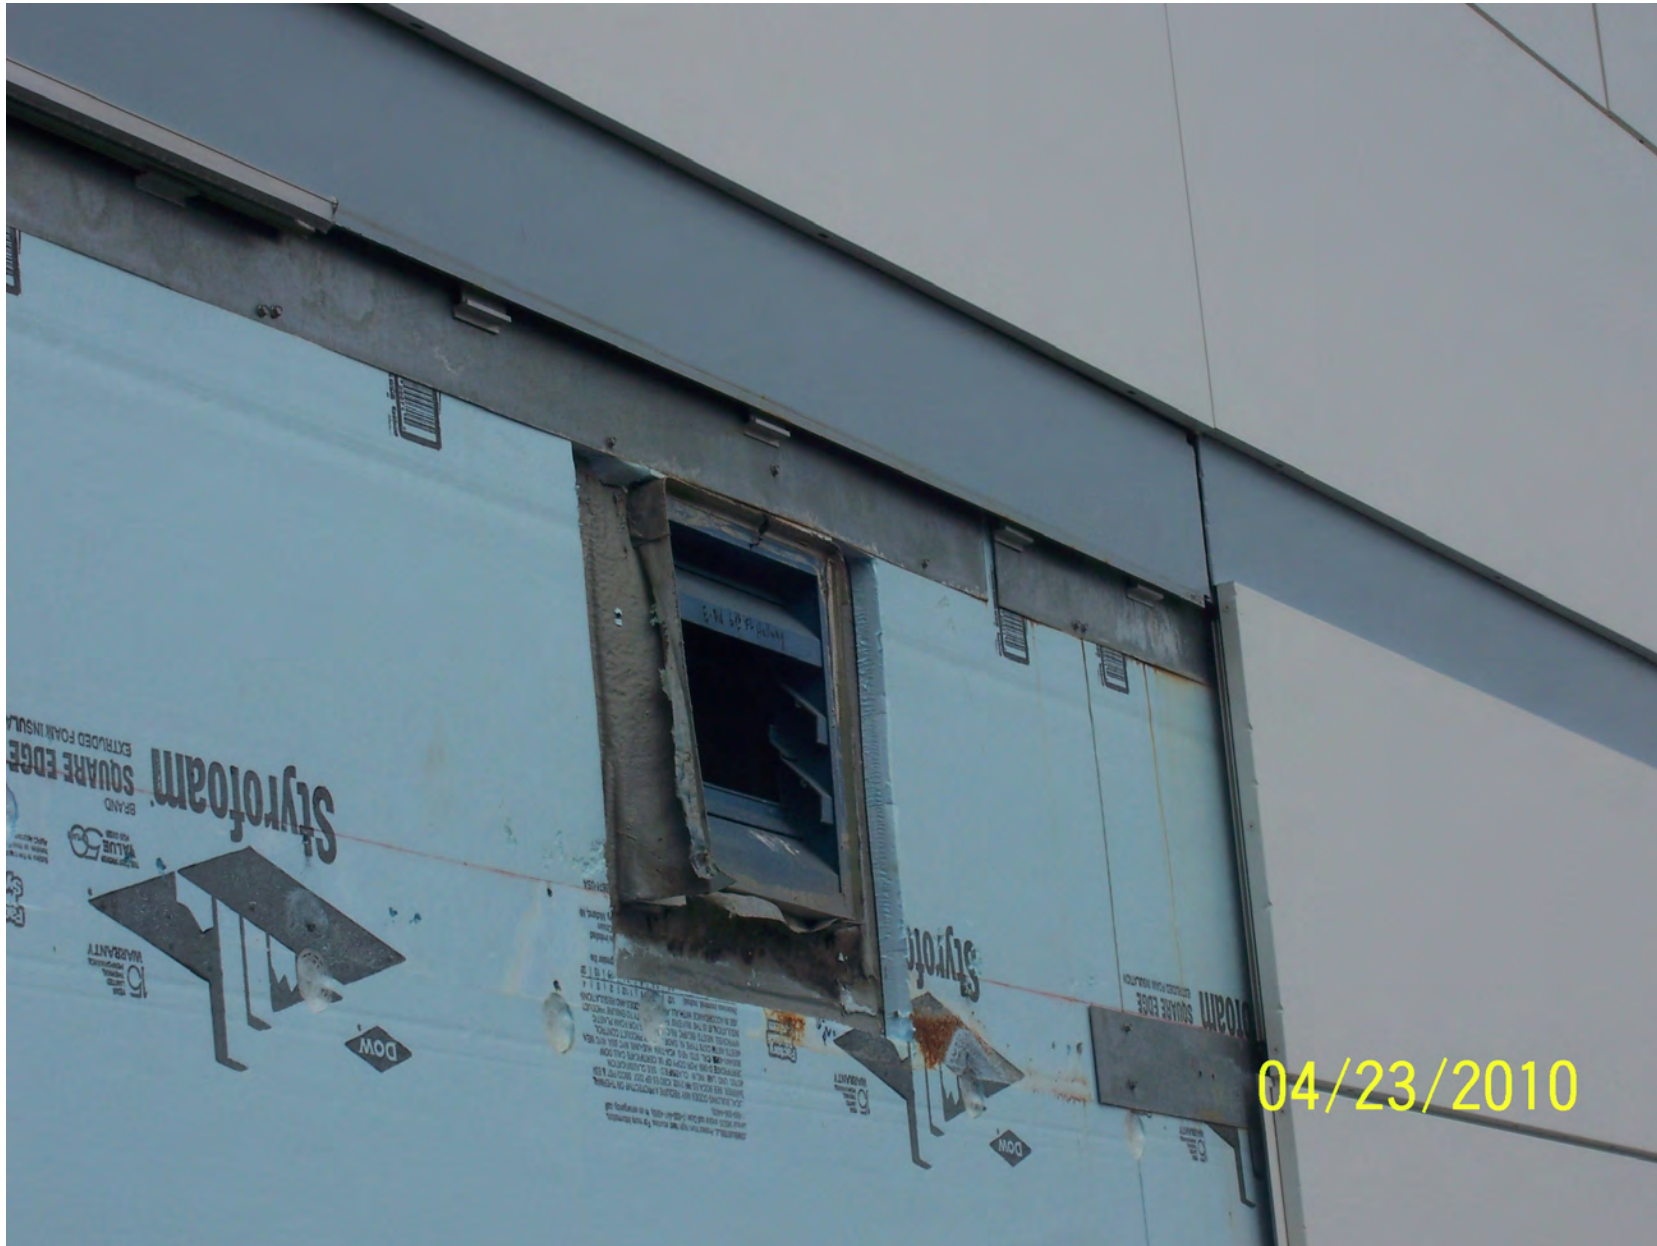
The adhesion of the S/A detail membrane was failing at many locations

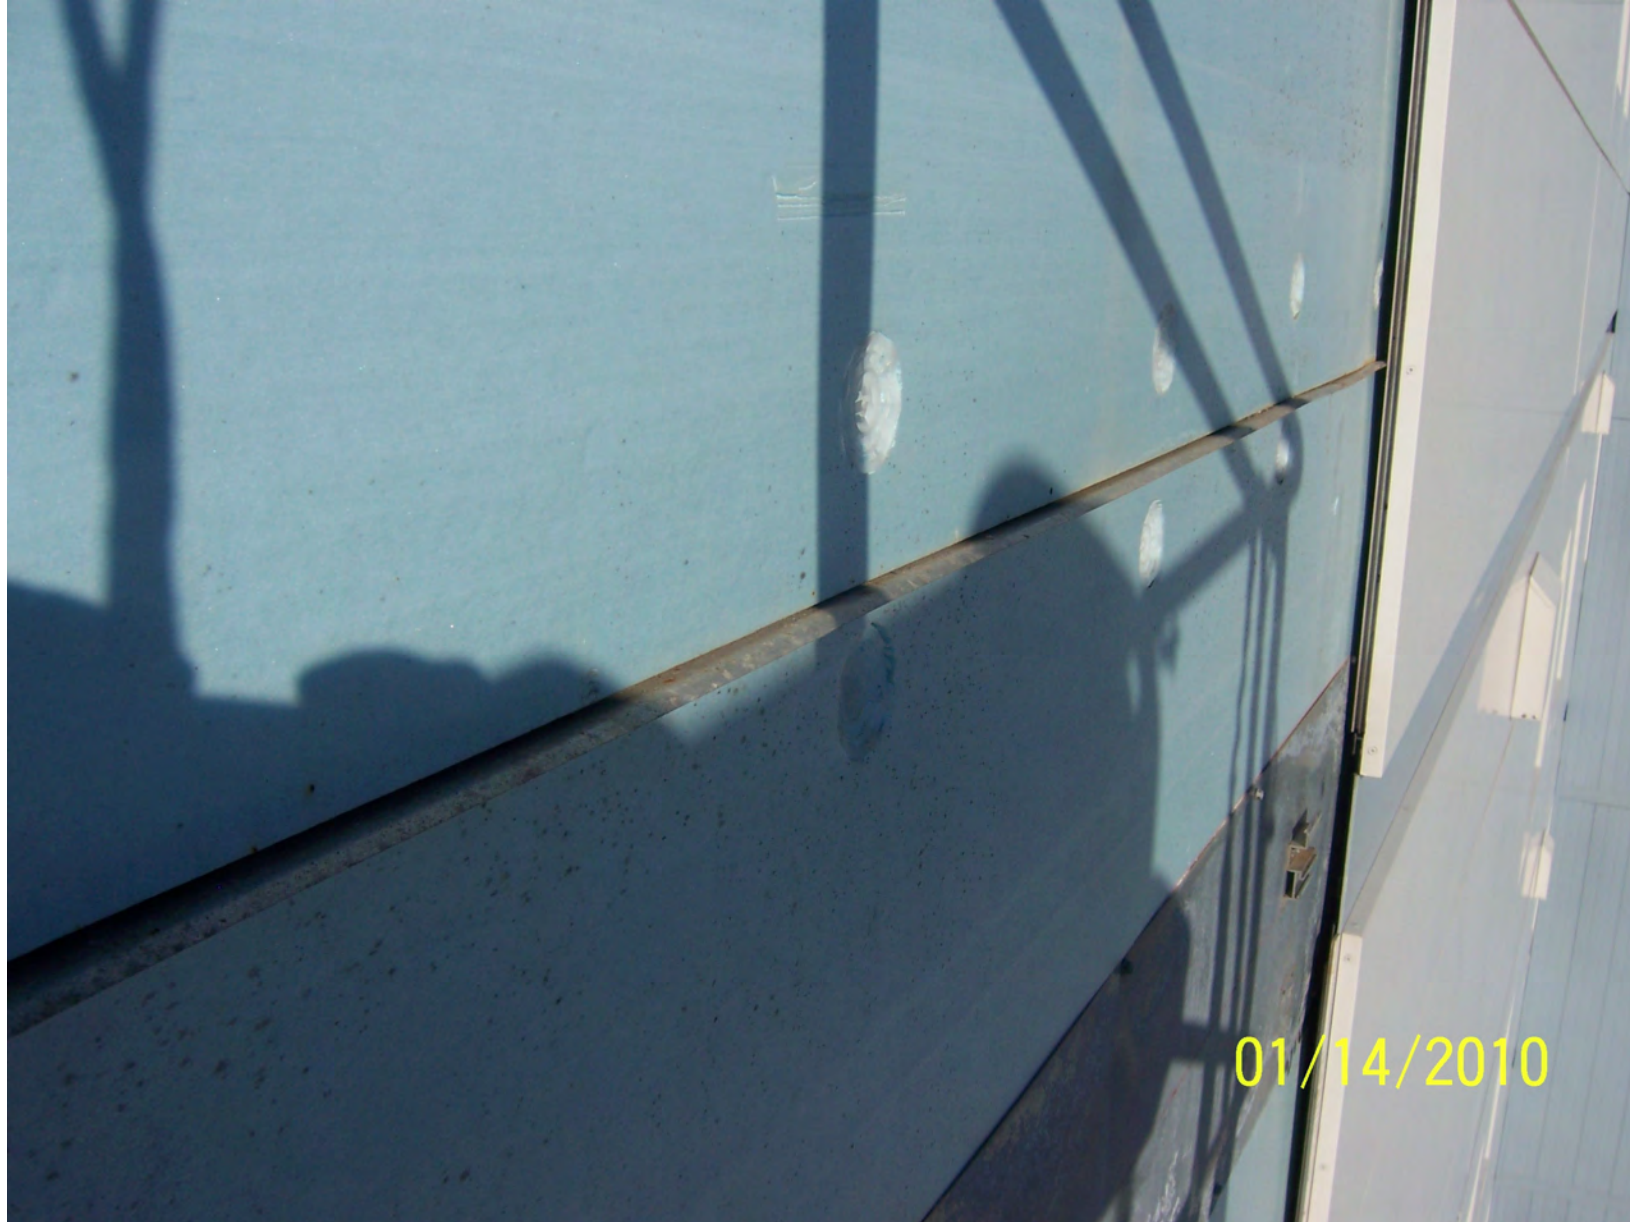
The “kick out” flashing

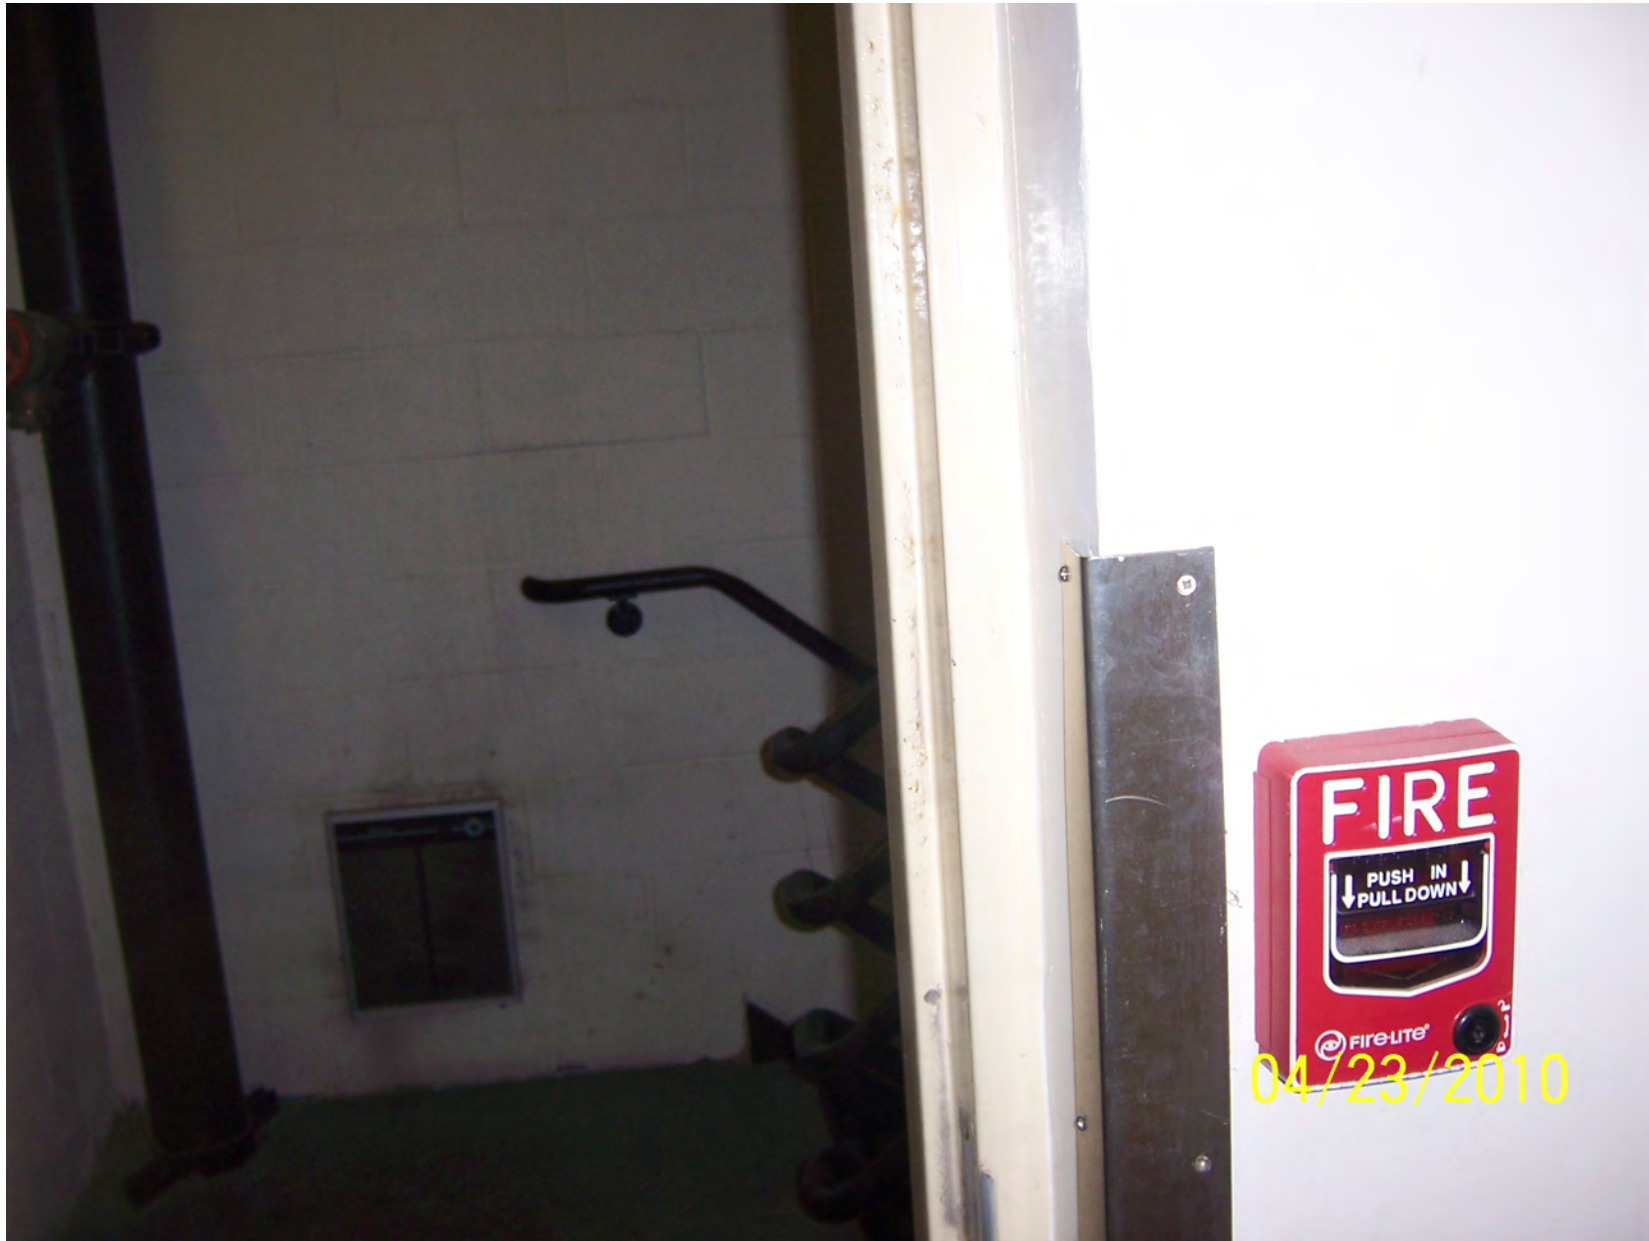
The stairwells that were supposed to be positively pressurized were sucking air into them.

4. If the building is experiencing significant negative pressurization when it is supposed to be positively pressurized.....

Fix it!!!
