air barrier  
**abaa**  
association of  
america  
**CONFERENCE  
& TRADE SHOW**  
MARCH 26-27  
**2019**  
NORFOLK  
**VA**  
AIR BARRIER EDUCATION TRACKS FOR  
THE CONSTRUCTION INDUSTRY

# Avoiding Building Enclosure System Failures

Len Anastasi

*EXO-TEC Consulting, Inc.*

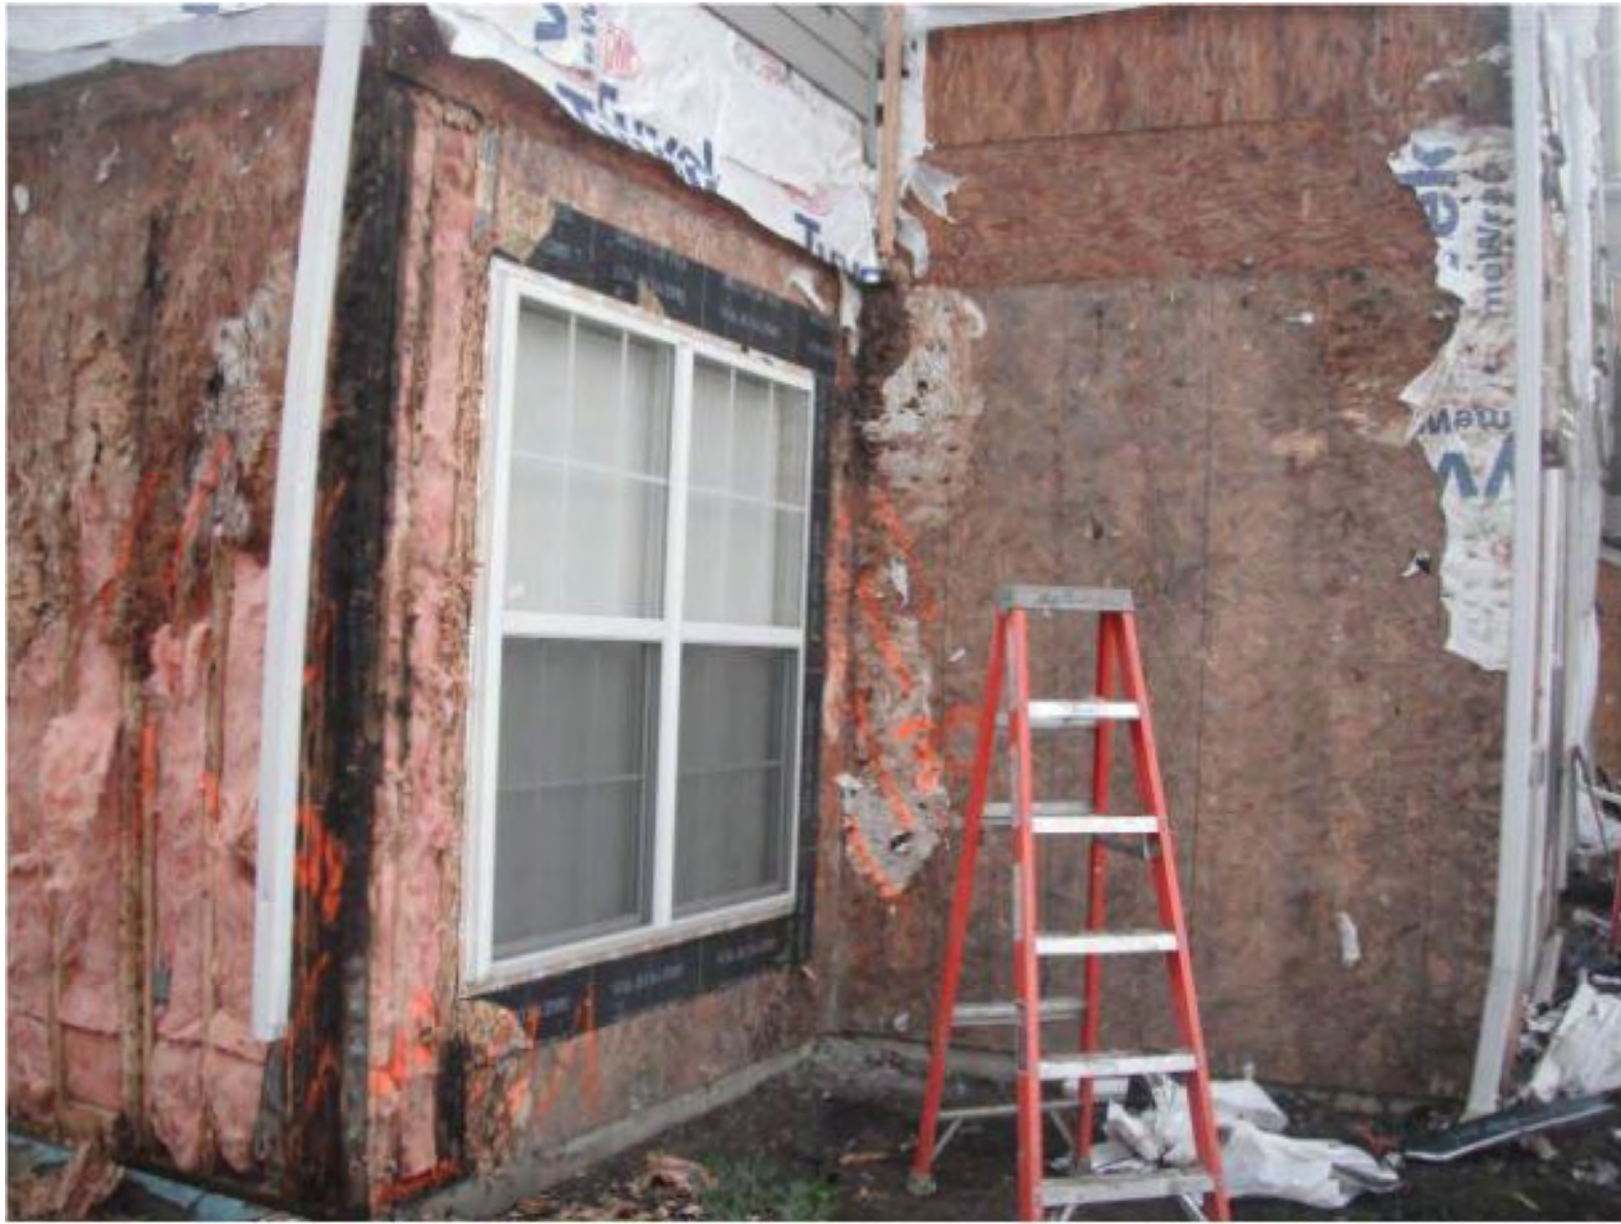
# The Failure

**All of the sheathing behind the thin stone veneer exhibited water damage and had to be replaced.**

**Properly drain and vent the  
veneer ( absorptive  
cladding system ).**

**A 1/4" wide drainage space  
is needed for water to  
effectively drain and vent  
an absorptive cladding  
system.**
