Can A Poor Air Seal Cause Roof Failure?

Timothy A. Mills, P.E., LEED AP, CIT II

TAM Consultants Inc.

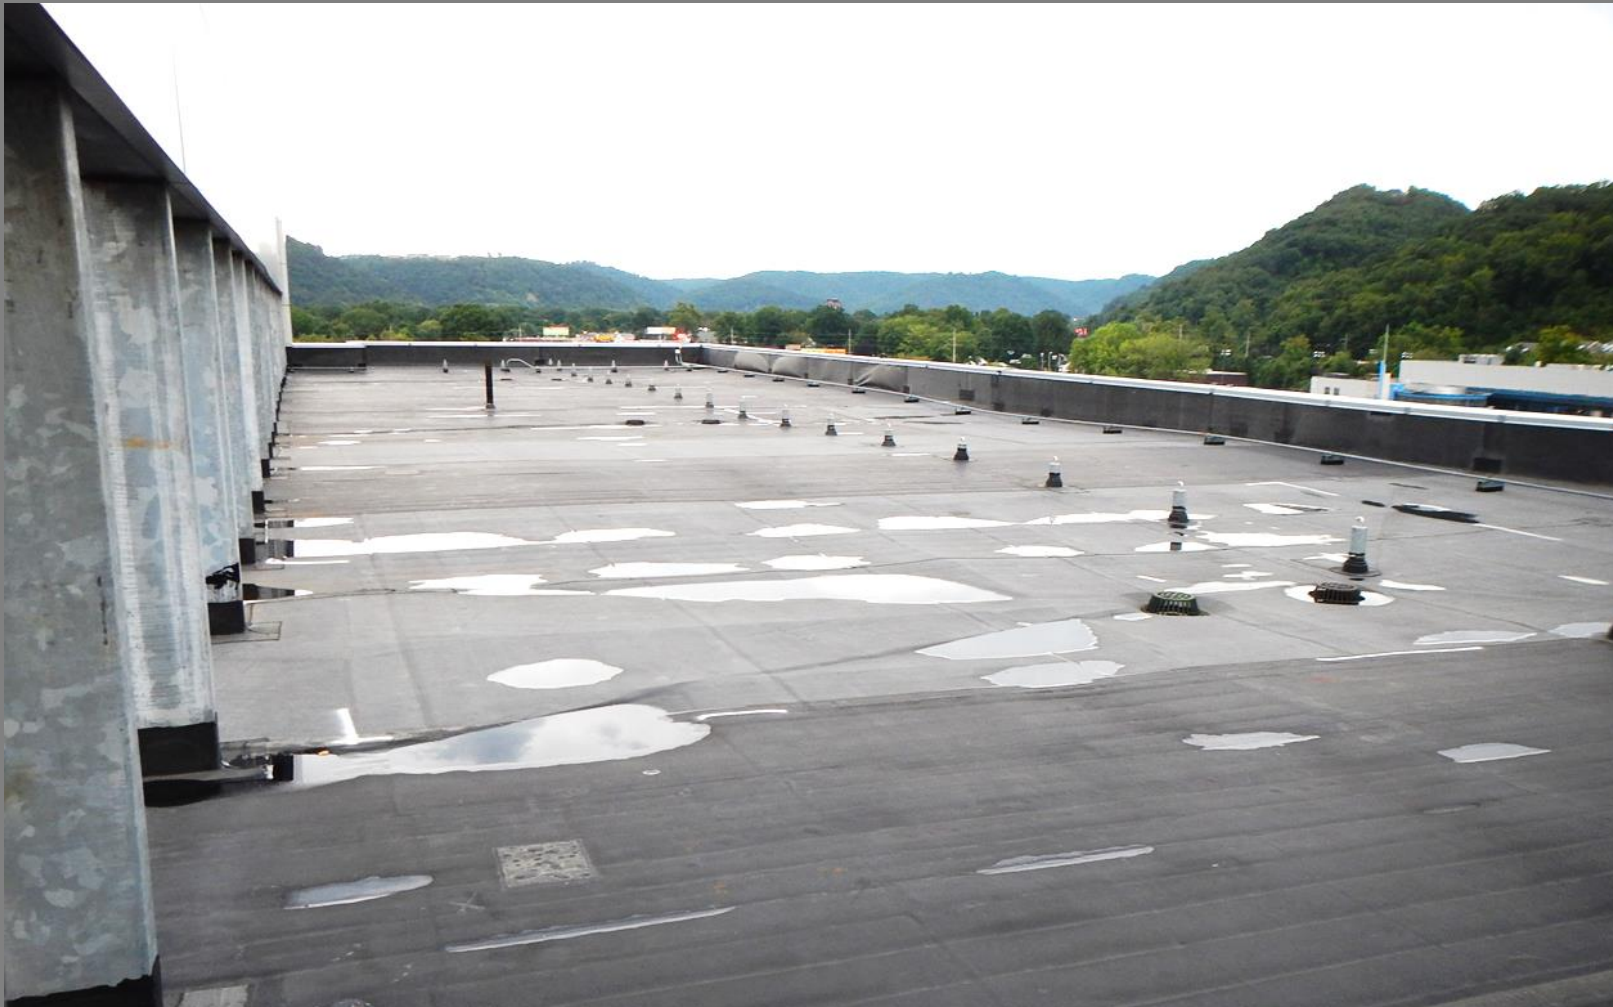
- Visual observations immediately indicated that there had been widespread bowing, cupping, delamination, or debonding in large areas of the roof insulation.
- This was readily visible on approximately 30 percent of the roof area.

View of roof area following a storm event, where ponding areas and insulation deformation is more evident.

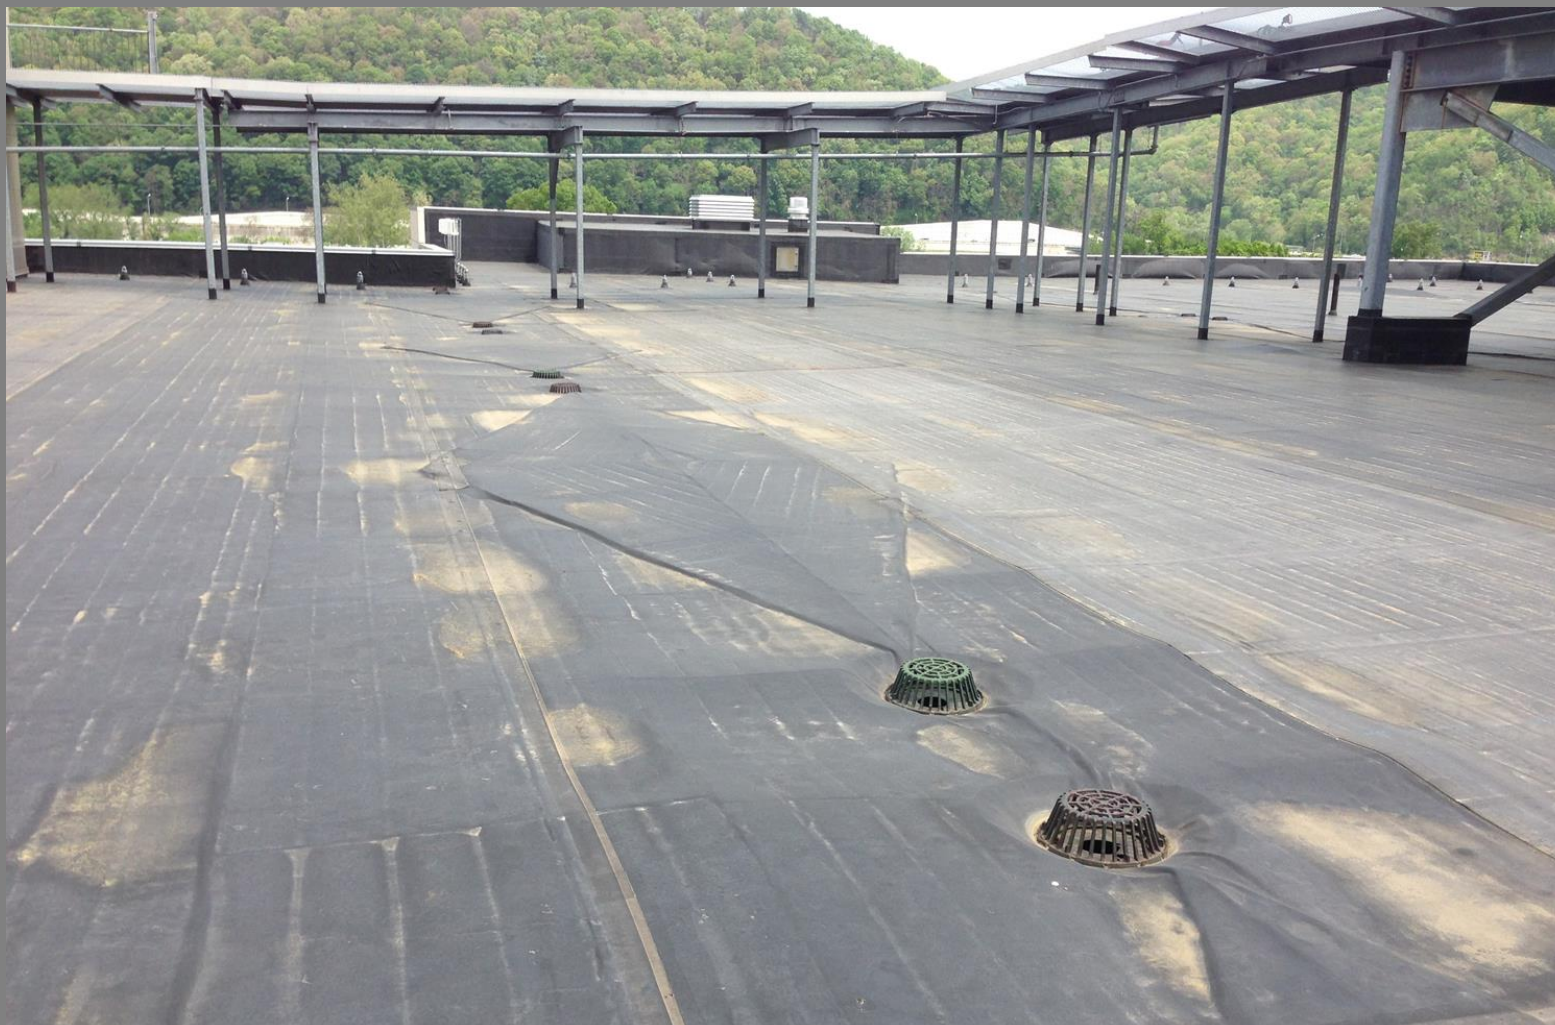
- The displacement of the insulation was severe enough that it created a series of many ponding areas across the roof and impeded water flow, preventing the roof from easily draining.

View of failed roof system, the photo does not convey the large amount of insulation deformation, note dirty spots where ponding frequently occurs.

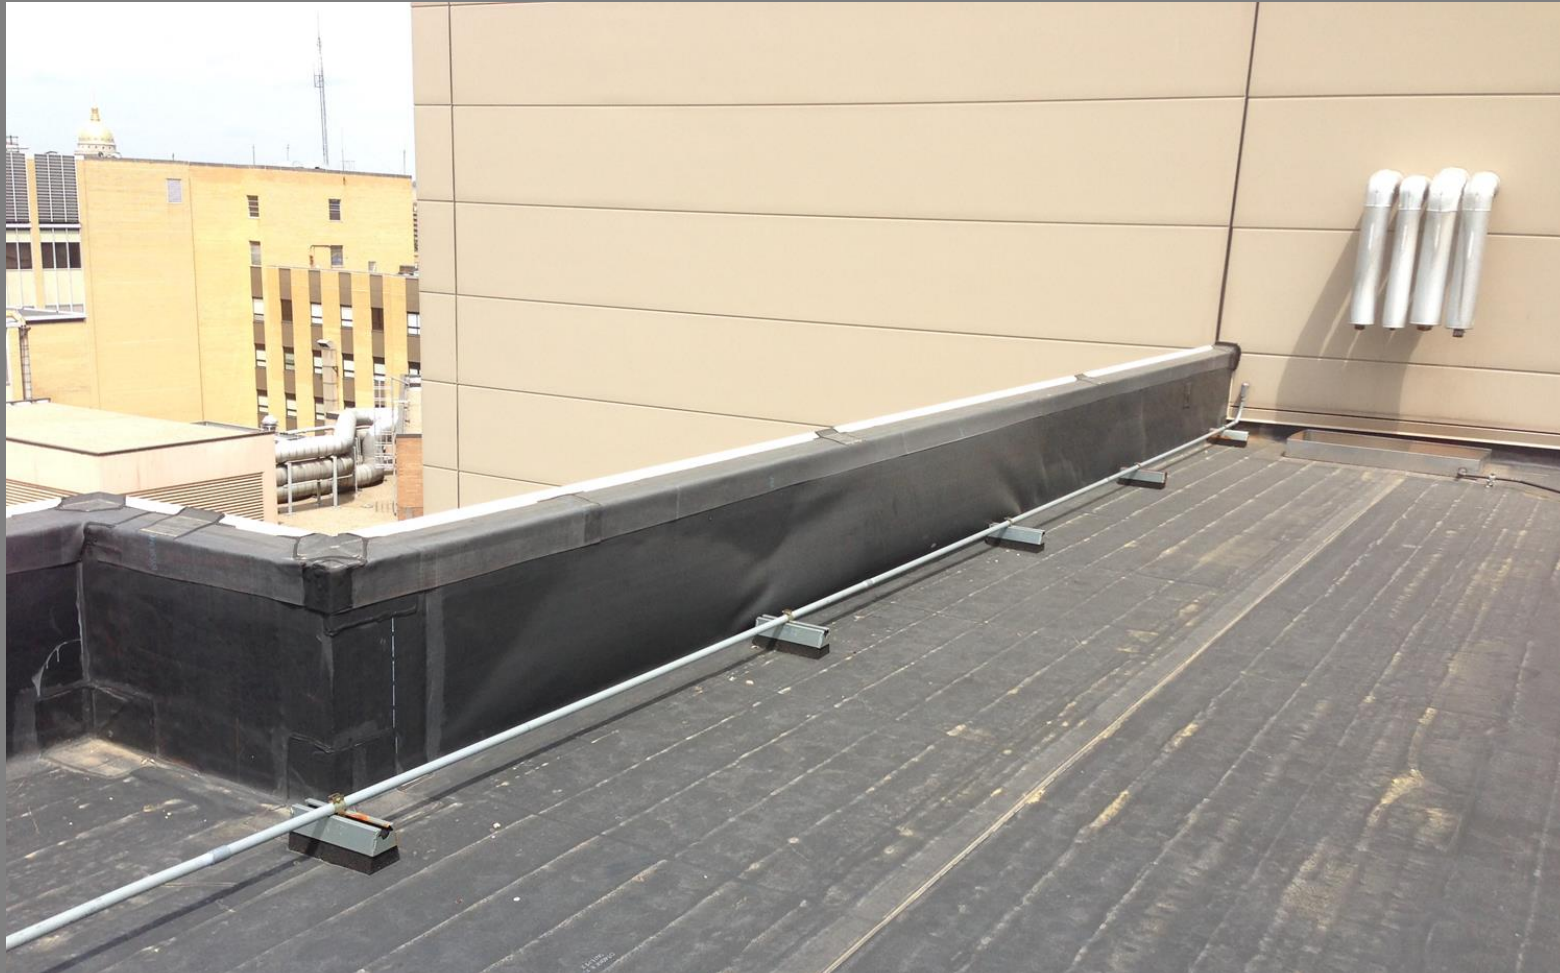
- During the inspection of the lap seams it was determined that in general the EPDM roof membrane seams appeared to be in serviceable condition with very few deficiencies noted and in need of perhaps a small amount of maintenance.
- The fully adhered roof membrane had separated from the pre-cast parapet walls in a large number of areas around the entire perimeter of the building.

View of a parapet wall where EPDM membrane has debonded from the wall surface.

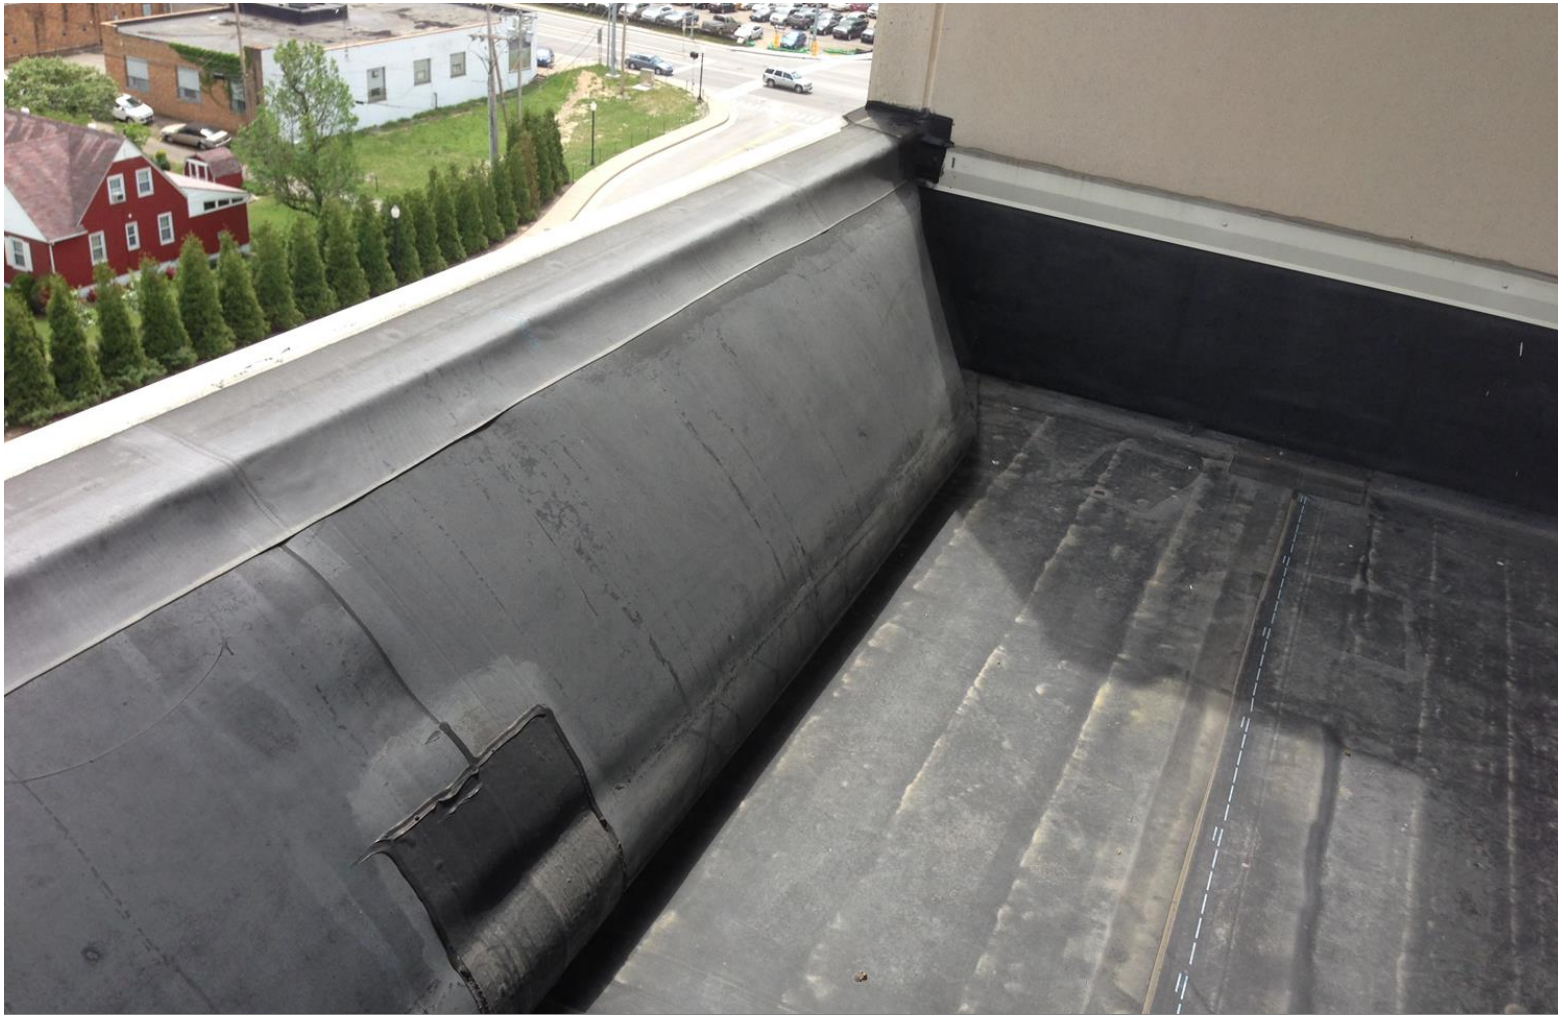
- Interior building air pressurization from the mechanical system was affecting the roofing system.
- The membrane was ballooning out due to internal building pressure.
- The membrane had also become debonded from the reinforced EPDM strip at the base of the wall.

View of parapet wall where membrane is ballooning out and has deboned from the pre-cast concrete wall.

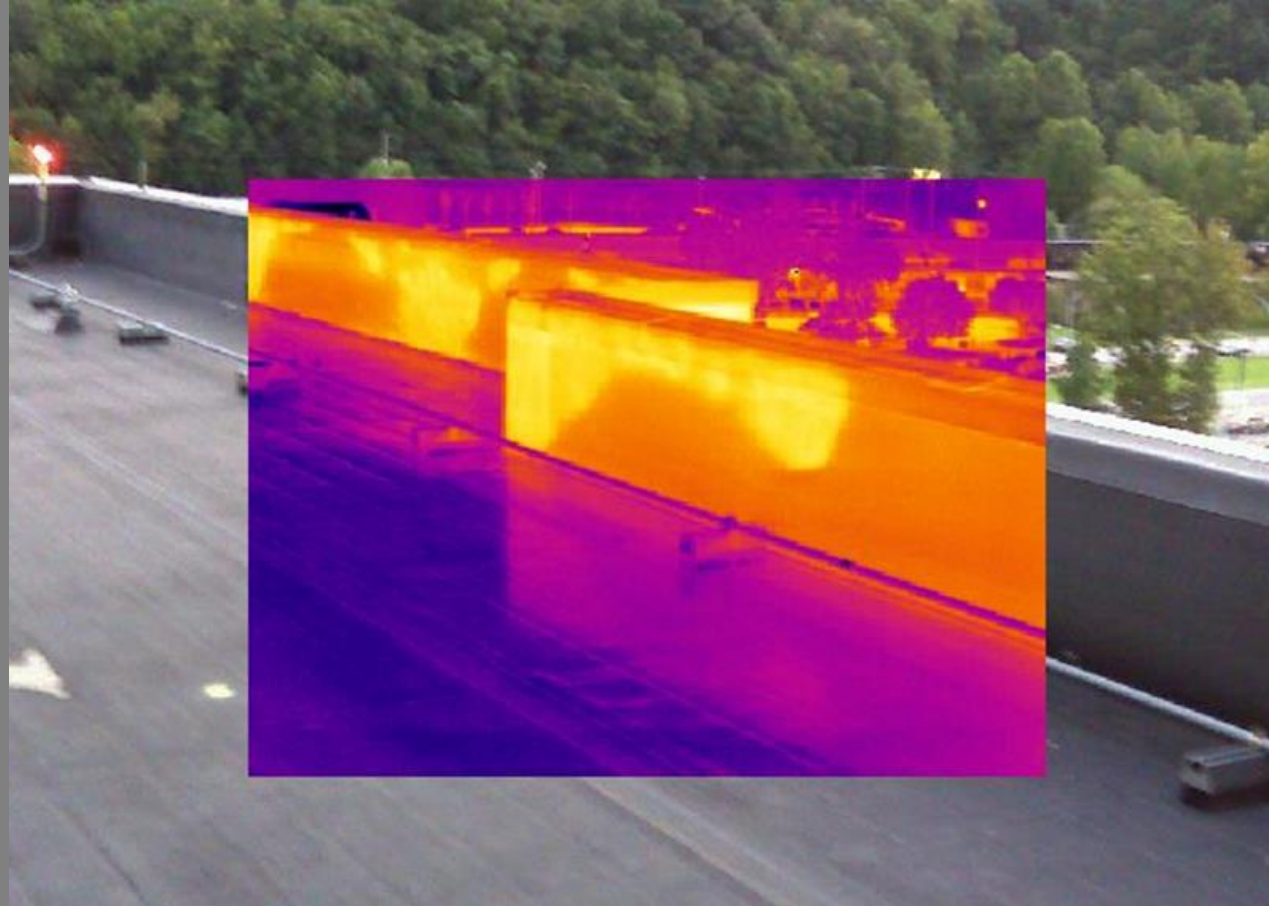
- The thermal imaging survey also clearly revealed areas of debonded roofing membrane at the parapet walls around the entire roof area.
- It became clear that conditioned air from the interior of the building was easily finding its way to the roof level at the perimeter condition where the roof deck and parapet wall meet.

Thermal image of parapet wall where membrane separation is clearly visible.

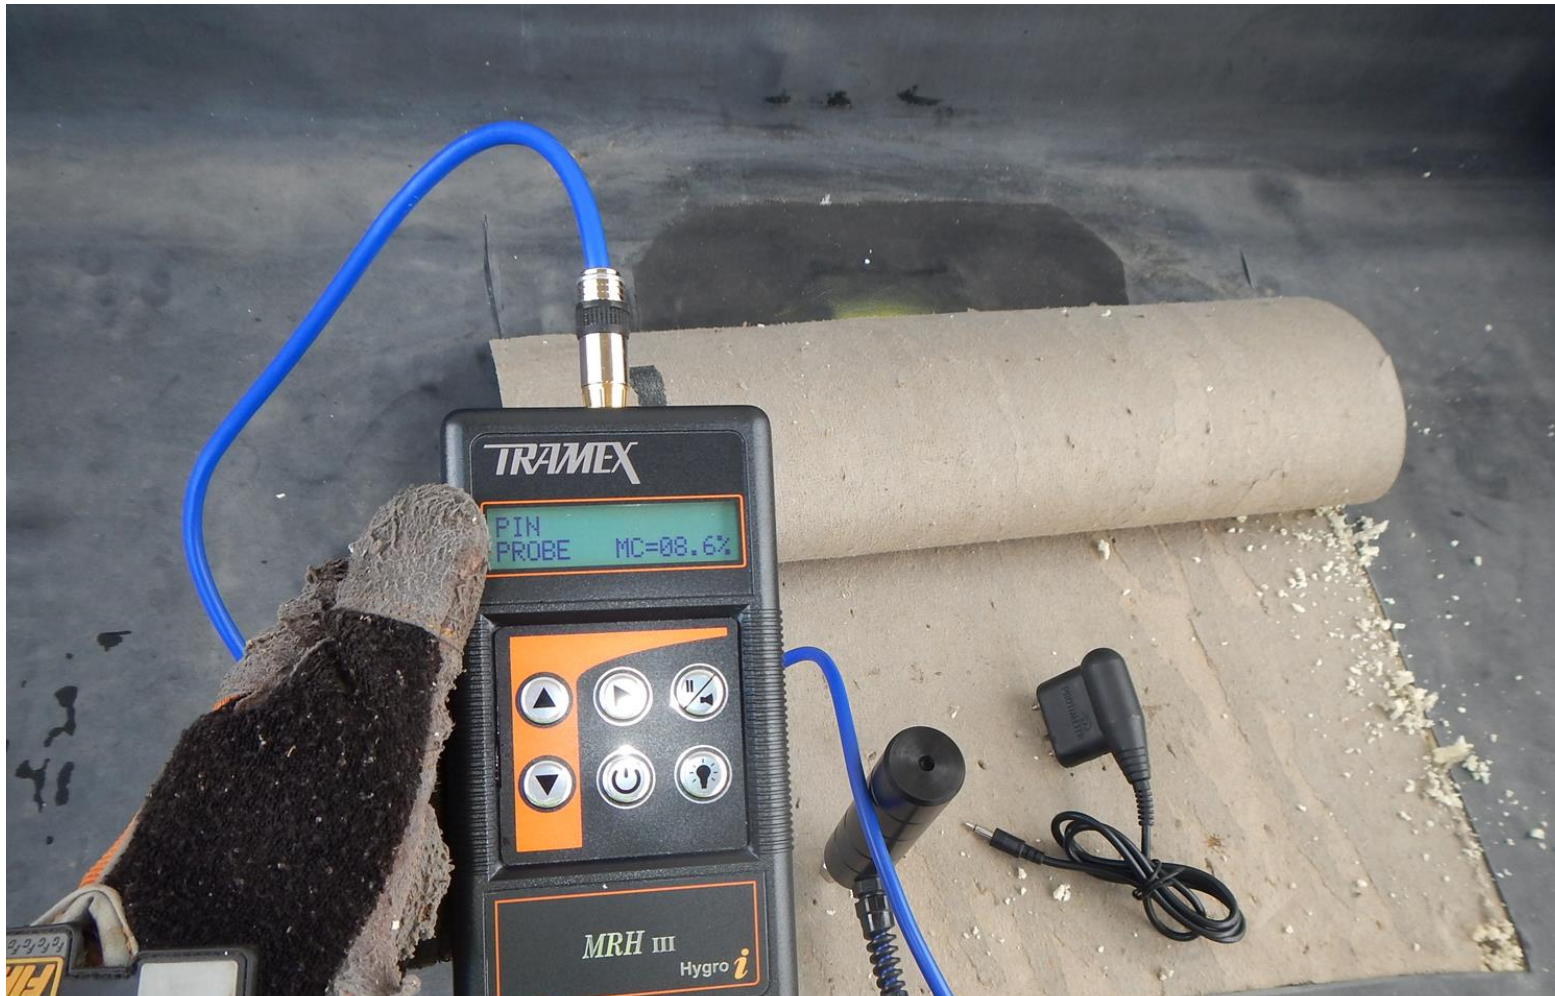
Using a moisture meter for a quick check for moisture content at both the surface and deep layers of insulation.

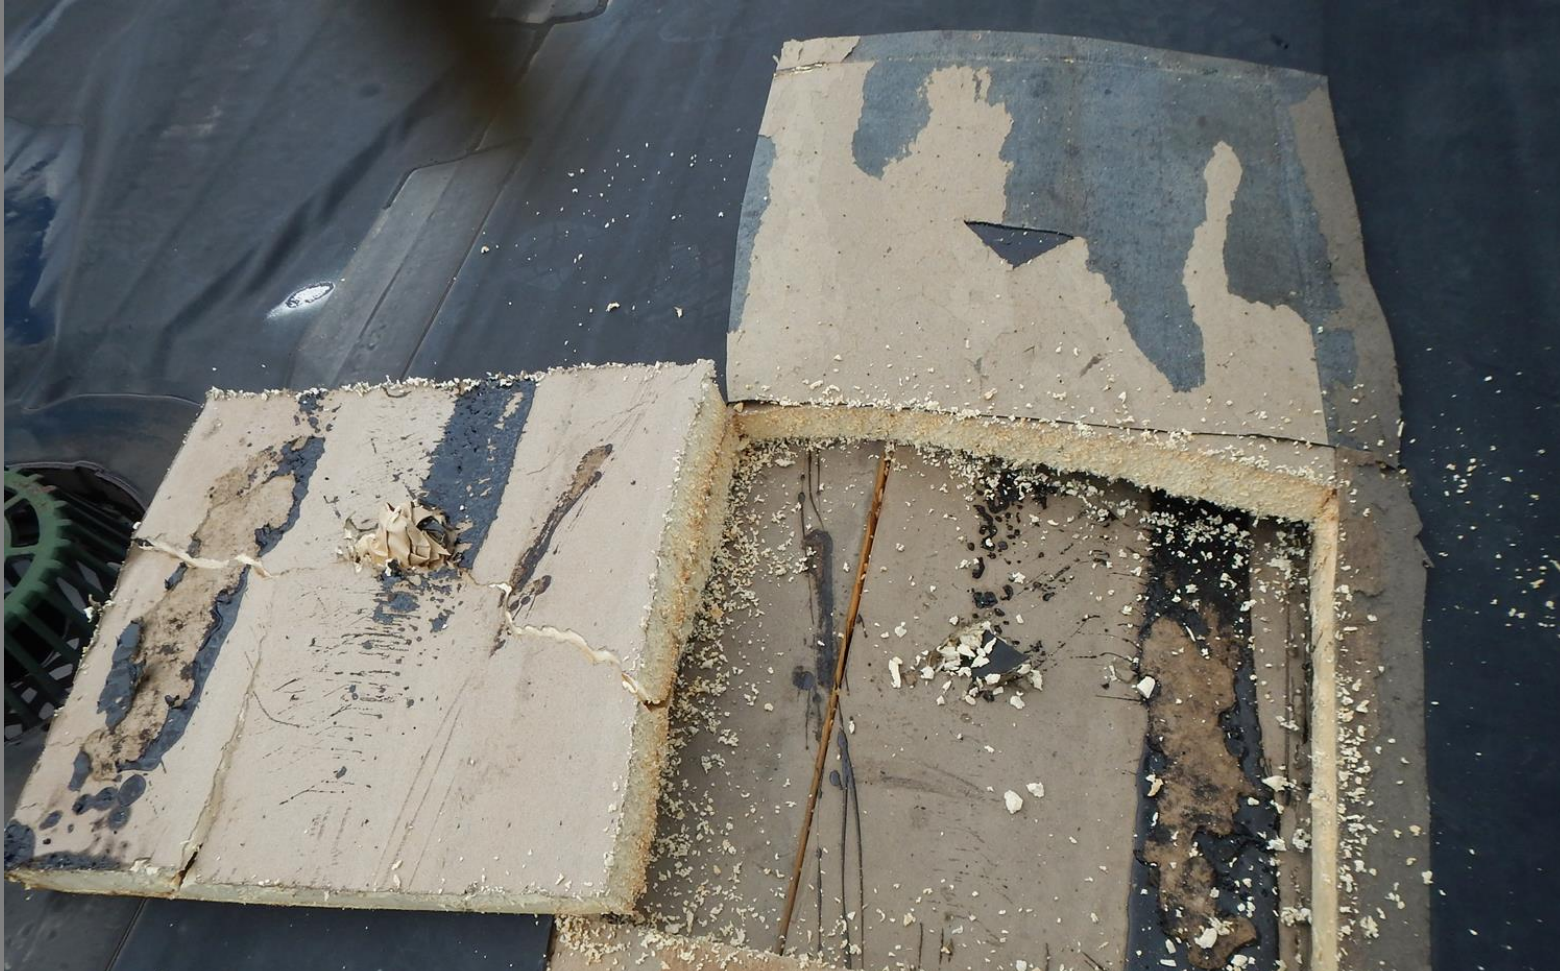
- Five roof core cuts were made.
- Four in the field and one at the parapet wall.
 - Interlayer adhesion for the various rigid board insulation layers was poor.
 - Poor adhesion occurred as a result of either:
 - too little asphalt,
 - the use of asphalt that was too cold,
 - insulation boards that are not stepped into place as they were placed into the hot asphalt.
- .

View of poor interlayer adhesion between insulation boards.

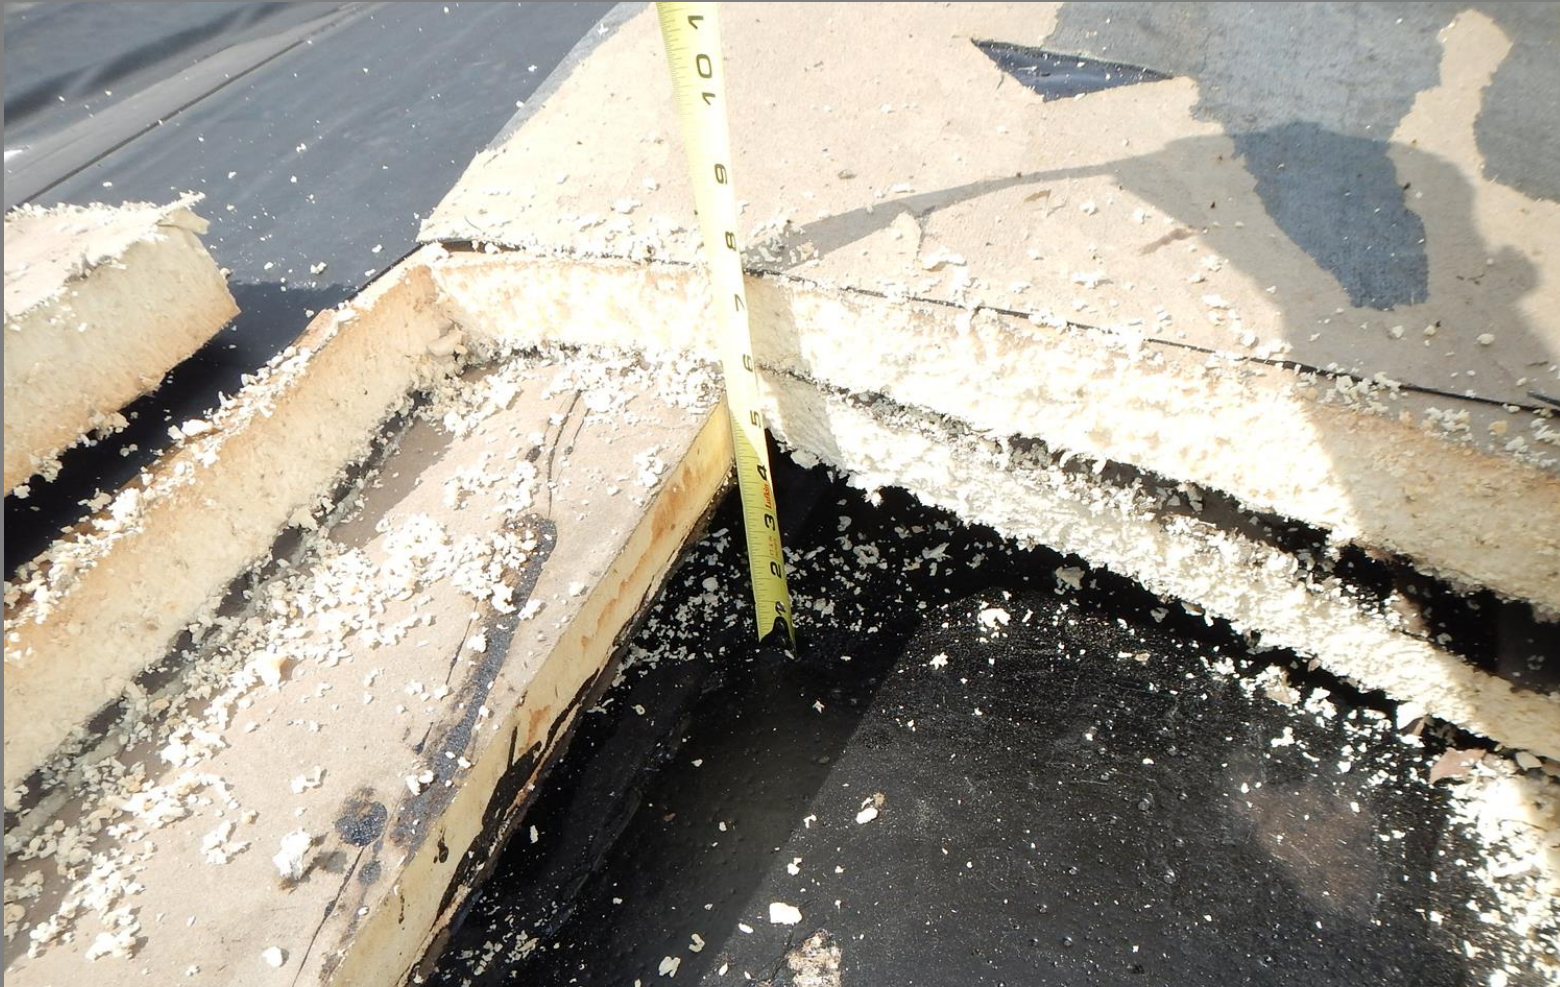
View of deformed polyisocyanurate insulation.

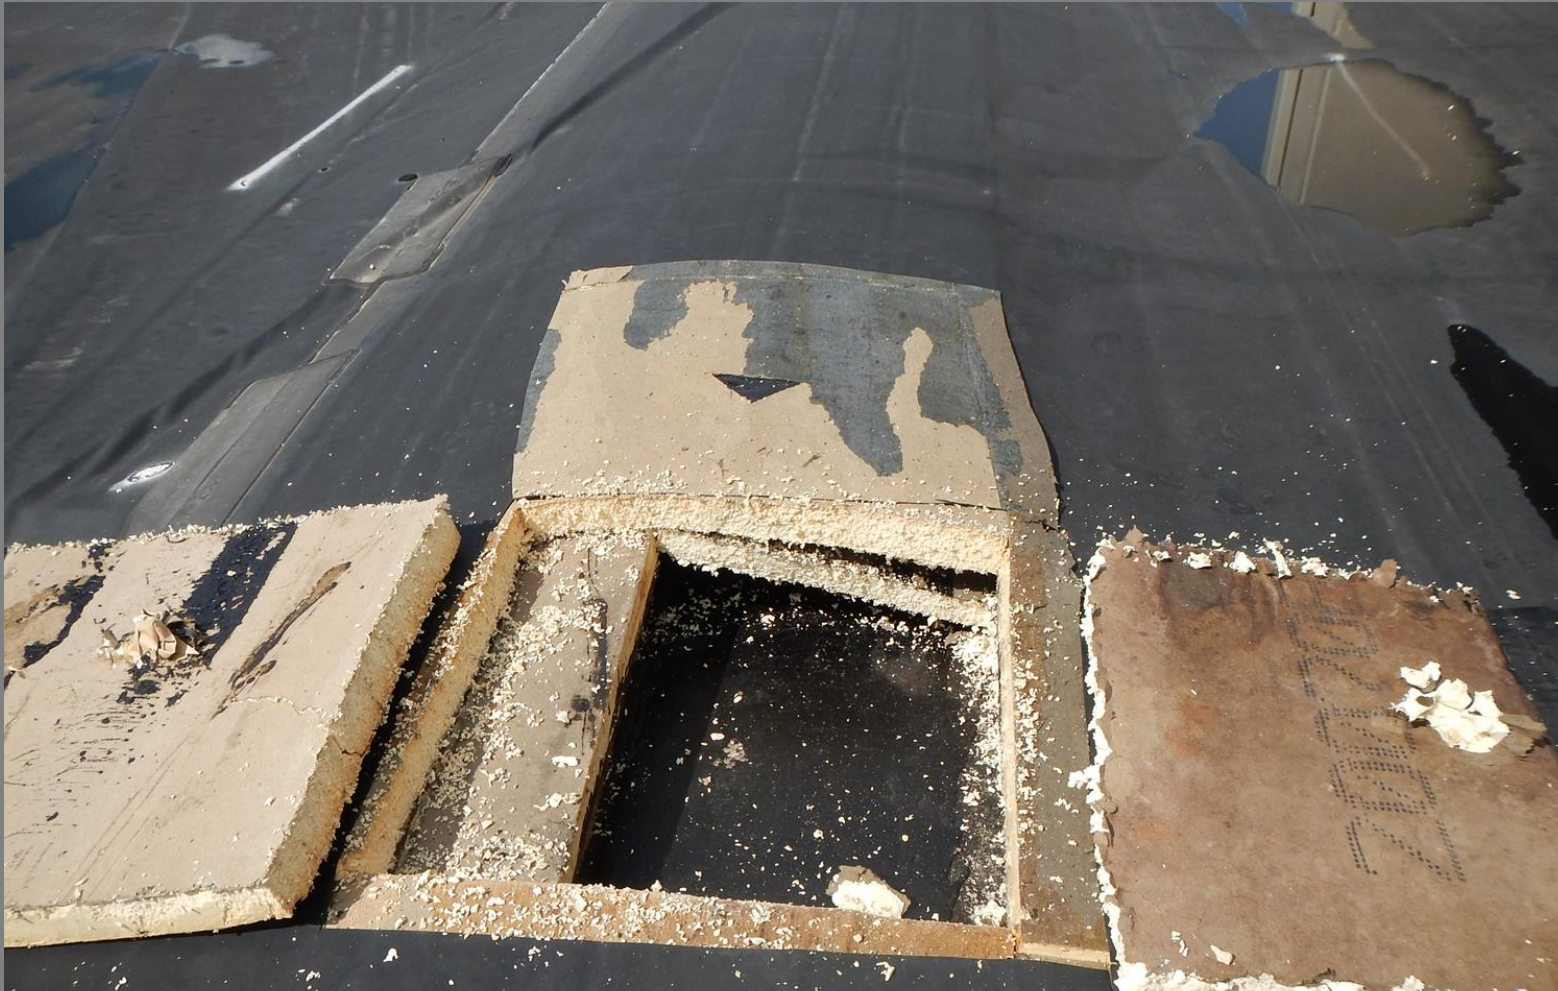
View of large deformation in the insulation, note evidence of water staining even though insulation was dry.

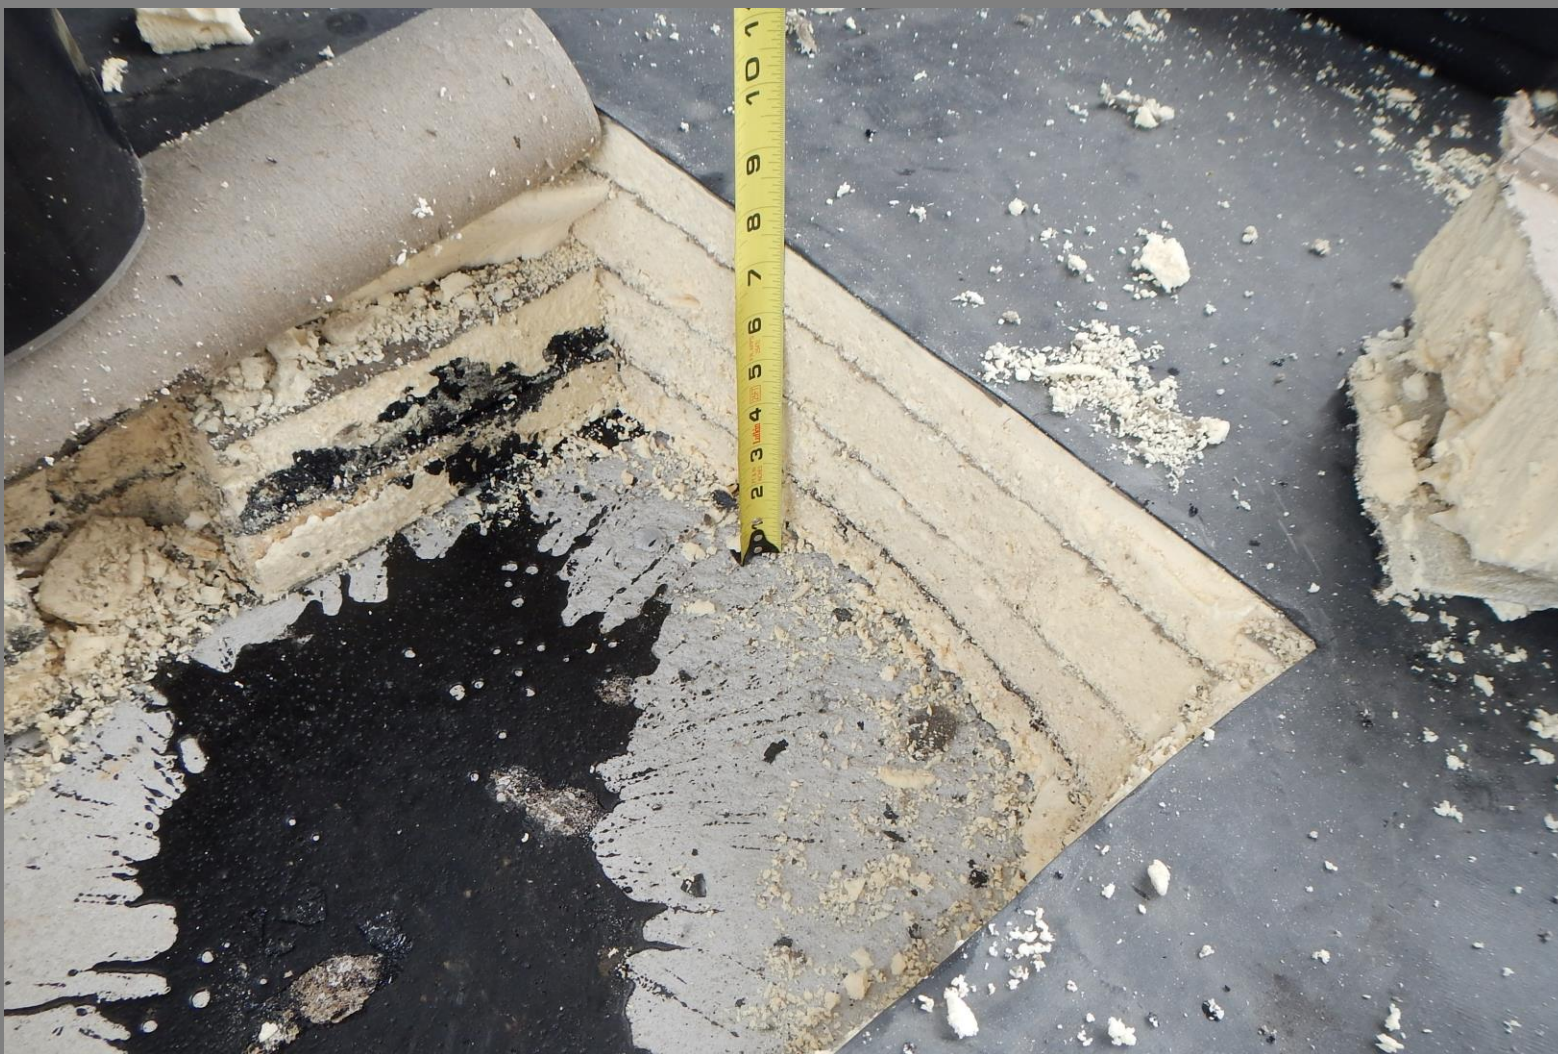
View of poor asphalt coverage on concrete deck

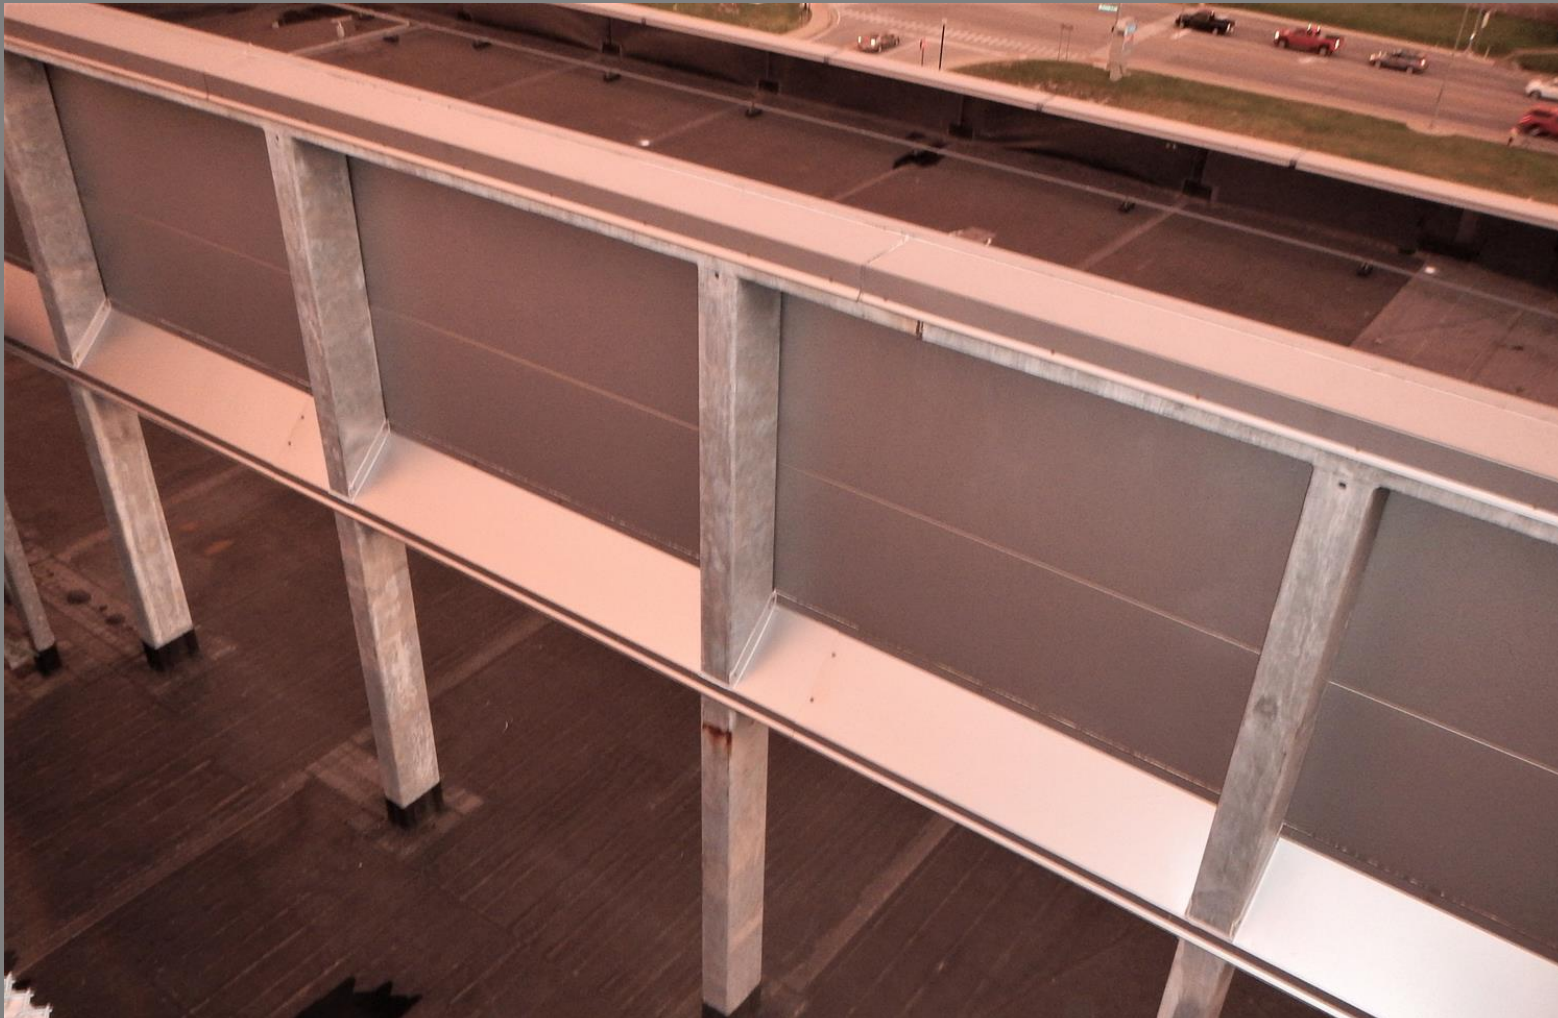
View of mechanical screen galvanized steel columns with exposed drain holes at the top of each column.

- Evaluation of the steel structures revealed small three-quarter inch diameter drain holes in the tube steel members.
- As part of the galvanizing process, drain holes are installed at both ends of the tube steel assembly in order to allow the steel assemblies to drain once they are lifted from the galvanizing dip tanks. Some galvanizing shops will seal those holes with a plug, but often they are never sealed.

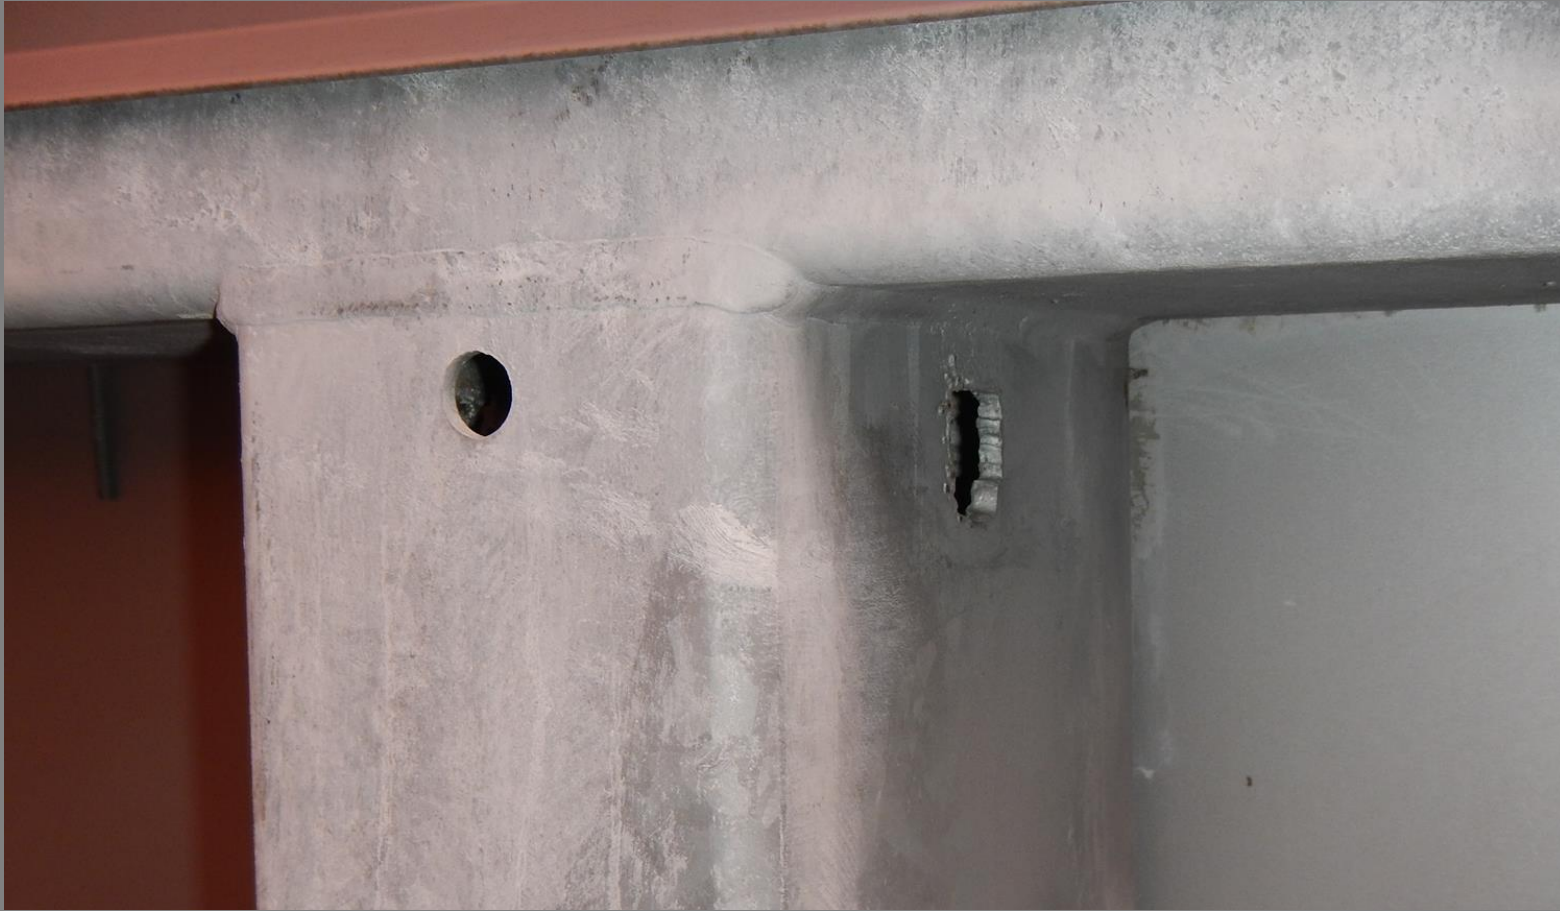
- This observation yielded two conclusions including:
 - first; any water that got into the structural steel tube sections was directed to the bottom of the roof assembly directly to the concrete deck where the column base plates were attached to the deck.
 - second; each structural column was acting like a small, tiny chimney providing a direct air path from the roof assembly to the exterior, a highly undesirable condition.

Close-up view of exposed drain holes in the galvanized steel columns allowing direct water infiltration and air exfiltration. Note some holes are drilled and some are cut with a torch.

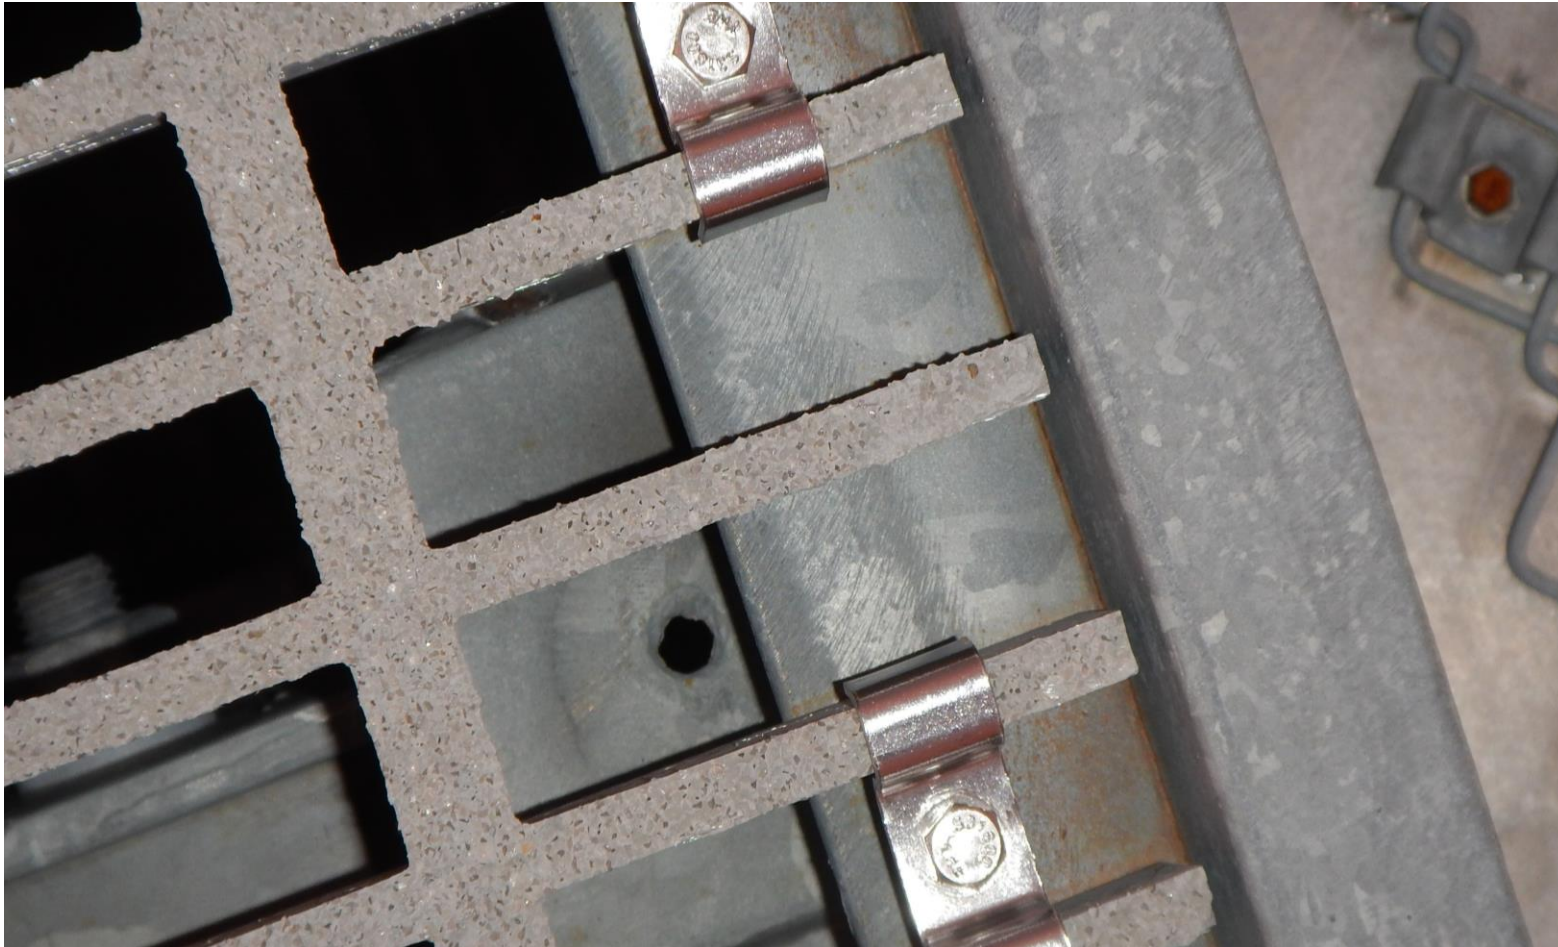
View of upward facing drain hole in a galvanized steel column.

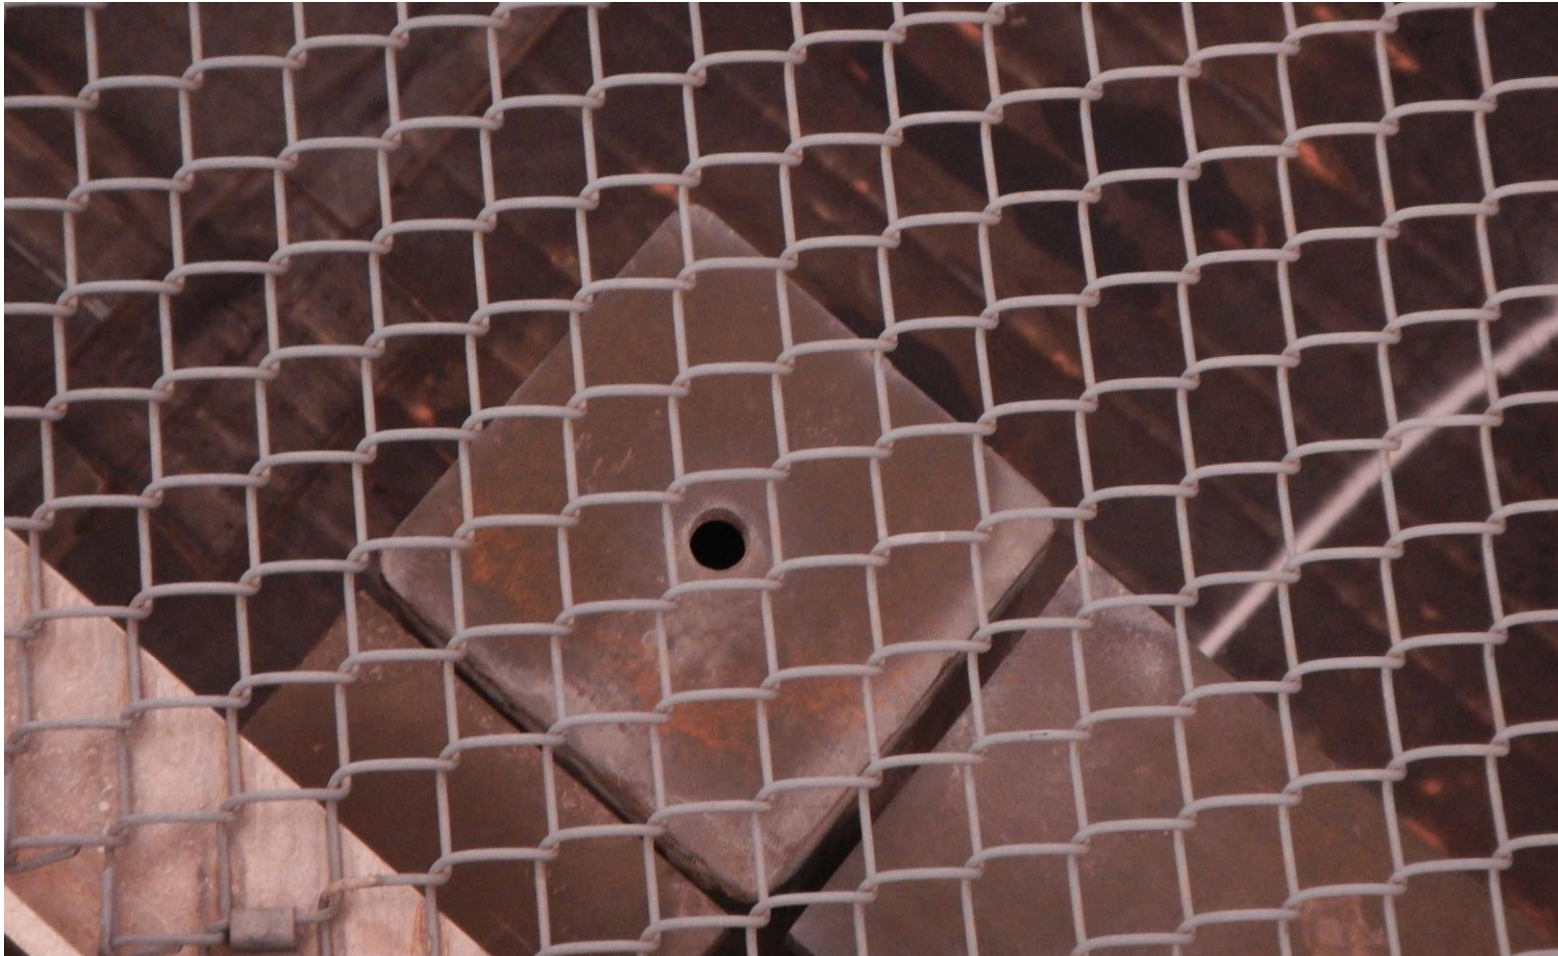
View of upward facing drain hole in a galvanized steel column.
