Can A Poor Air Seal Cause Roof Failure?

Timothy A. Mills, P.E., LEED AP, CIT II

TAM Consultants Inc.

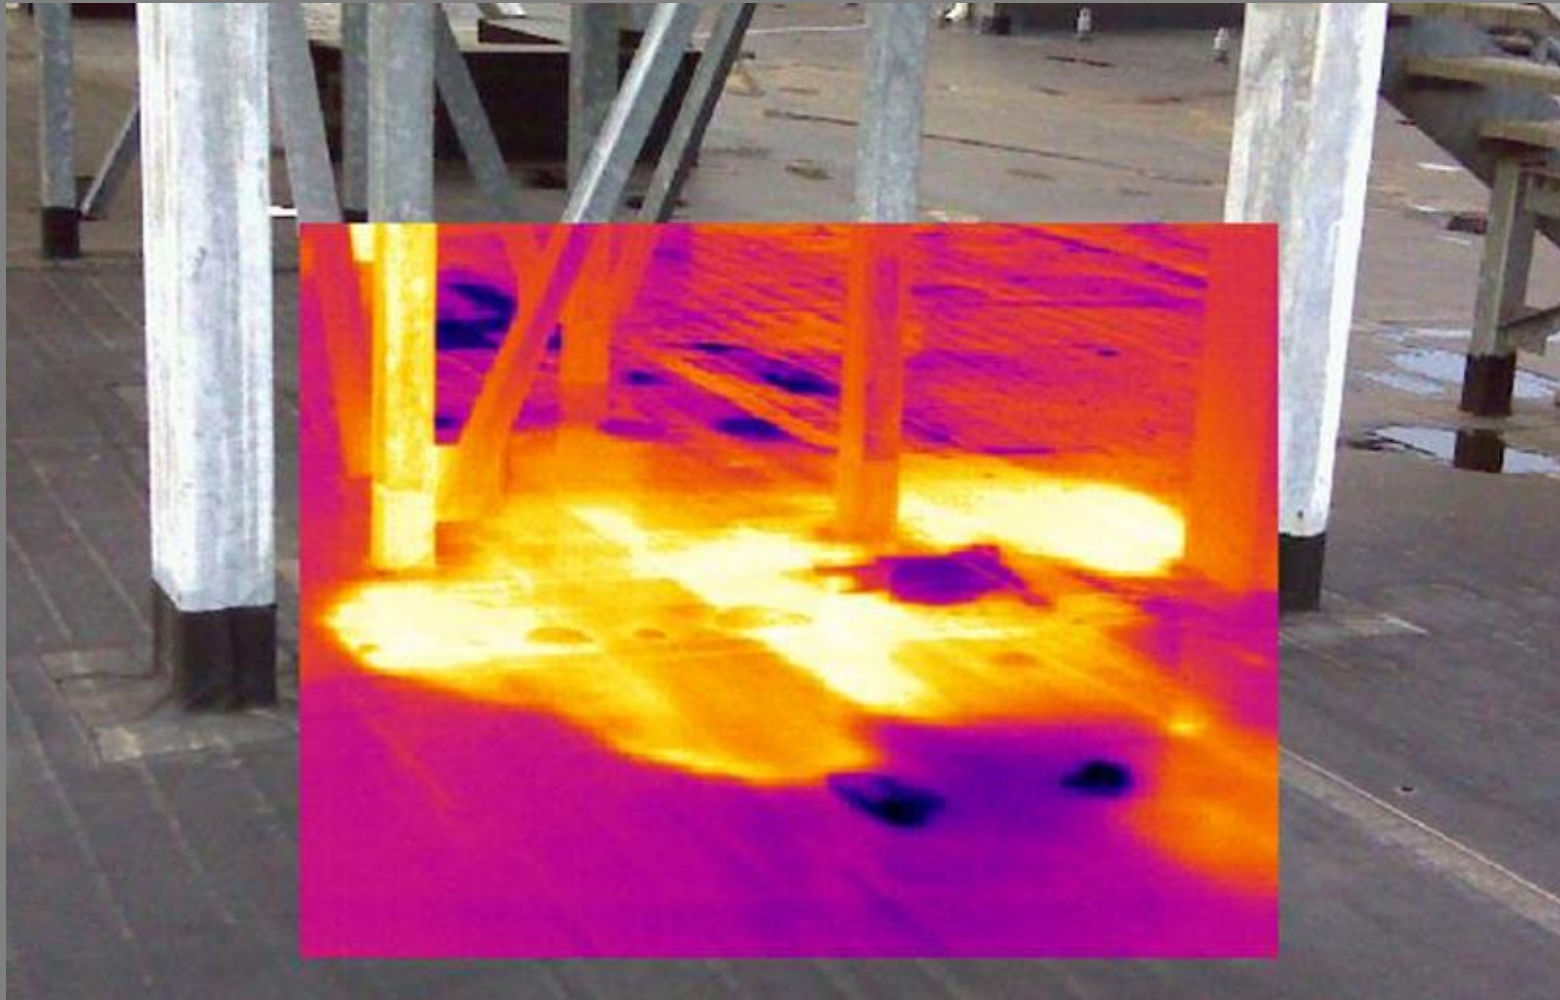
- The results of the infrared survey, core cuts, and moisture meter readings suggest that portions of the lower layers of insulation were or had been saturated. The absence of significant leaks in the surface of the membrane suggests that water was getting into the system either at leak points (holes) that were noted at the structural steel columns where it was finding its way directly to the concrete deck or by other means.

- These holes, in combination with the presence of measured internal air leaks around the perimeter of the roof, can also serve as a means of interior air flow directly into the roof system at the perimeter. This condition of uncontrolled air flow via exfiltration through the roof assembly very likely caused condensation during the cold winter months.

Thermal image of saturated roof insulation adjacent to galvanized steel columns where drain holes are allowing water entry into the roof system.
