# This Won't Go Away – Mold In Office Buildings

Timothy A. Mills, P.E., LEED AP, CIT II  
*TAM Consultants, Inc., A Terracon Company*

This presentation is reprinted with permission from the IIBEC Building Enclosure Symposium, November 11-12, 2019, Louisville, Kentucky. IIBEC is an international association of building envelope consultants whose members specialize in design, investigation, repair, and management of building envelope systems. For more information, visit [www.iibec.org](http://www.iibec.org).

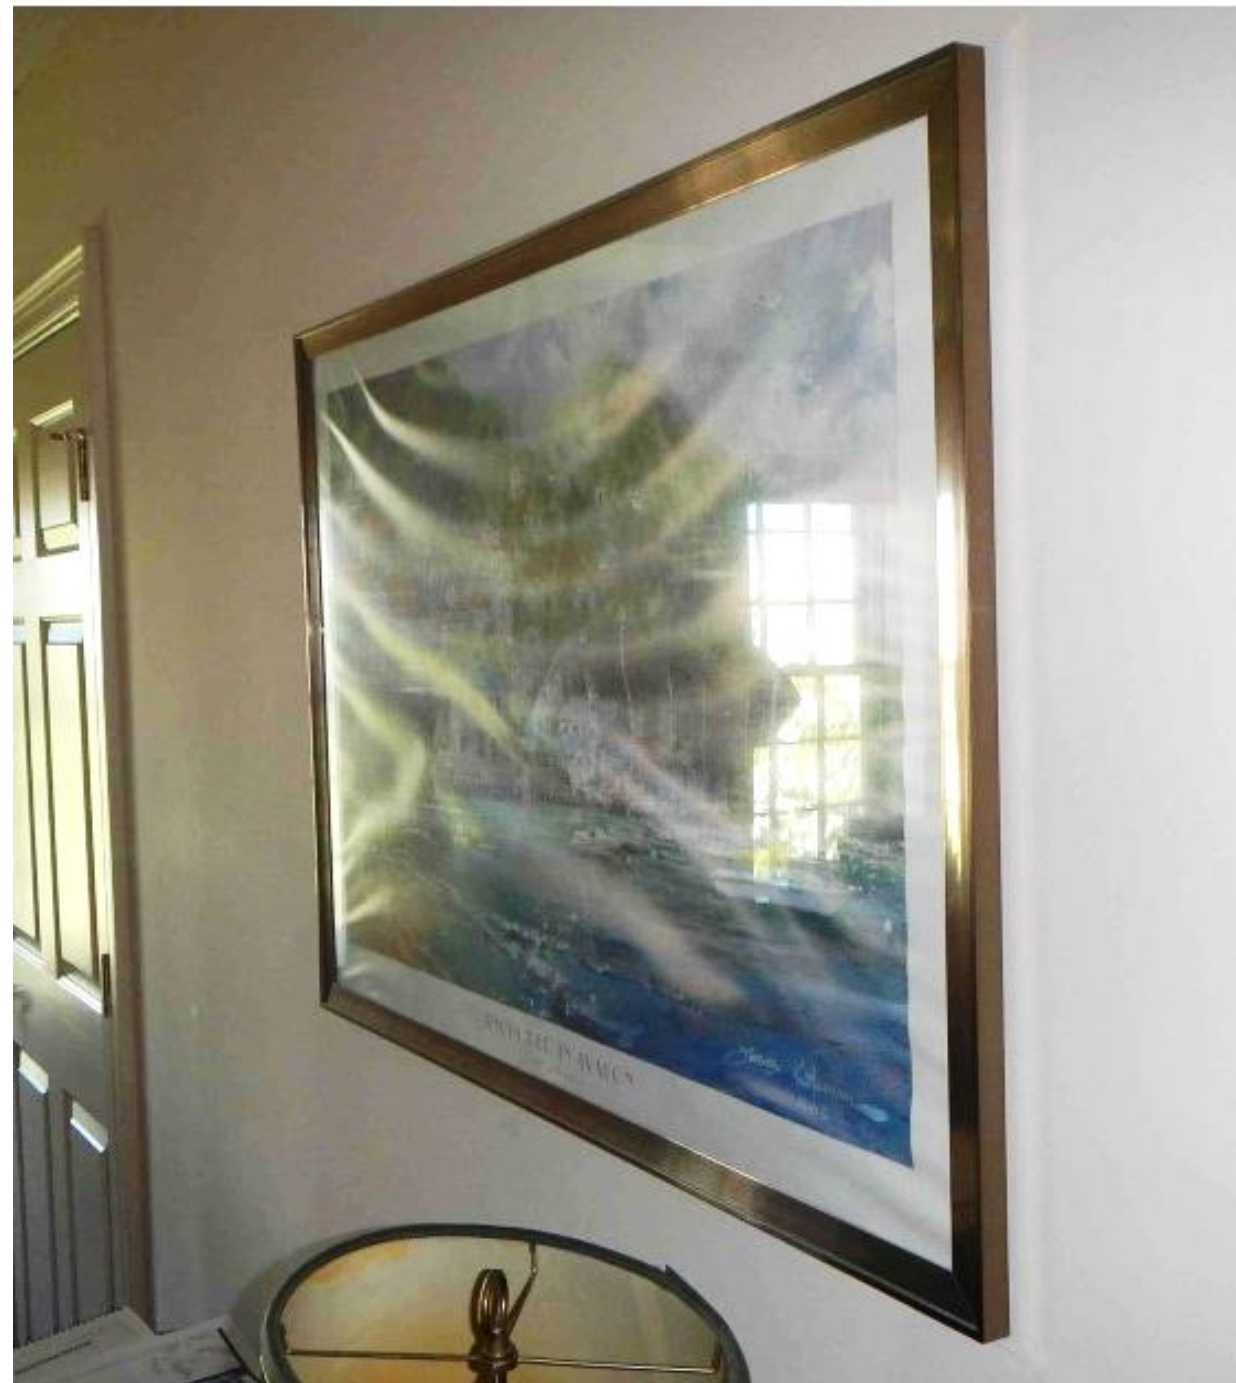
In spaces with high relative humidity look for paper products that are wrinkled: artwork, photos, copier paper, magazines and books.

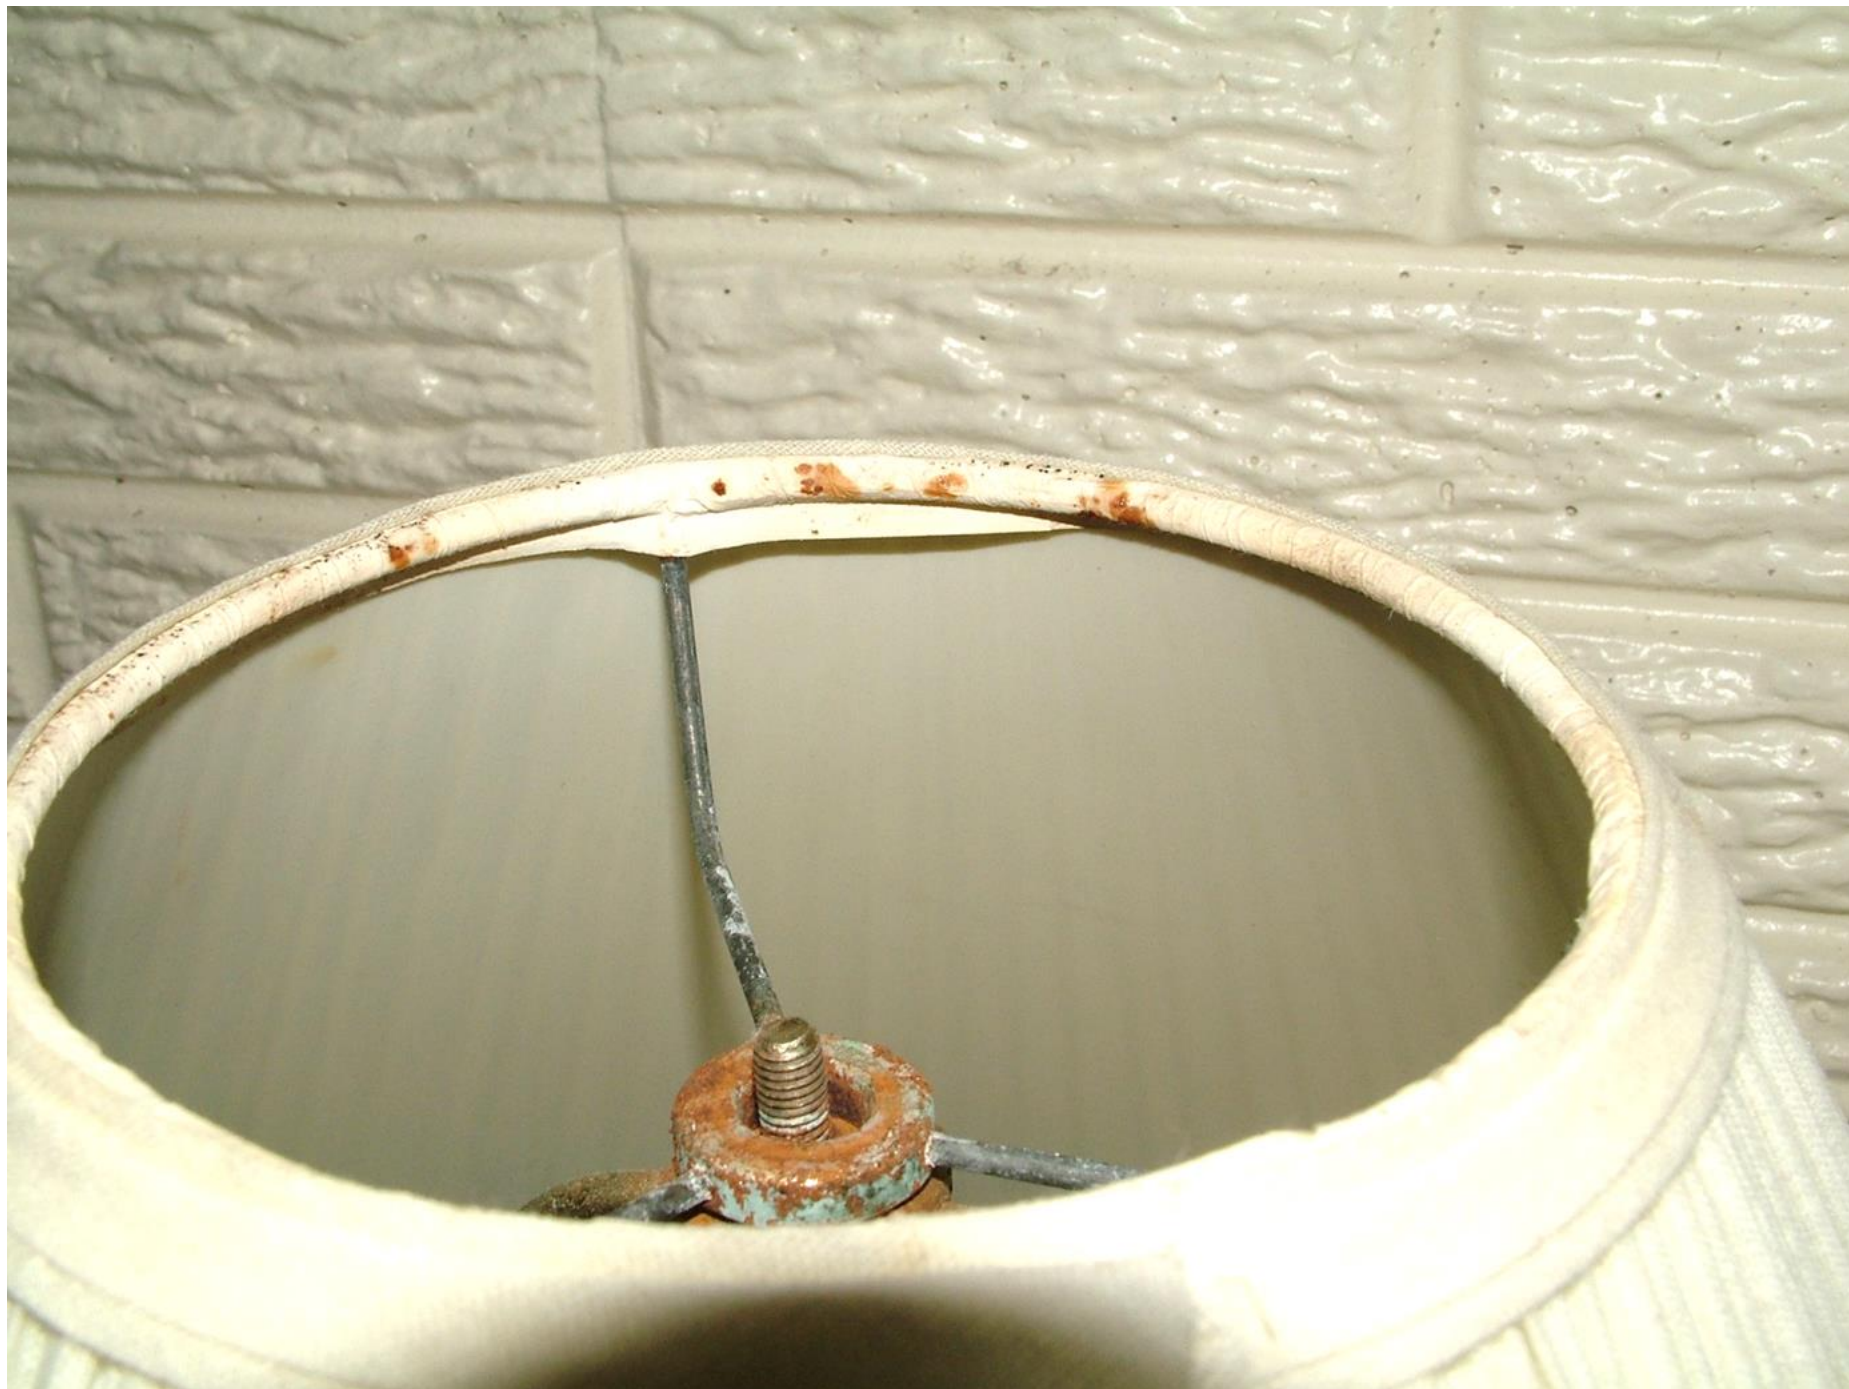
In spaces with high relative humidity look for surface rust on office furniture and drywall corner beads.

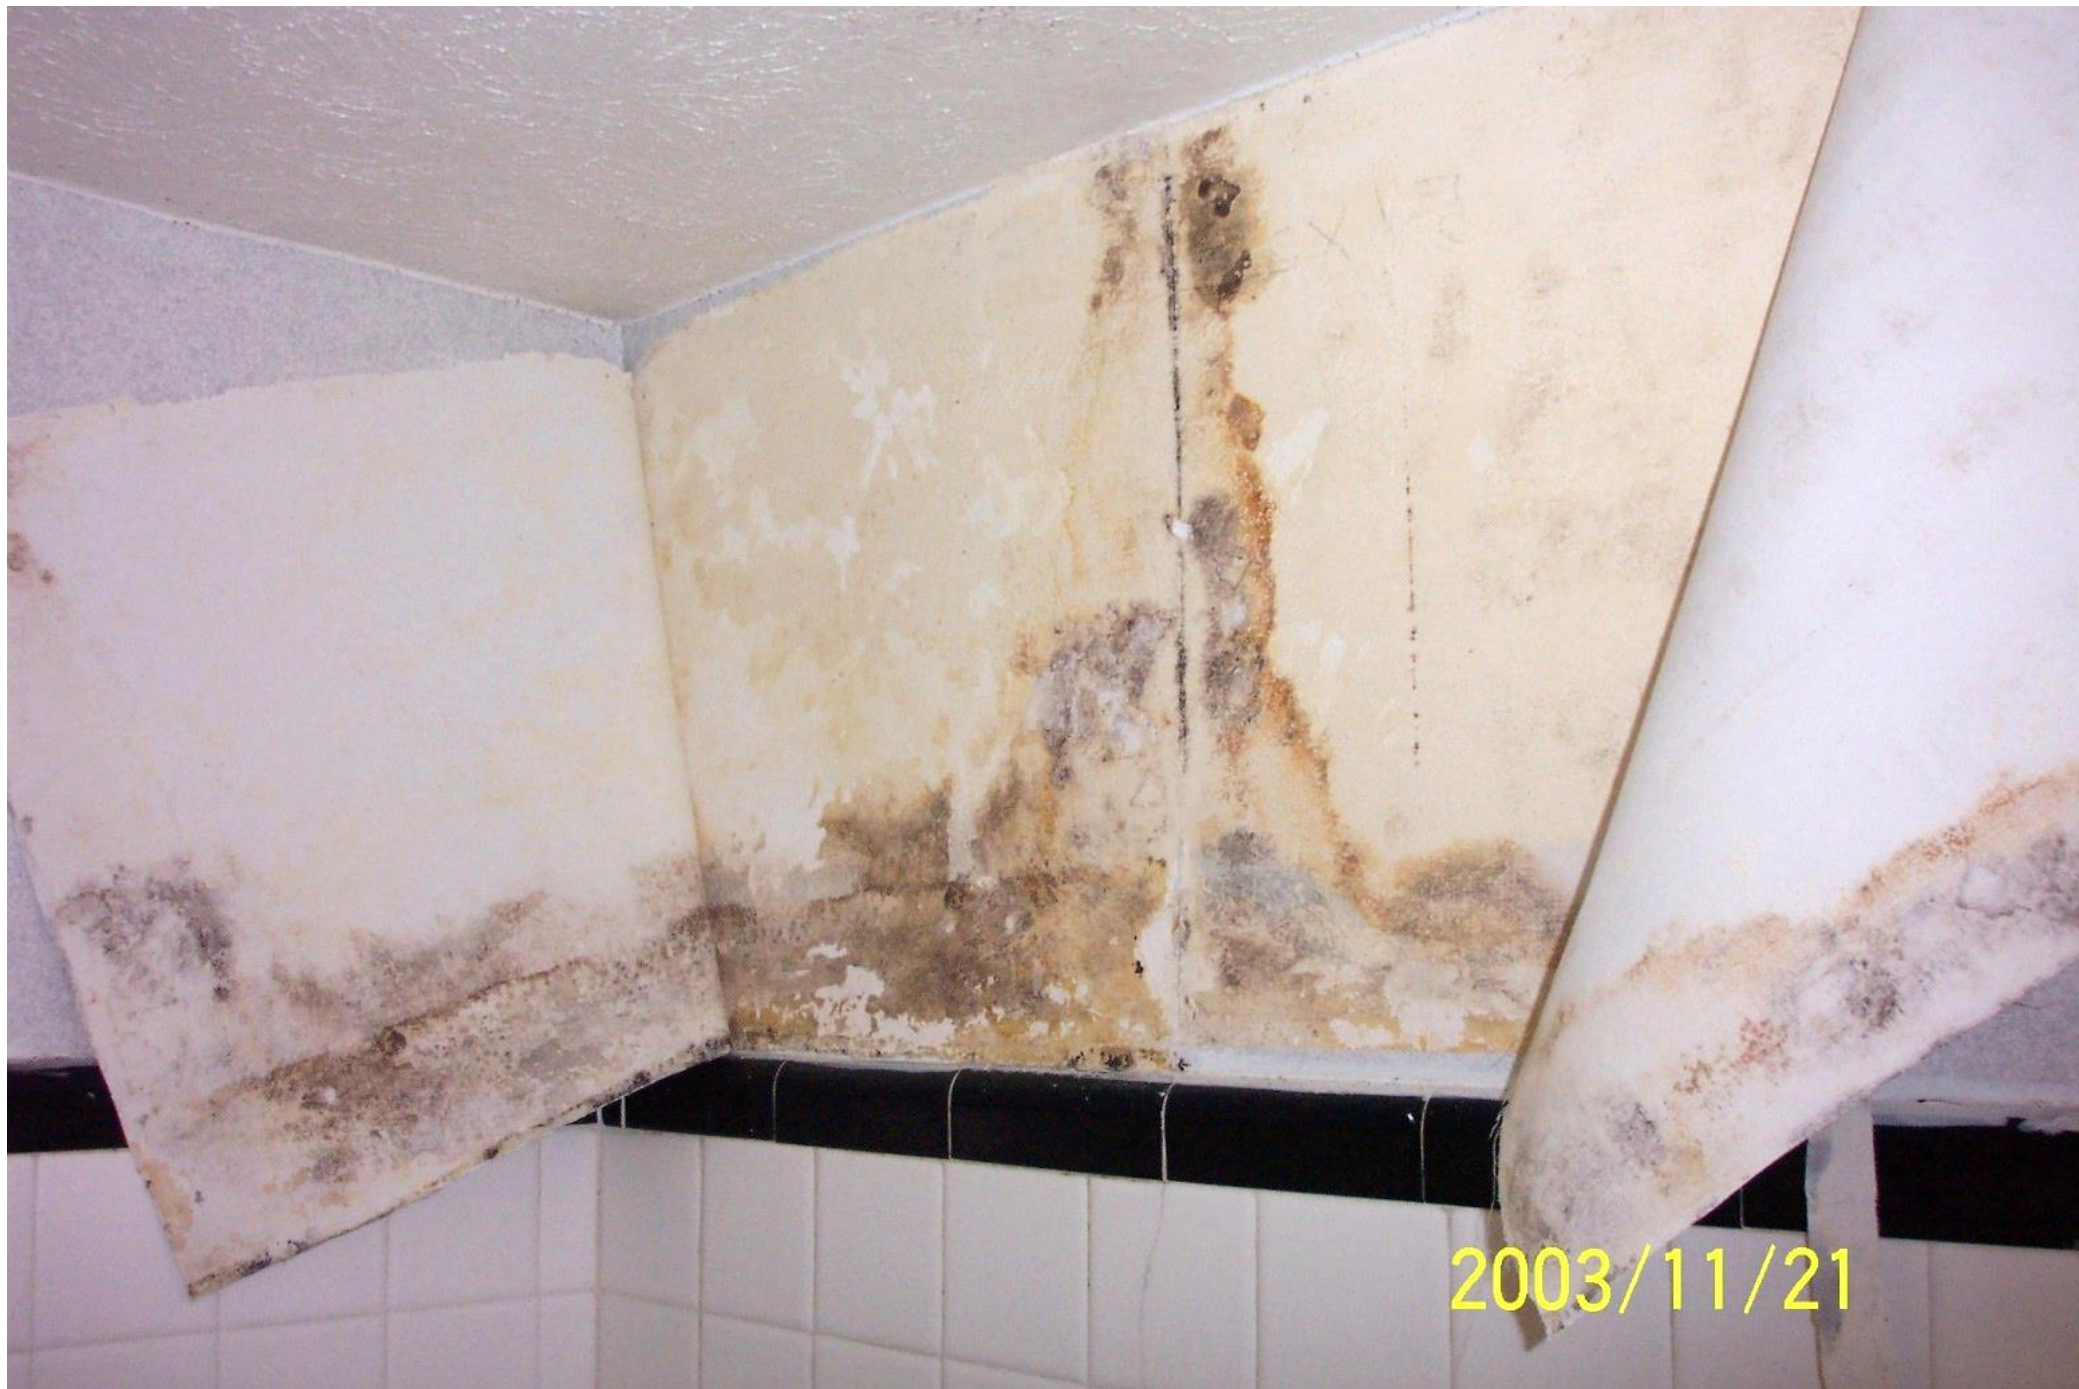
Vinyl wall coverings will act as a vapor barrier and will trap moisture.

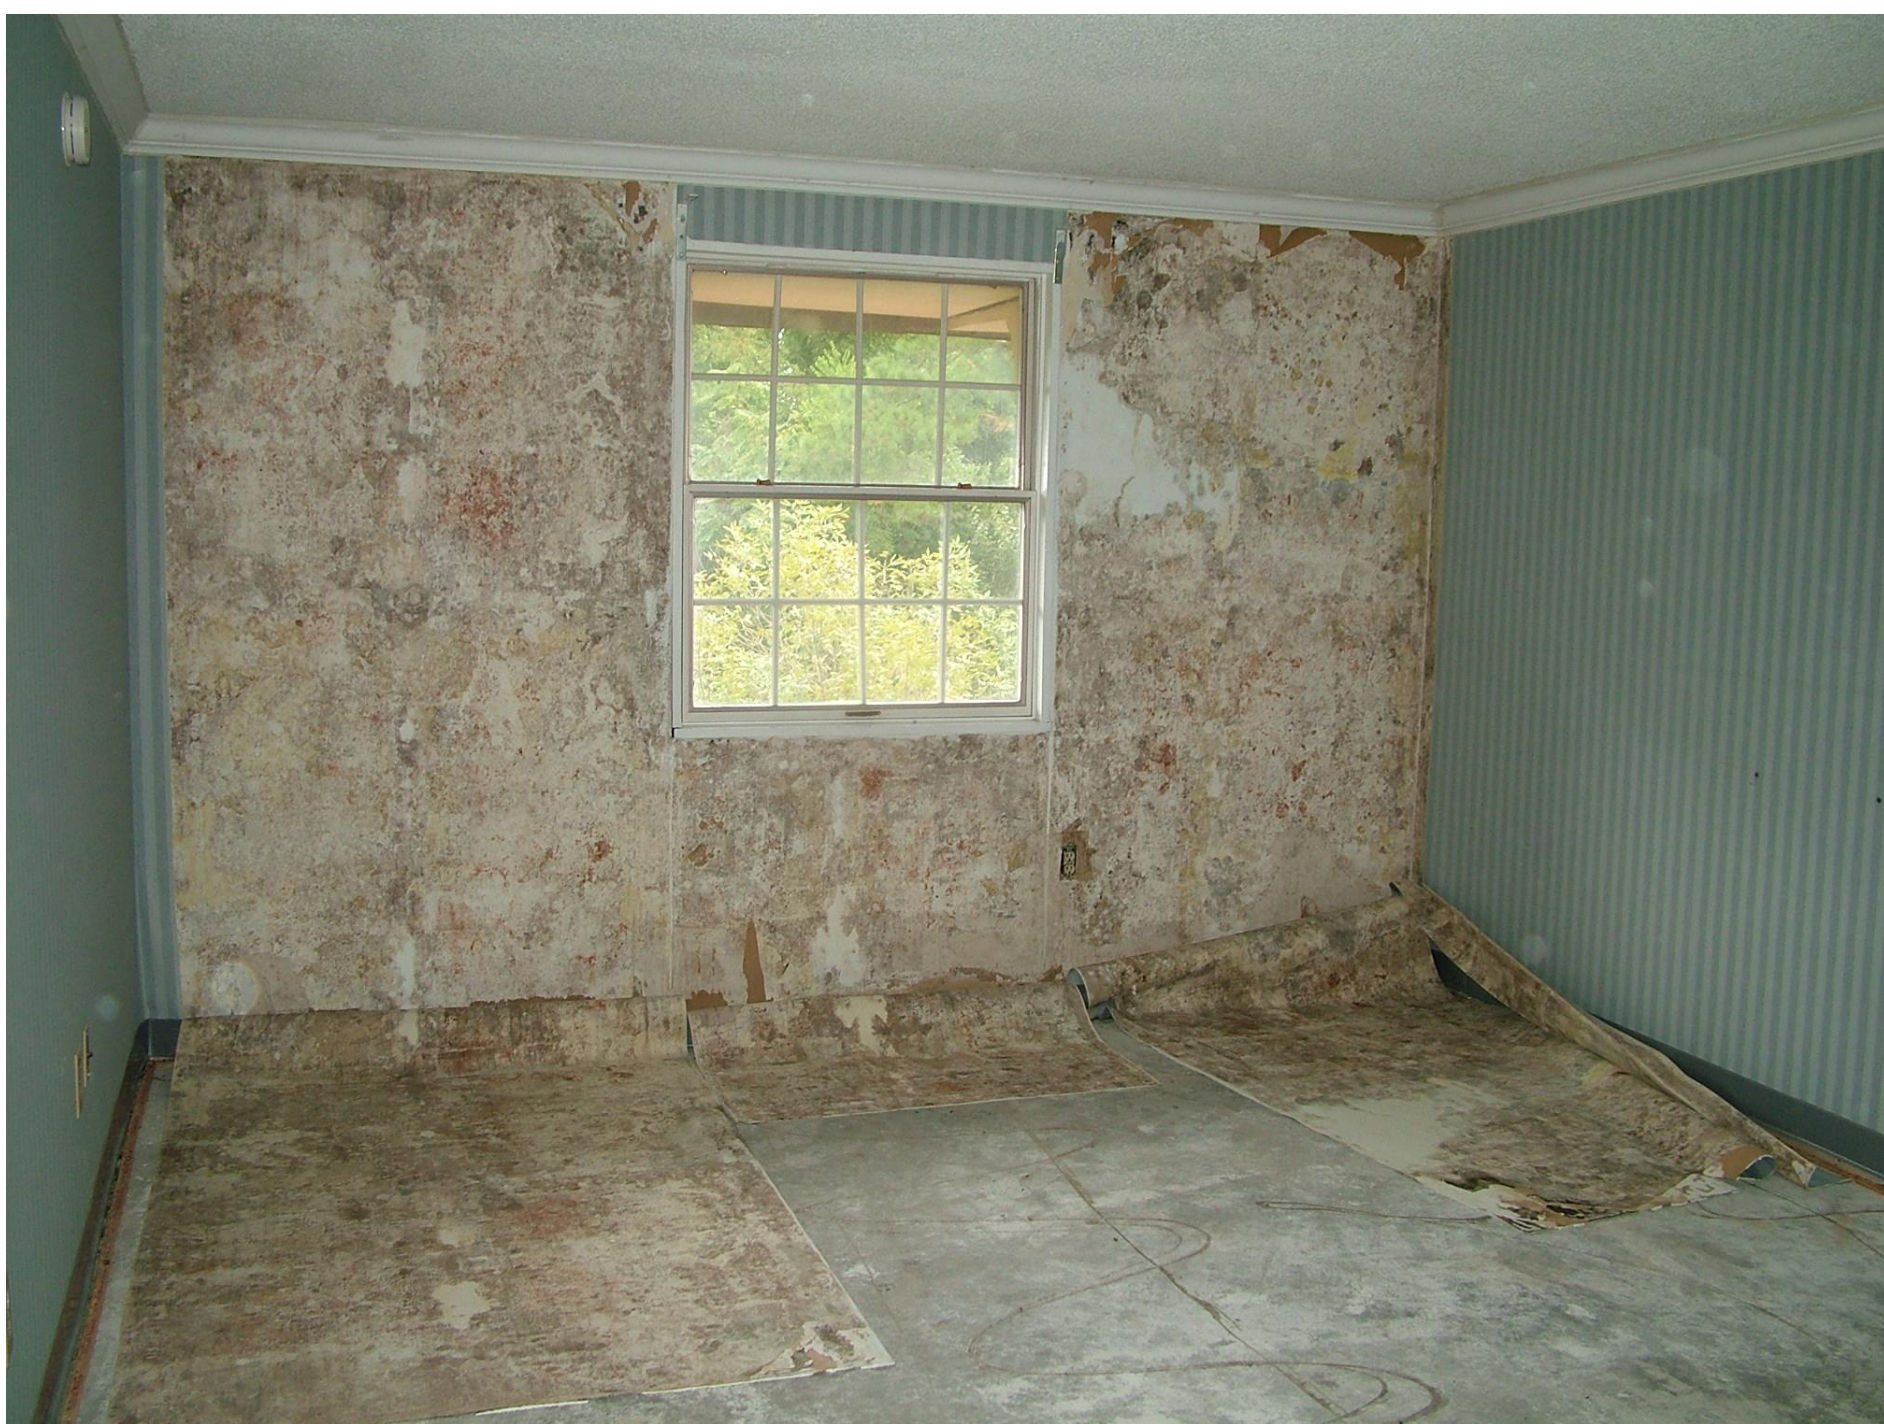
Vinyl wall coverings will act as a vapor barrier and will trap moisture.

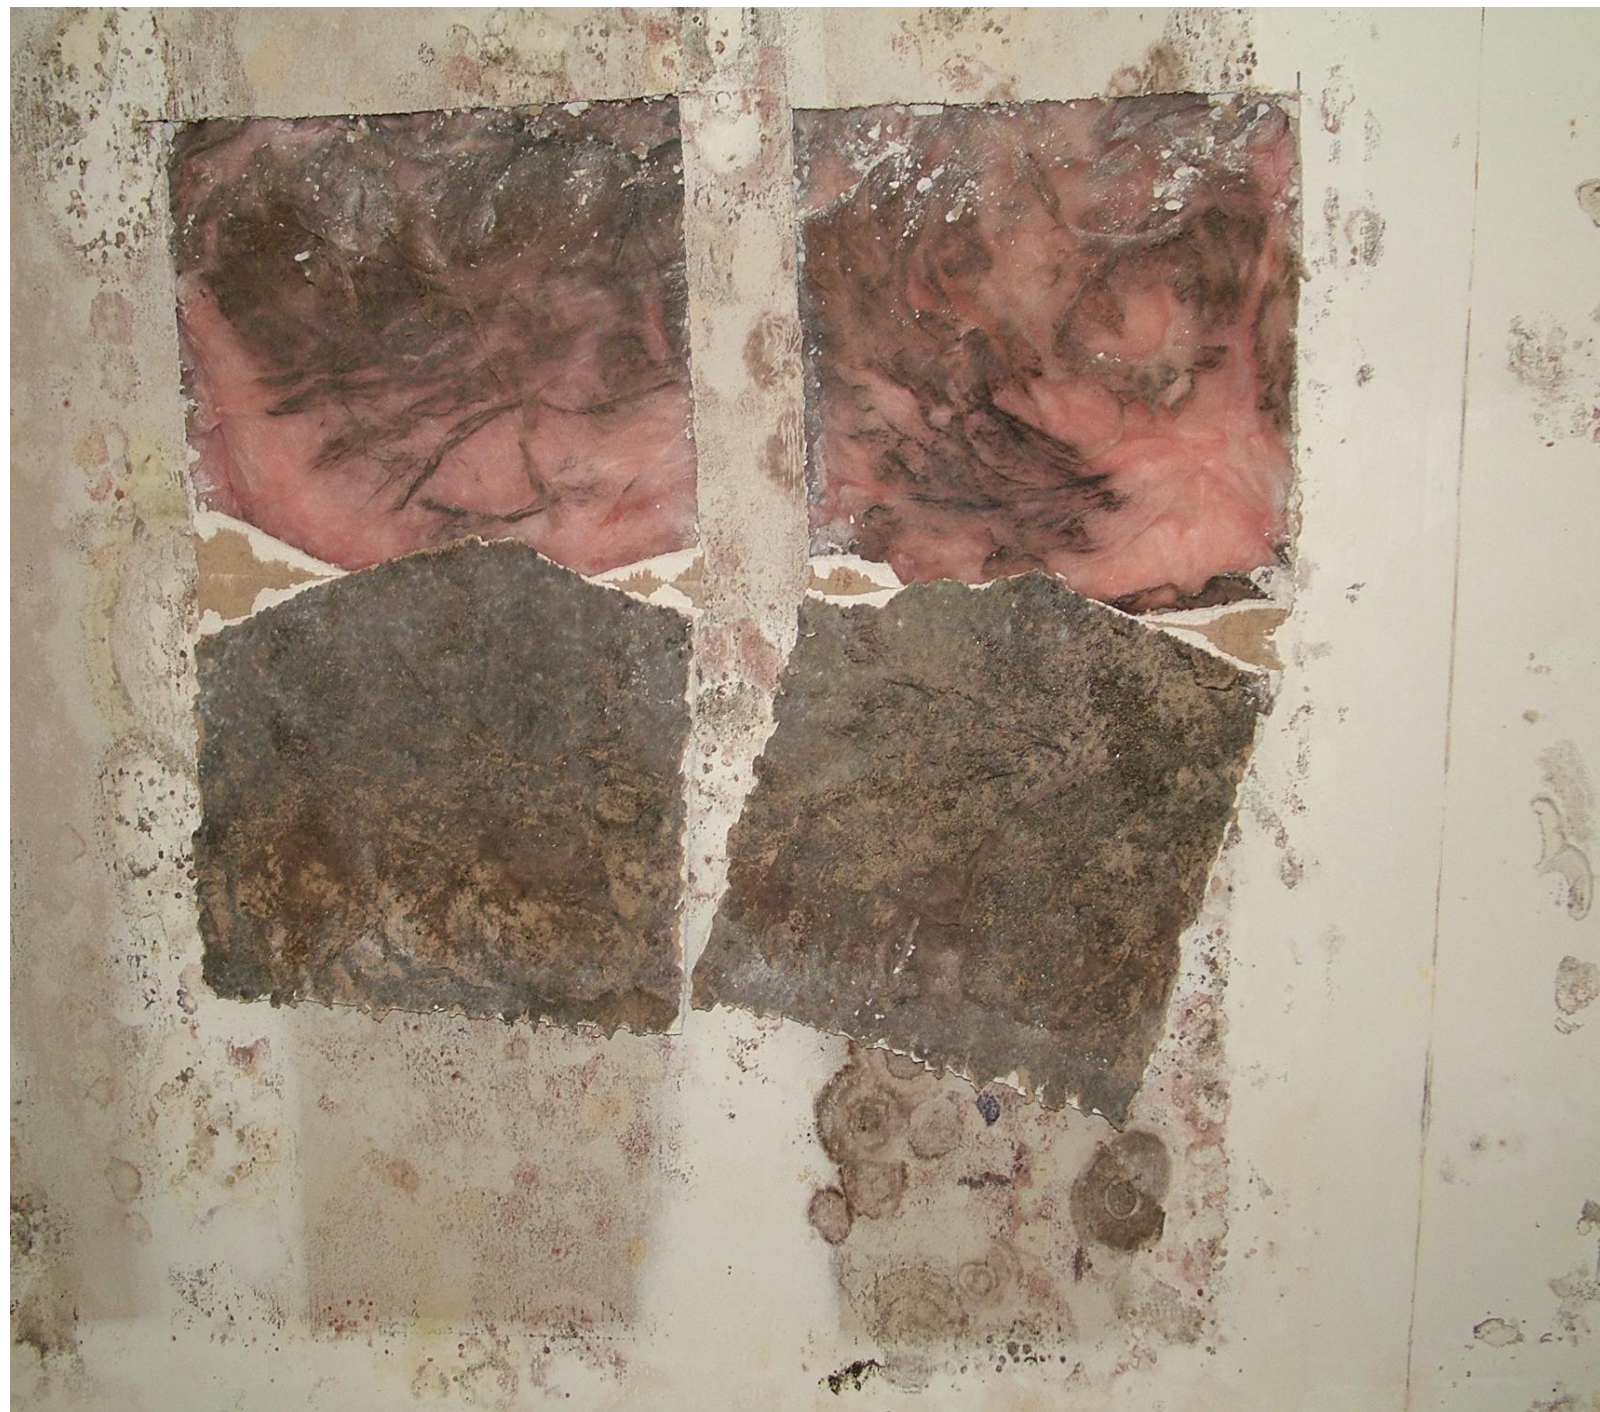
Example of mold development inside an insulated wall assembly with mold development on the inside of the stud cavity as well as on the outside of the drywall finish where it occurred behind vinyl wall coverings.

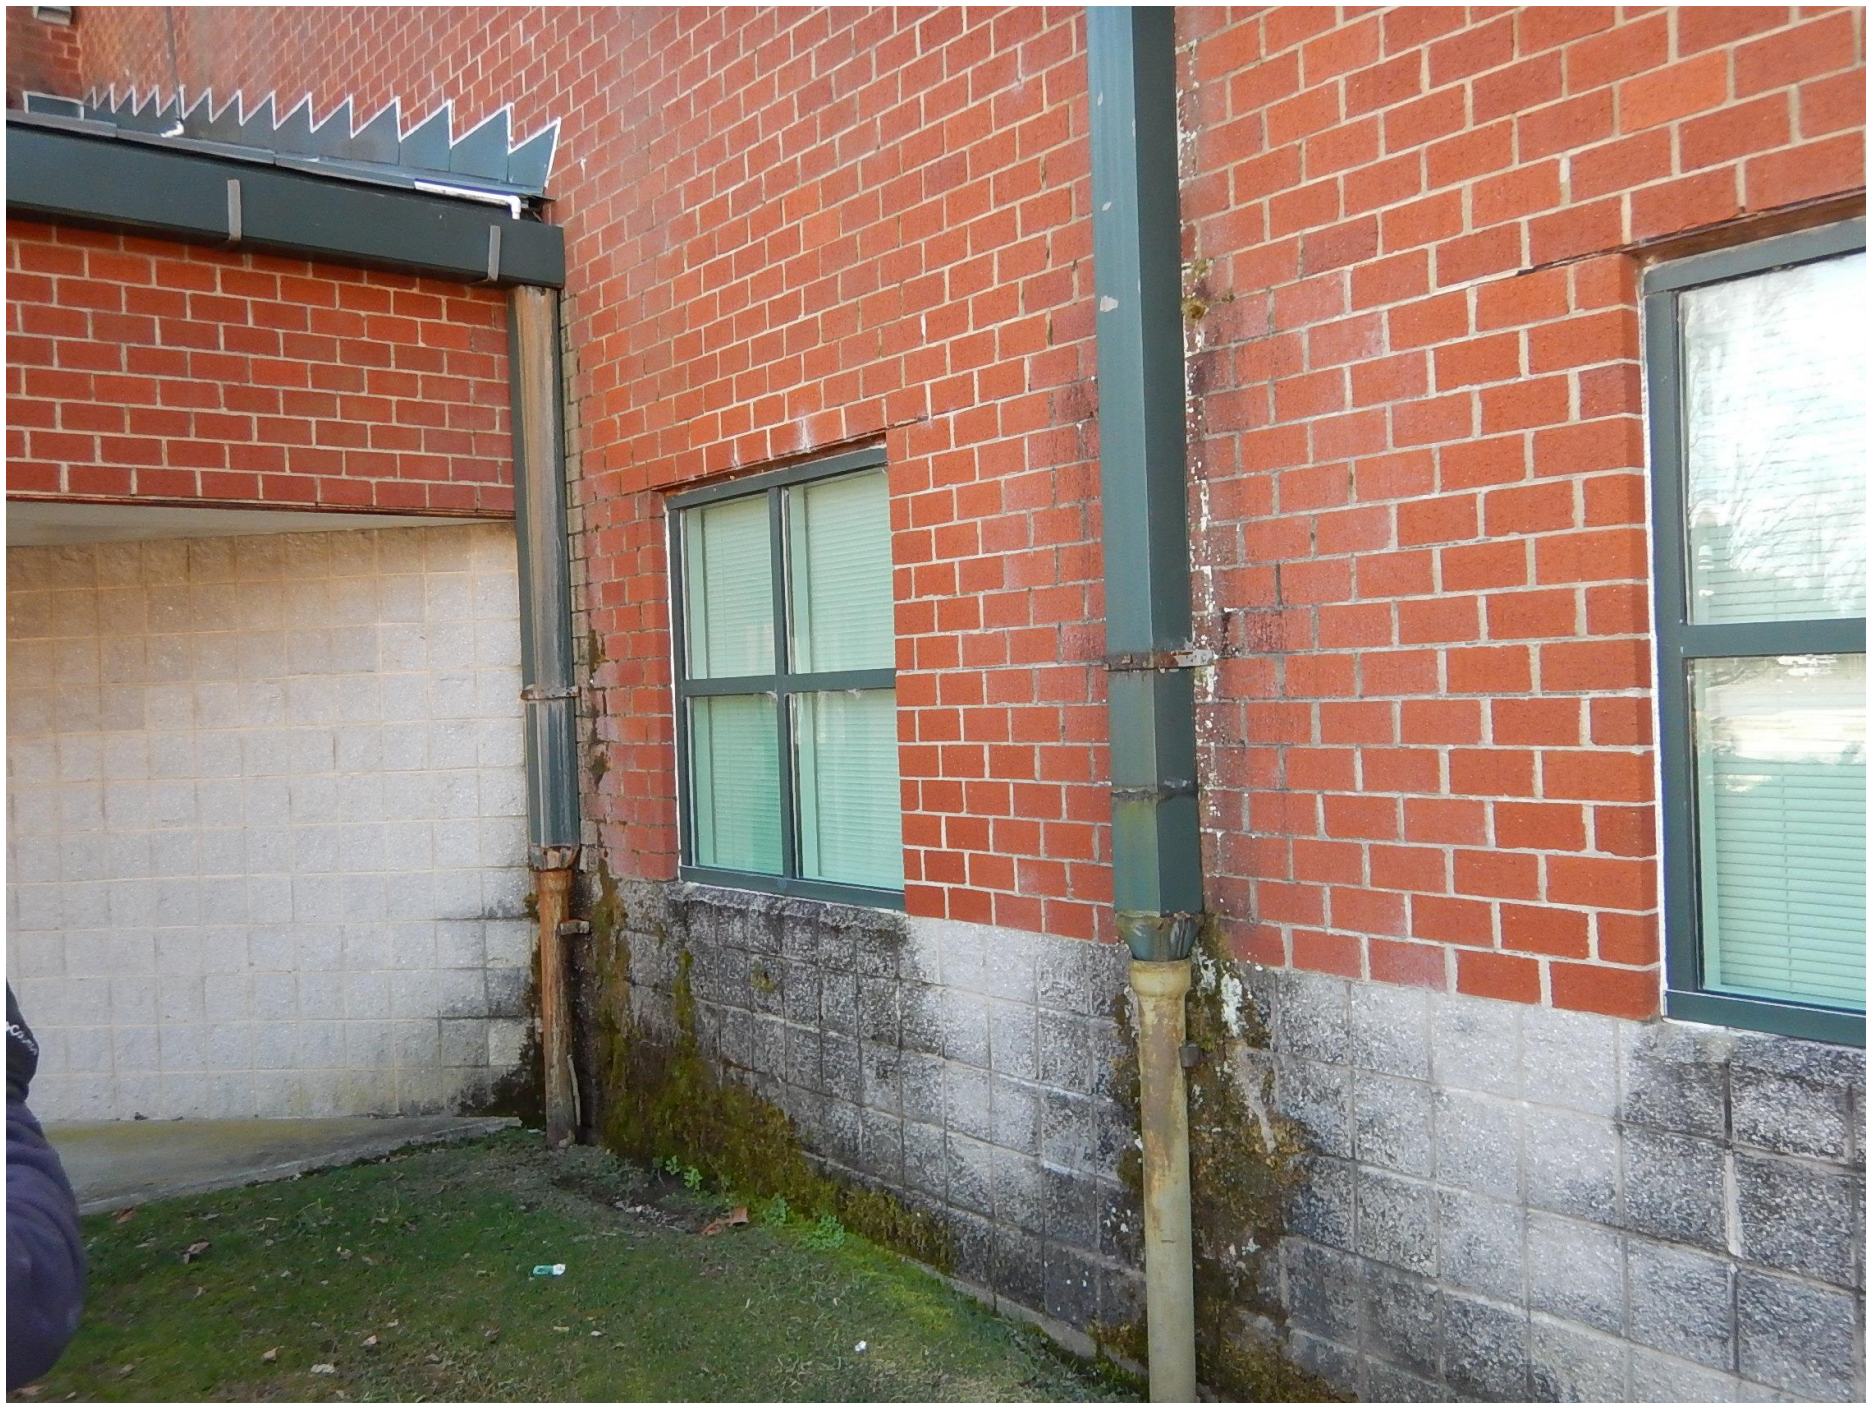
Lack of maintenance, leaking downspouts, poor grading and plant growth on the walls are contributing building failure and increased moisture in the masonry cavity.

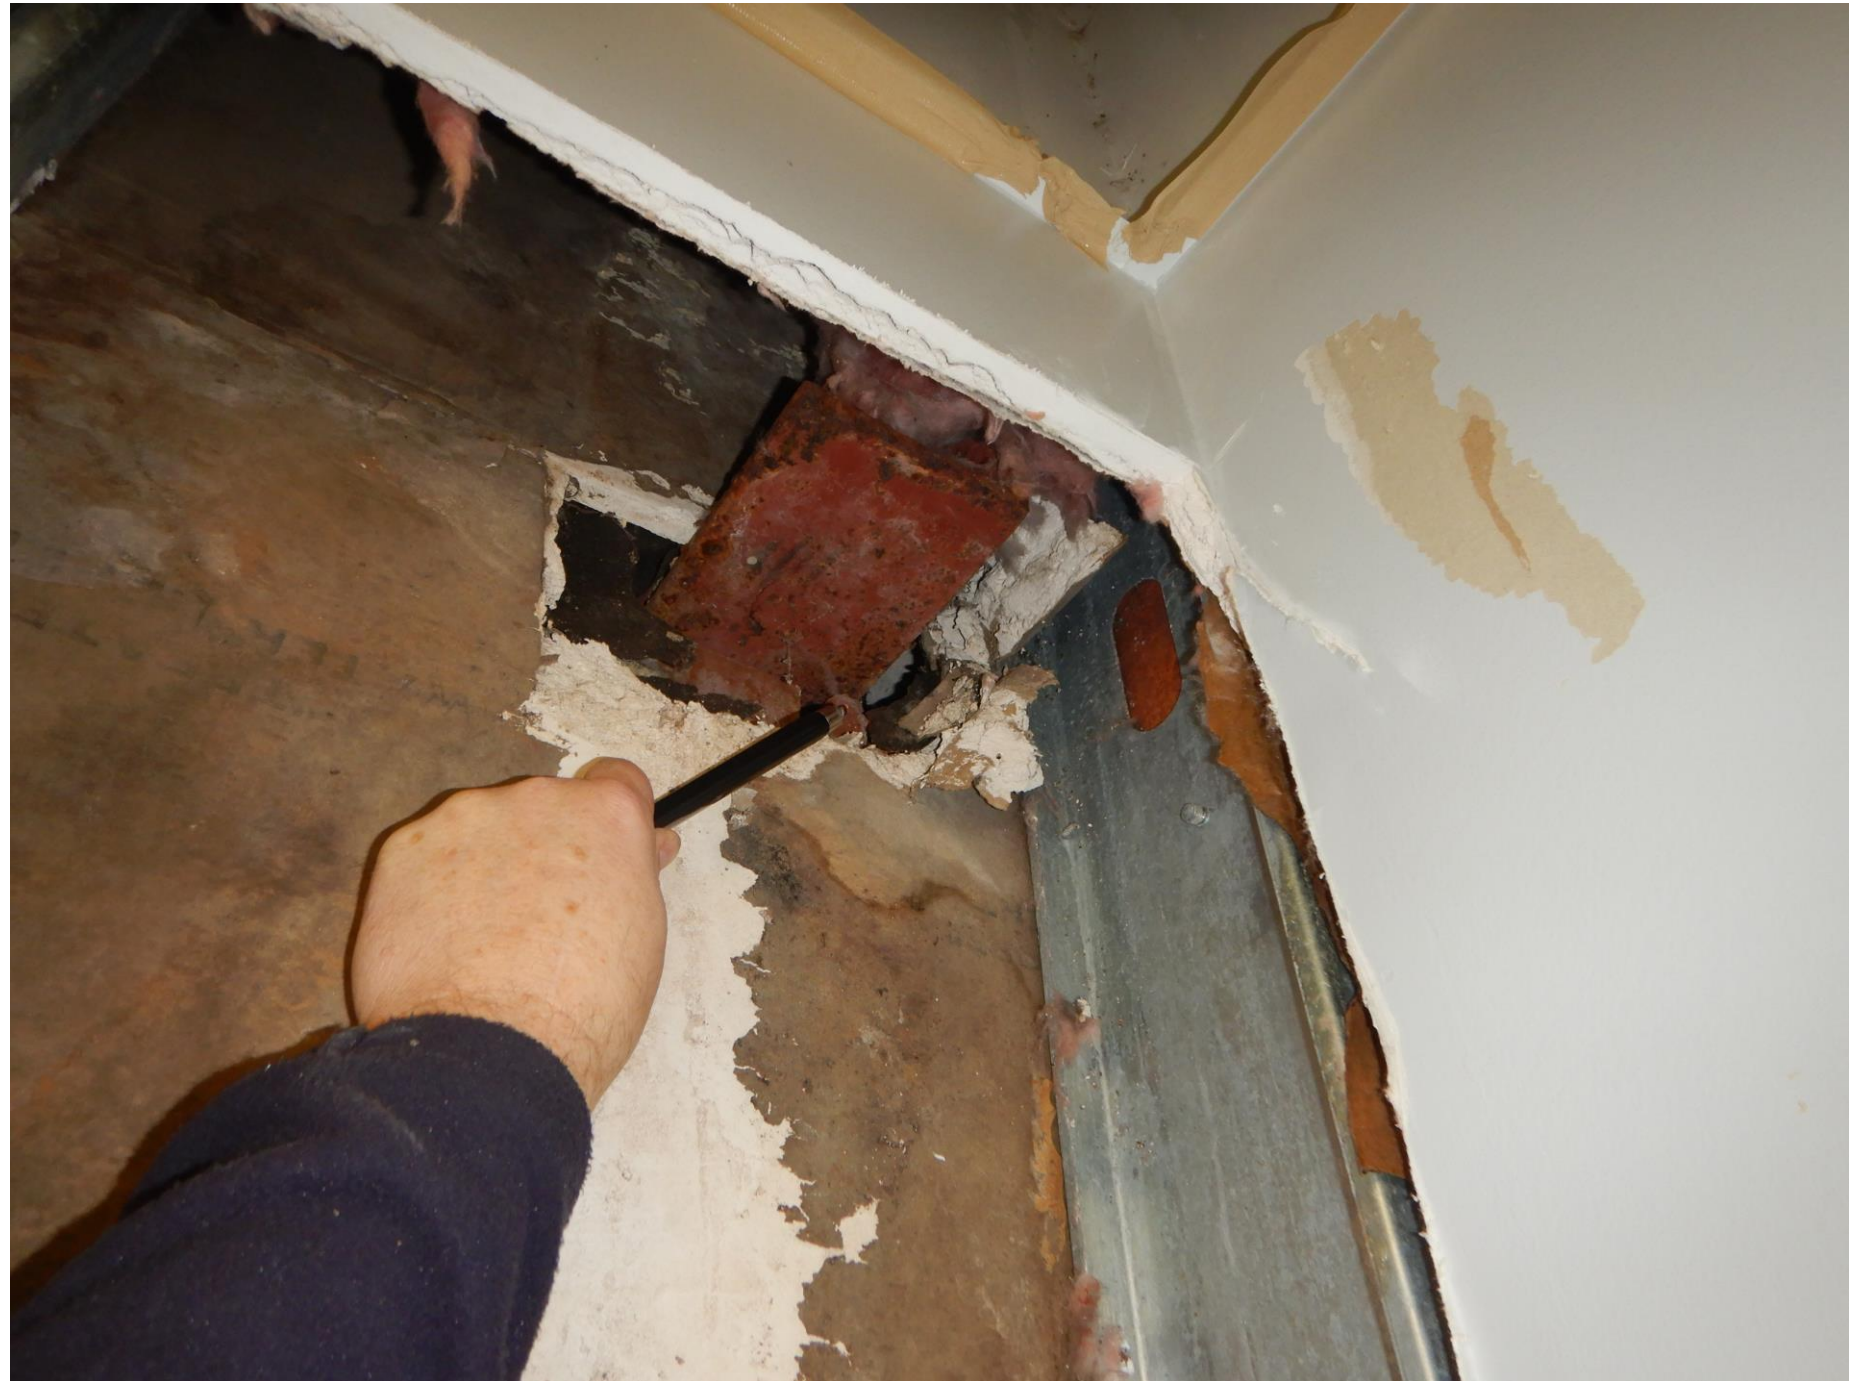
Open penetrations in the exterior envelope are never a good thing.

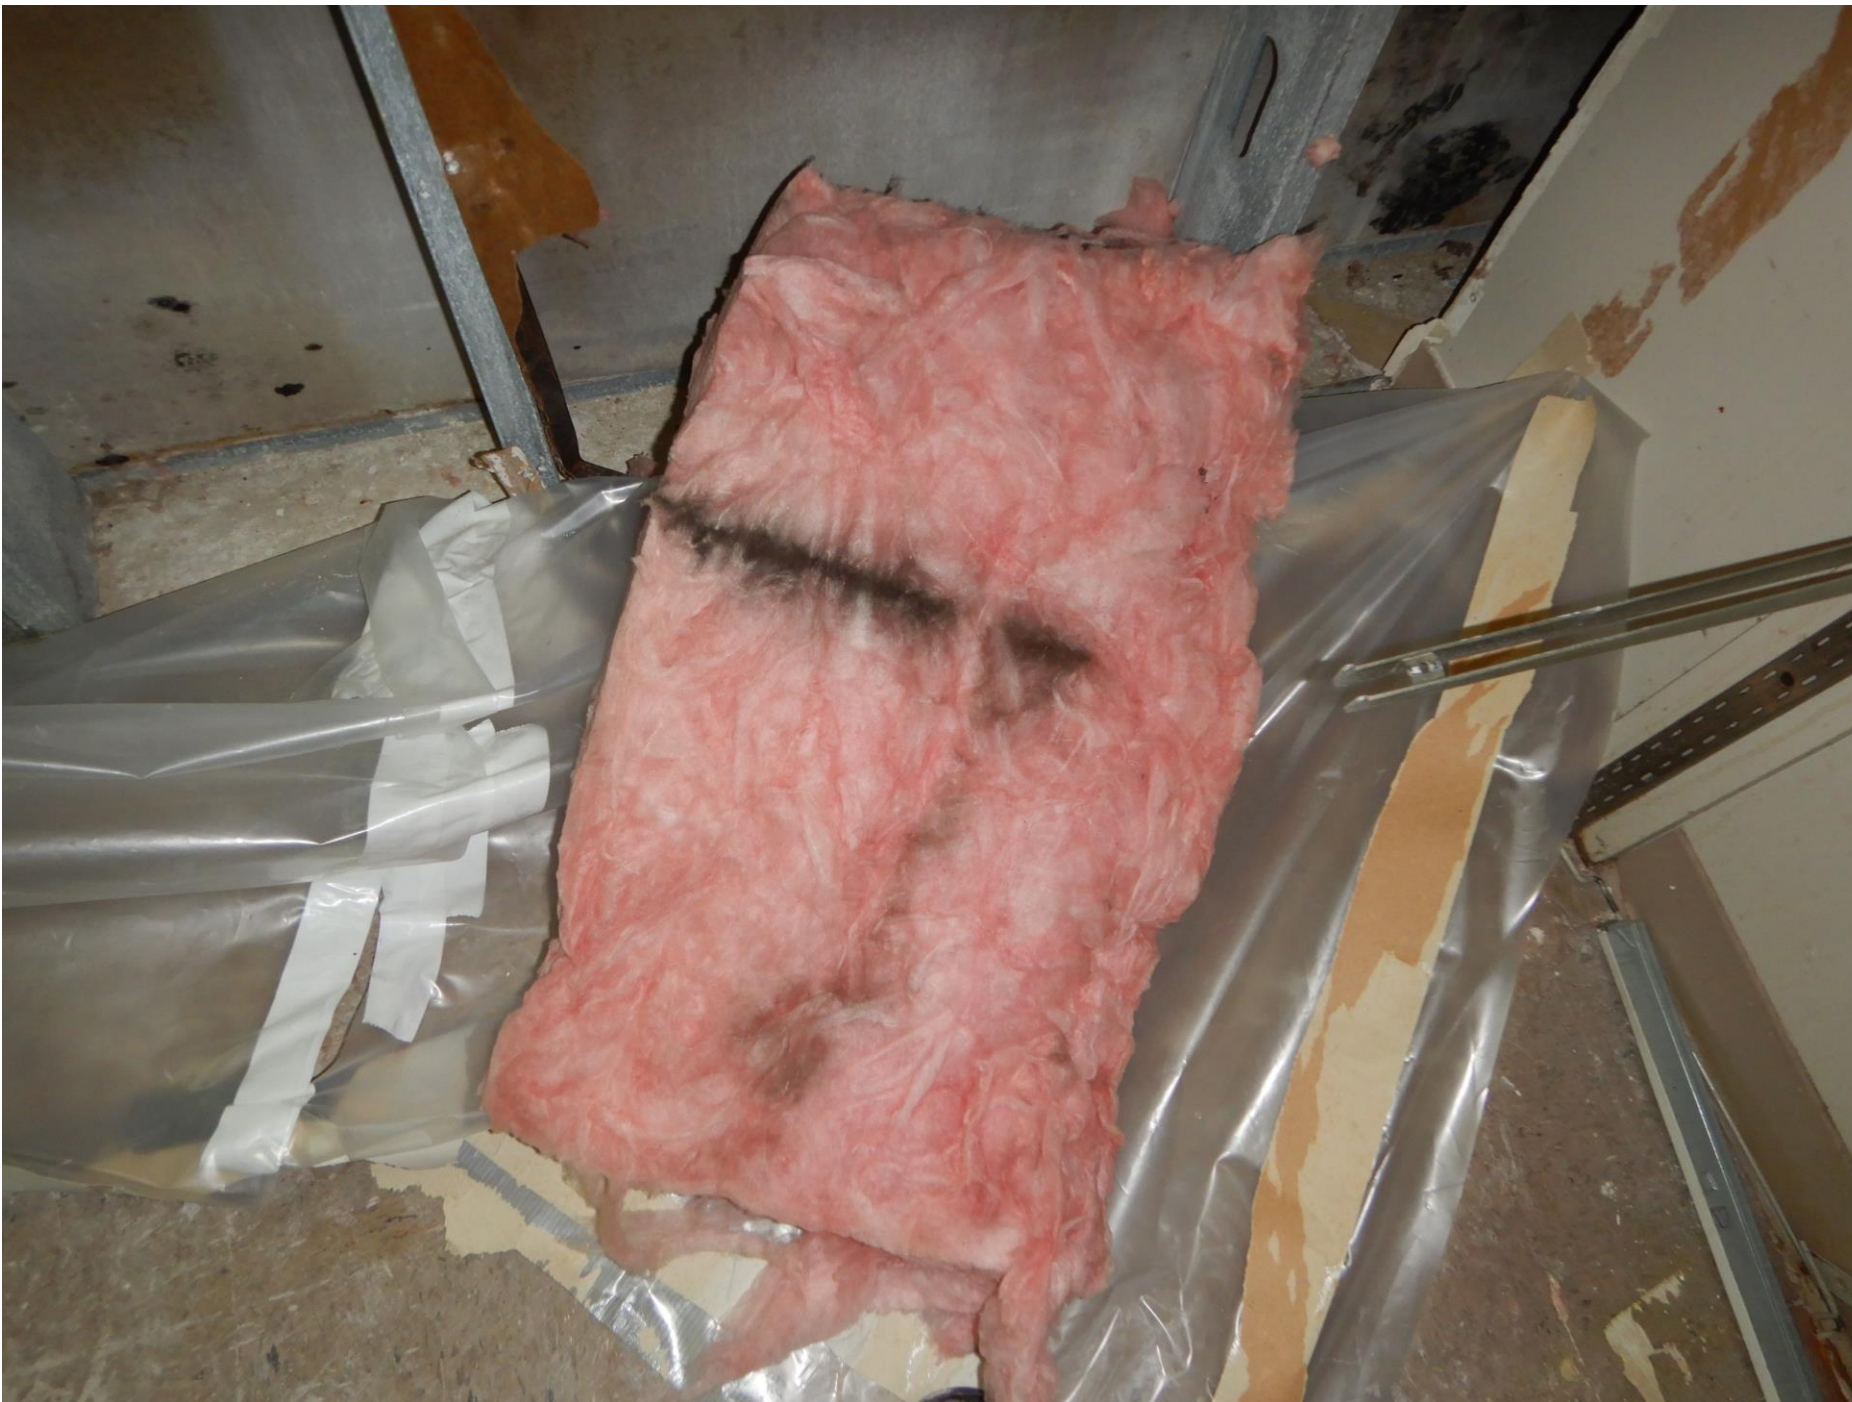
Look for dirt and dust staining (not mold) accumulation on the glass batt insulation and at other places.

This occurs due to unintended air infiltration at a sheathing joint in the wall sheathing where the insulation acts as a filter collecting and trapping dirt and dust particles.

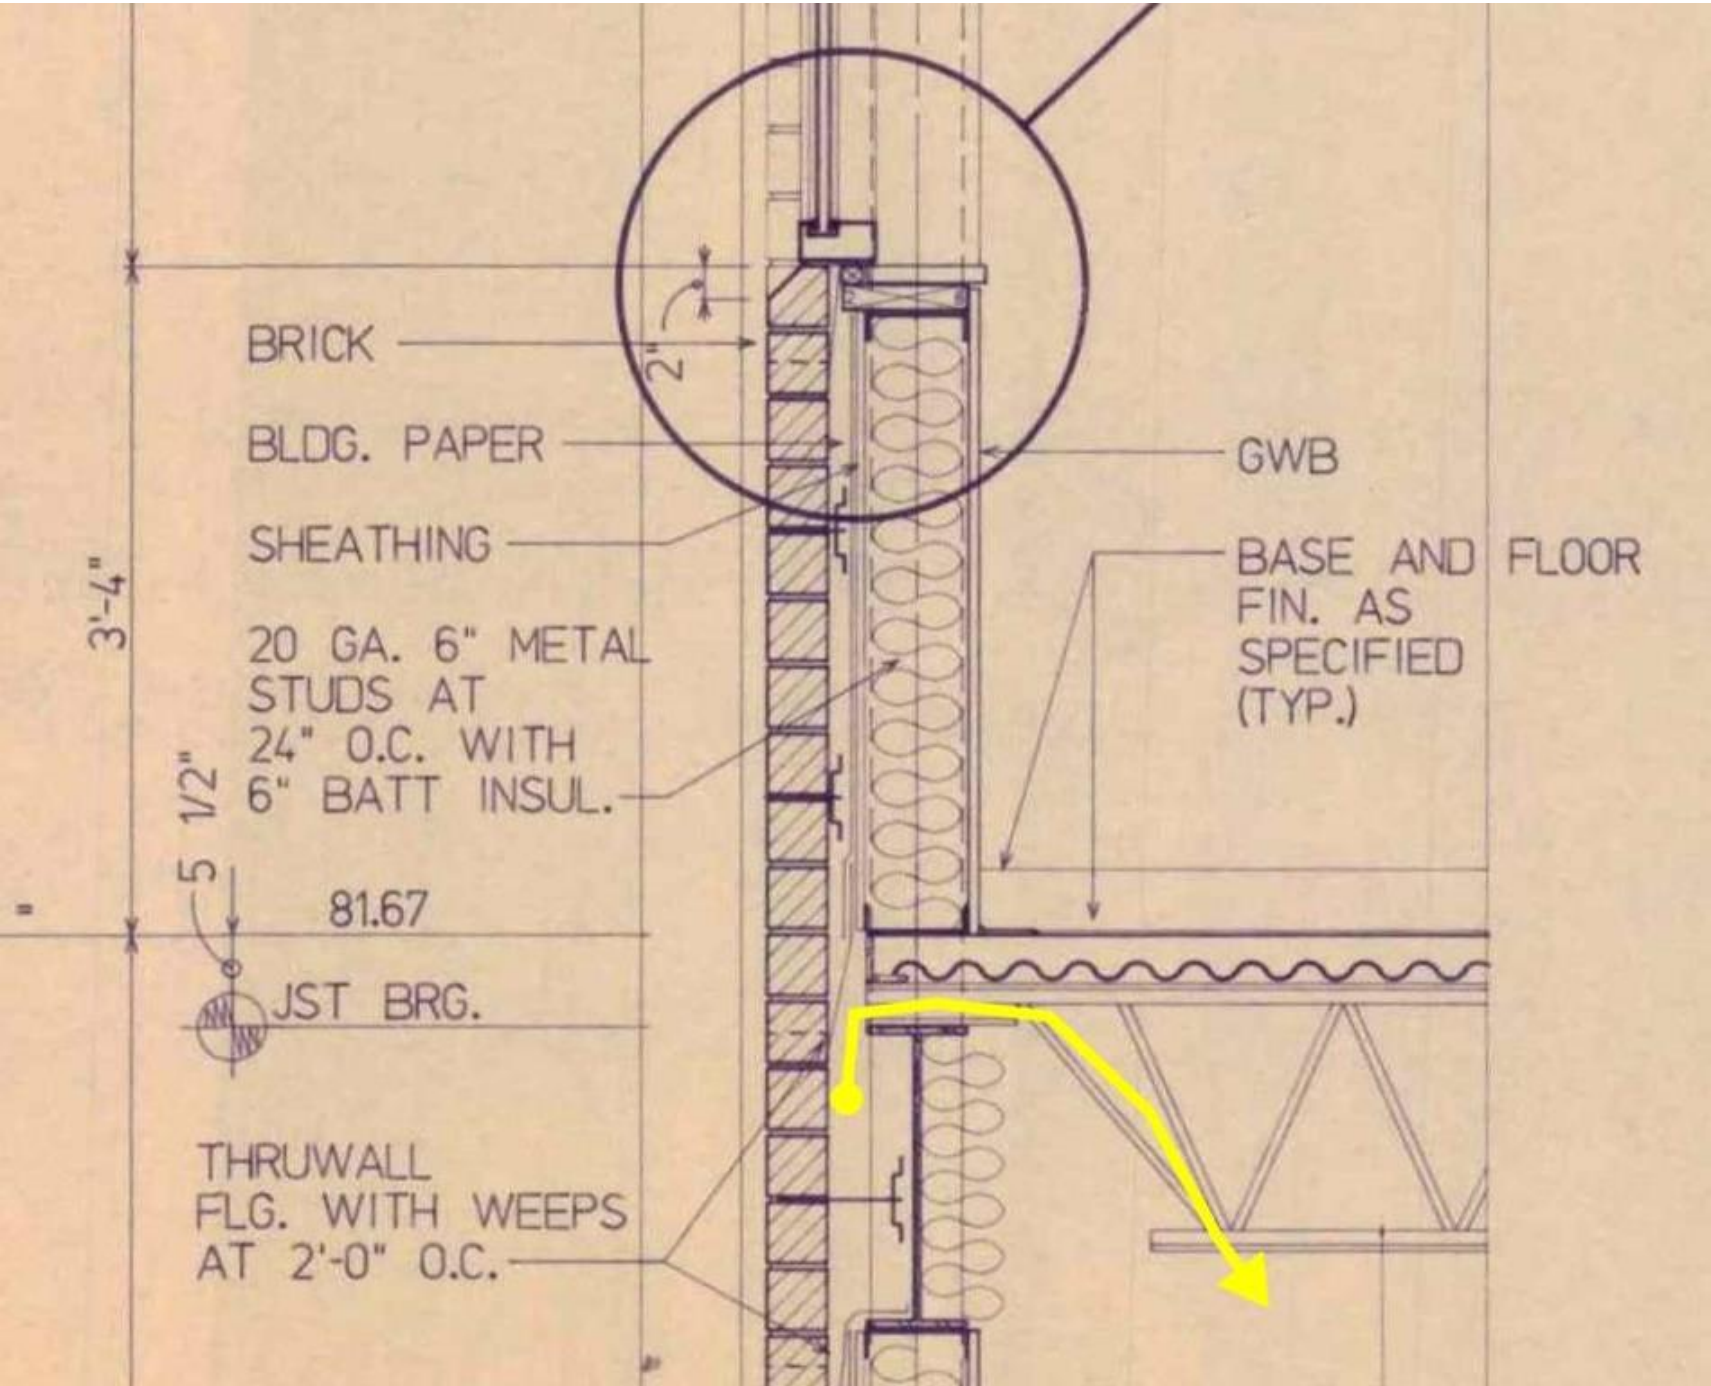
Depicting the detailing of the exterior wall weather barrier and other building elements and the bearing condition for the second-floor structural steel bar joists and floor slab. Note opportunities for easy air transfer between the masonry cladding cavity and the above ceiling return air plenum.
