# This Won't Go Away – Mold In Office Buildings

Timothy A. Mills, P.E., LEED AP, CIT II  
*TAM Consultants, Inc., A Terracon Company*

This presentation is reprinted with permission from the IIBEC Building Enclosure Symposium, November 11-12, 2019, Louisville, Kentucky. IIBEC is an international association of building envelope consultants whose members specialize in design, investigation, repair, and management of building envelope systems. For more information, visit [www.iibec.org](http://www.iibec.org).

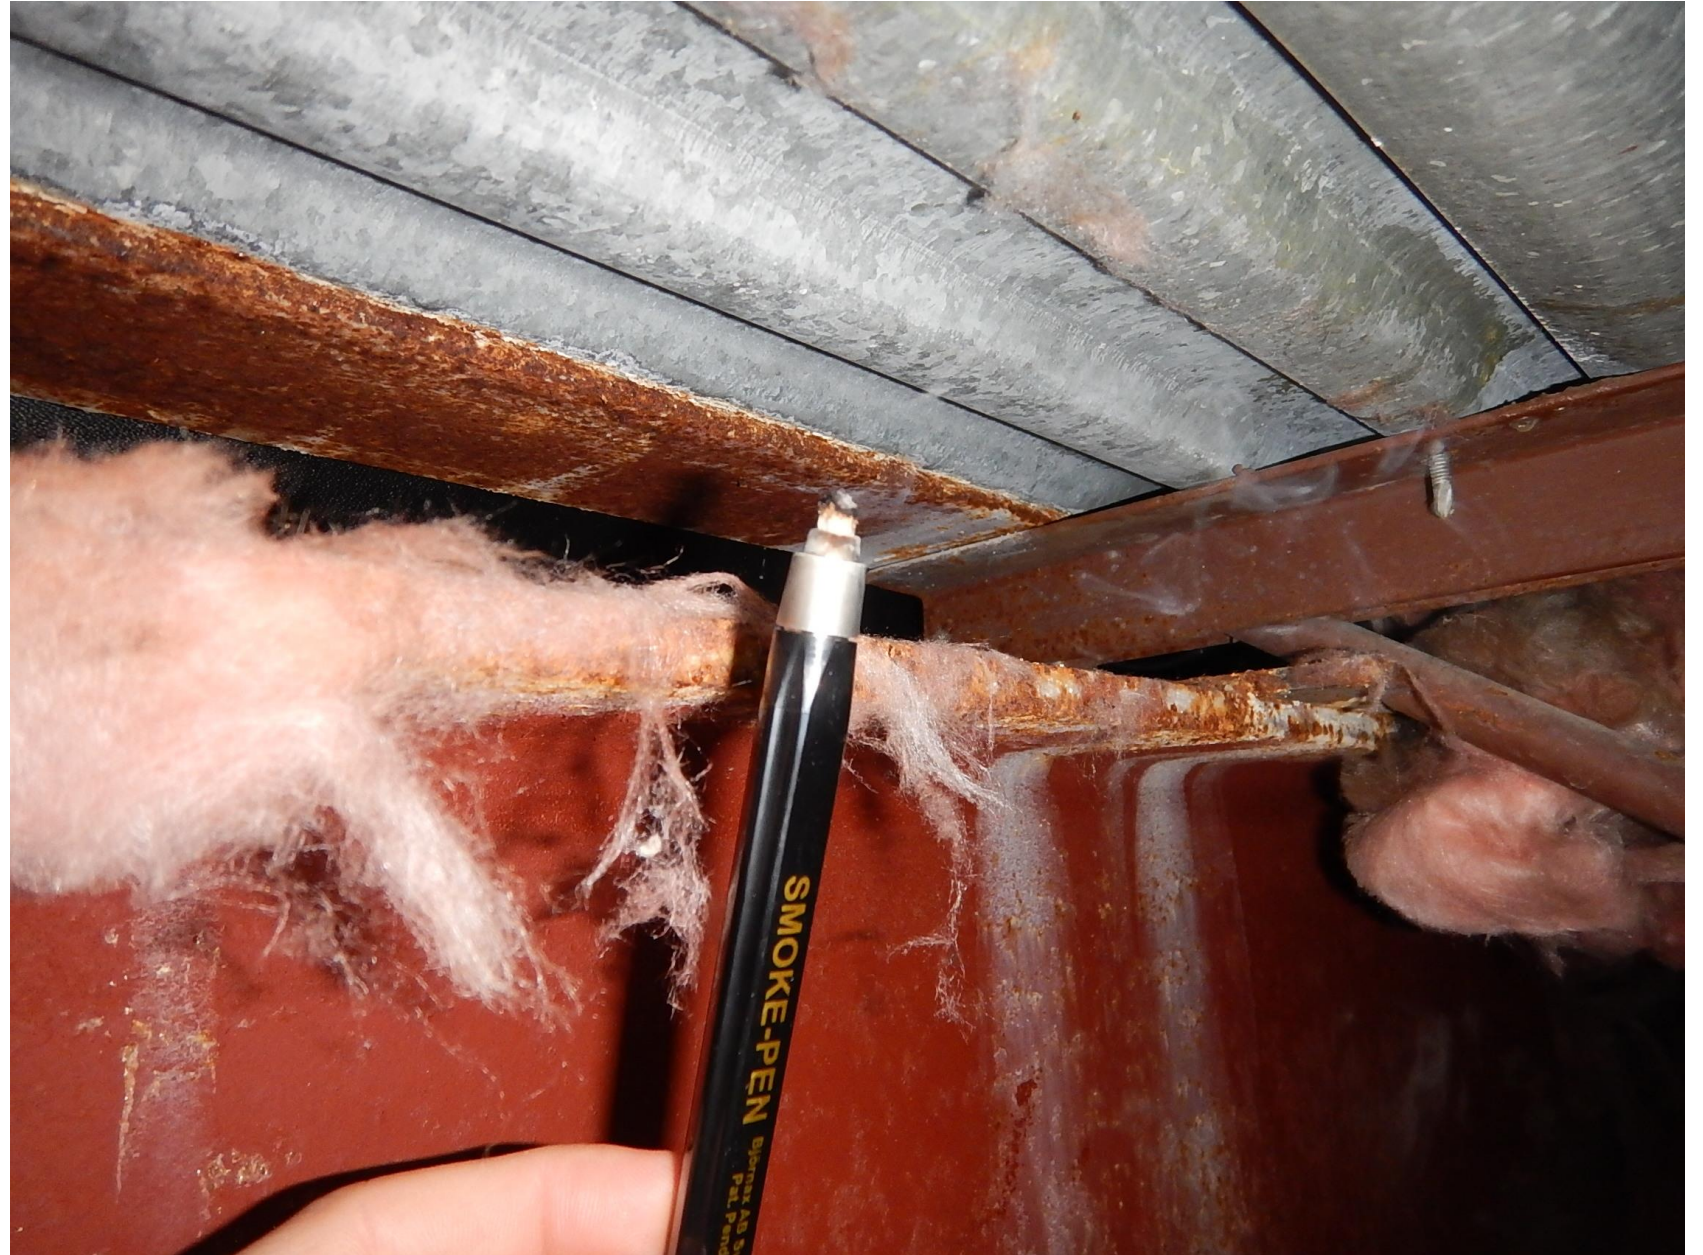
As-built condition where second floor joist bears on exterior structural steel perimeter beam providing an annular slot around the entire perimeter of the building which is open to the masonry cladding cavity. Smoke pencil used to verify unintended air infiltration at this location.

- In our case study it would be relatively easy to seal up the annular space at the perimeter second-floor steel bearing line because the open masonry cavity is relatively easy to access from inside and above the lay-in ceiling tiles.

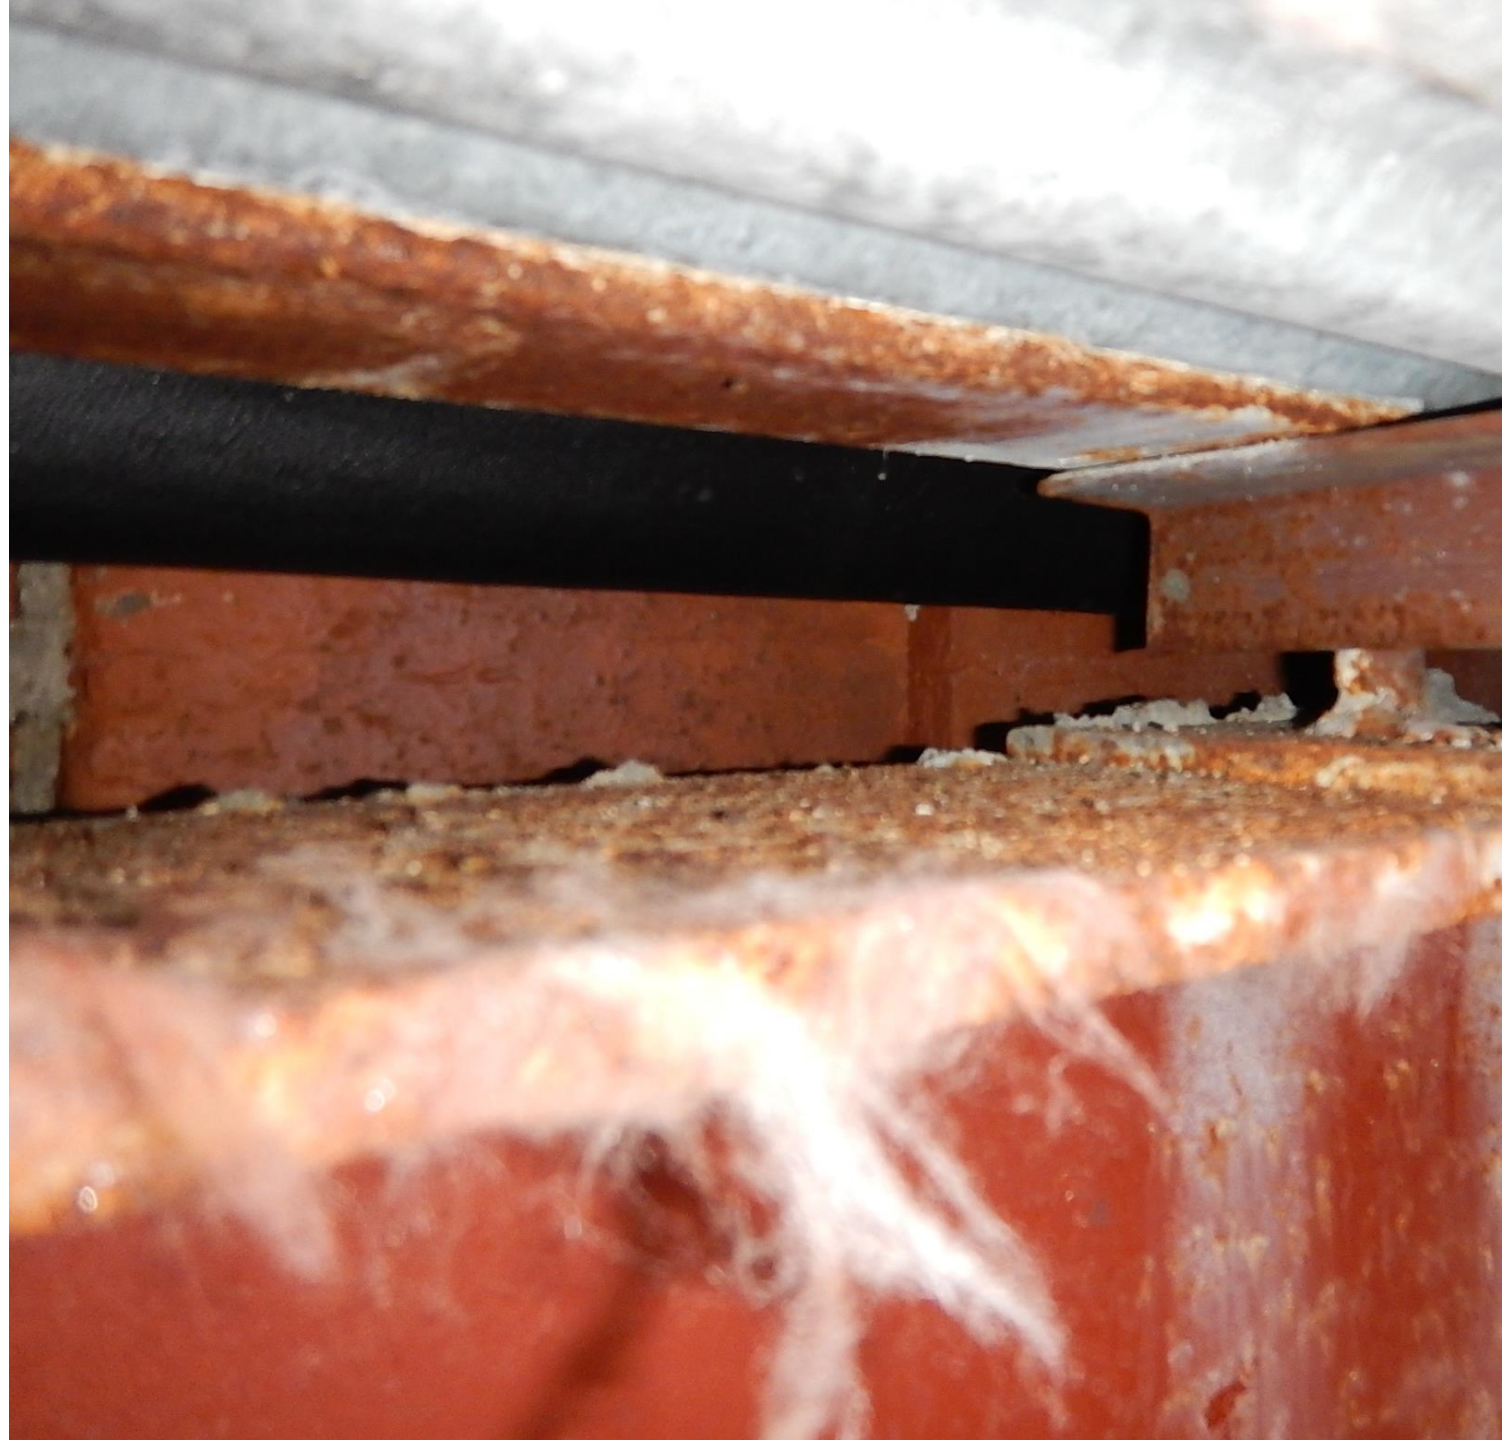
Direct view of the masonry cavity (back side of brick cladding visible from interior plenum space) between the second-floor steel form deck and structural steel framing.

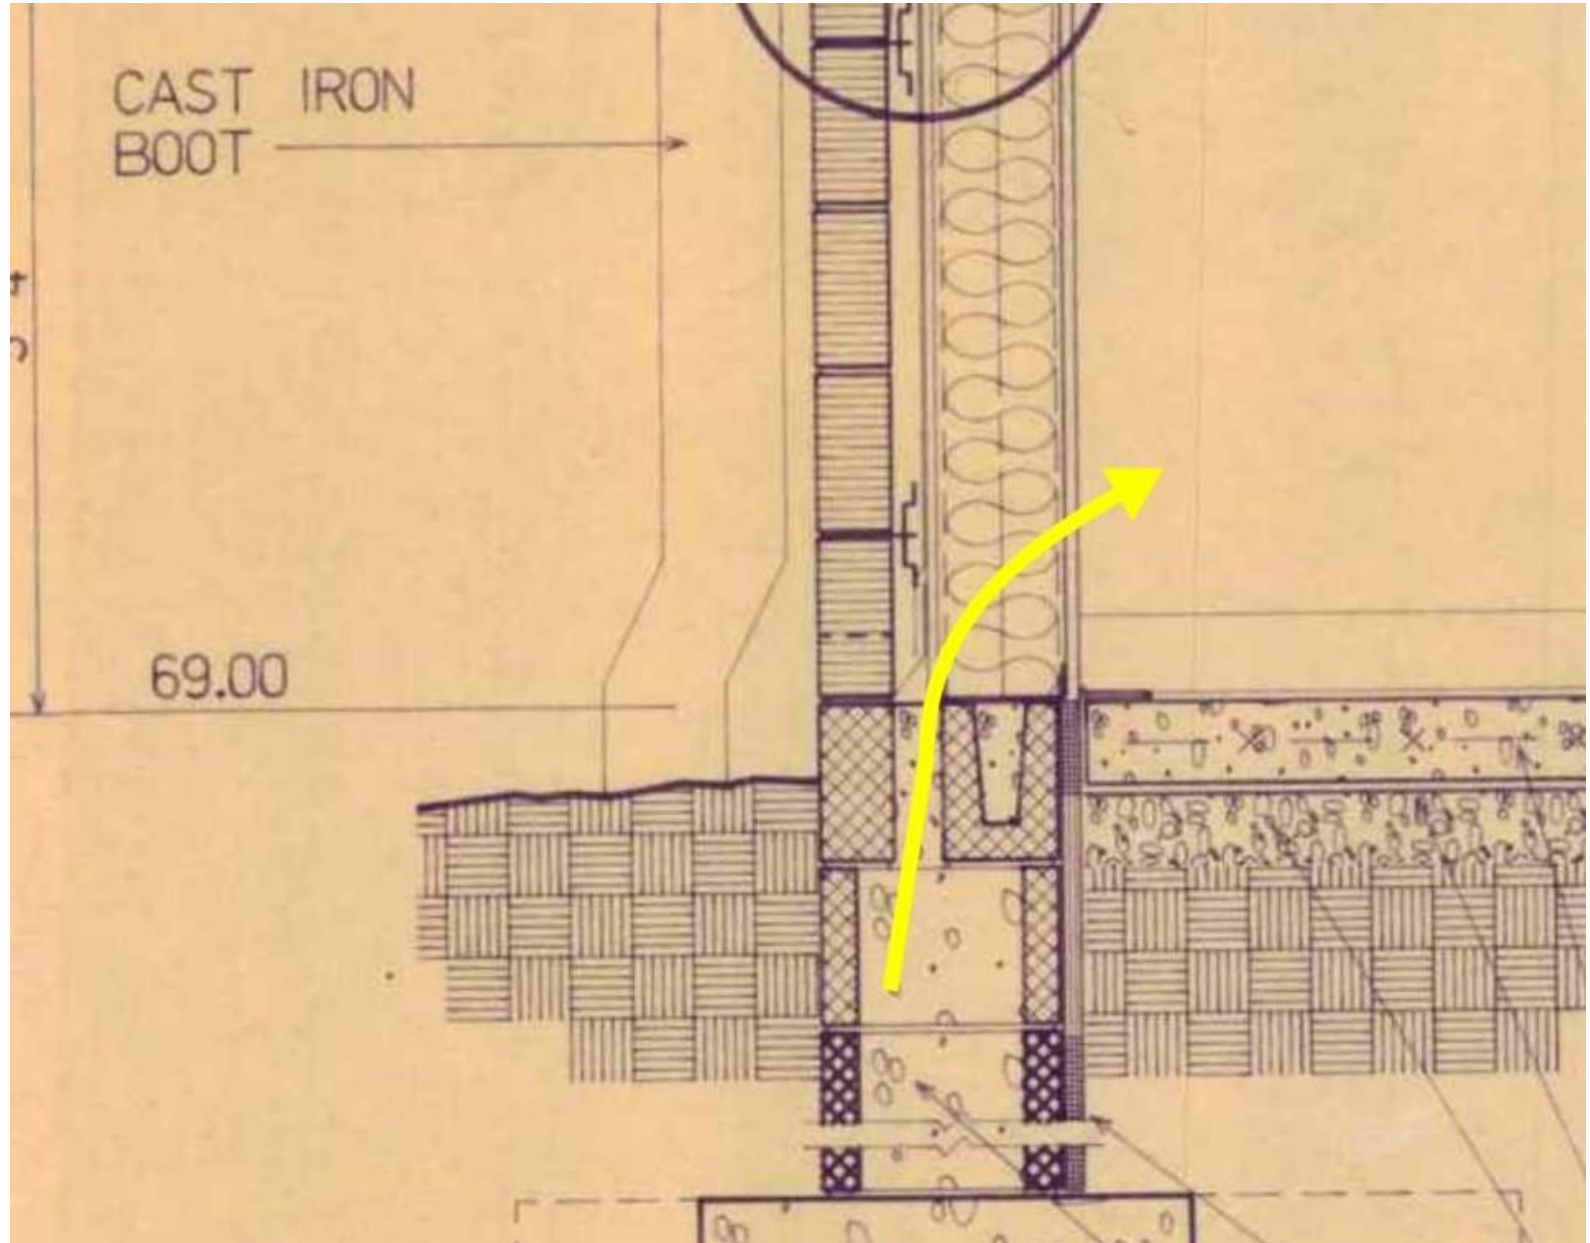
Base of wall detail that does not provide for good separation between the always damp or wet ground condition and the base of the wall studs and gypsum sheathing.

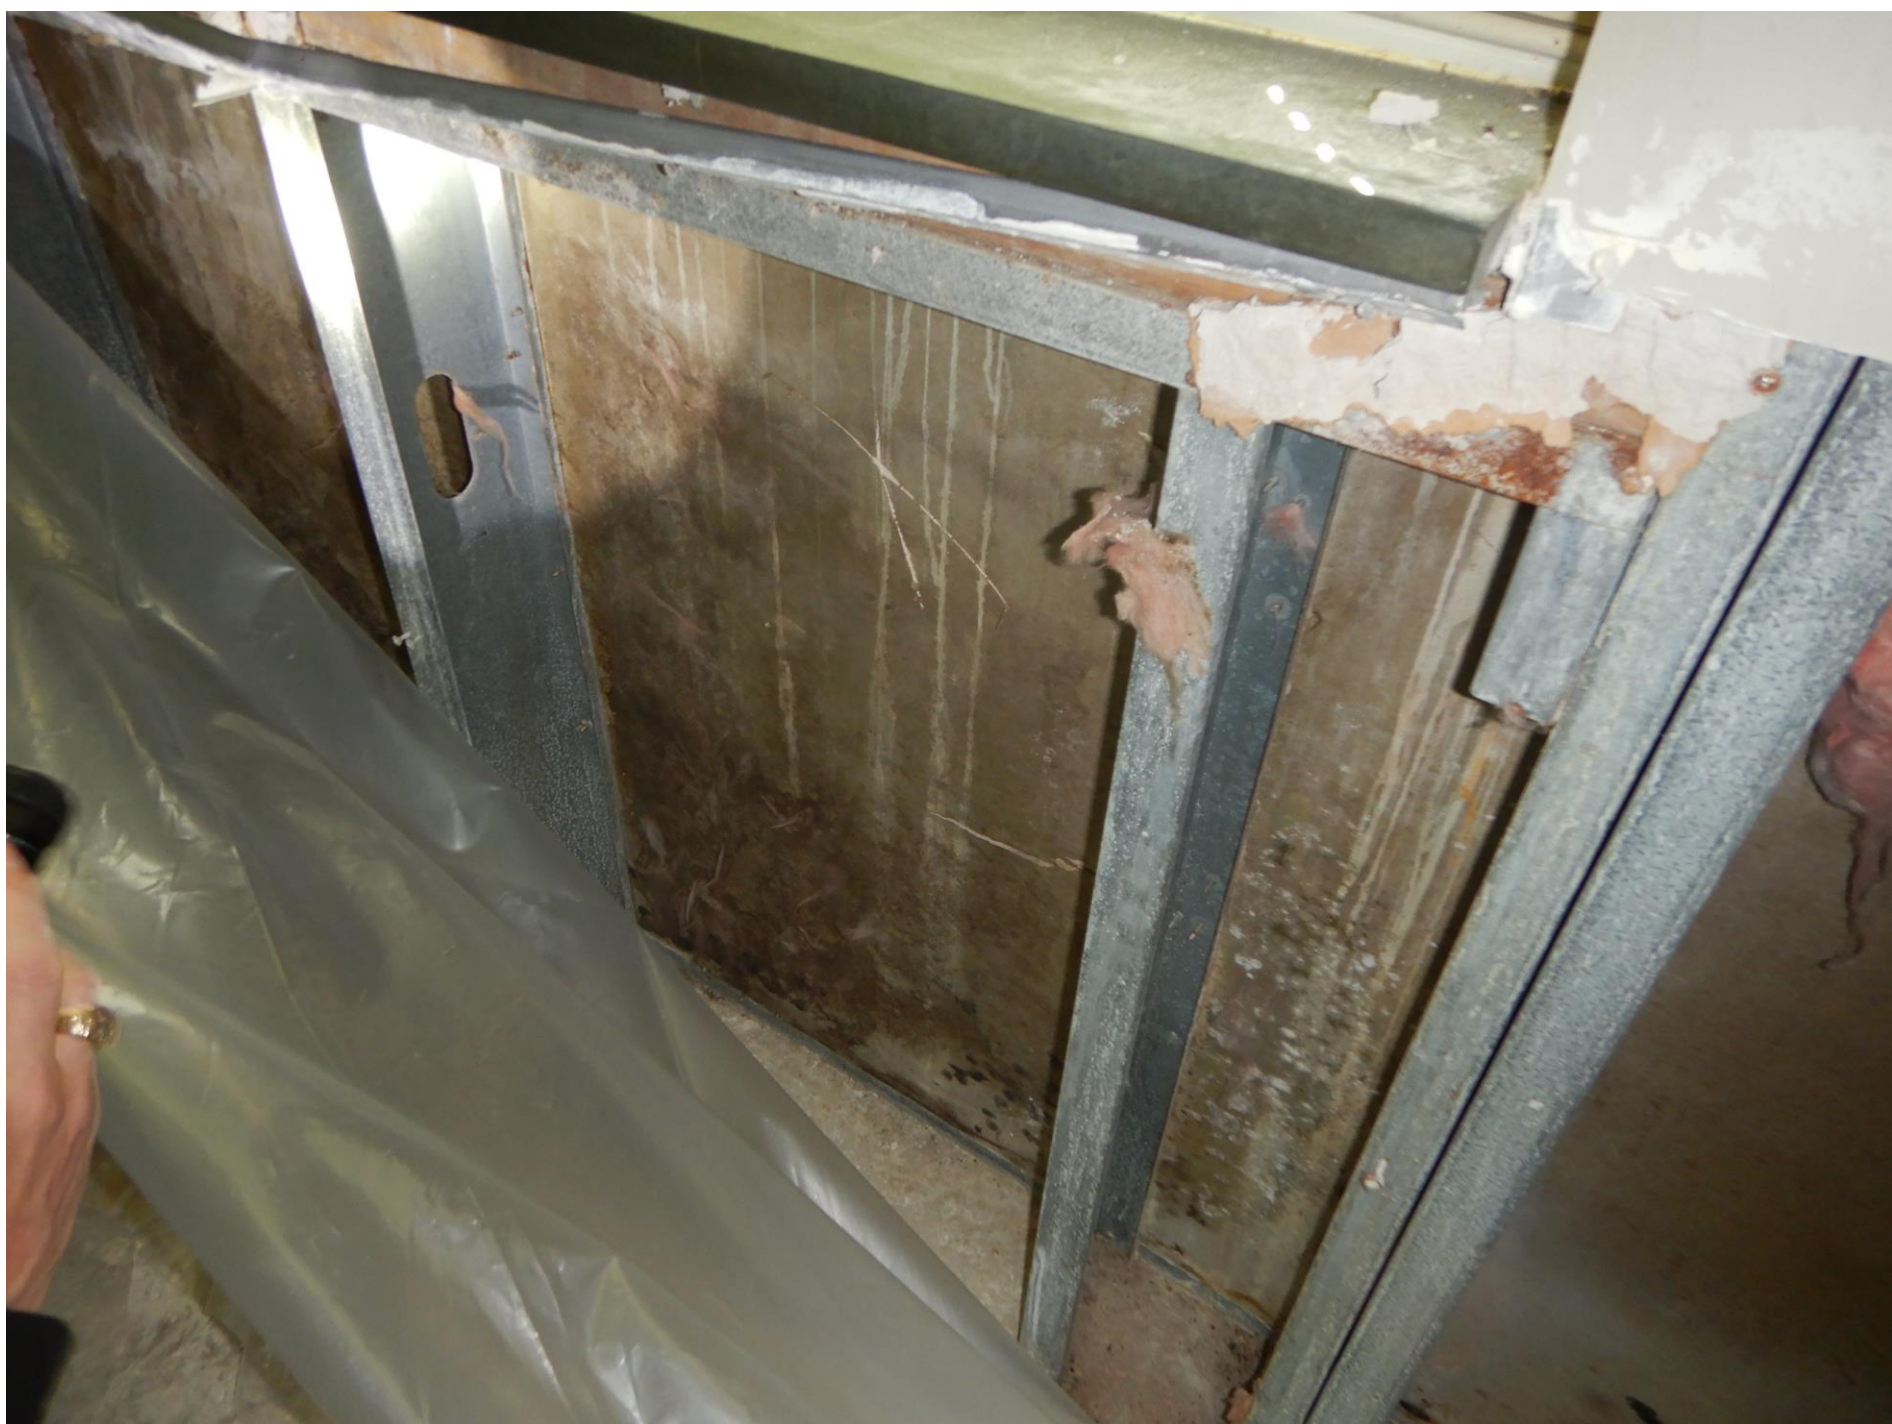
Where mold development and water damage is occurring inside the stud cavity on the paper faced sheathing.

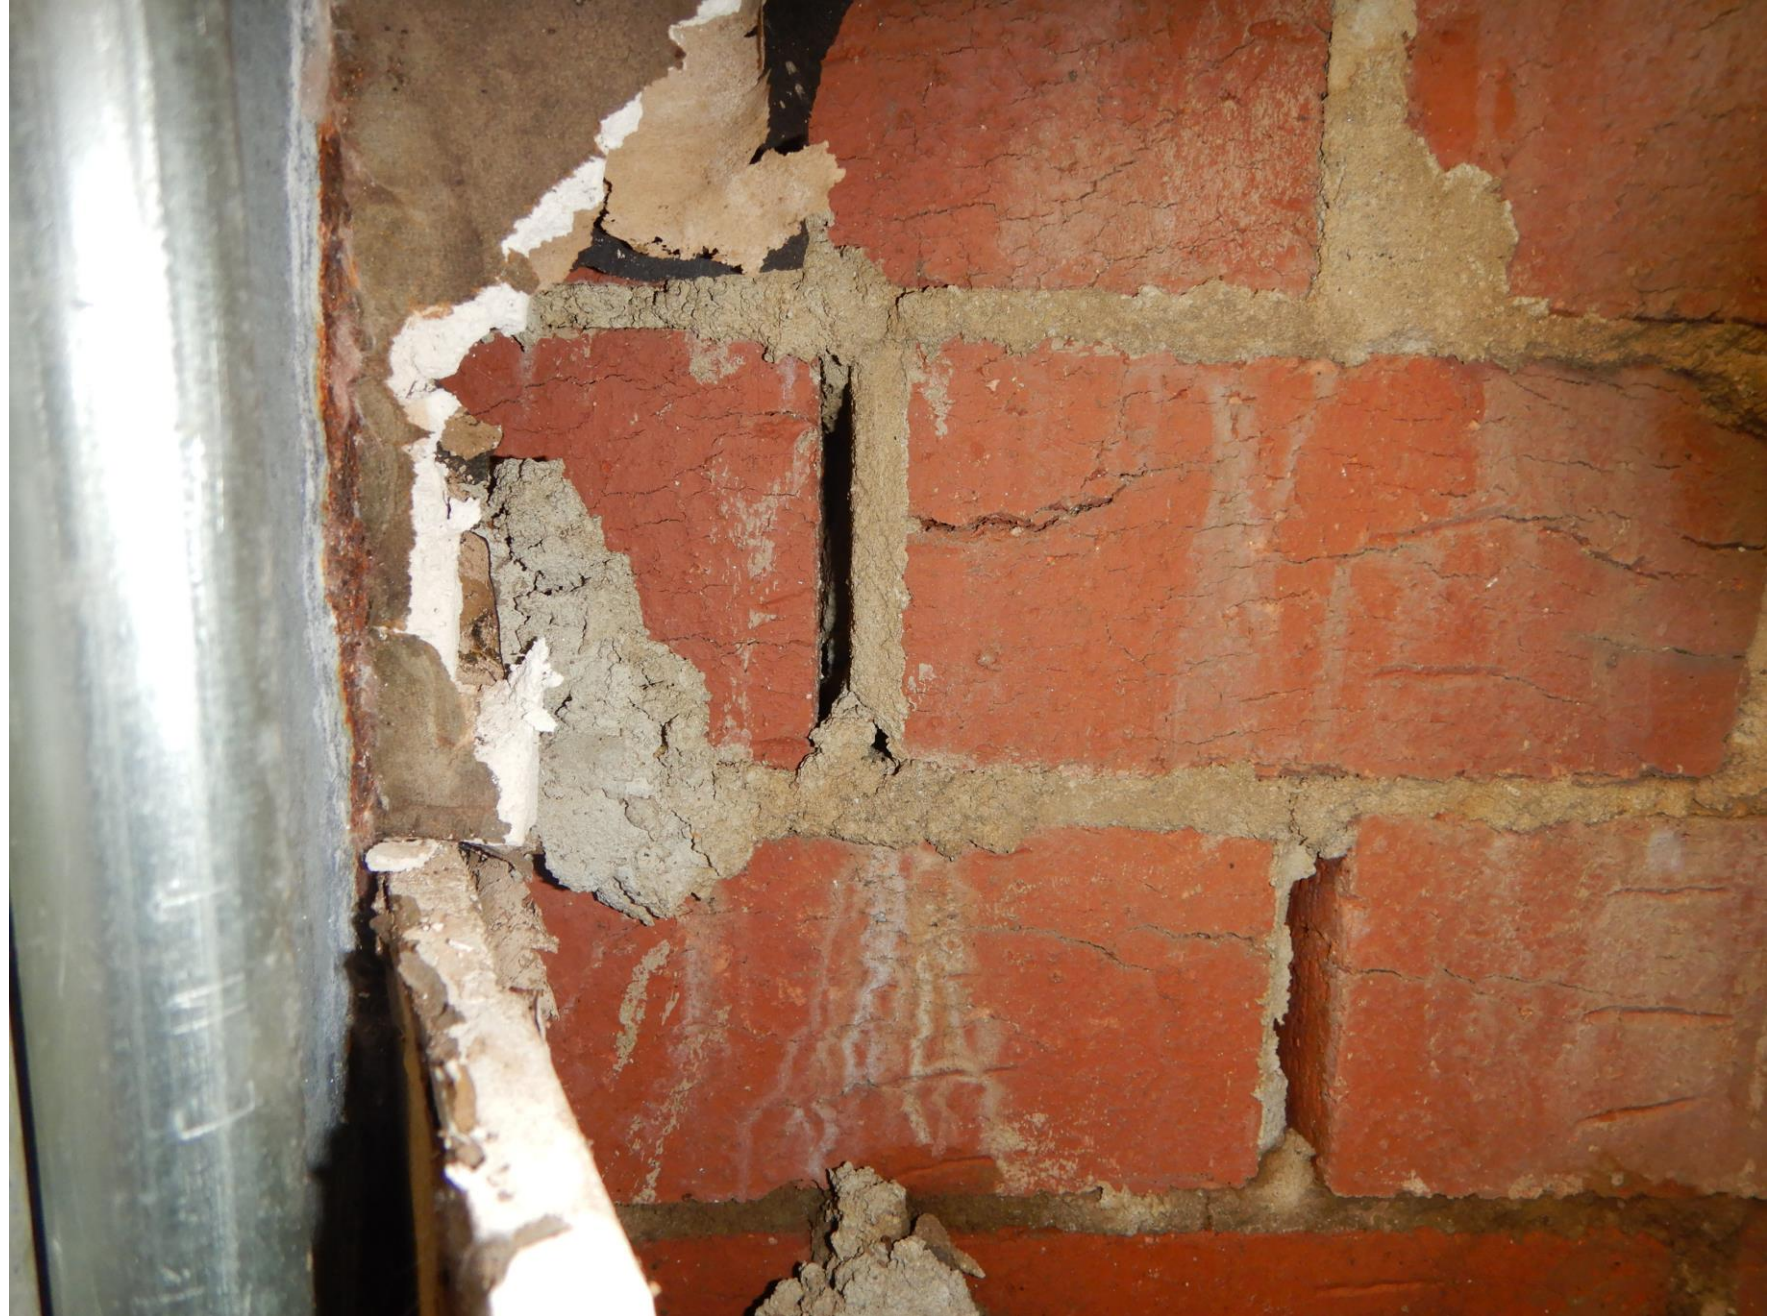
Typical condition of the backside of a completed masonry cladding (facing the cavity). Note poorly executed head joints. Often daylight is visible. In our experience this is a common occurrence in masonry cladding construction.

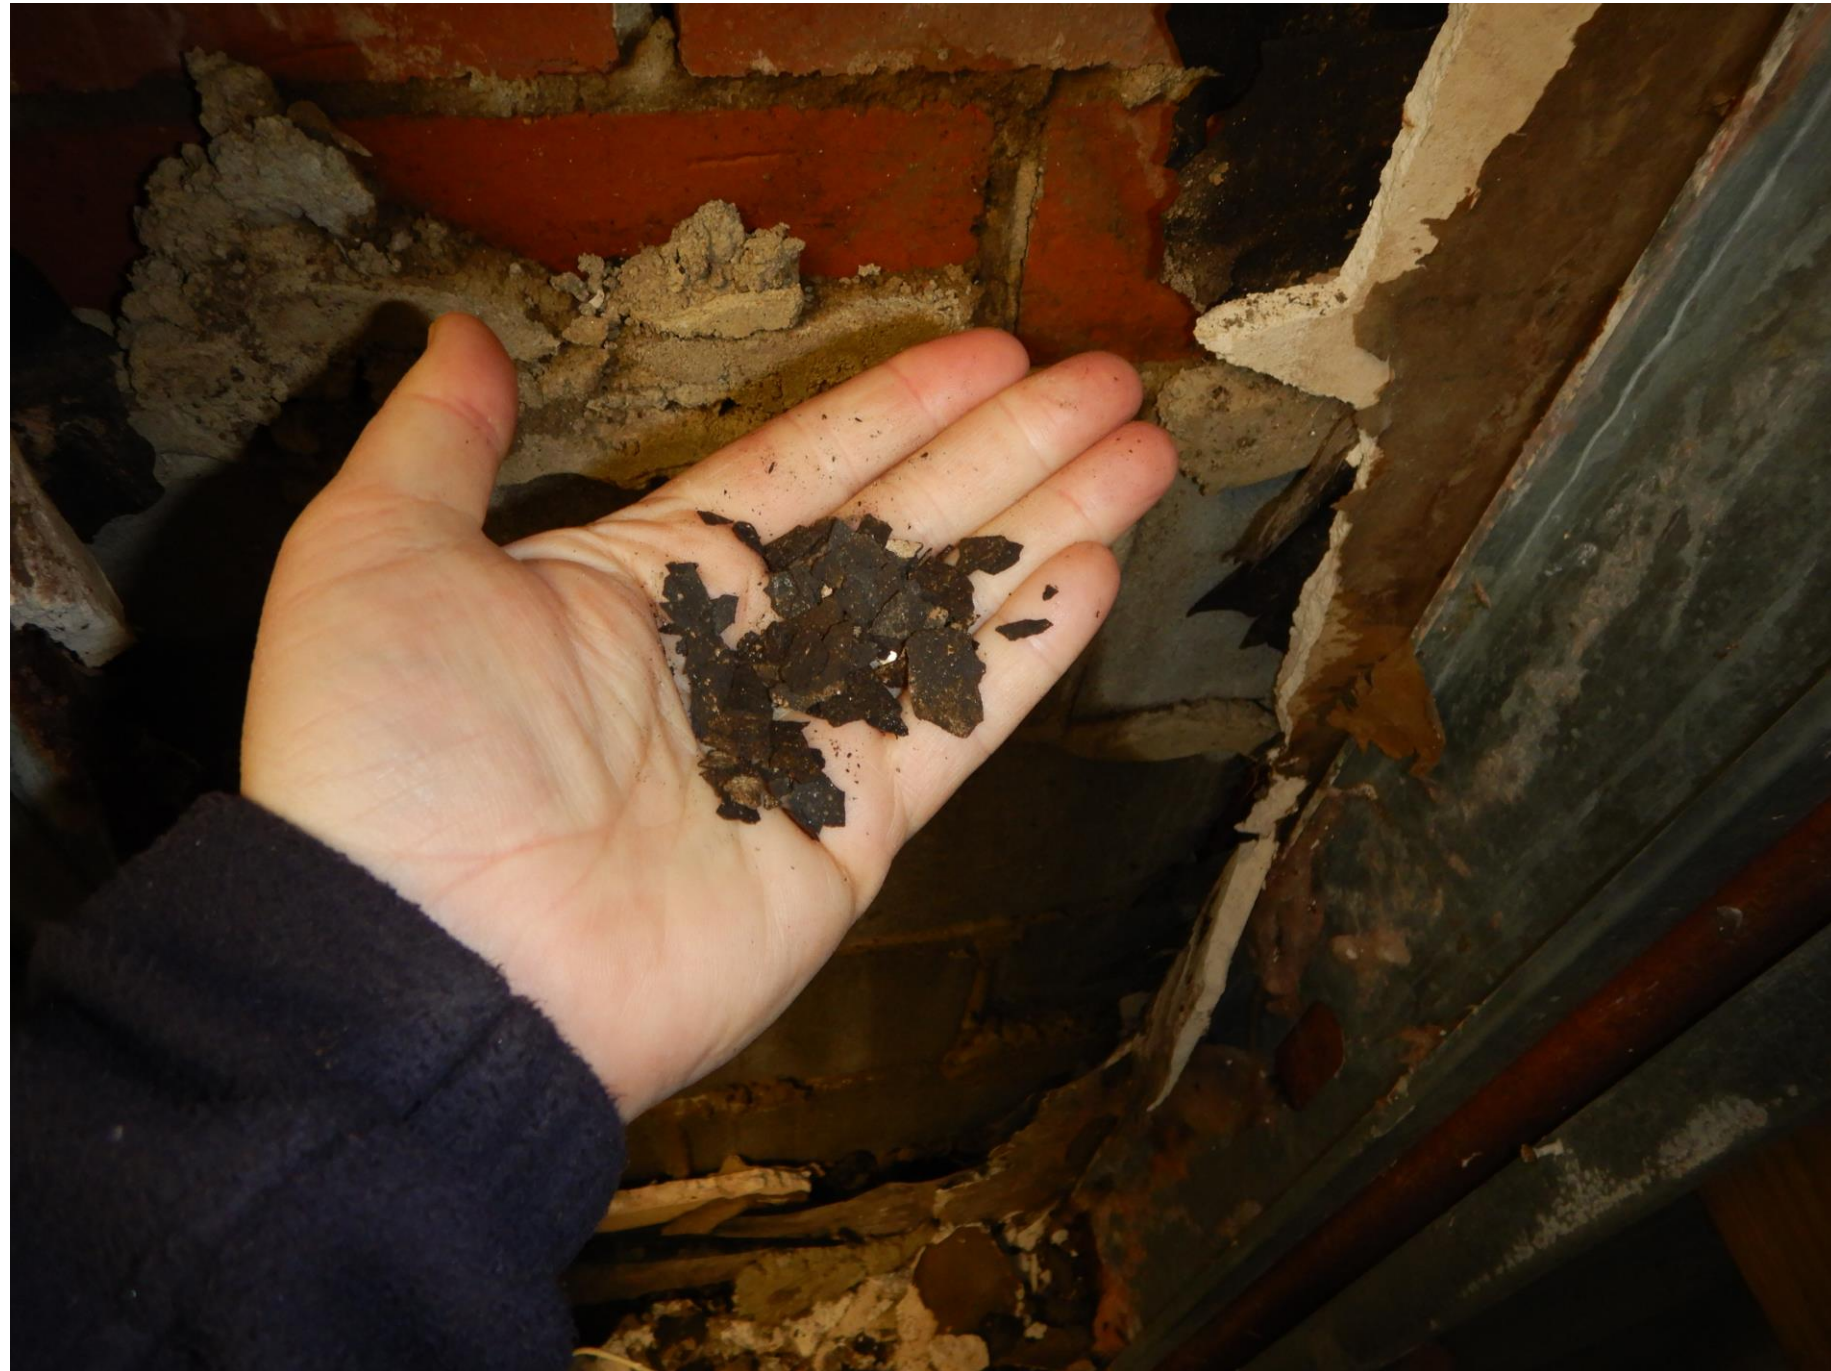
Installed weather resistant barrier (building felt) has become brittle, is easily damaged and disintegrates on contact.

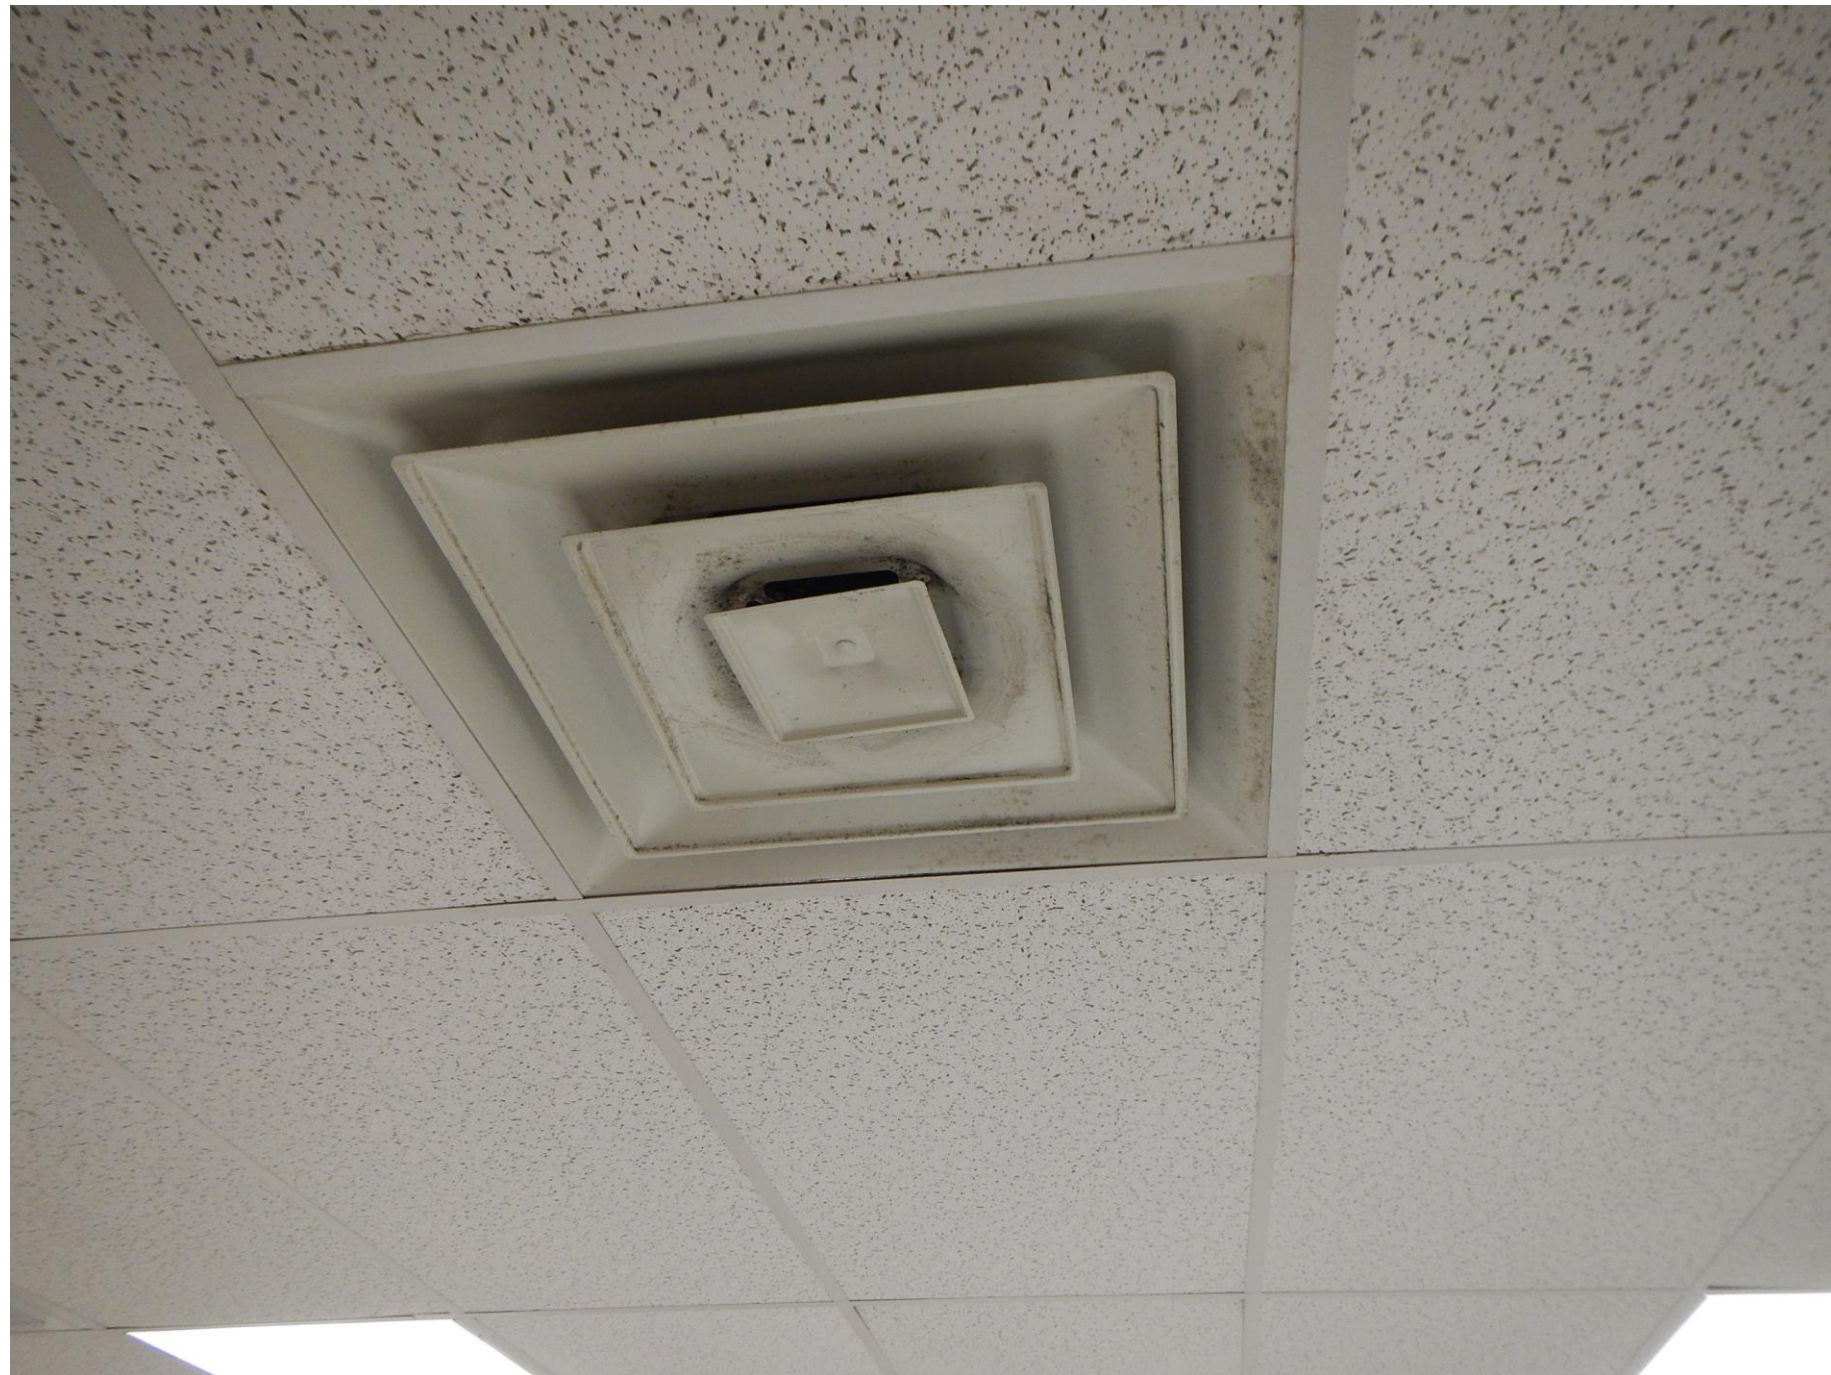
No, the dirt,  
dust and  
mold is not  
coming out  
of the supply  
registers.

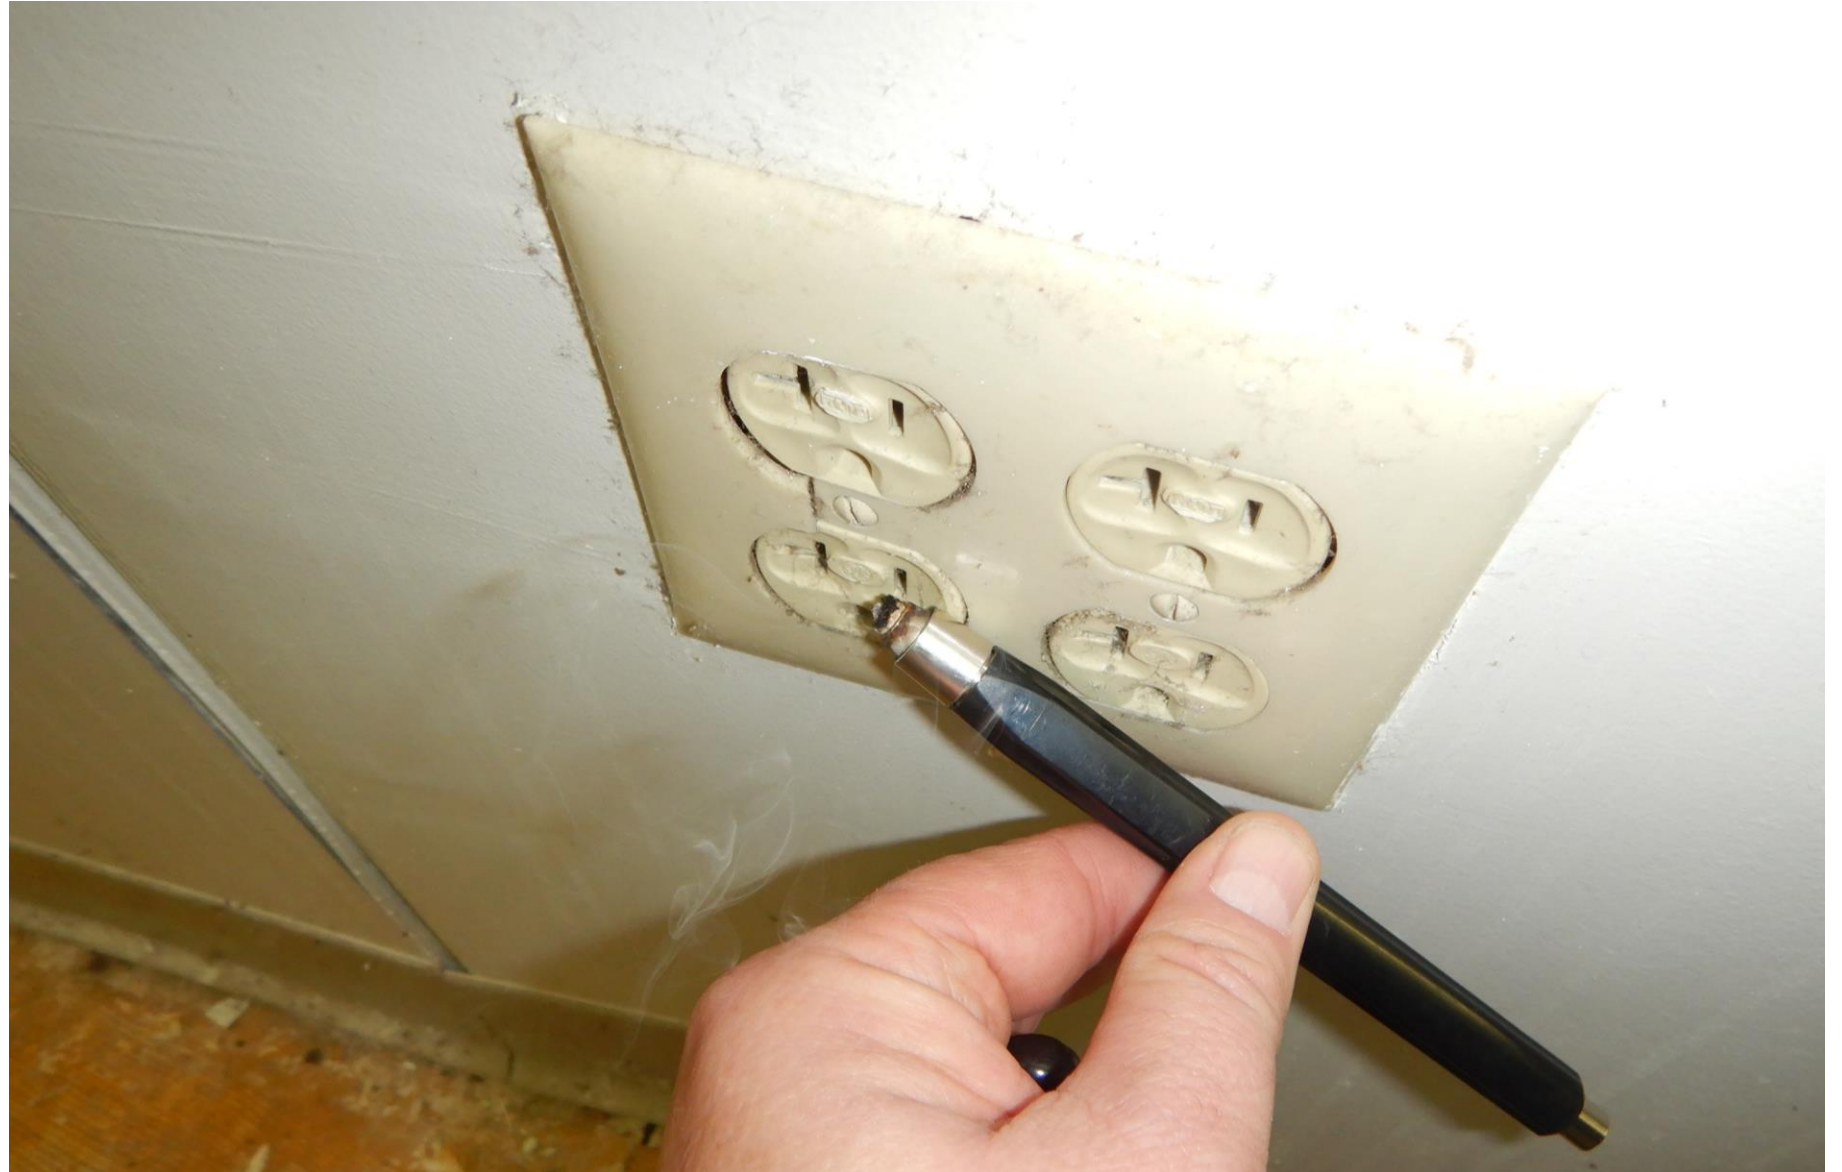
Use smoke  
at  
receptacles  
to check for  
infiltration  
or  
exfiltration

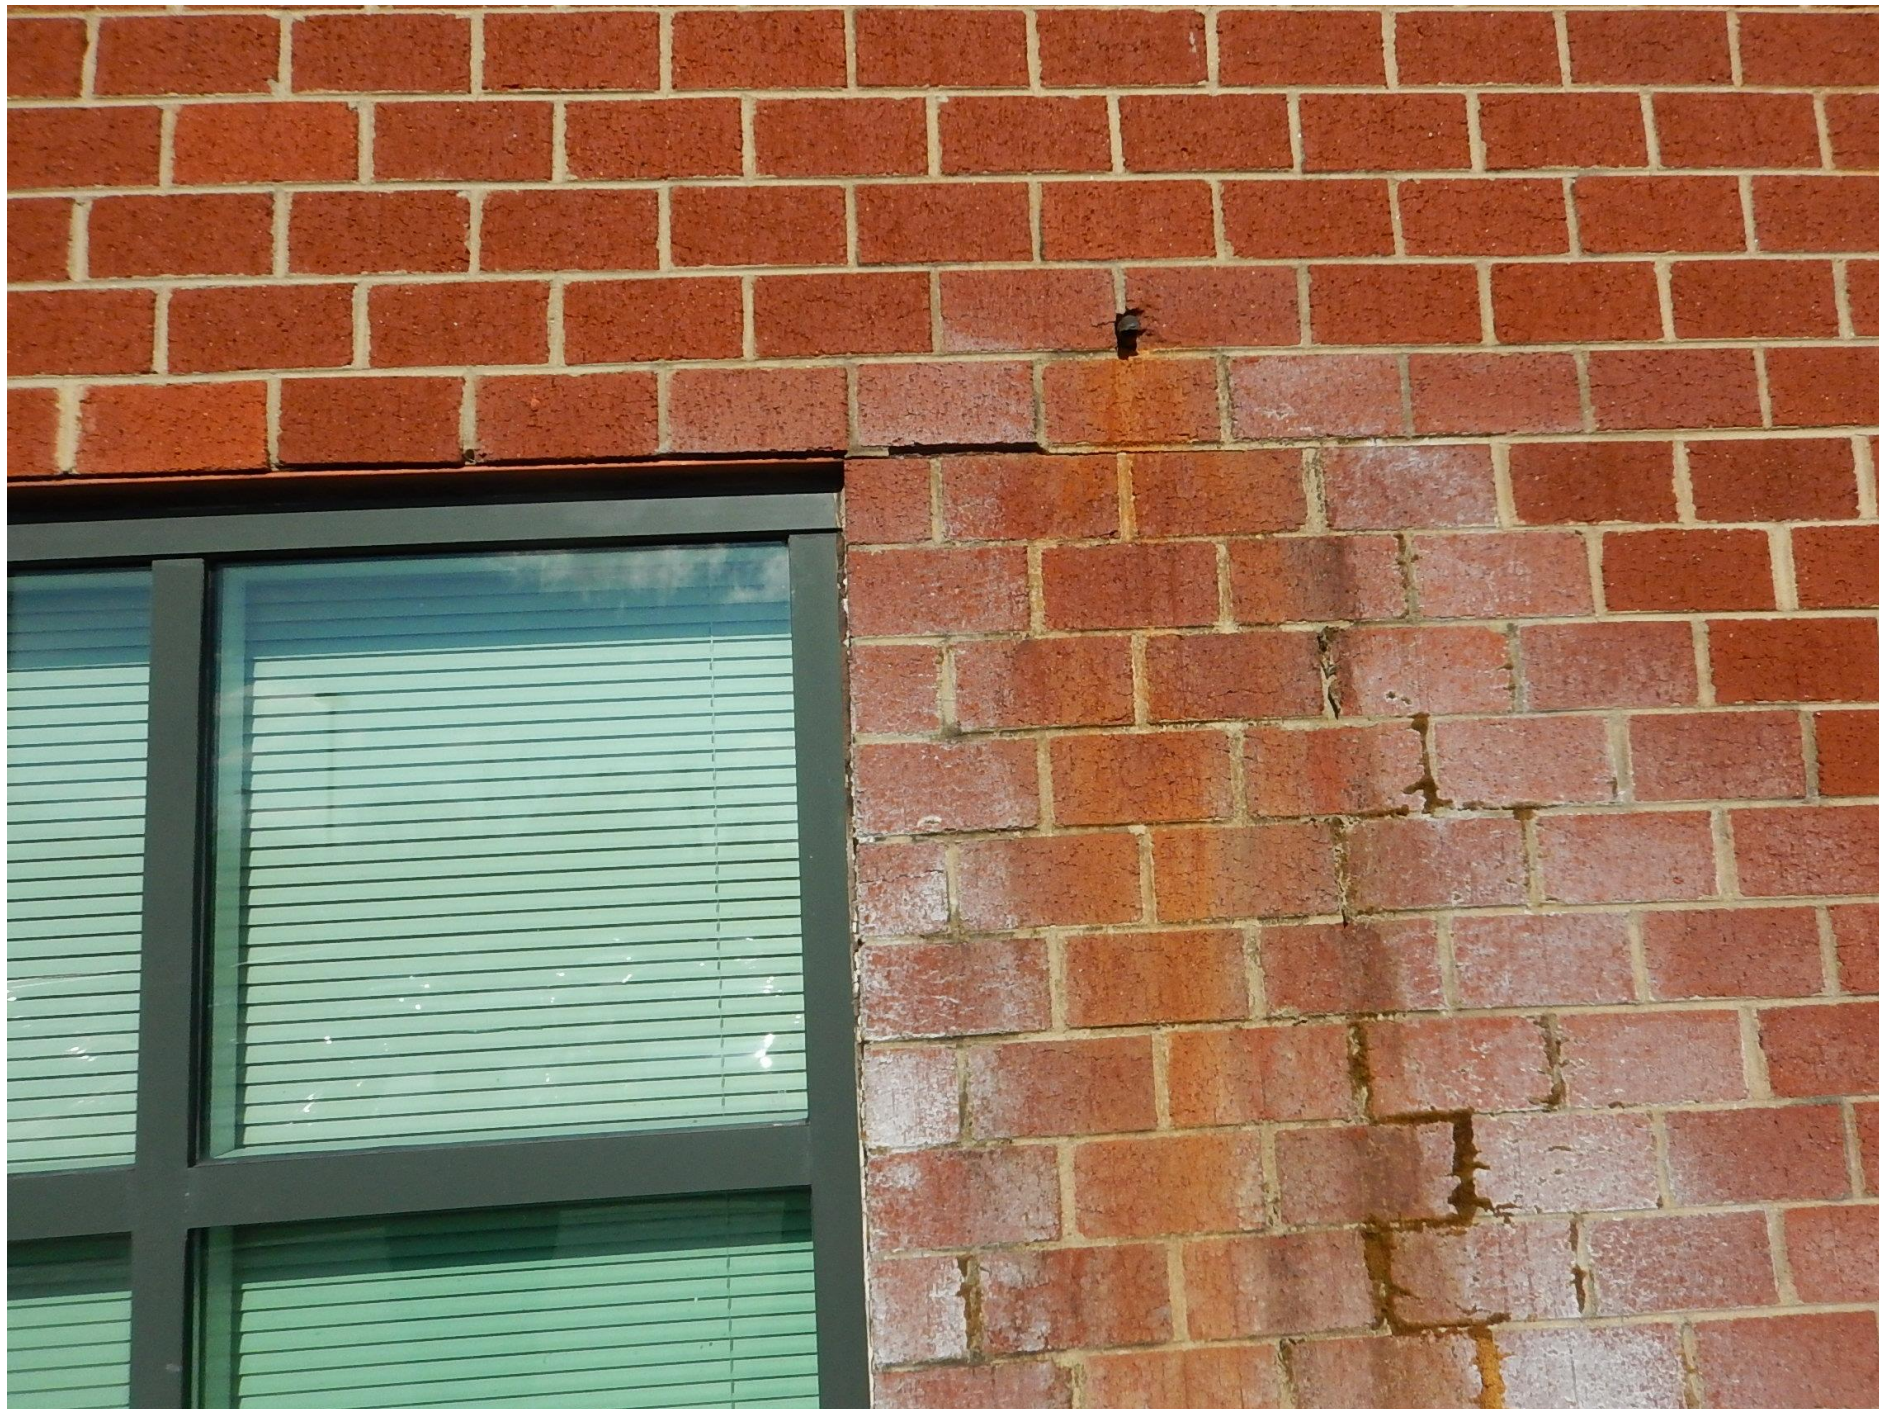
HVAC  
overflow  
pan  
condensate  
drains
