# This Won't Go Away – Mold In Office Buildings

Timothy A. Mills, P.E., LEED AP, CIT II  
*TAM Consultants, Inc., A Terracon Company*

This presentation is reprinted with permission from the IIBEC Building Enclosure Symposium, November 11-12, 2019, Louisville, Kentucky. IIBEC is an international association of building envelope consultants whose members specialize in design, investigation, repair, and management of building envelope systems. For more information, visit [www.iibec.org](http://www.iibec.org).

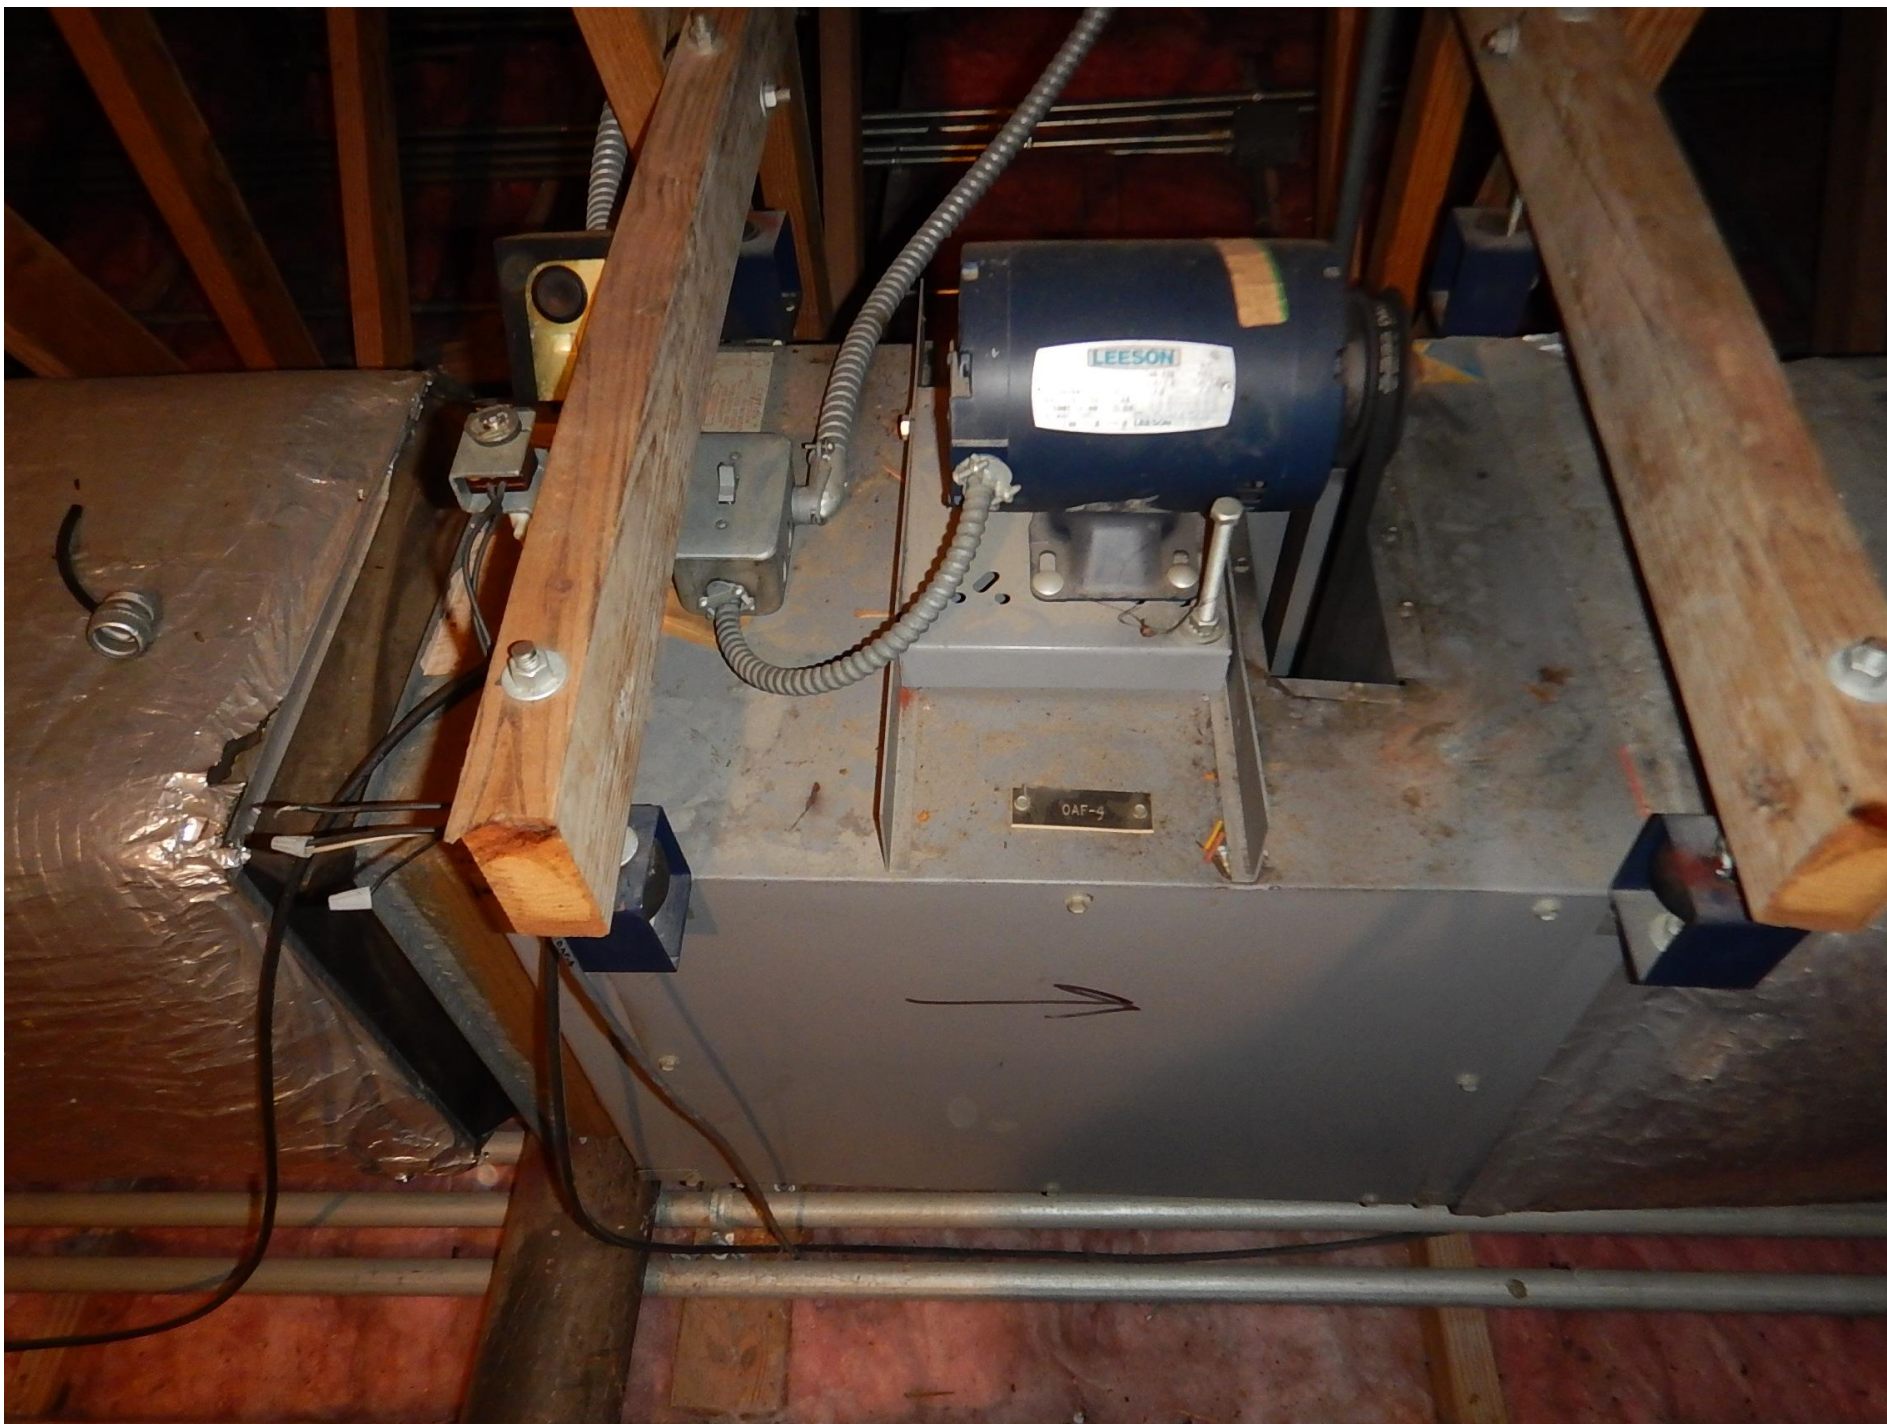
One of four outside air fans installed in the attic space providing ducted outside air directly to the 17 air handler units throughout the building. This unit was inoperable.

- Furthermore, a more reliable method to pressurize the building with outside air while also ensuring that air is conditioned before introduction into the interior environment could be to install a dedicated outdoor air system (DOAS). Such a system would not have to rely on the air handler cooling coils to dehumidify the air before it is introduced into the building.

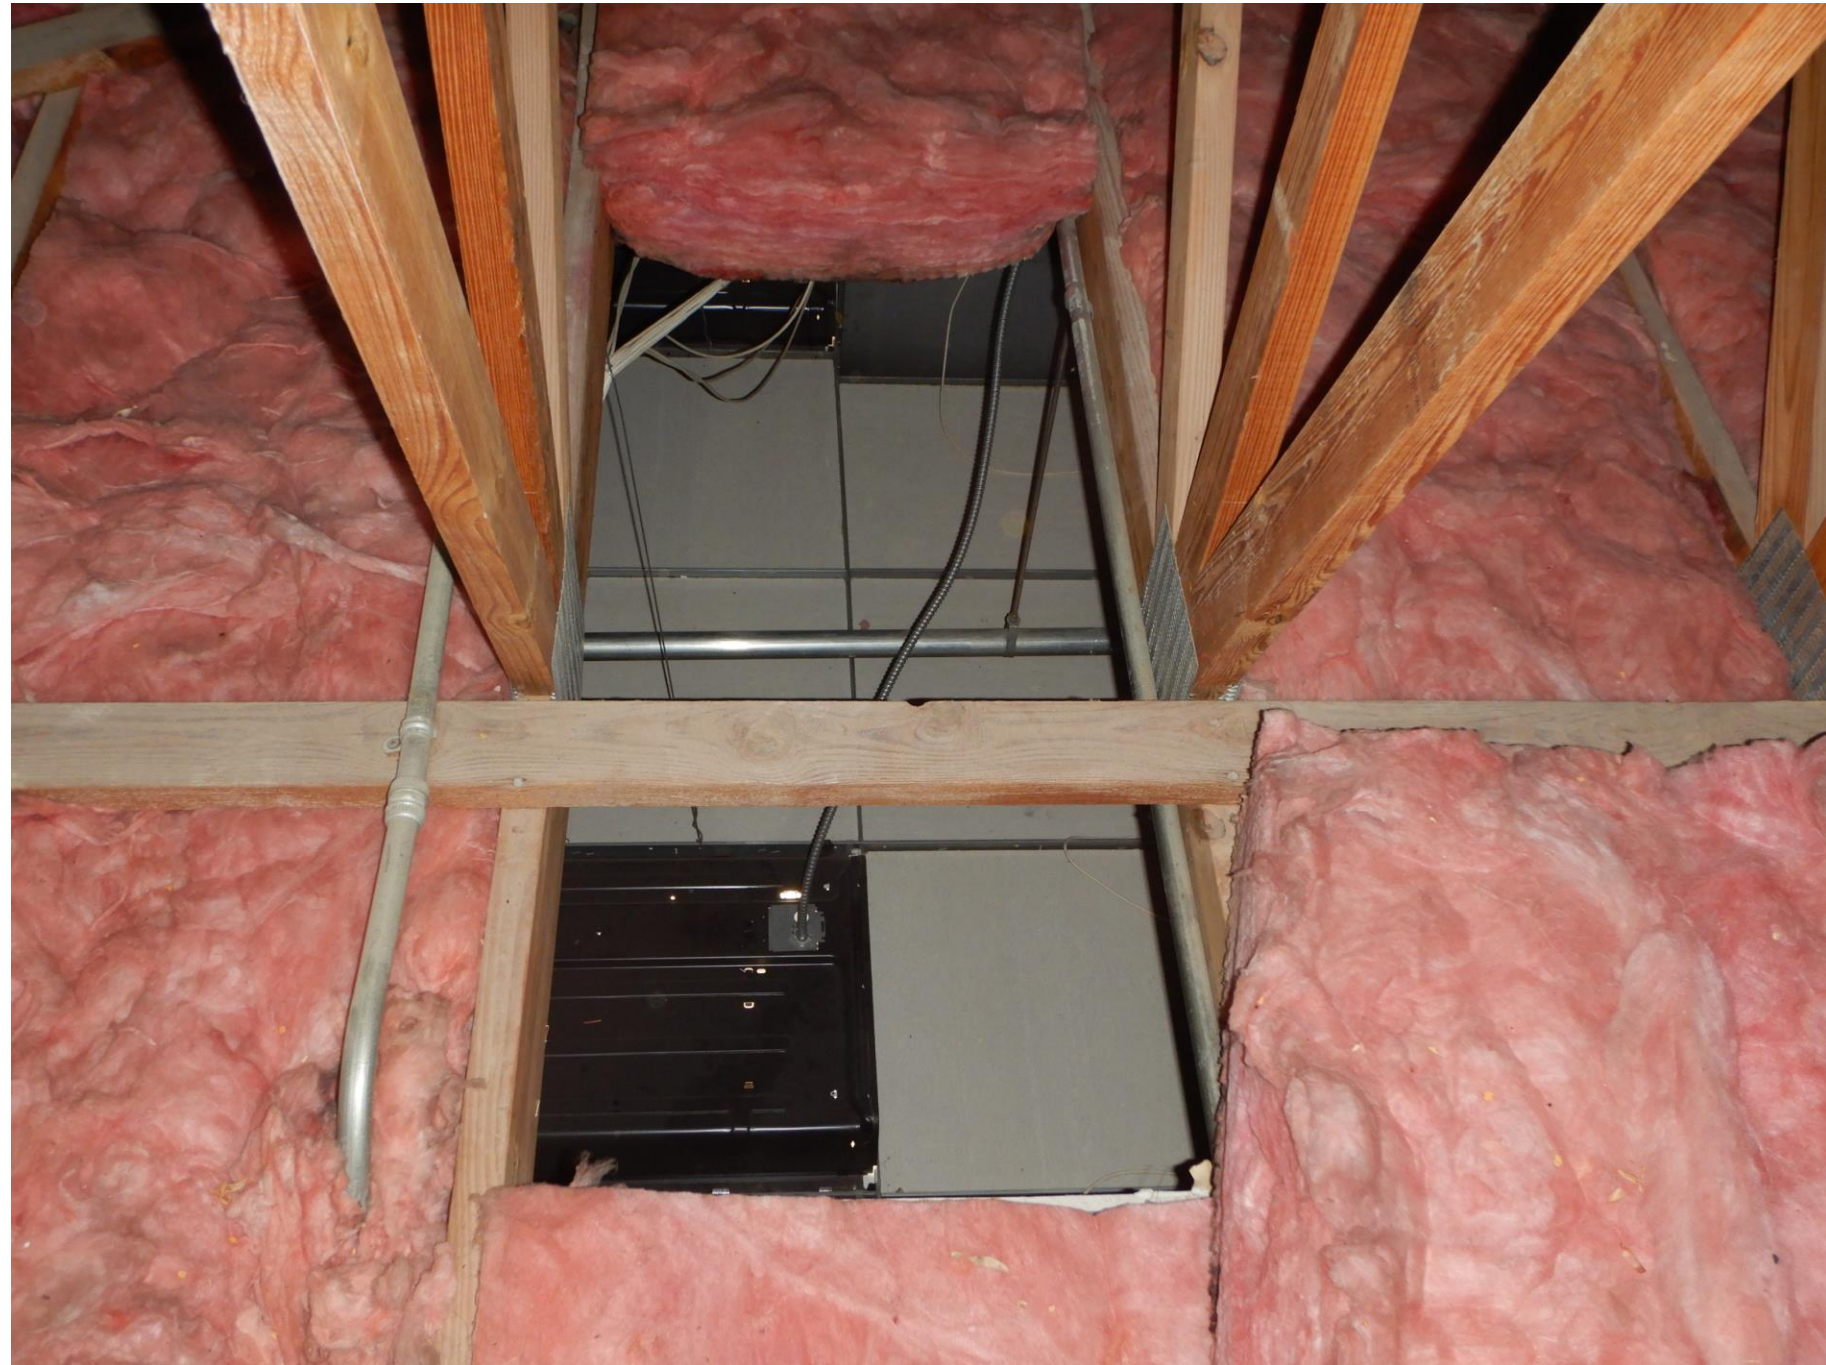
A common condition where the attic is missing thermal insulation creating an open condition to the return air plenum below.

- Likewise, the attic area could be separated from the second-floor ceiling plenum space by installing either a sheet air barrier or gypsum drywall air barrier to the bottom of the attic trusses. This modification is more intrusive as it will require removal and reinstallation of the suspended ceiling system; however, it is a feasible approach.
