Invisible Improvement: Air Tightening an Office in a Historic Pier

4EA Building Science

Invisible Improvement: Air Tightening an Office in a Historic Timber Pier

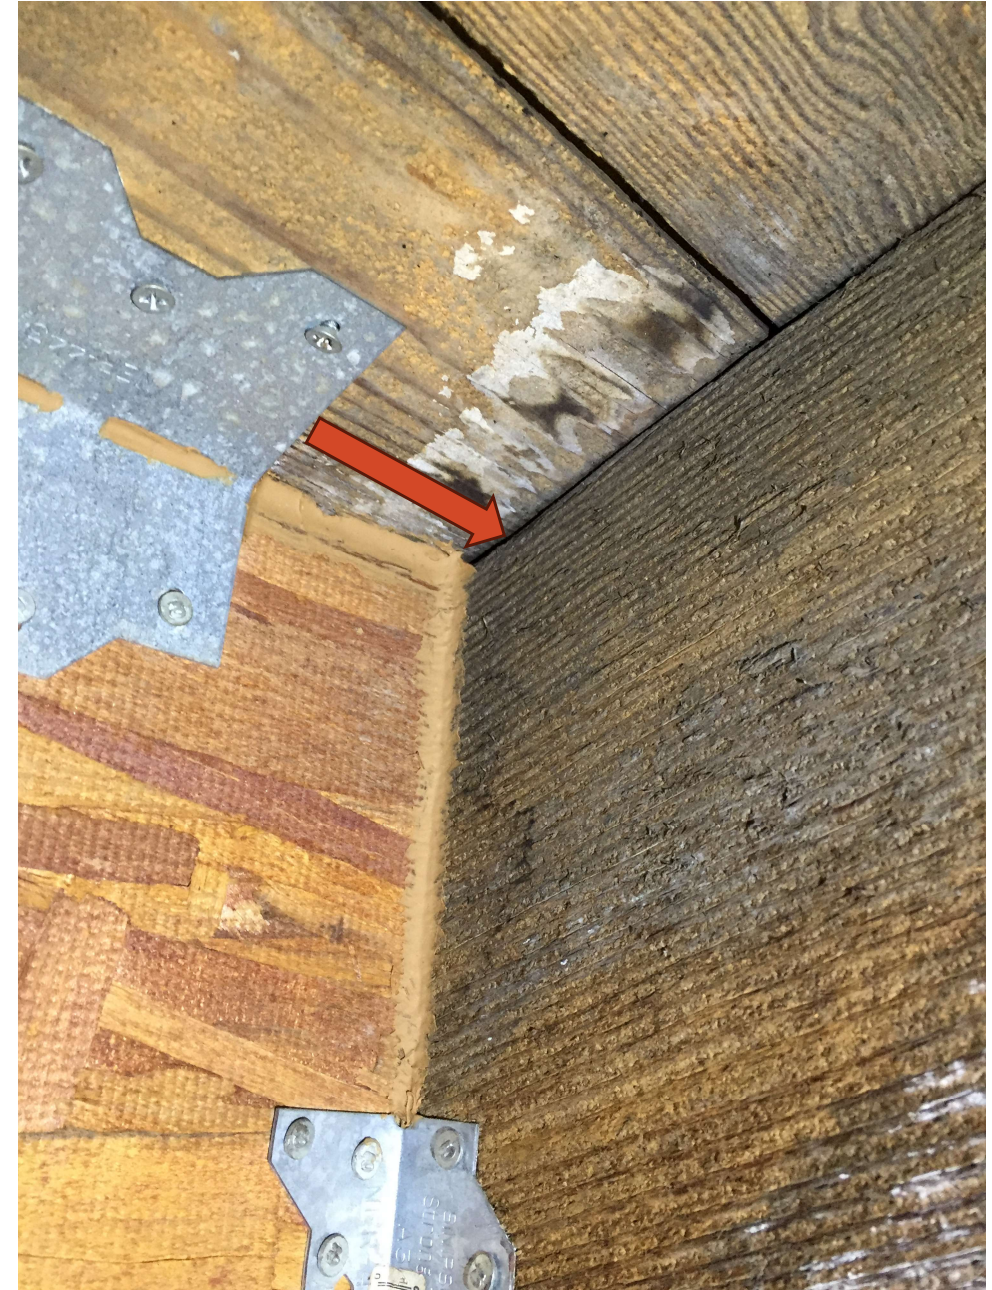
- Still room for improvement
- Some locations were missed or were not accessible
- Sealing of blocking at rafters was a 3D problem (car decking to rafters could not be sealed).
