Non-Visible Energy – Decoding Electromagnetic Energy and Thermodynamics

Case Study 1 – CoxHealth Patient Tower Addition

Case Study 2 – Primatara Mansion

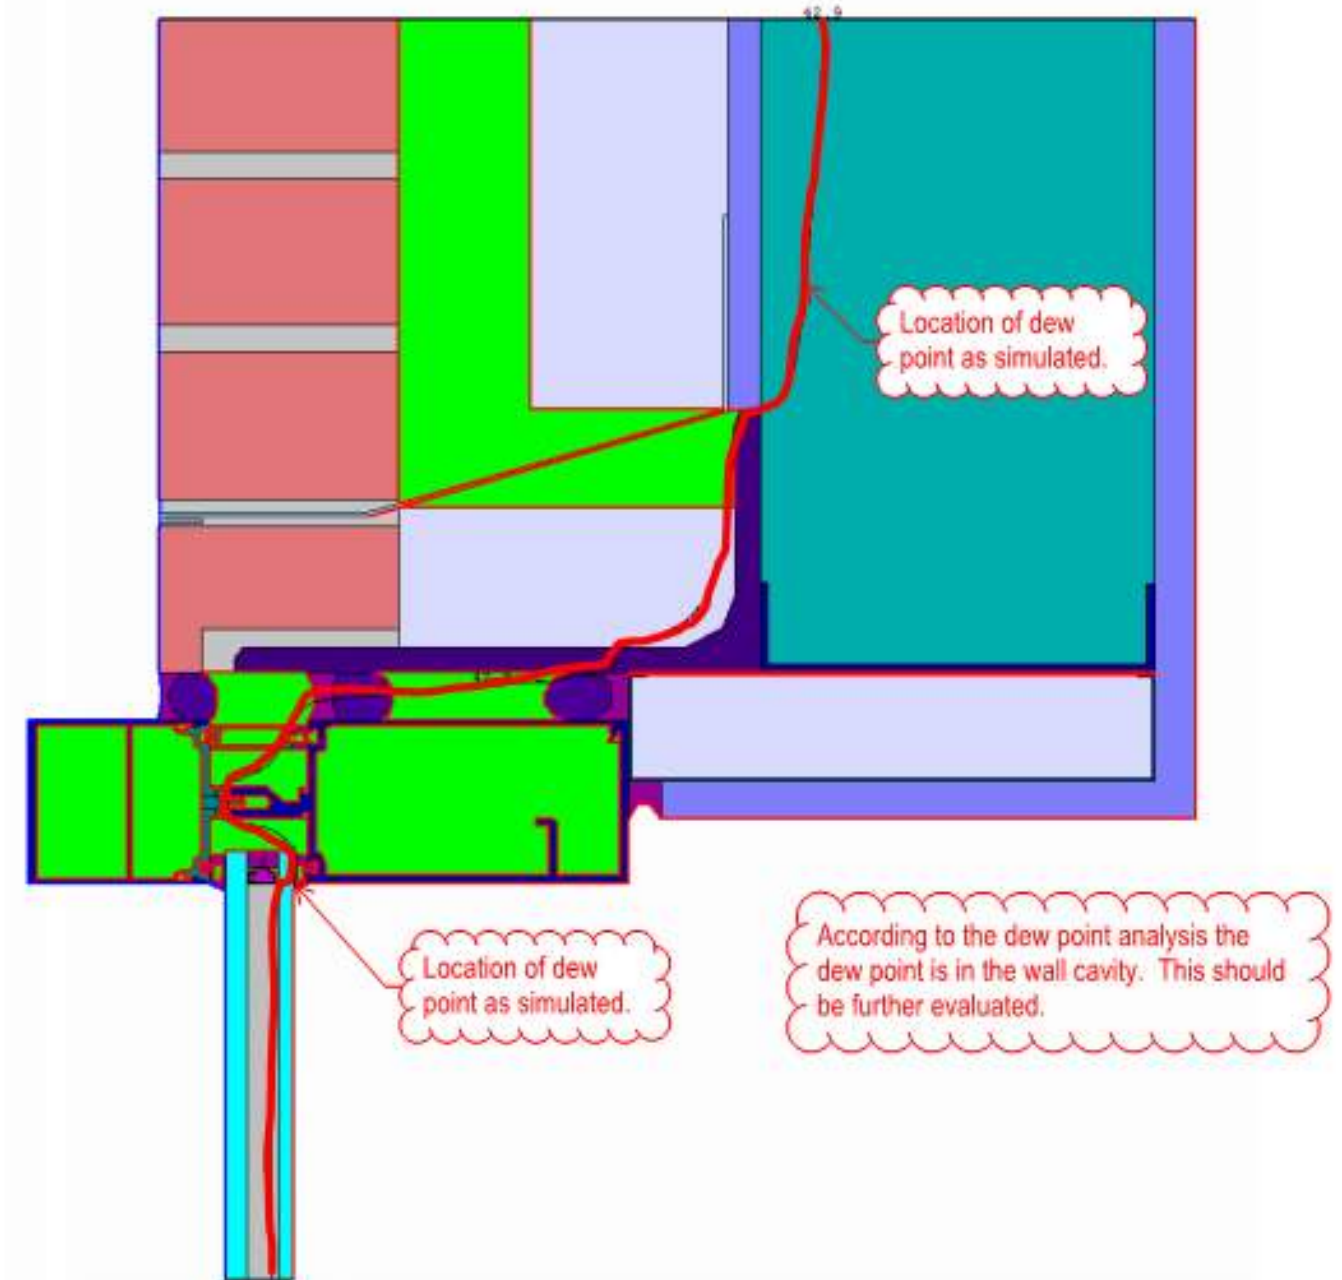
Brick Spandrel Over Vision Head (R.H.=35%) Detail
Color Image of Material Assignments with Isotherm at Dew Point Temperature

EXTERIOR DESIGN TEMPERATURE	= 3 °F
EXTERIOR WIND SPEED	= 15 mph
INTERIOR TEMPERATURE	= 72 °F
INTERIOR RELATIVE HUMIDITY	= 35 %
INTERIOR DEW POINT TEMPERATURE	= 42.9 °F

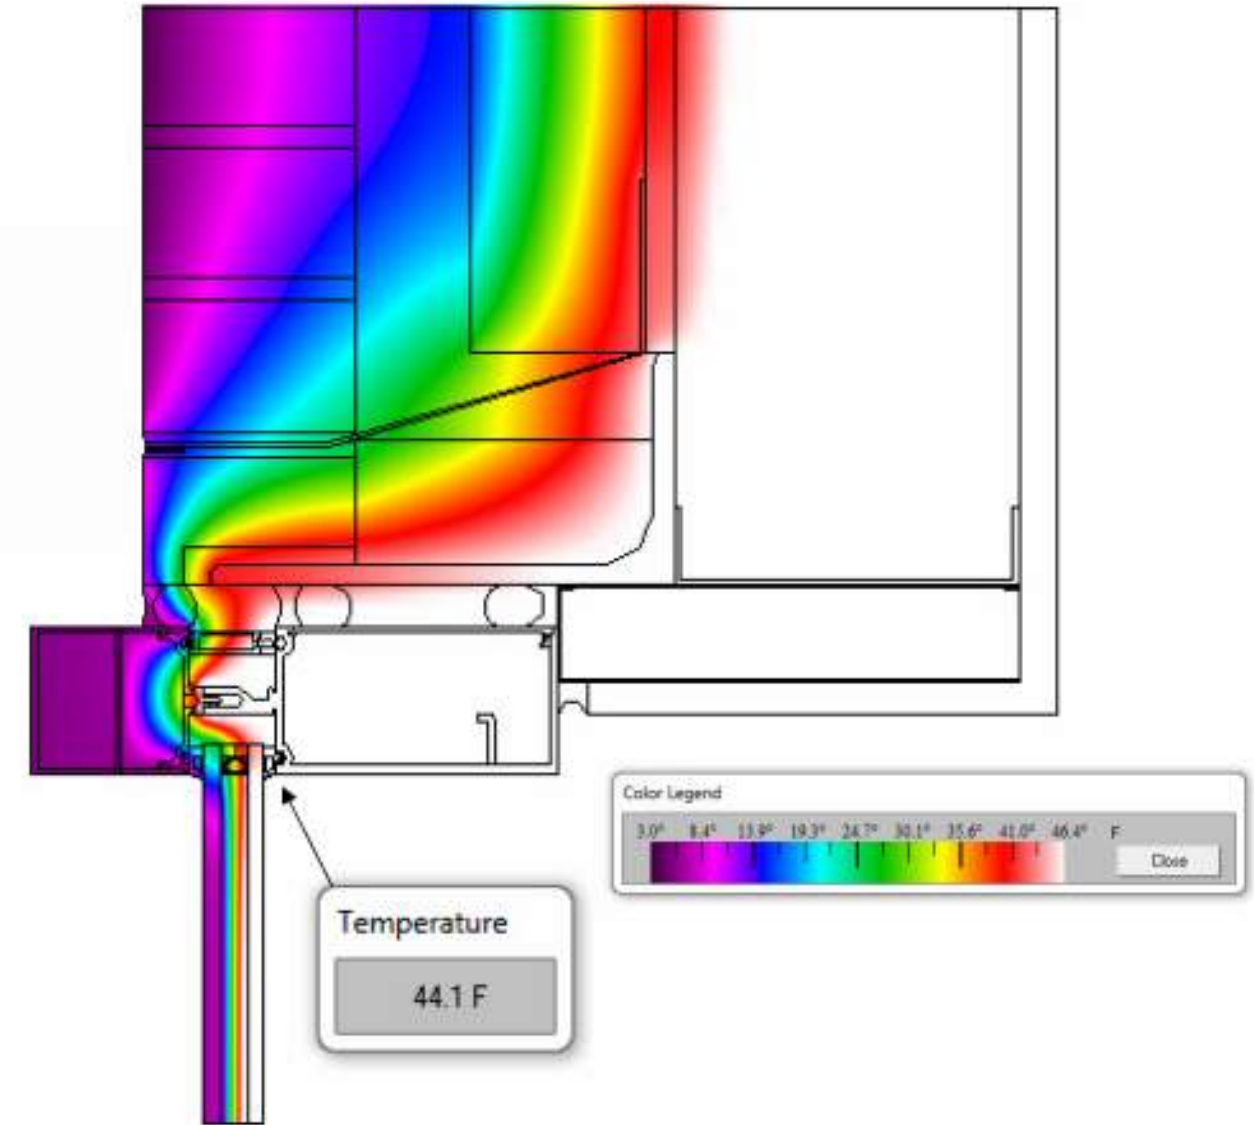
Brick Spandrel Over Vision Head (R.H.=35%) Detail
Color Infrared Image with Temperatures at or Below the Dew Point
and Lowest Interior Surface Temperature

EXTERIOR DESIGN TEMPERATURE = 3 °F
EXTERIOR WIND SPEED = 15 mph
INTERIOR TEMPERATURE = 72 °F
INTERIOR RELATIVE HUMIDITY = 35 %
INTERIOR DEW POINT TEMPERATURE = 42.9 °F

Note: According to the design criteria used of: 3°F exterior temp, 72°F interior temp, wind velocity of 15 mph, relative humidity at 35% and dew point temperature of 42.9°F the projected surface temperatures of the frames above would result in surface condensation.

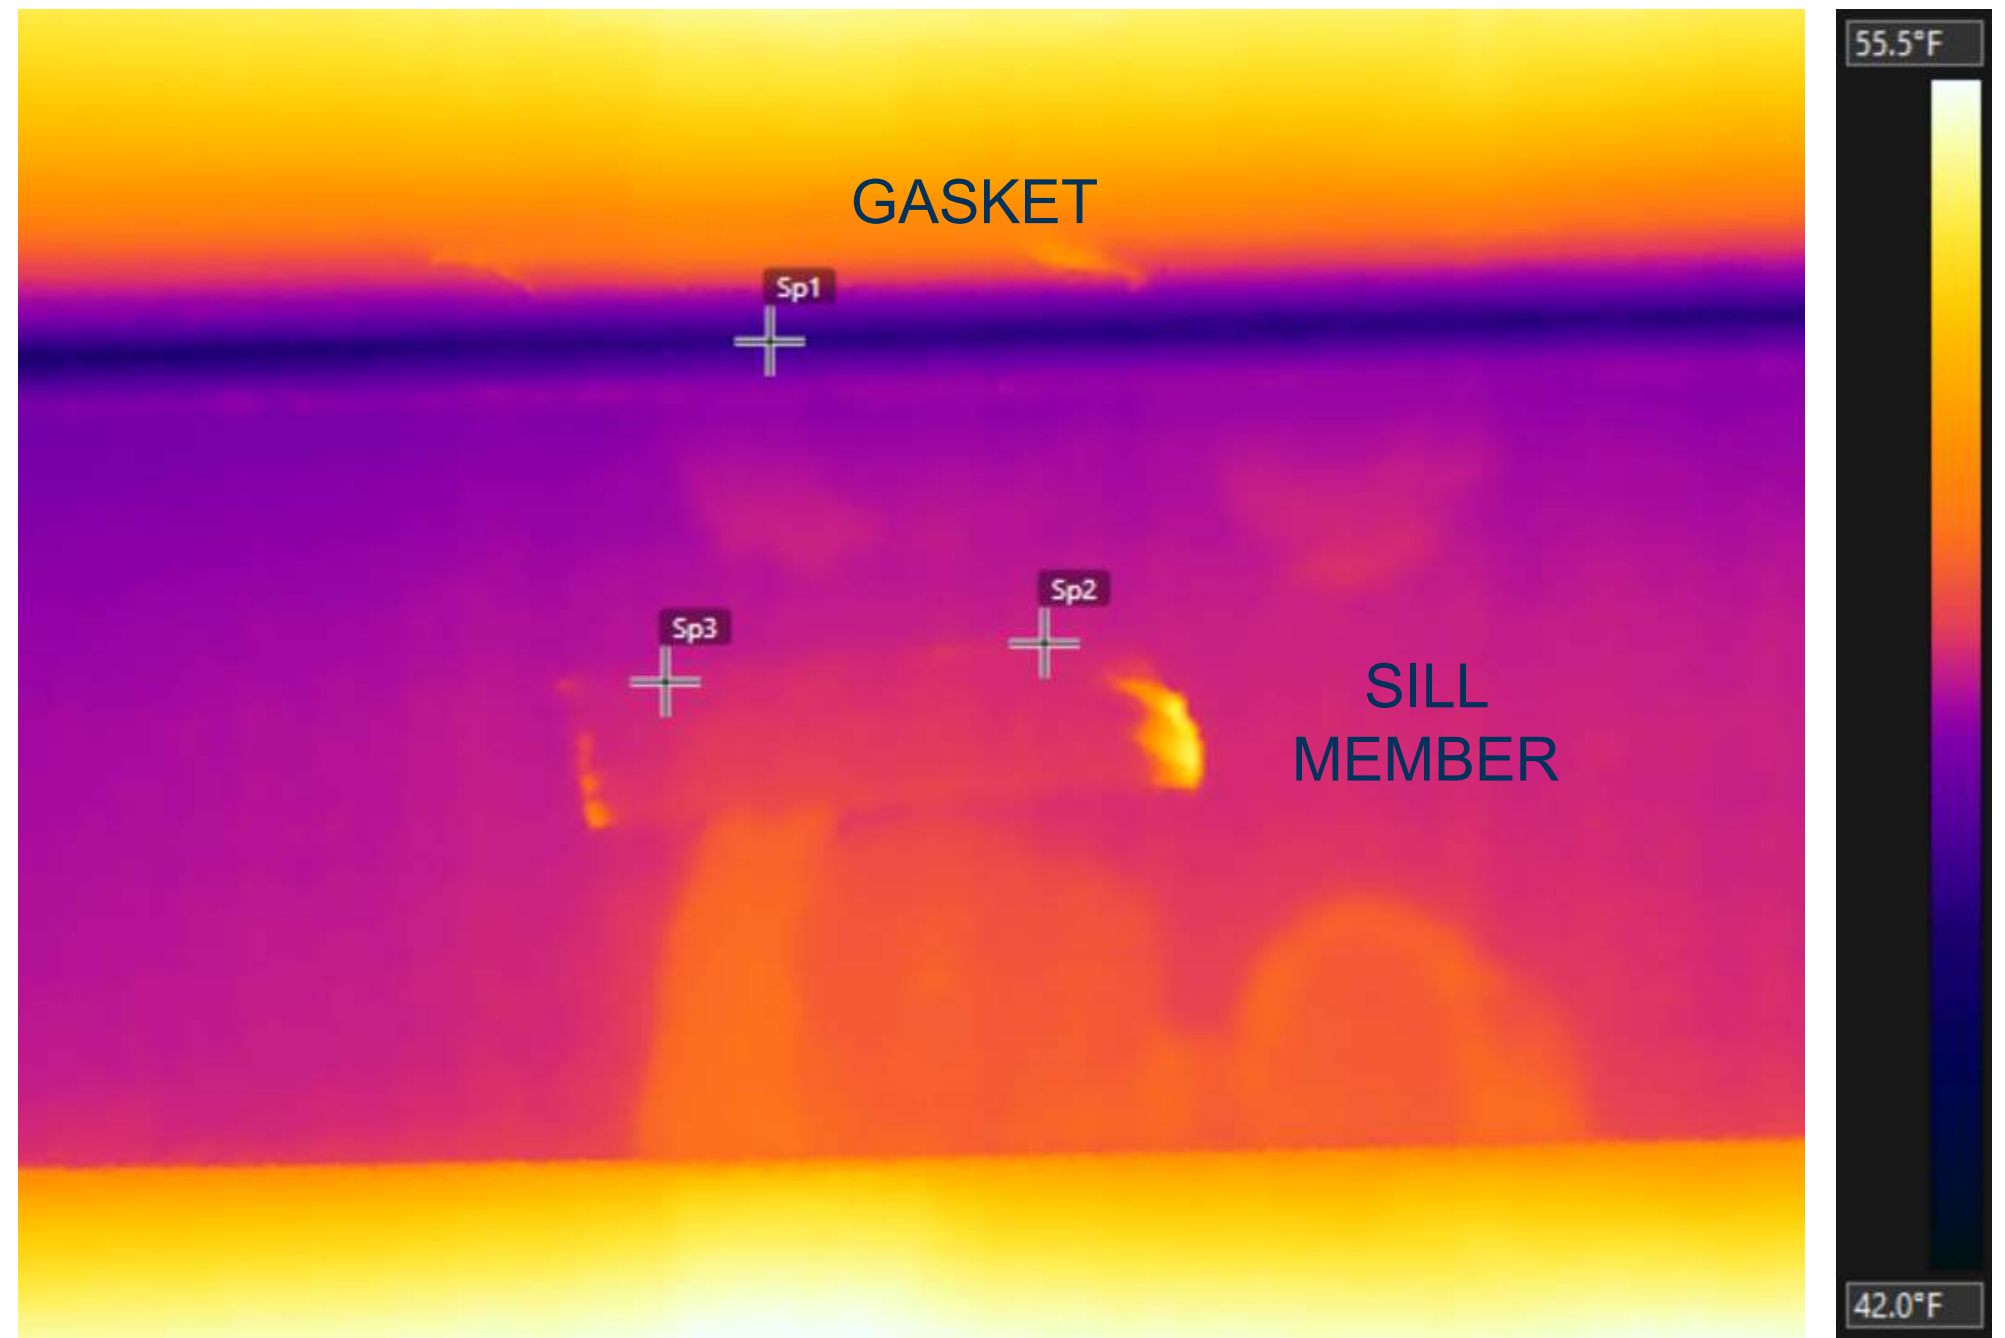
NICU Room 14 – Interior at Sill Tube

West light @ sill tube

Sp1	46.4 °F
Sp2	49.0 °F
Sp3	49.0 °F

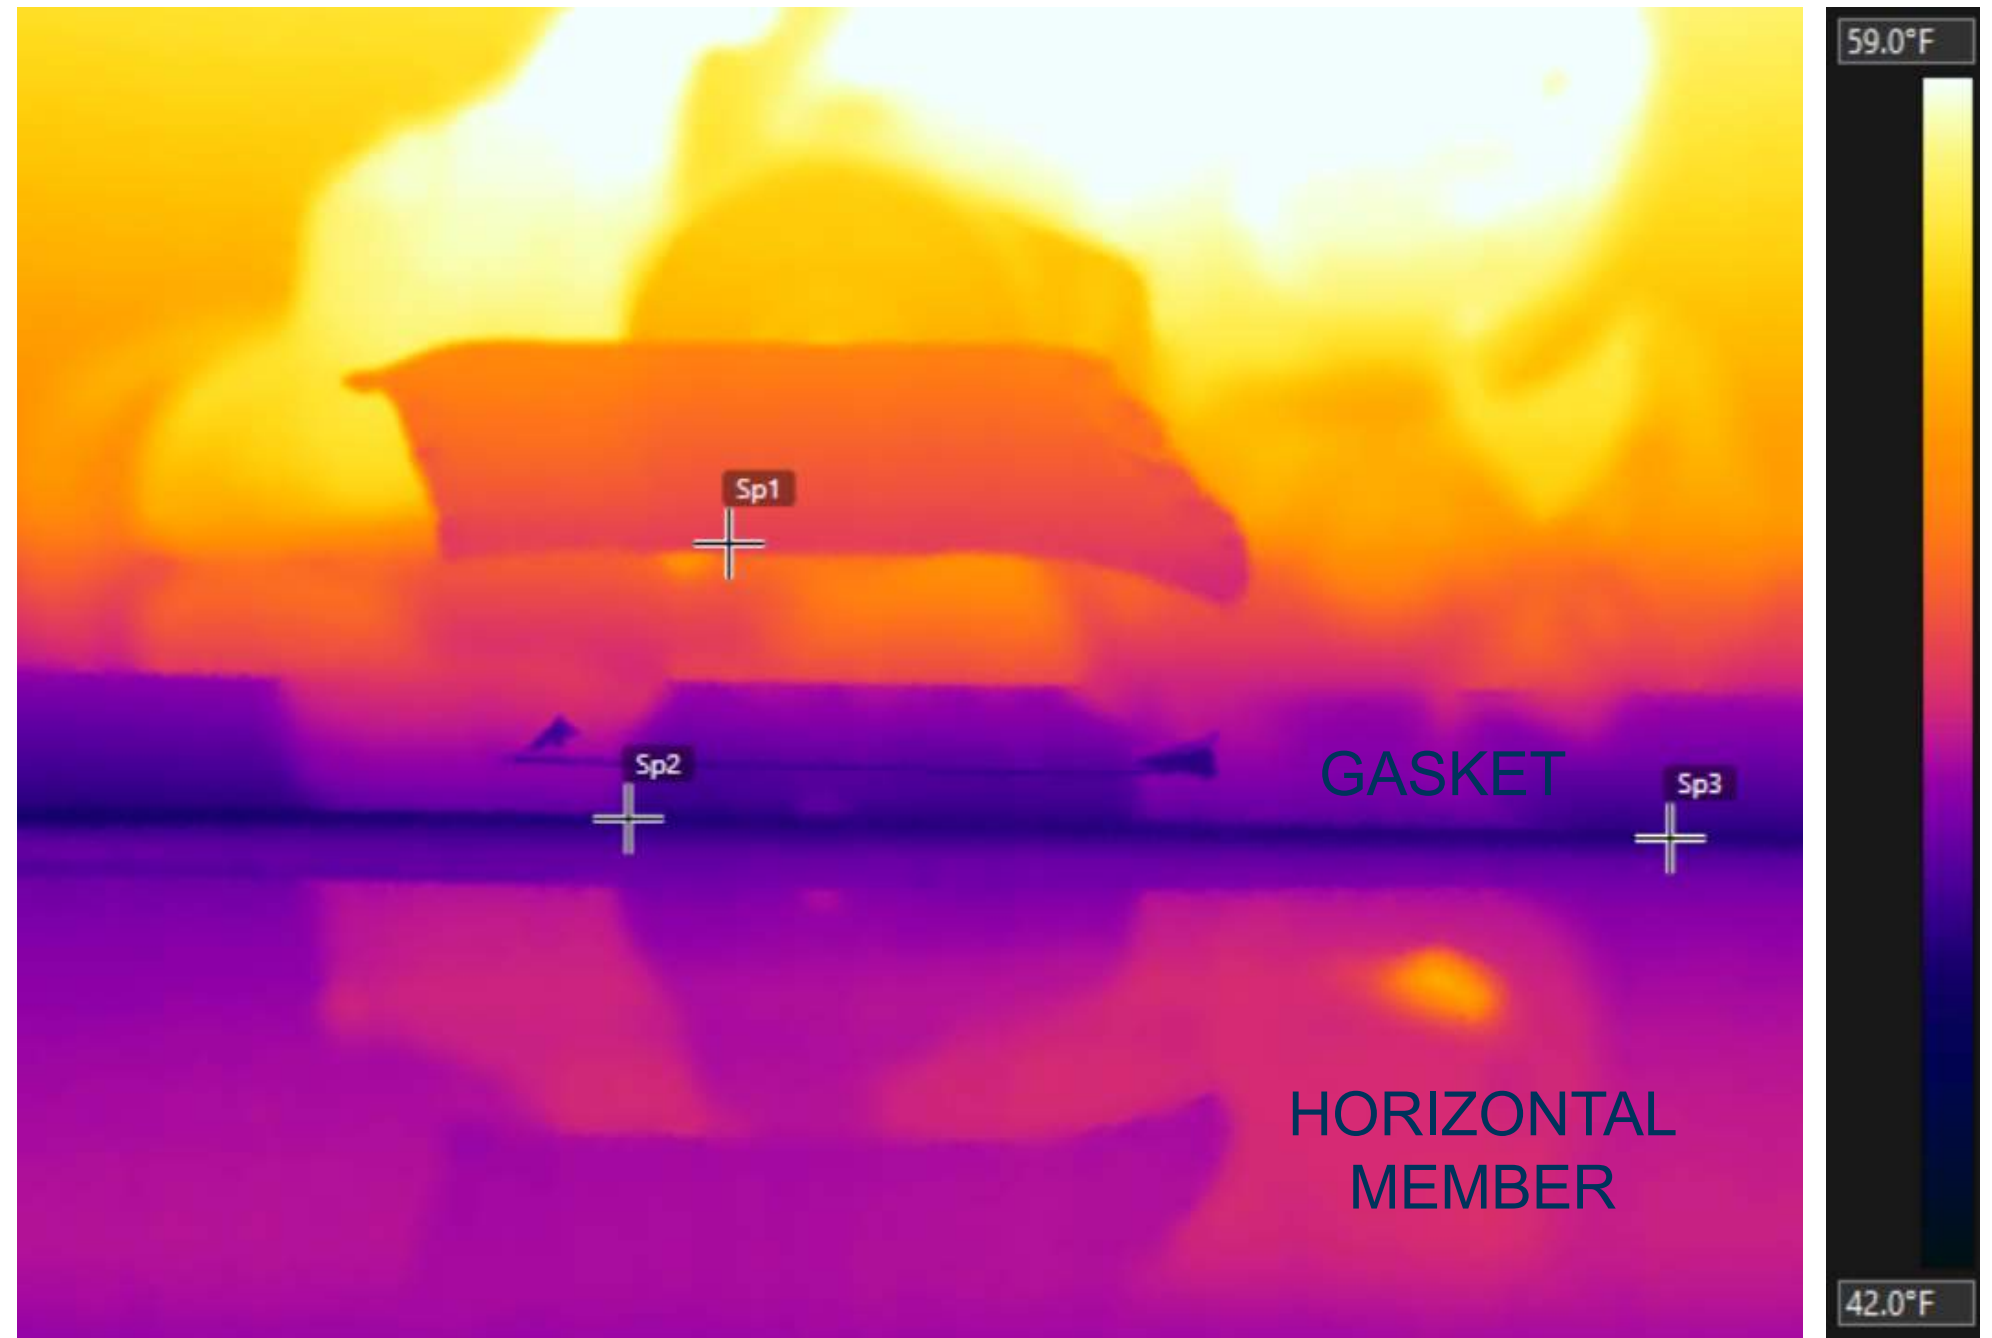
NICU Room 14 – Interior at Middle Tube

Note
West side mid lite

Sp1	50.8 °F
Sp2	46.7 °F
Sp3	46.6 °F

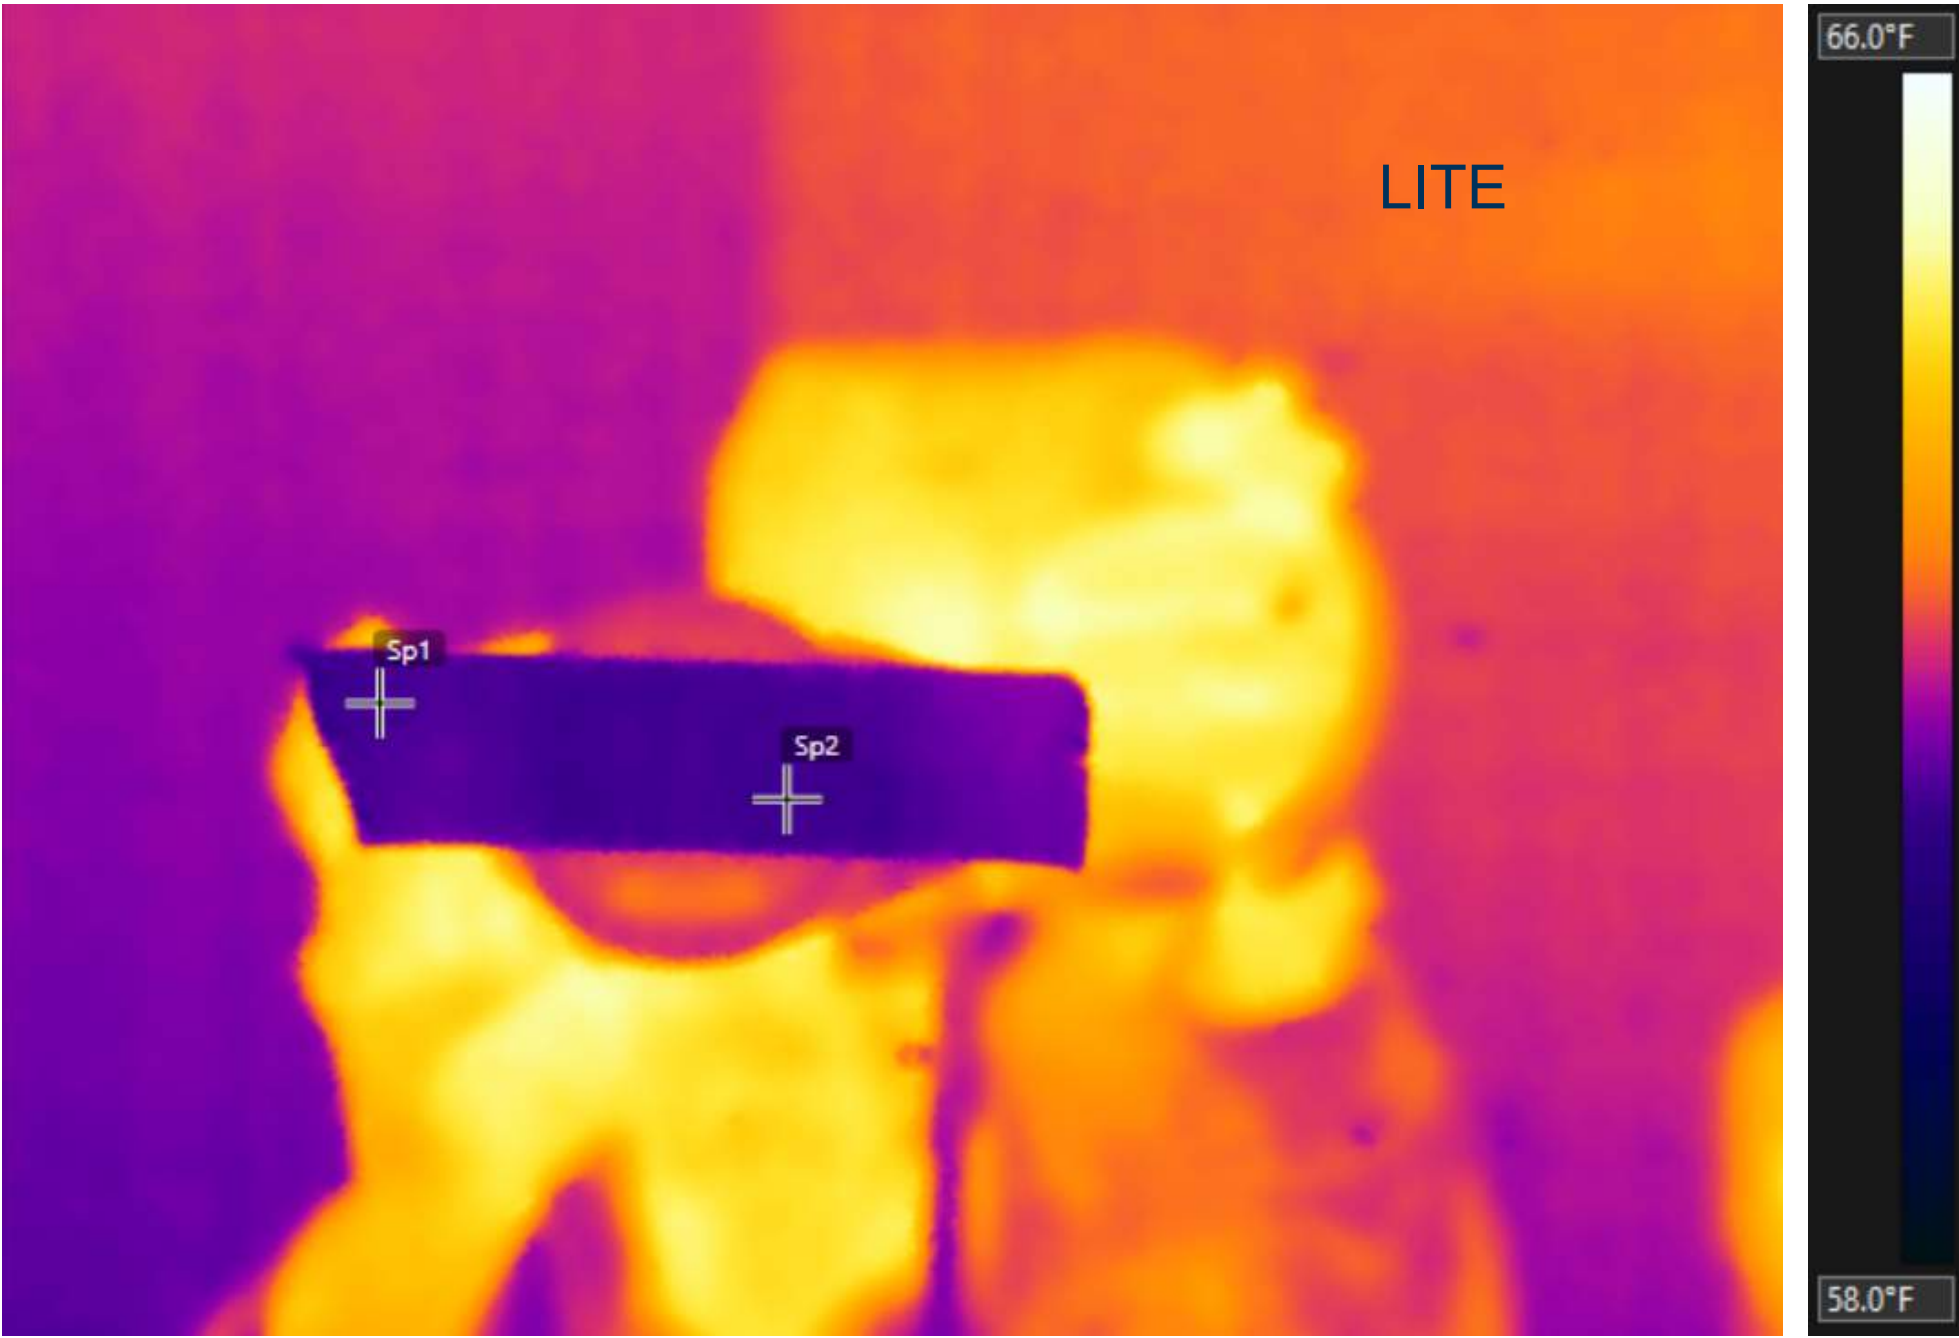
NICU Room 14 – Interior at Middle Lite

West side mid lite

Sp1	61.1 °F
Sp2	61.1 °F

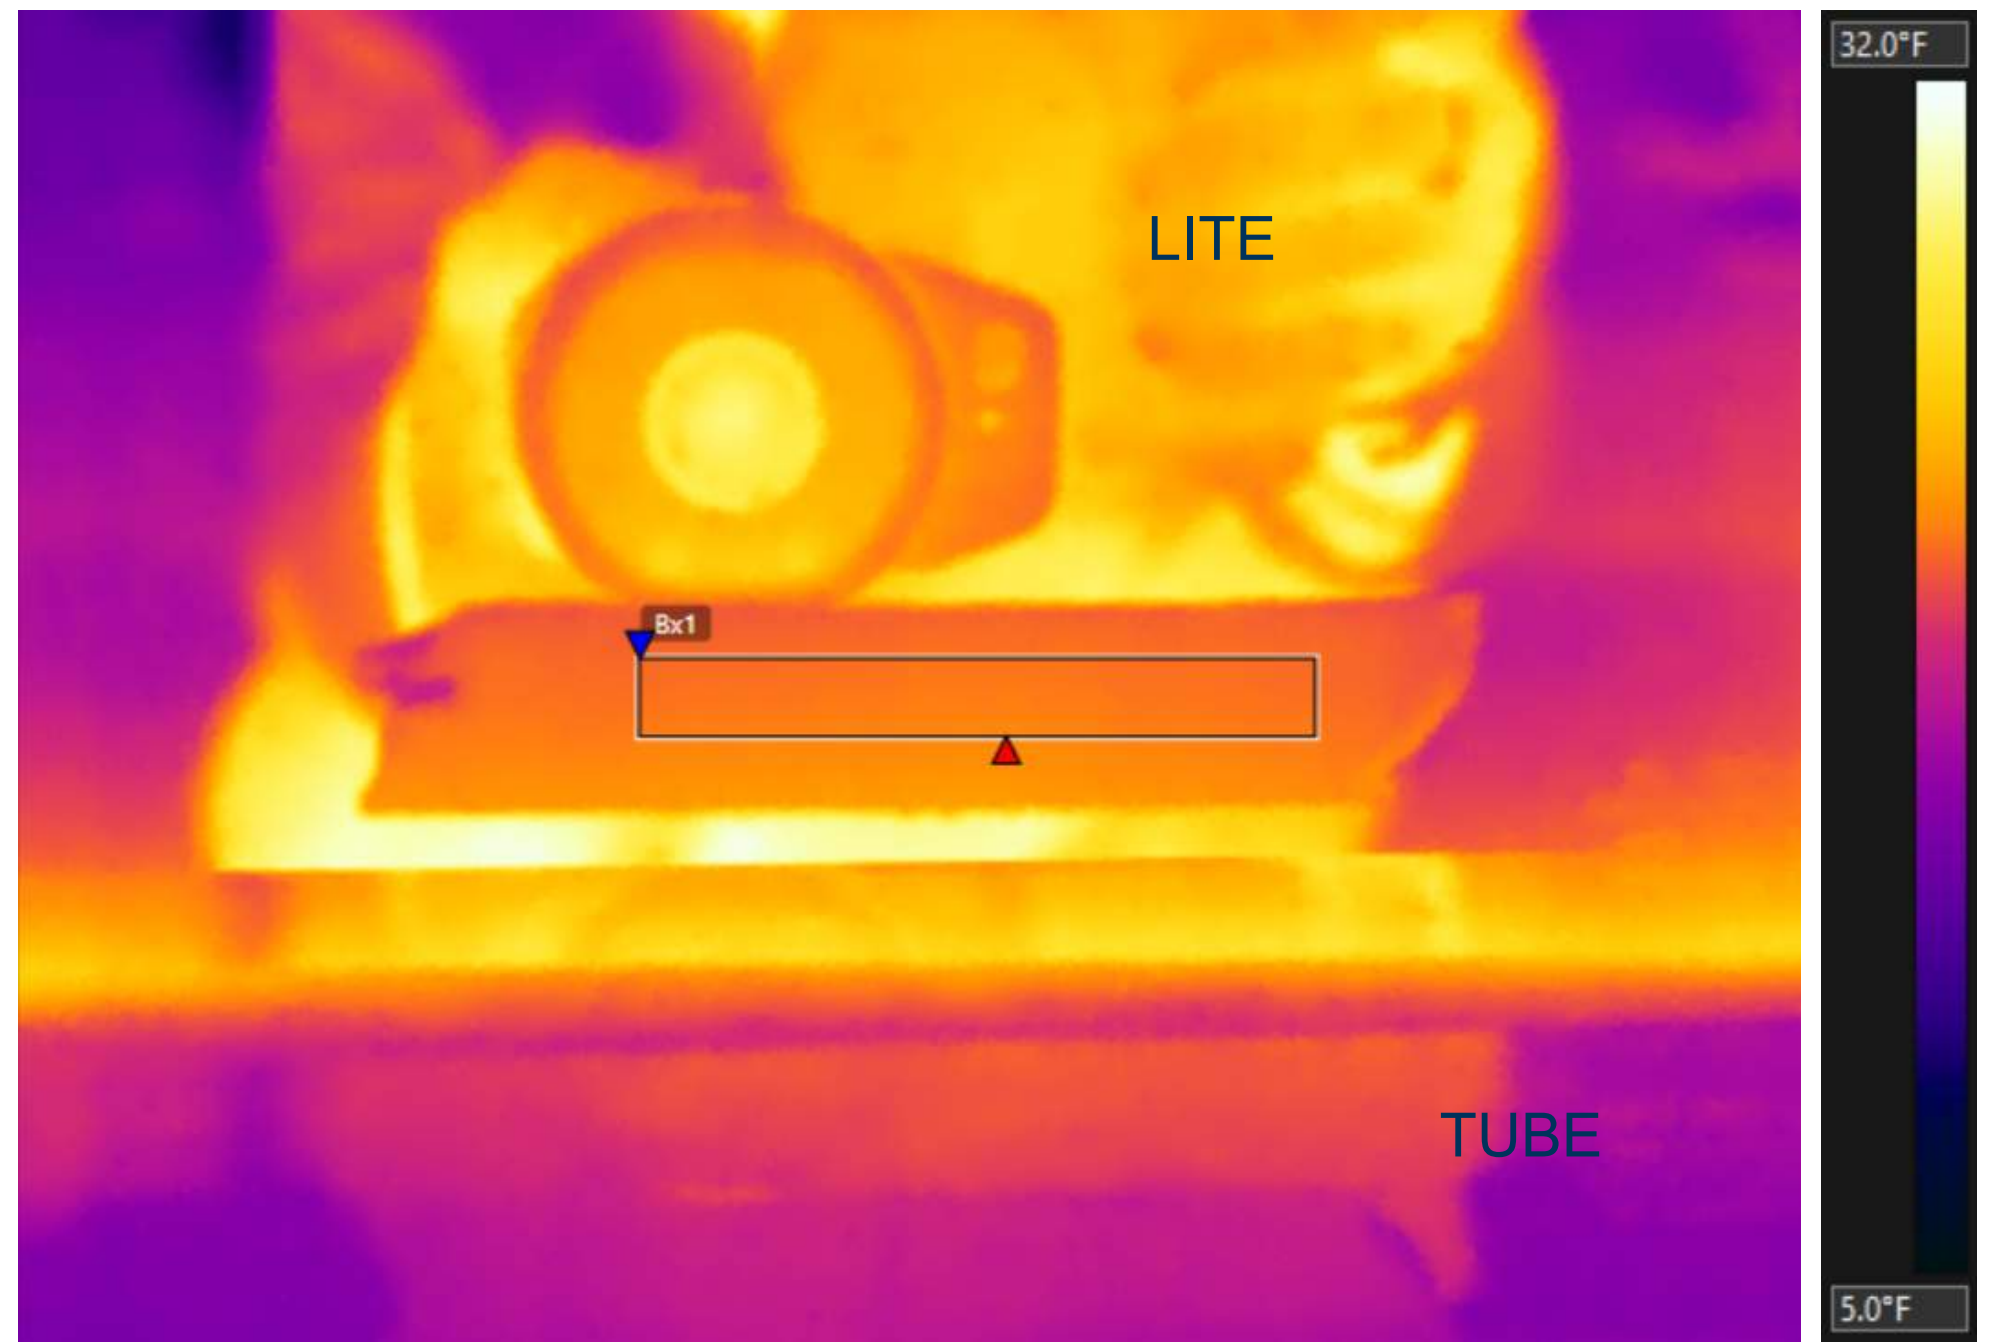
NICU Room 14 – Exterior at Sill Tube

Note
West outside of NICU14

Bx1	Max	23.9 °F
	Min	22.3 °F
	Average	23.2 °F

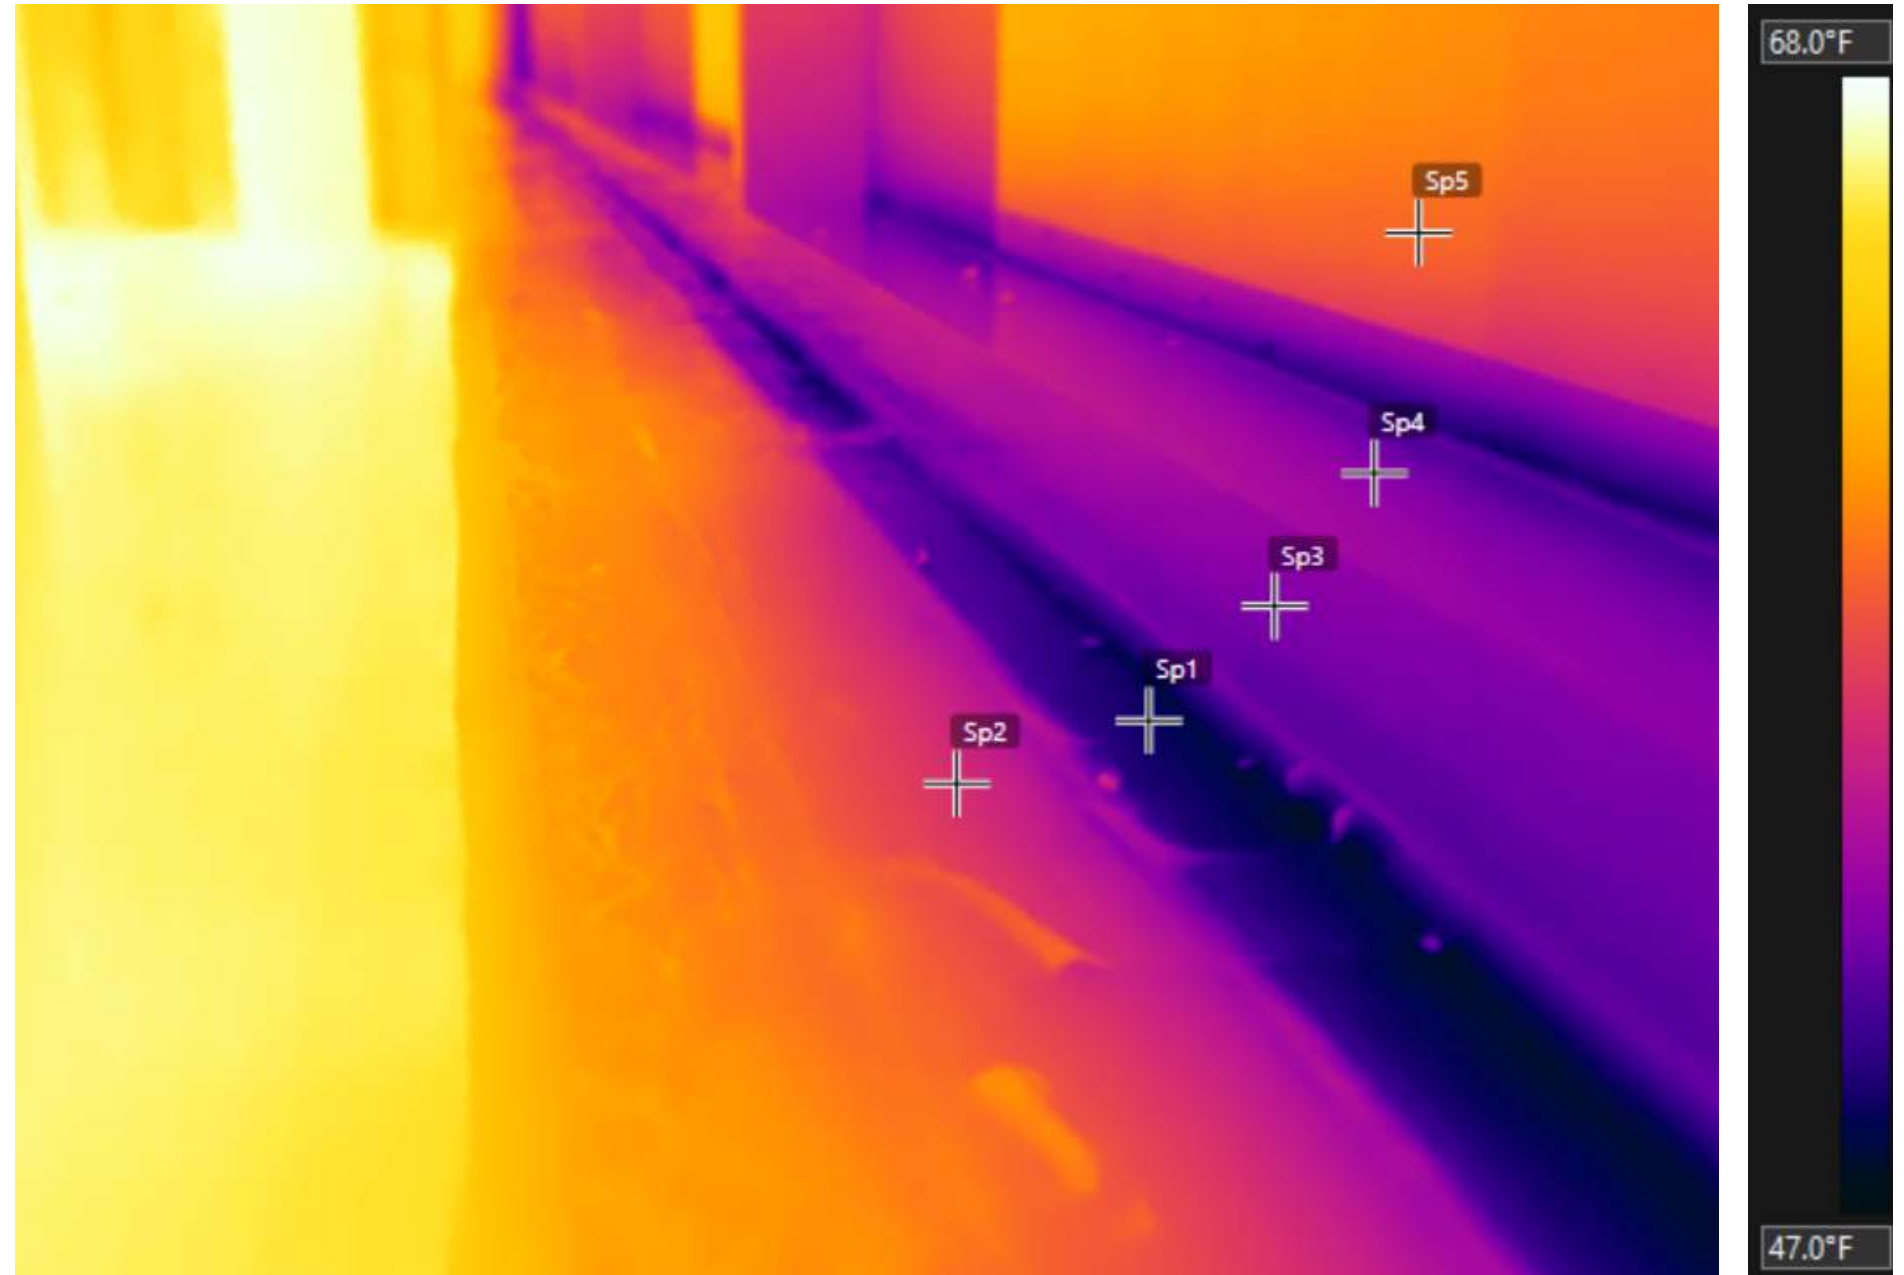
North wall 5th floor looking north, structural steel temperatures are lower than frame temperatures. This image was taken at 10:00 am when exterior ambient temperatures were approximately 22°F. This image shows the frame sitting on the cold side of the exterior wall, directly onto the steel member. The spot surface temperatures are as follows: Spot1 - 46.7°F, Spot2 - 60.0°F, Spot3 - 51.0°F, Spot4 - 51.0 °F, Spot5 - 51.8°F, Spot6 - 59.8°F.

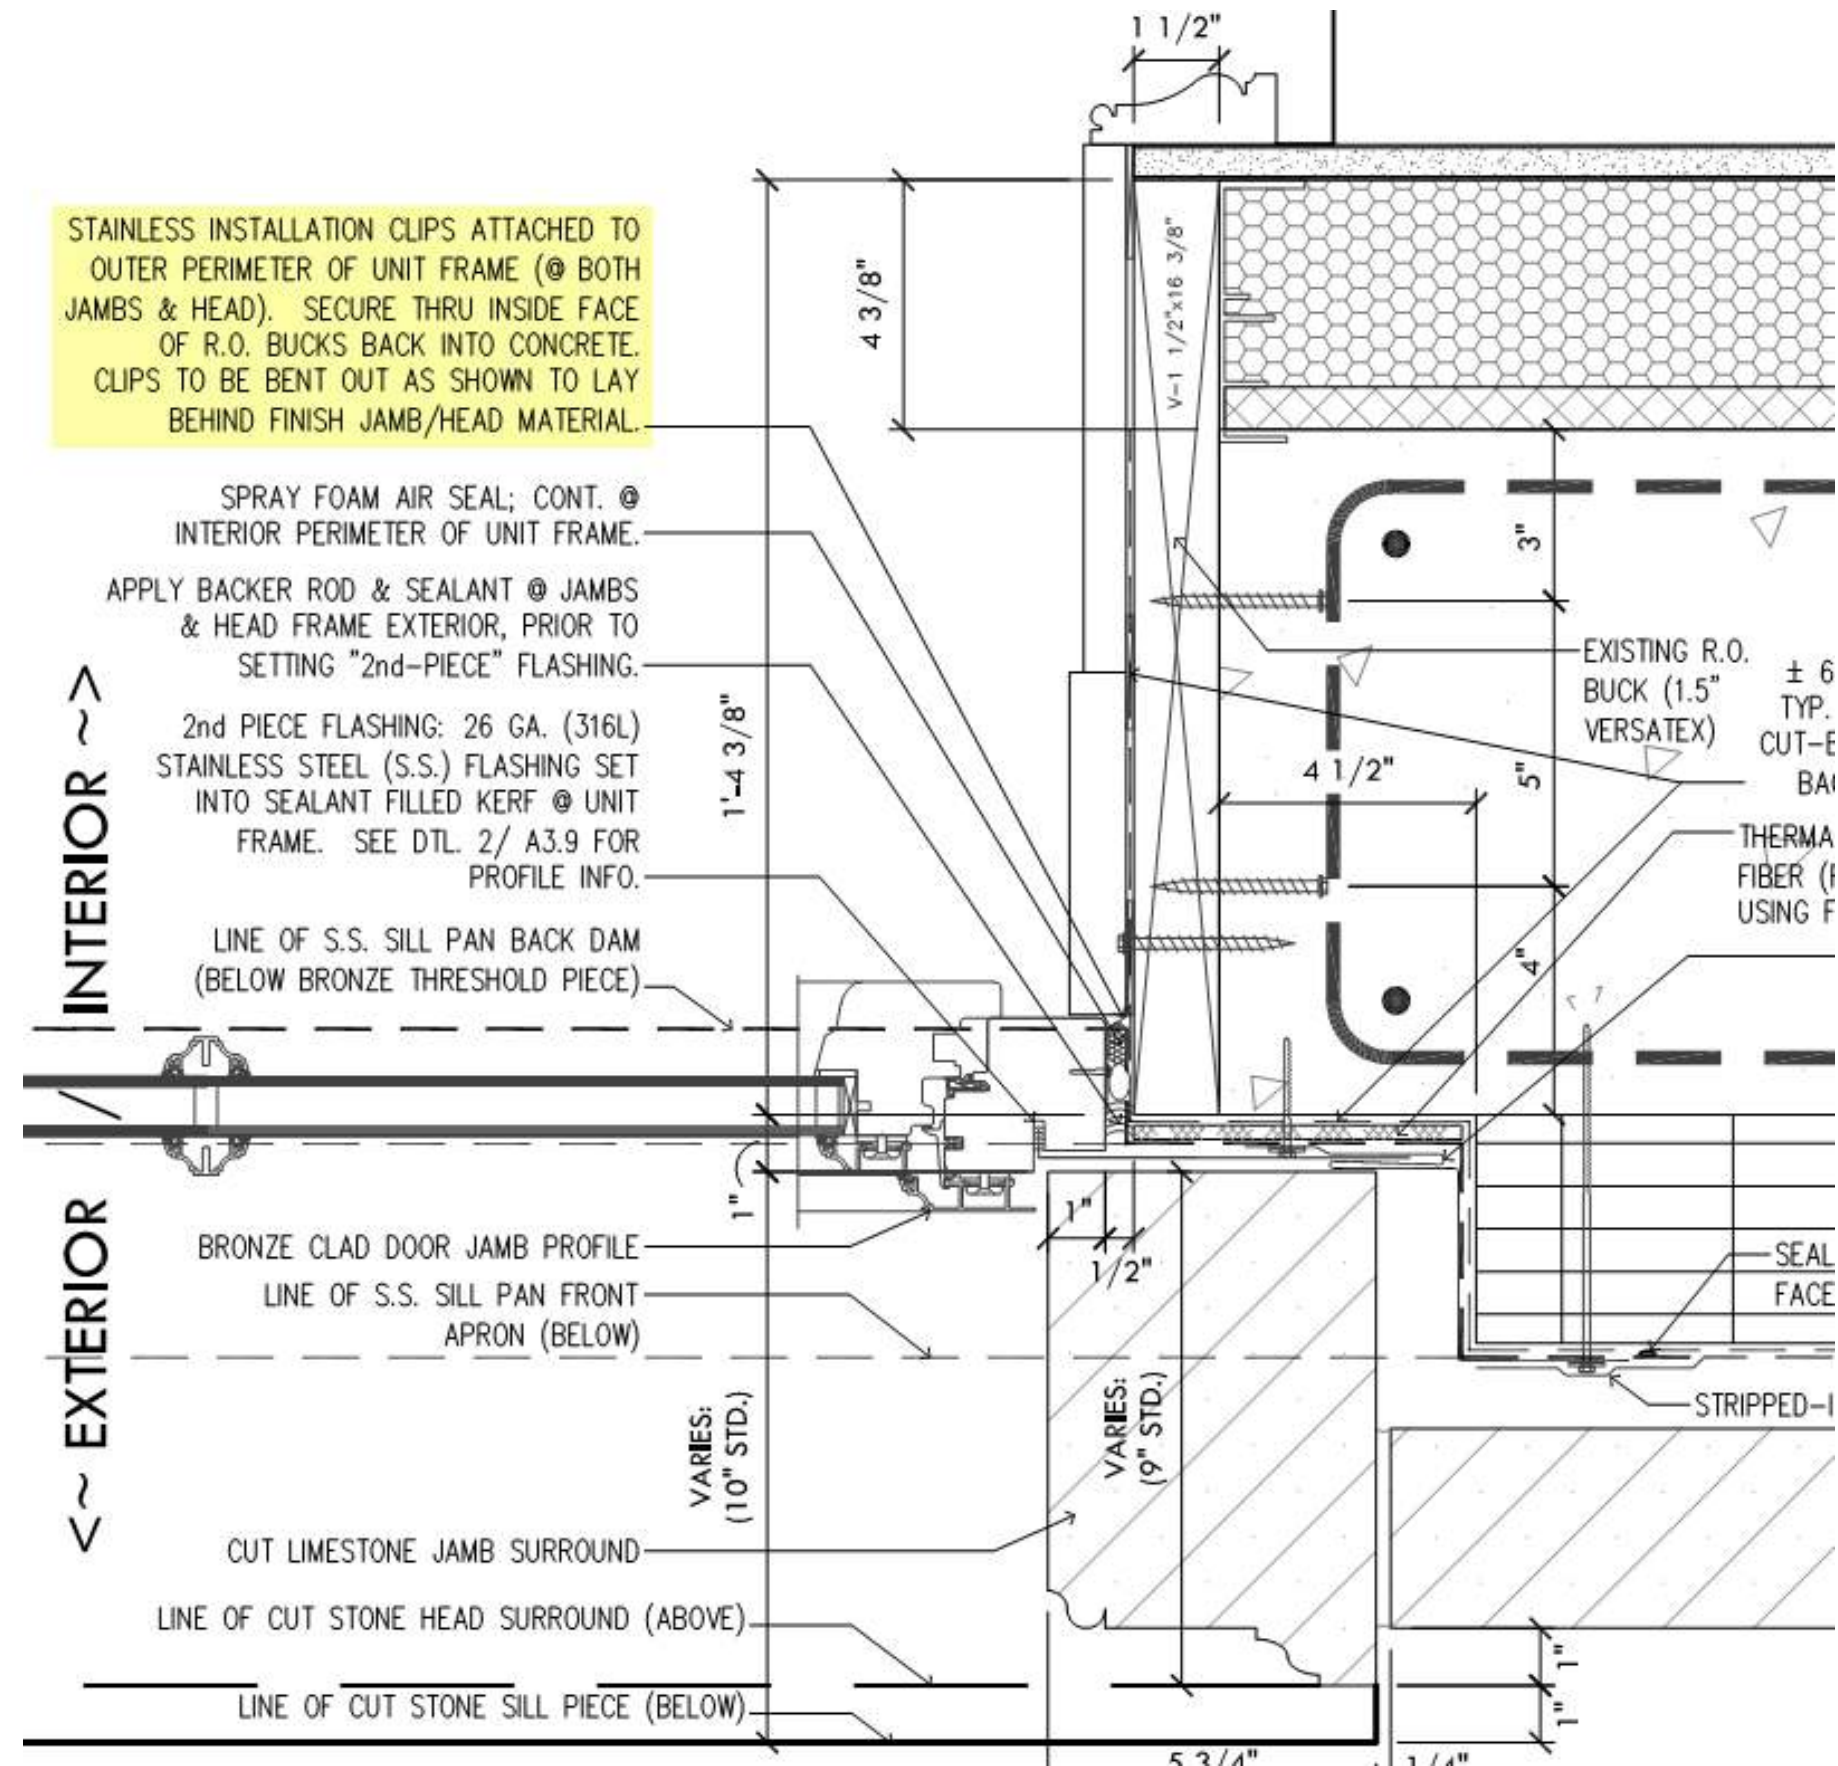
Leak Point at every window identified at the stainless clips at both the head and jambs.

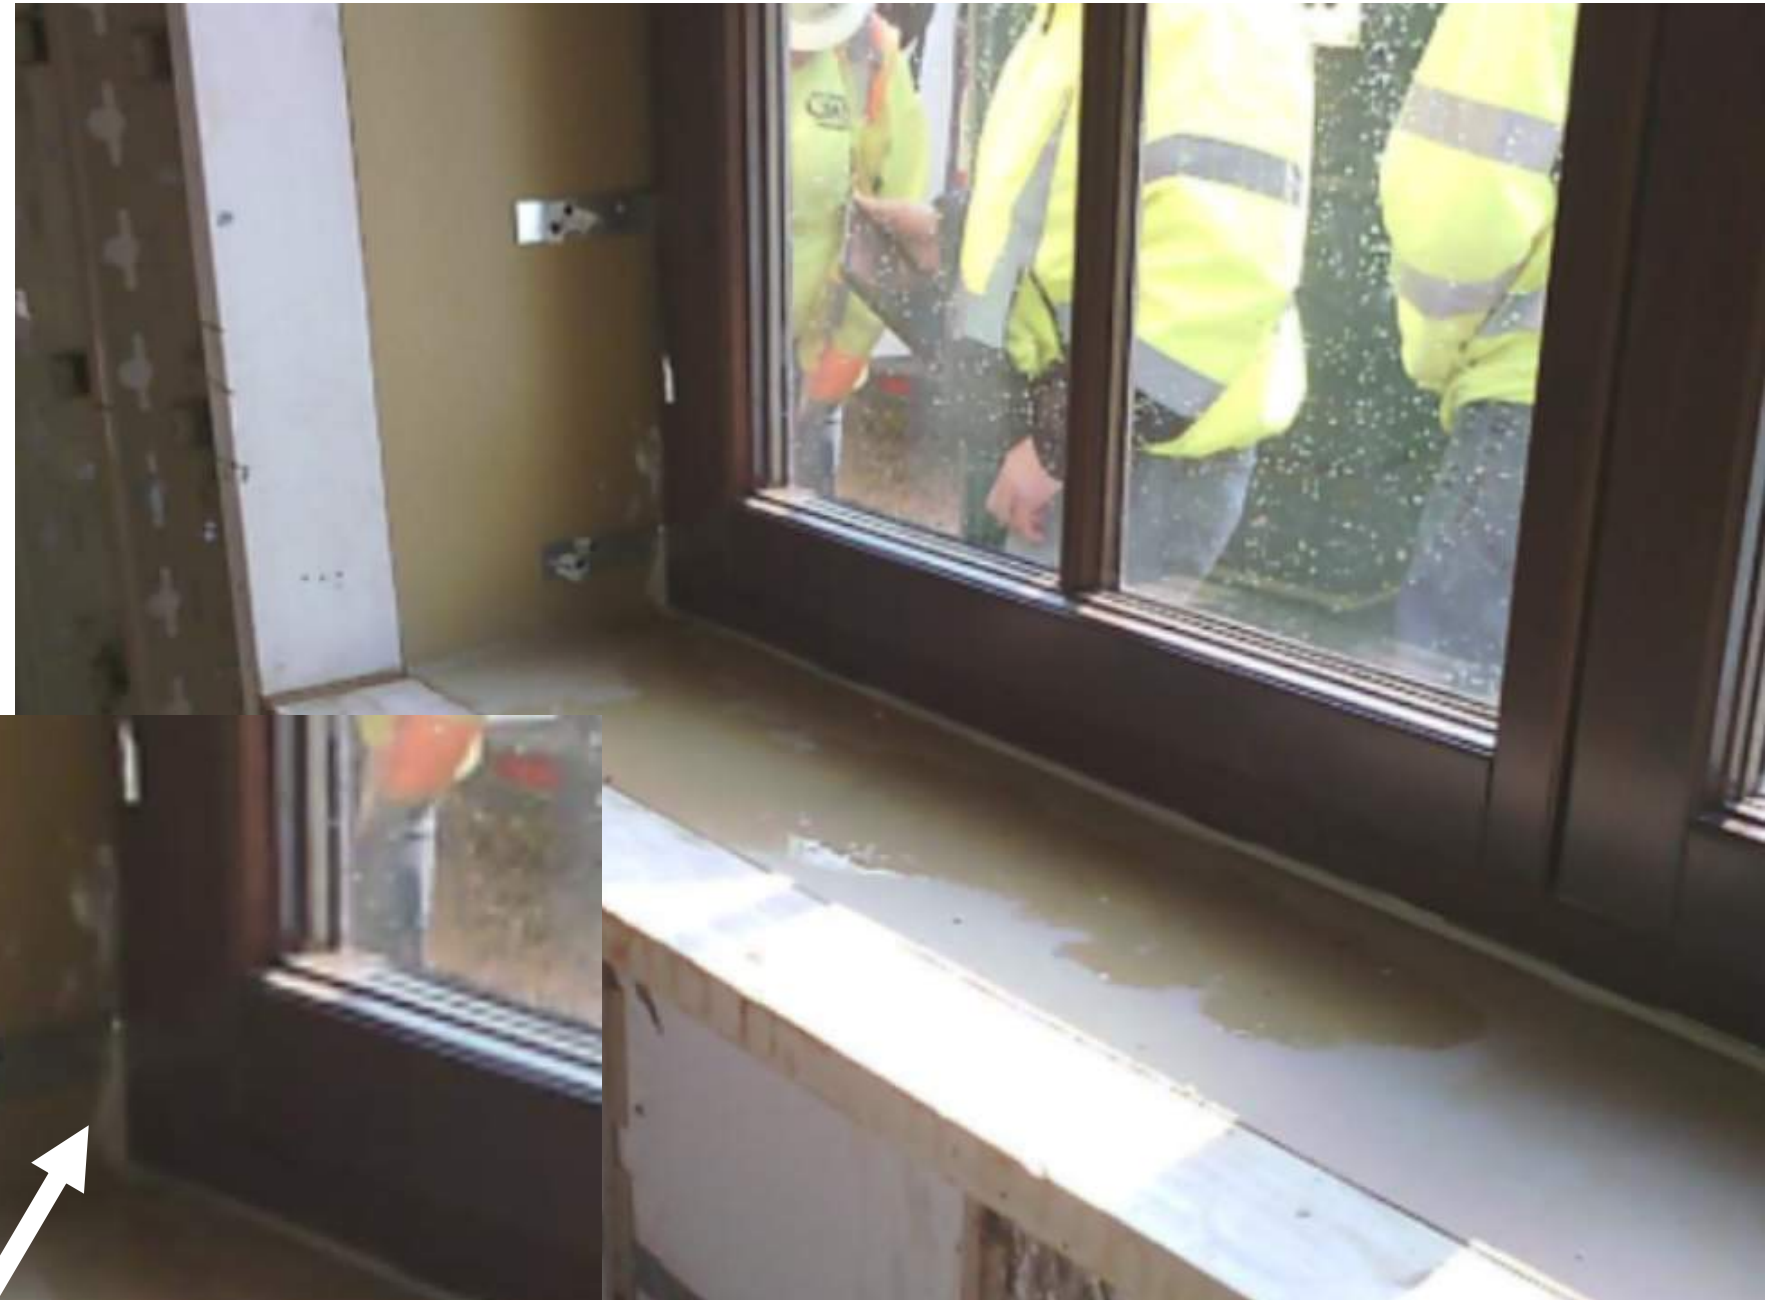
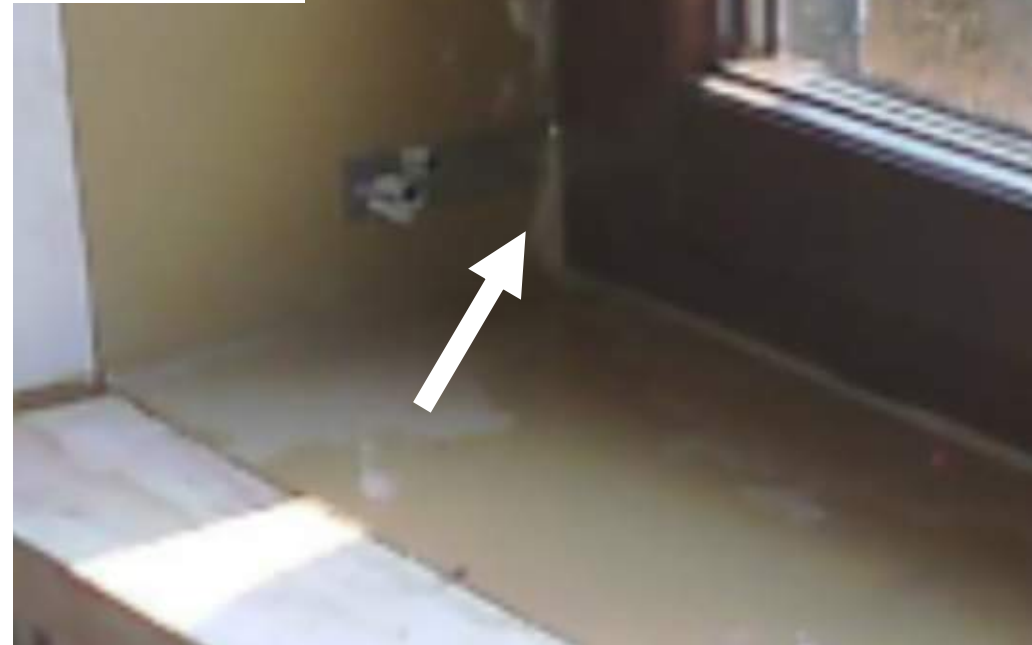
Leak Point at every
window identified at the
stainless clips at both
the head and jambs.
