Non-Visible Energy – Decoding Electromagnetic Energy and Thermodynamics

Case Study 1 – CoxHealth Patient Tower Addition

Case Study 2 – Primatara Mansion

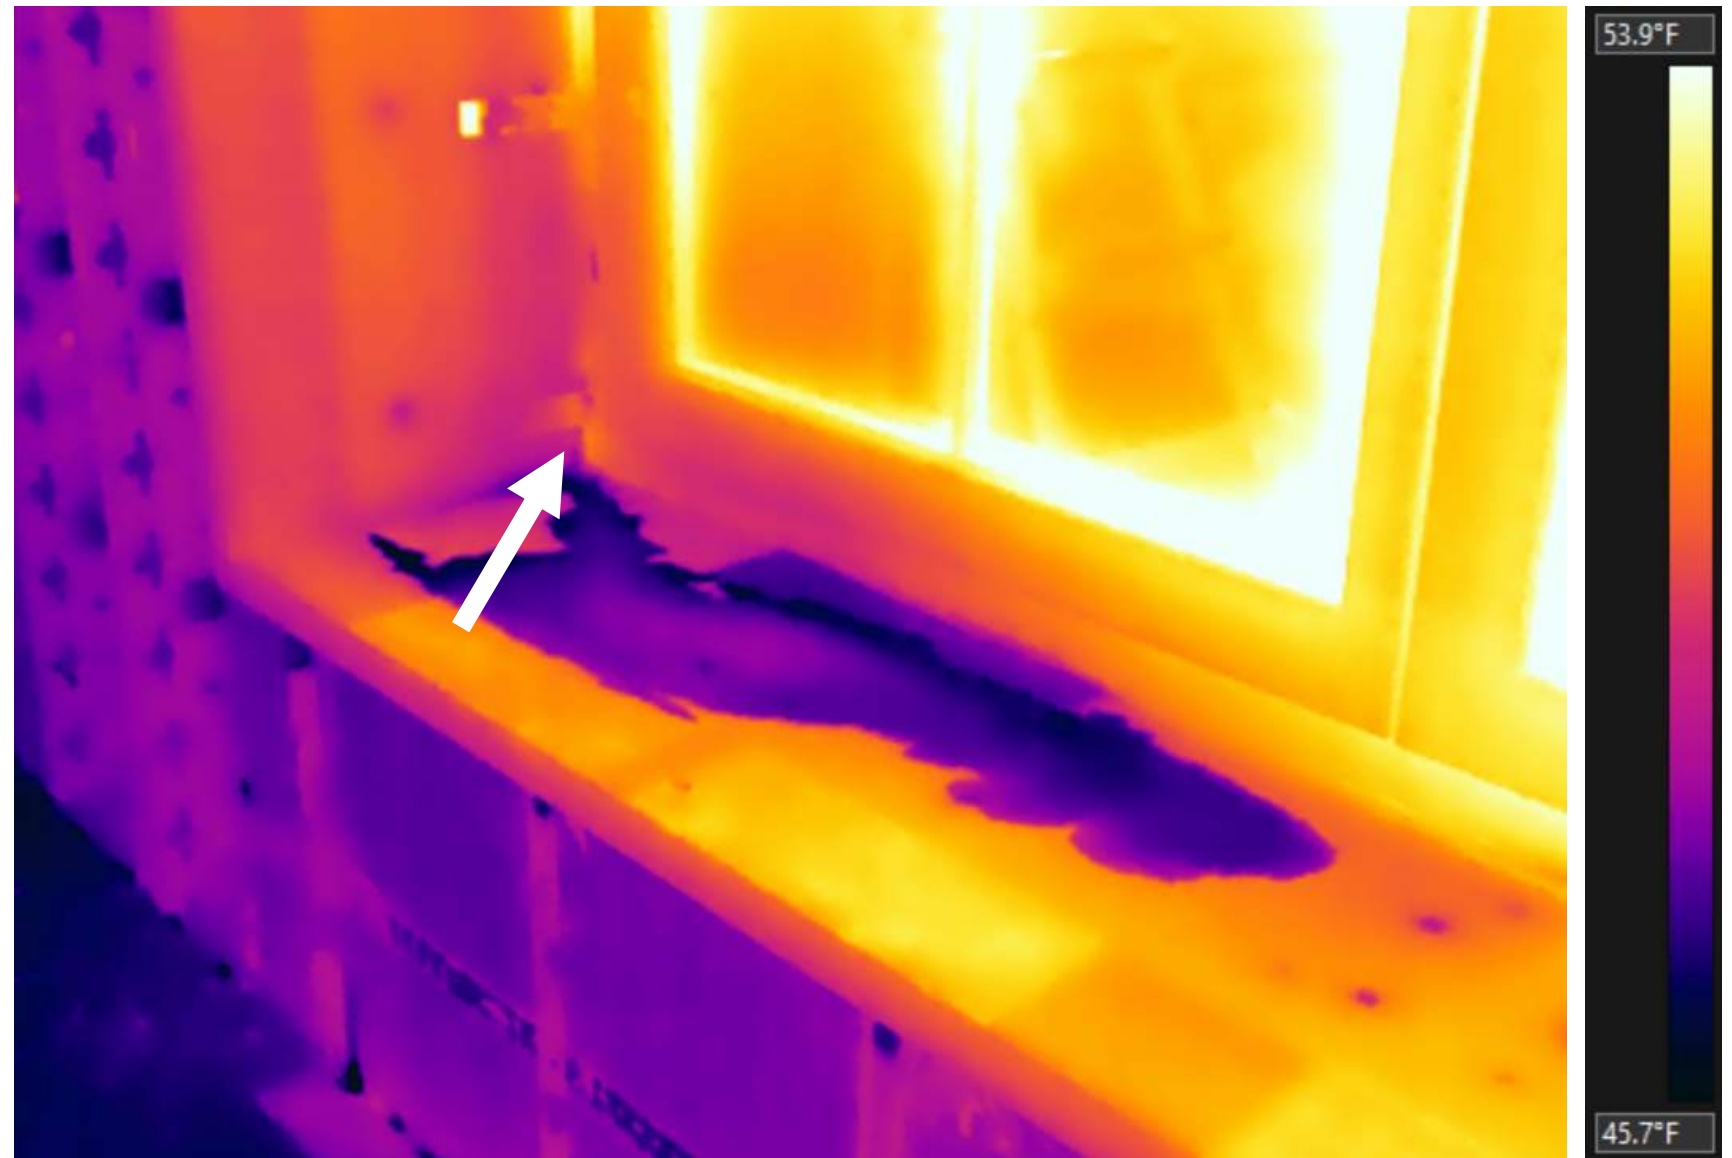
Leak Point at every window identified at the stainless clips at both the head and jambs.

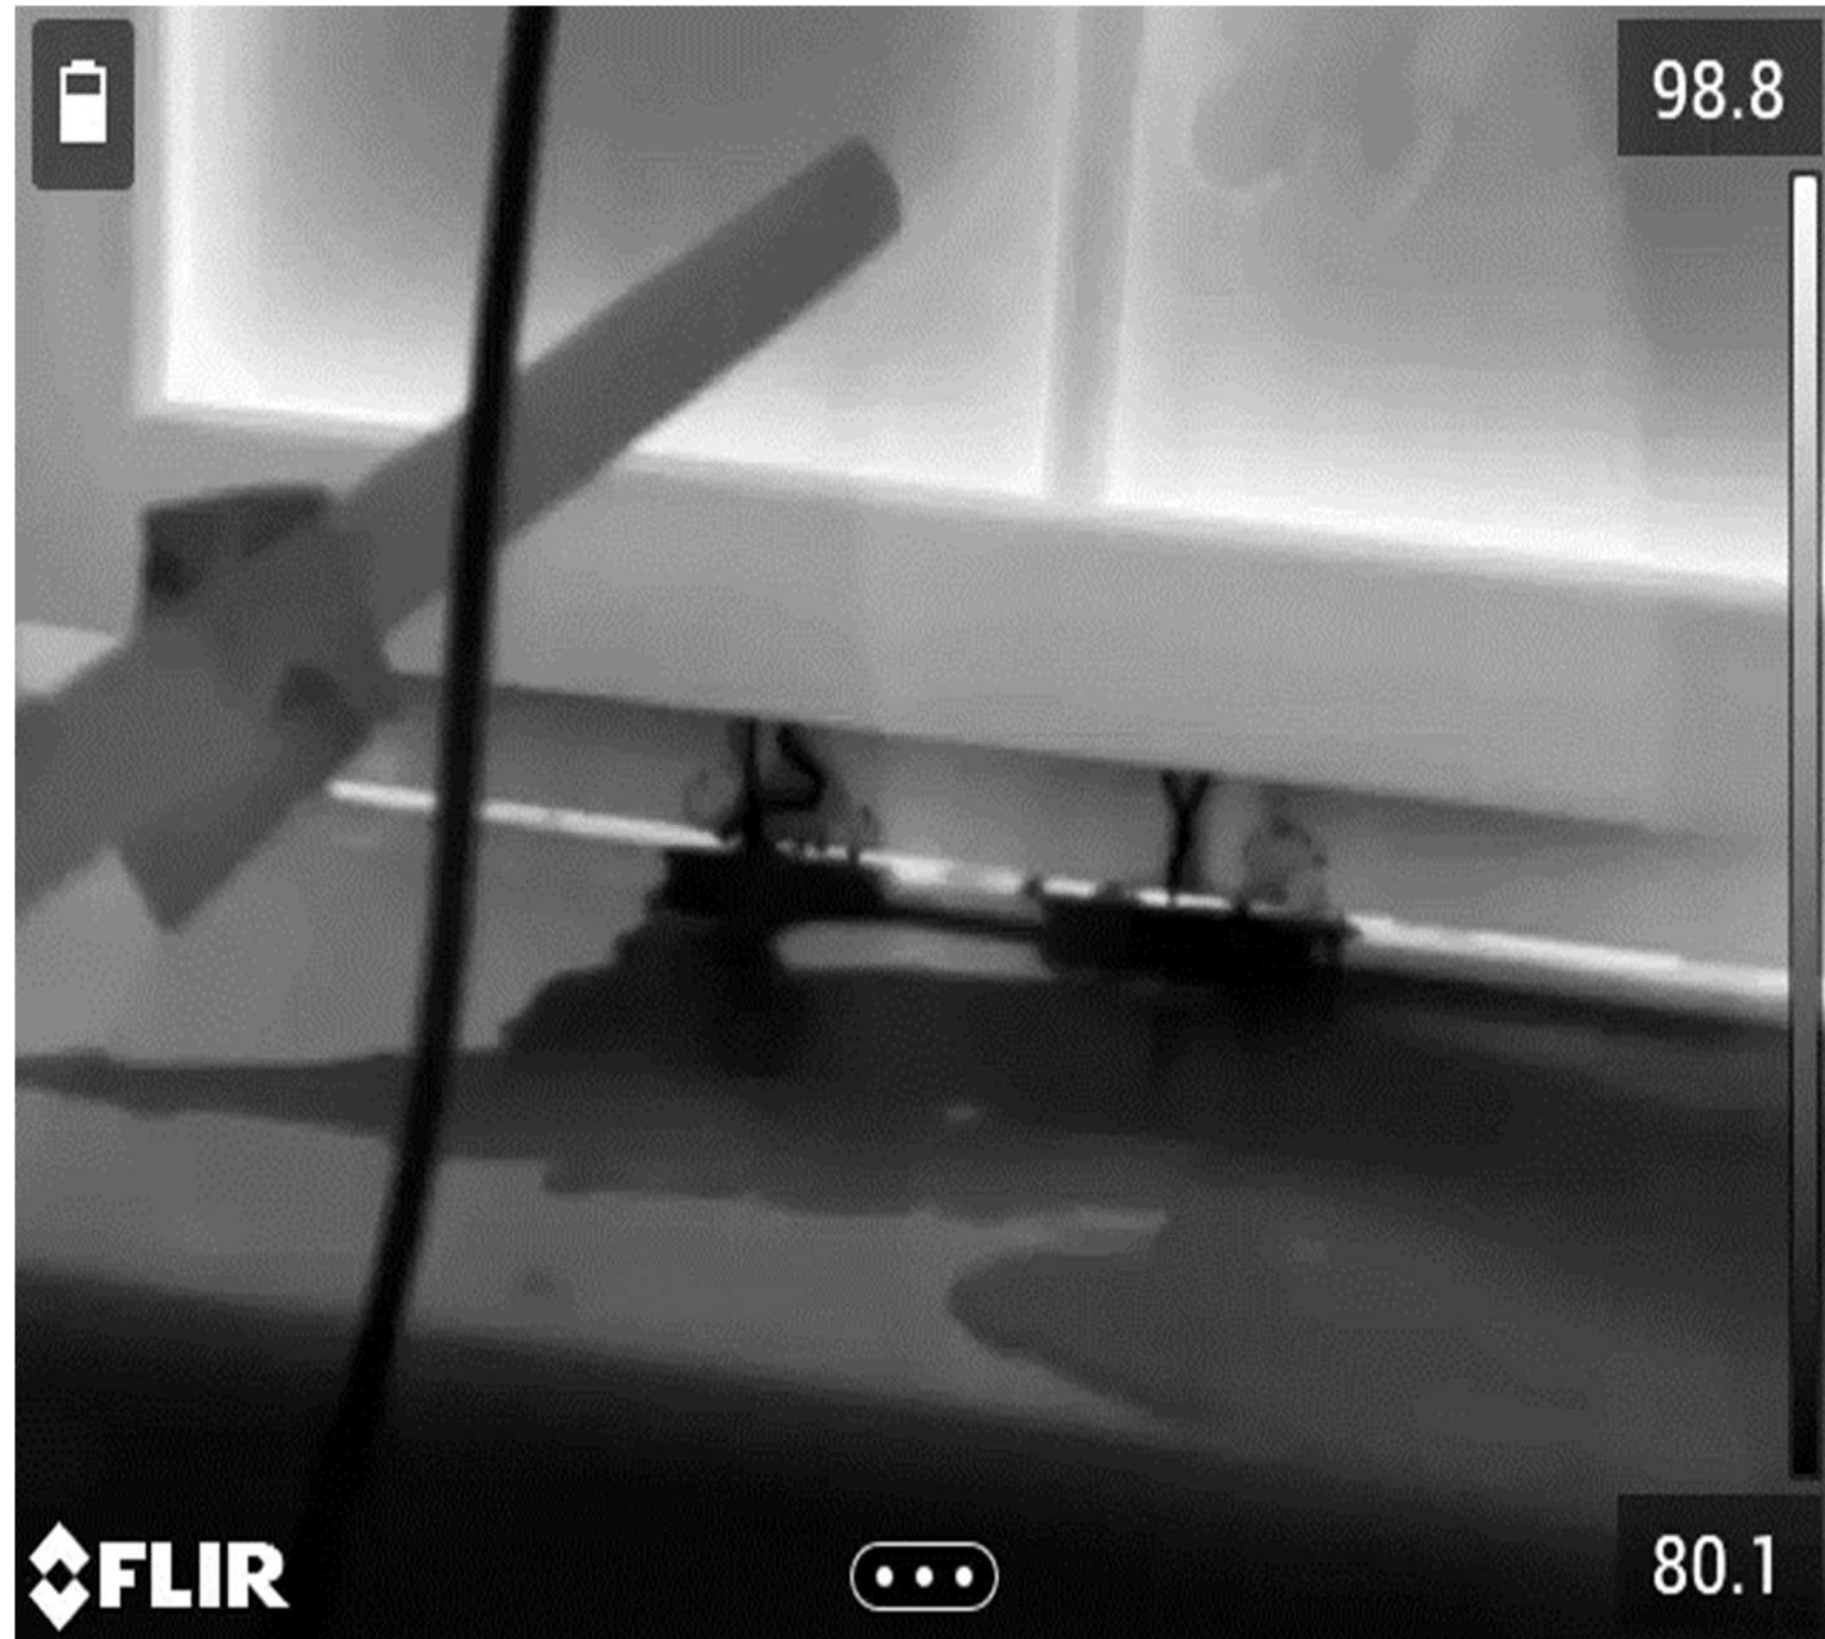
Unit failure at seals of
operable windows.

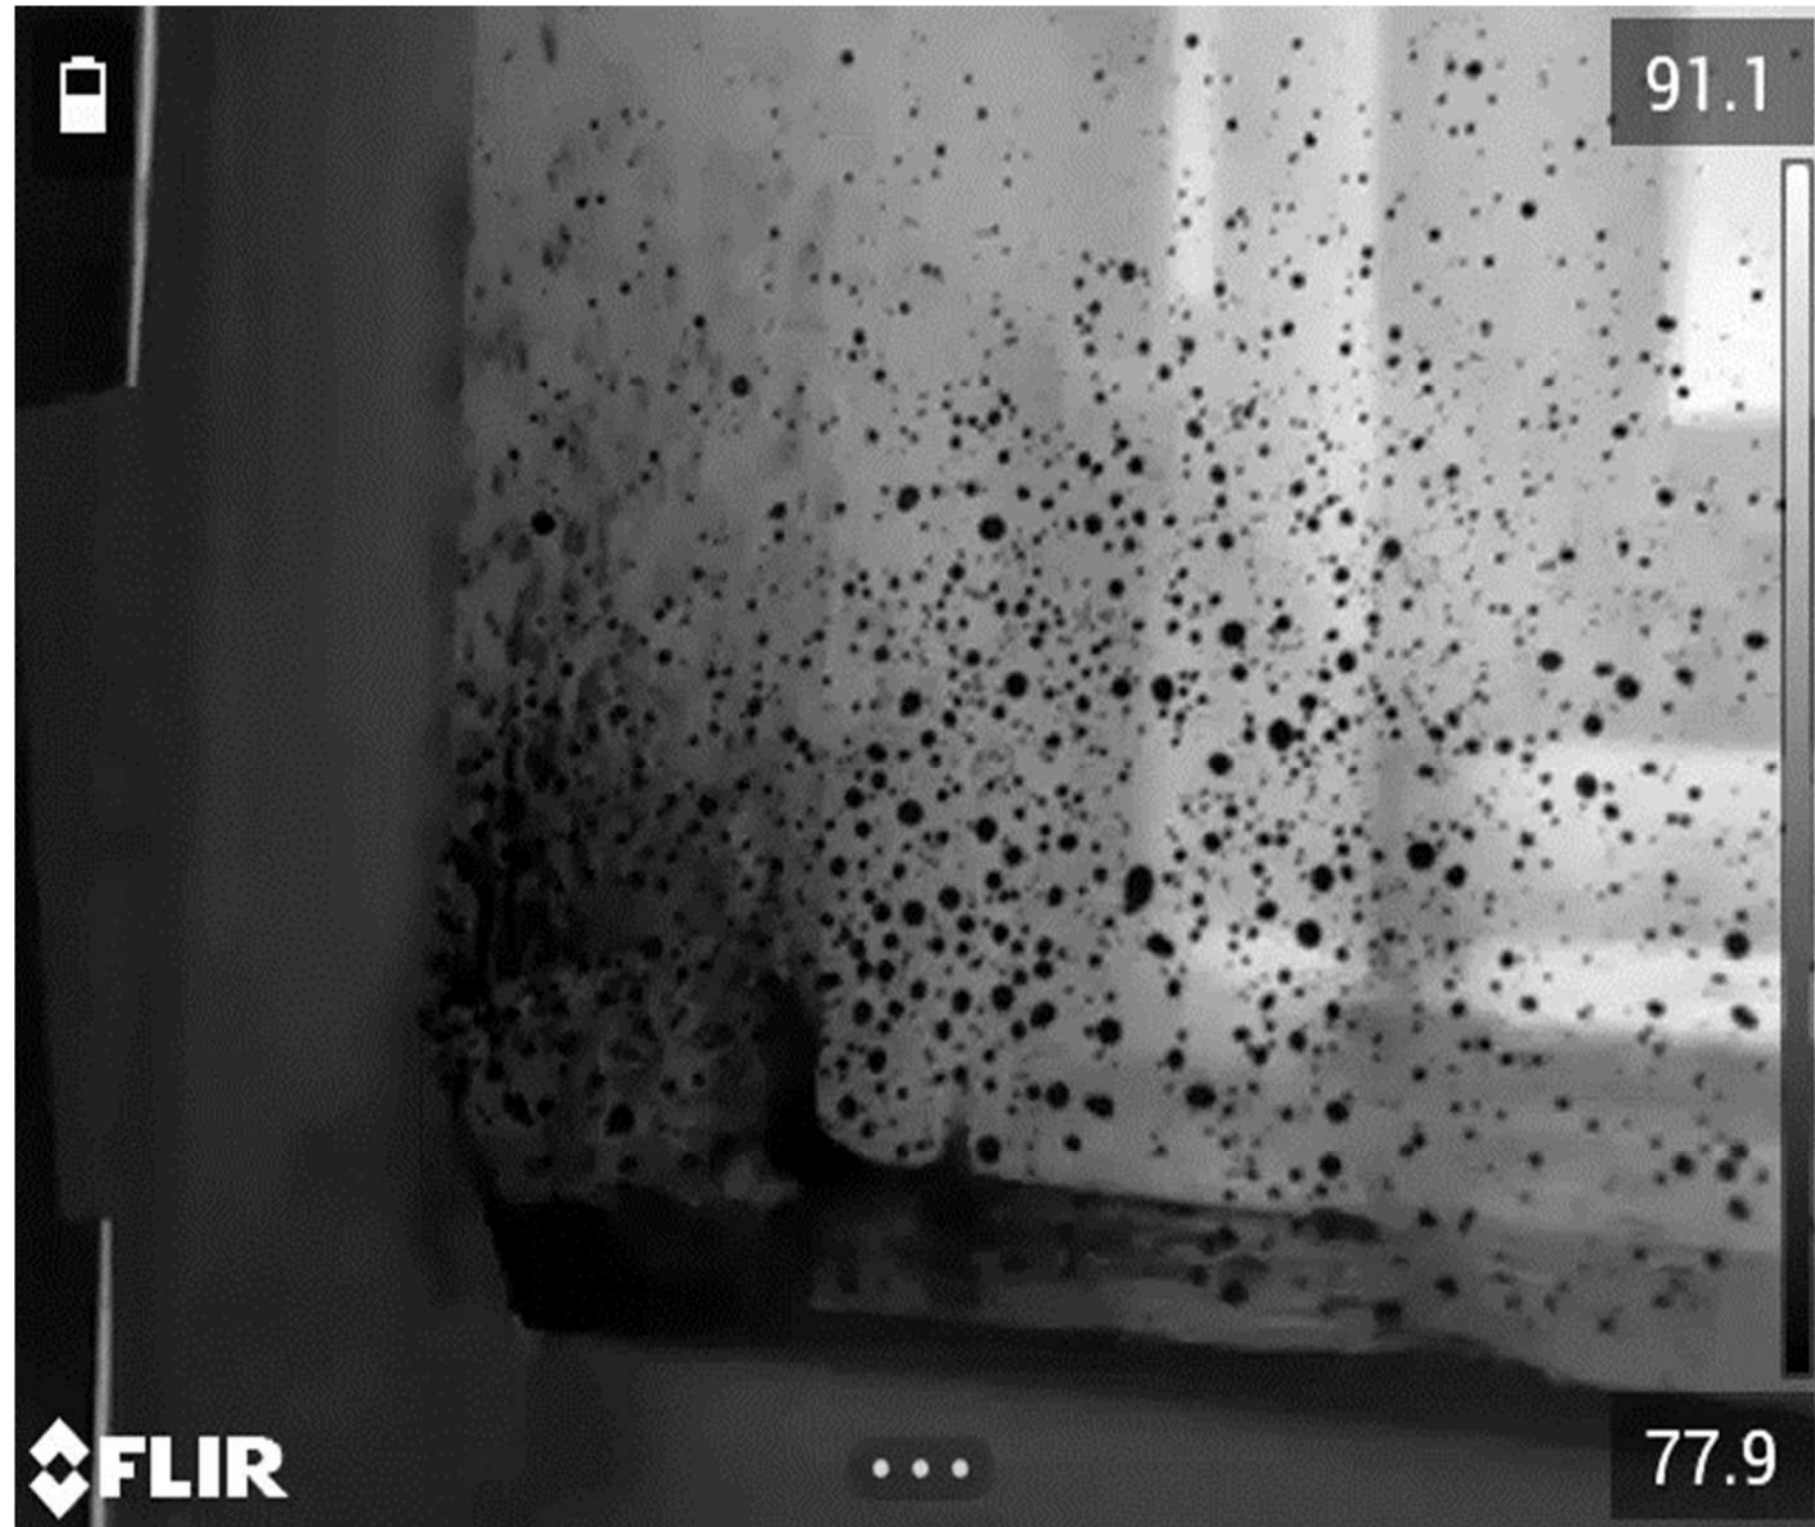
Installation failure
jamb/sill flashing of
windows.

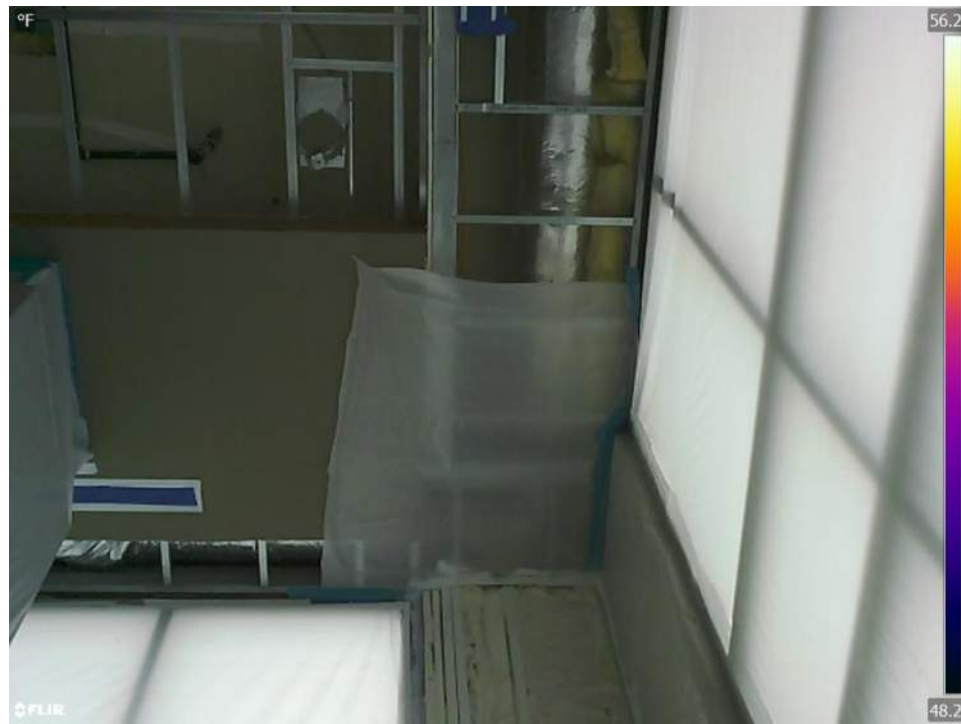
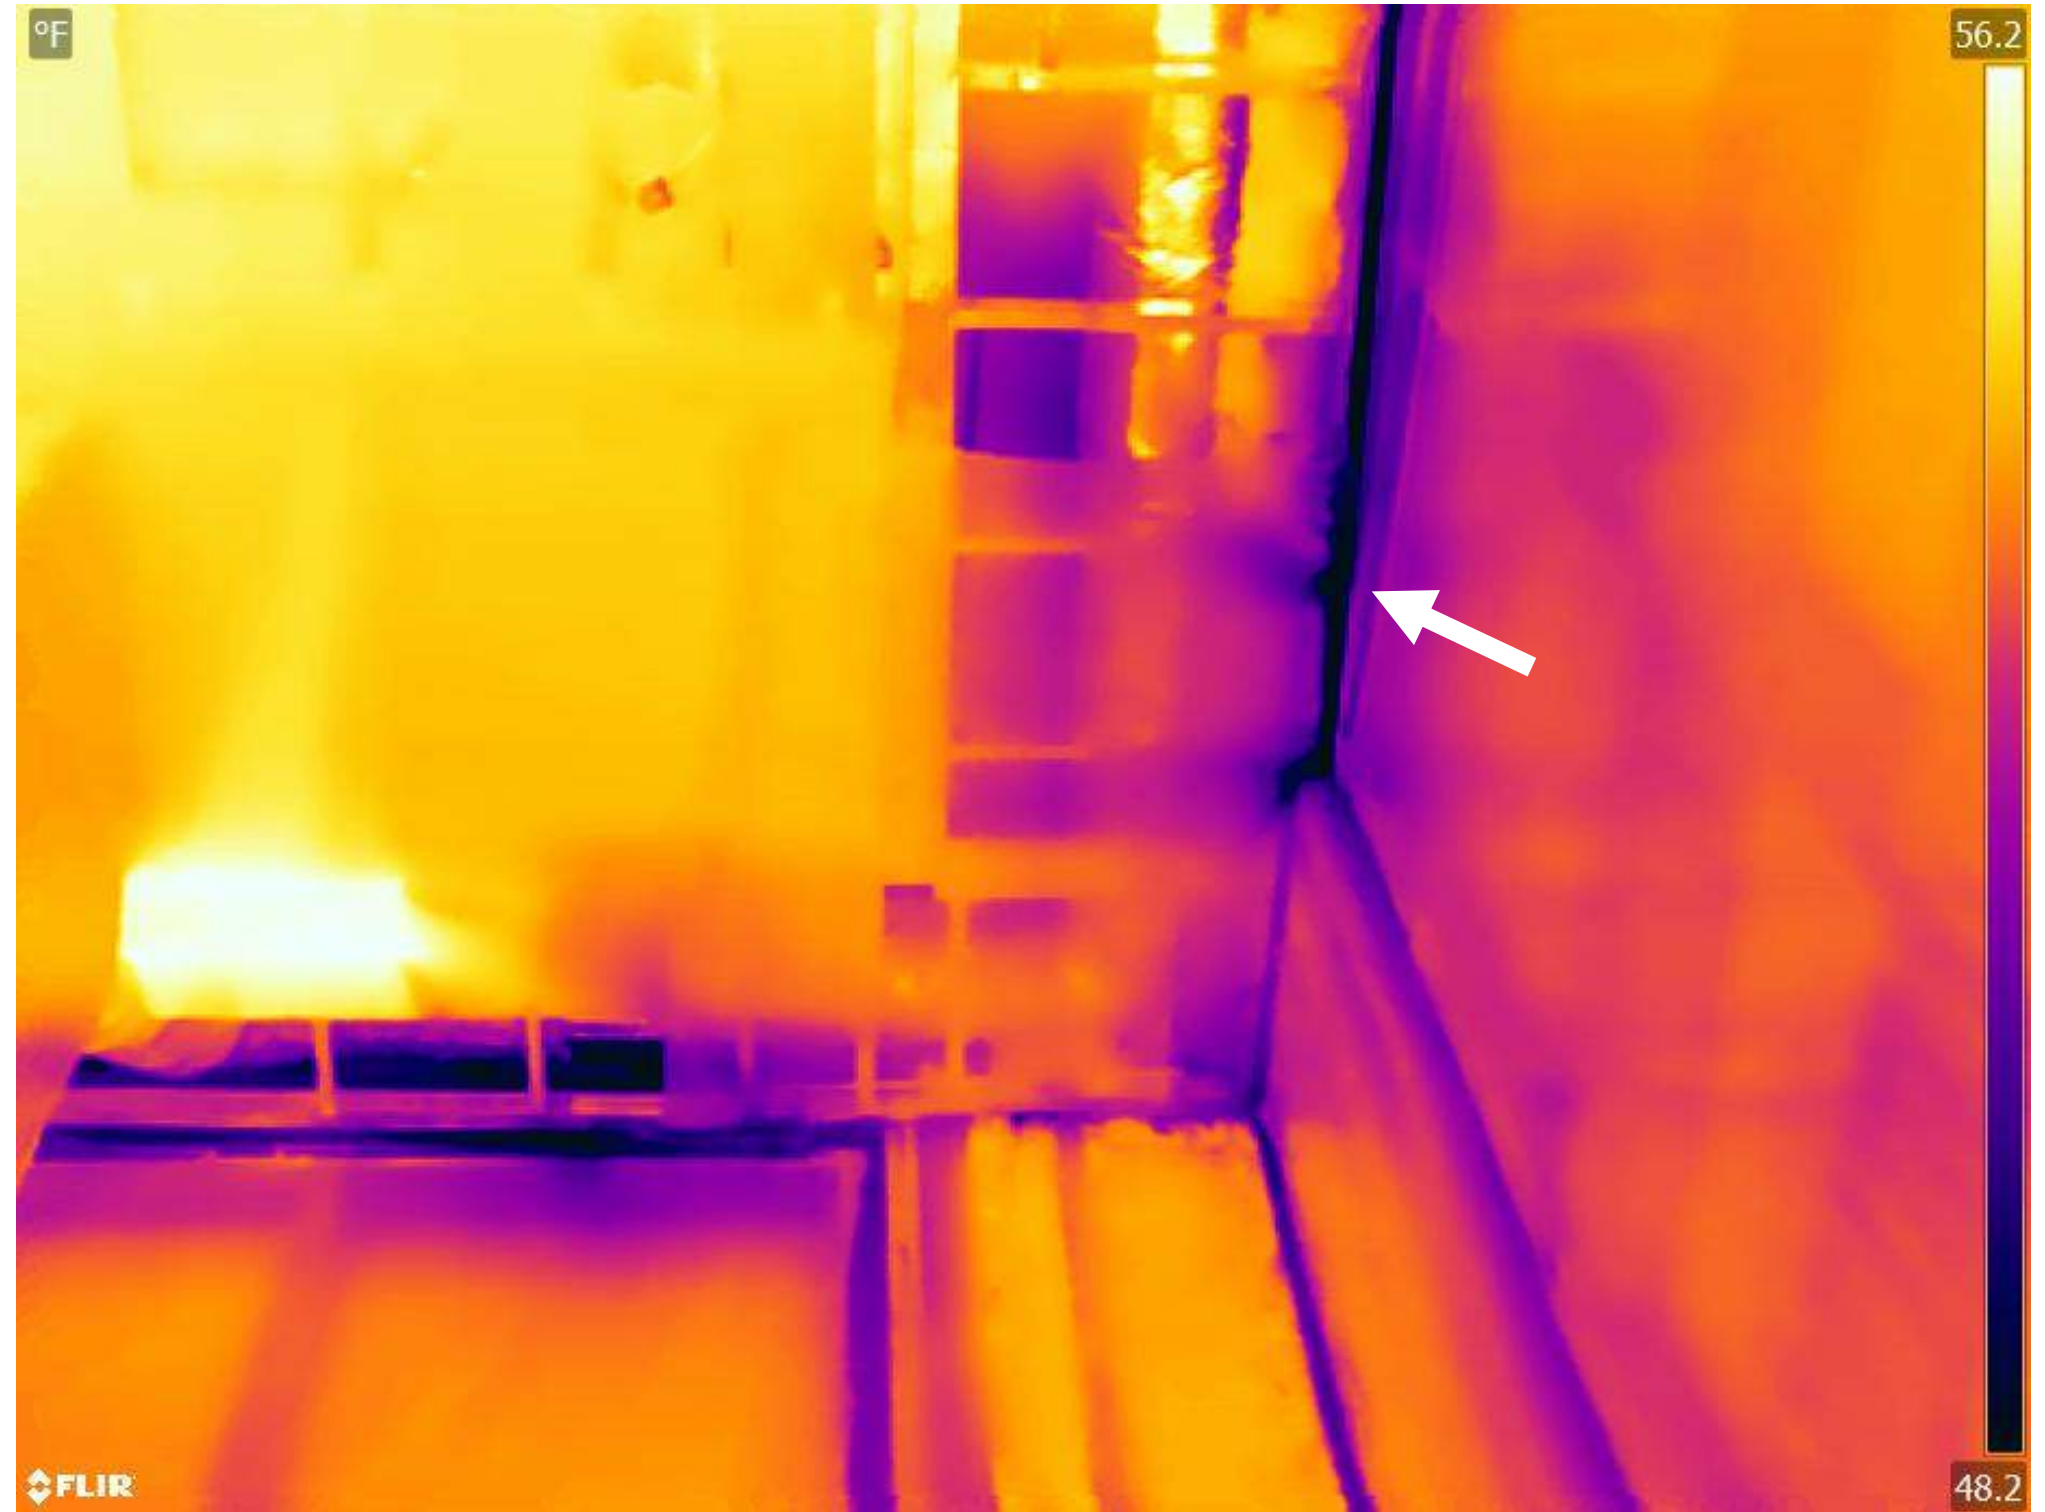
Air Infiltration at Head of Curtain Wall

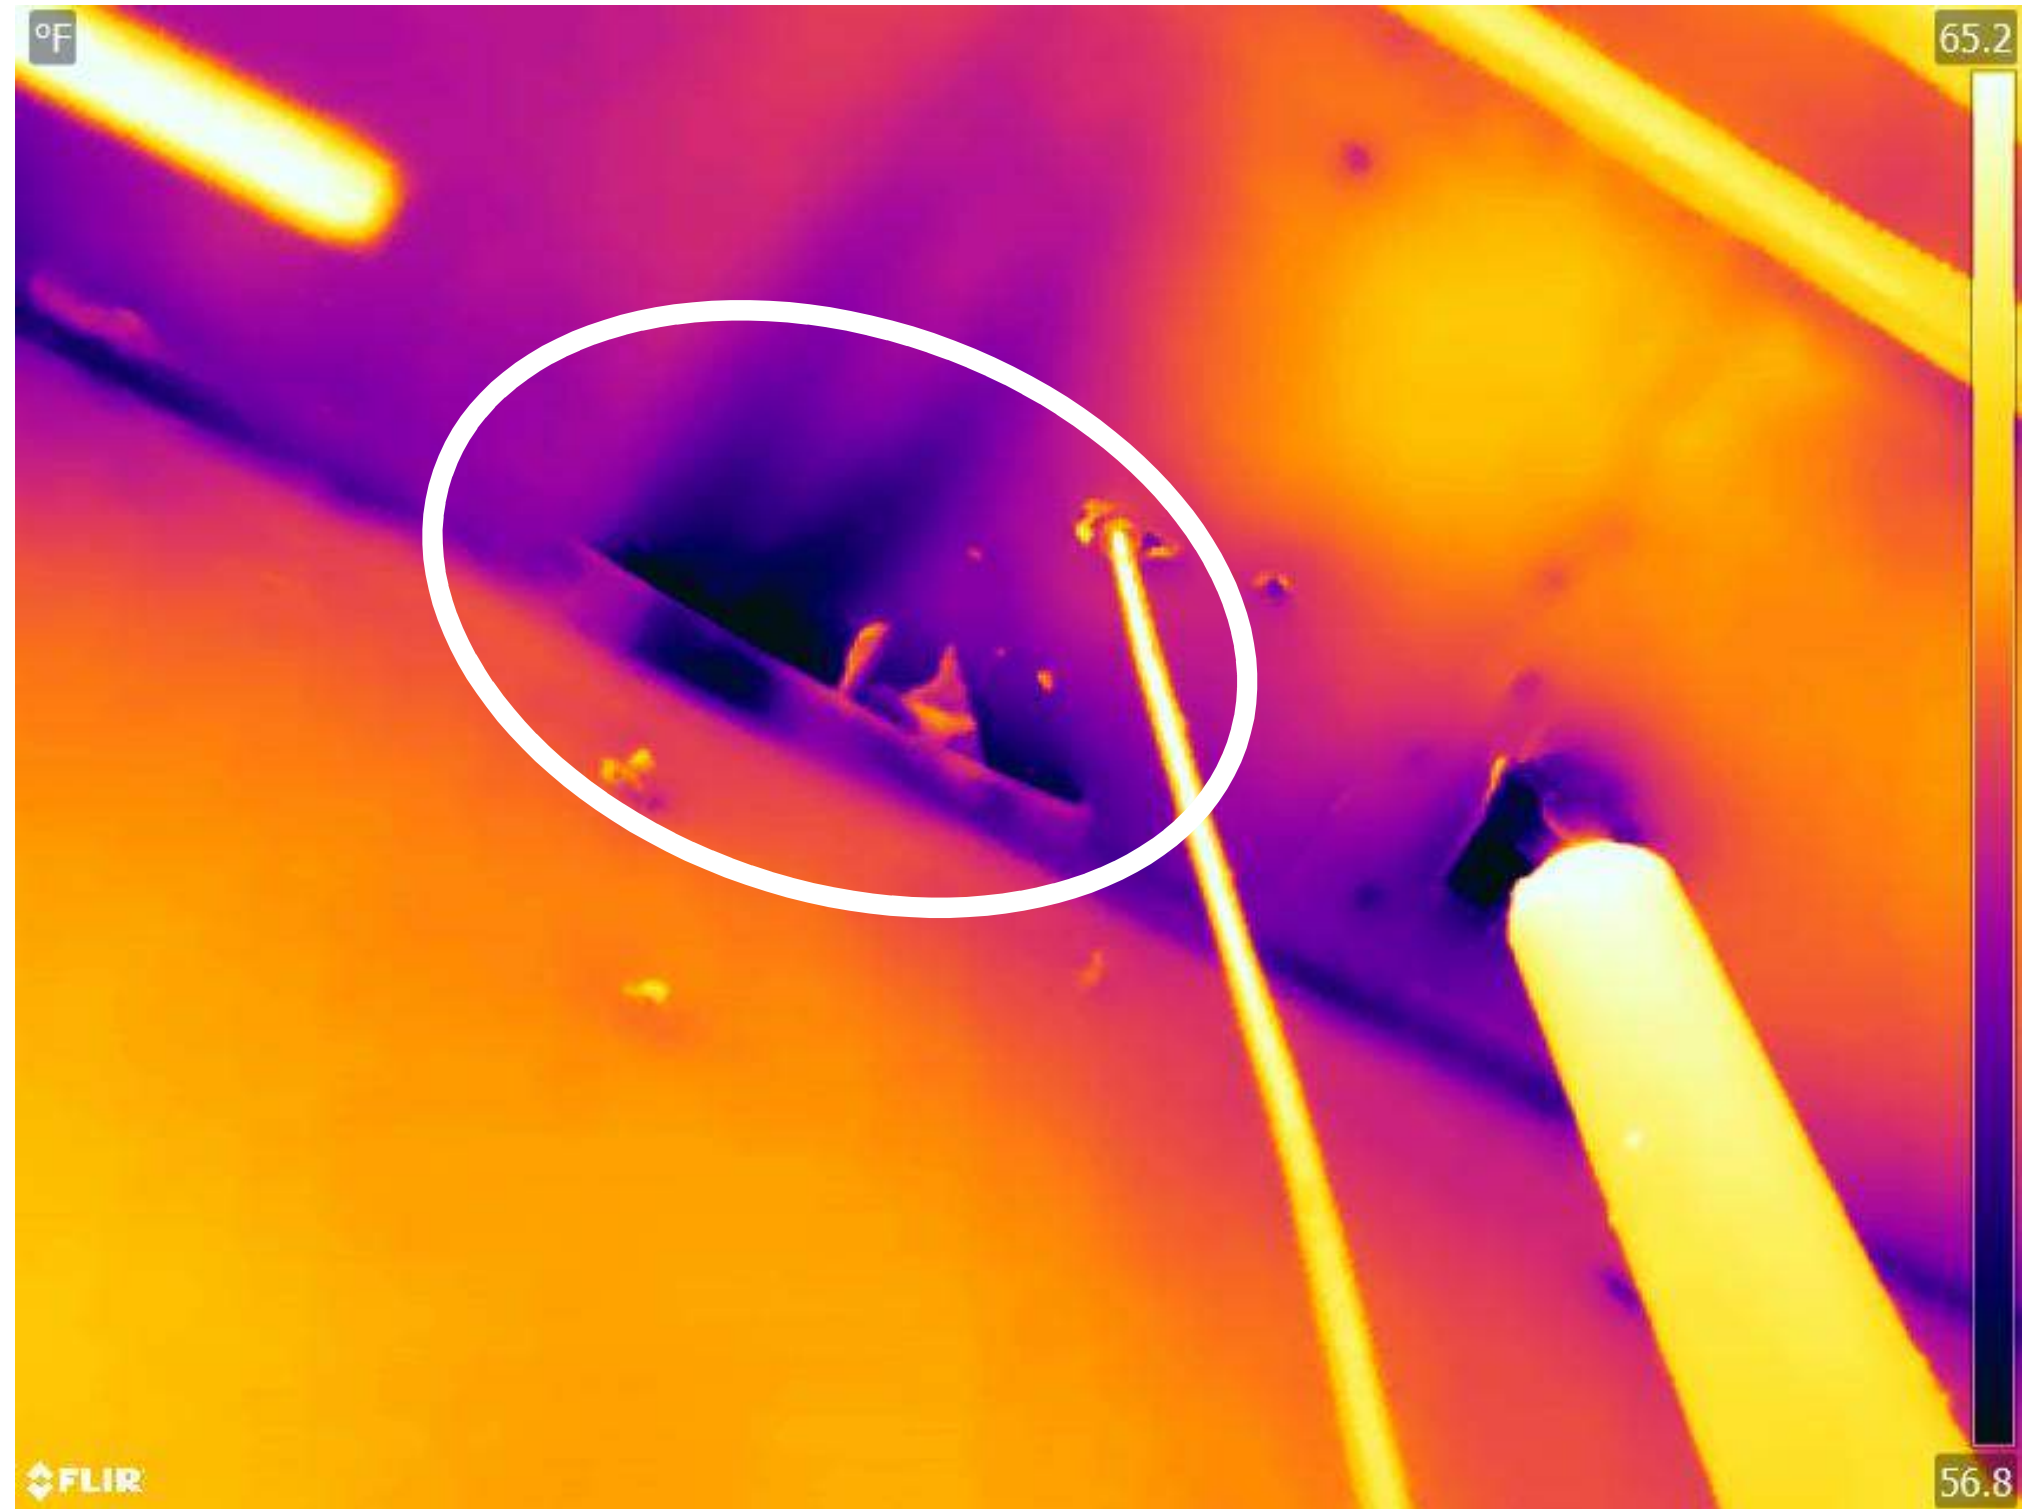
Air Infiltration on Exterior Wall in Return Air Plenum

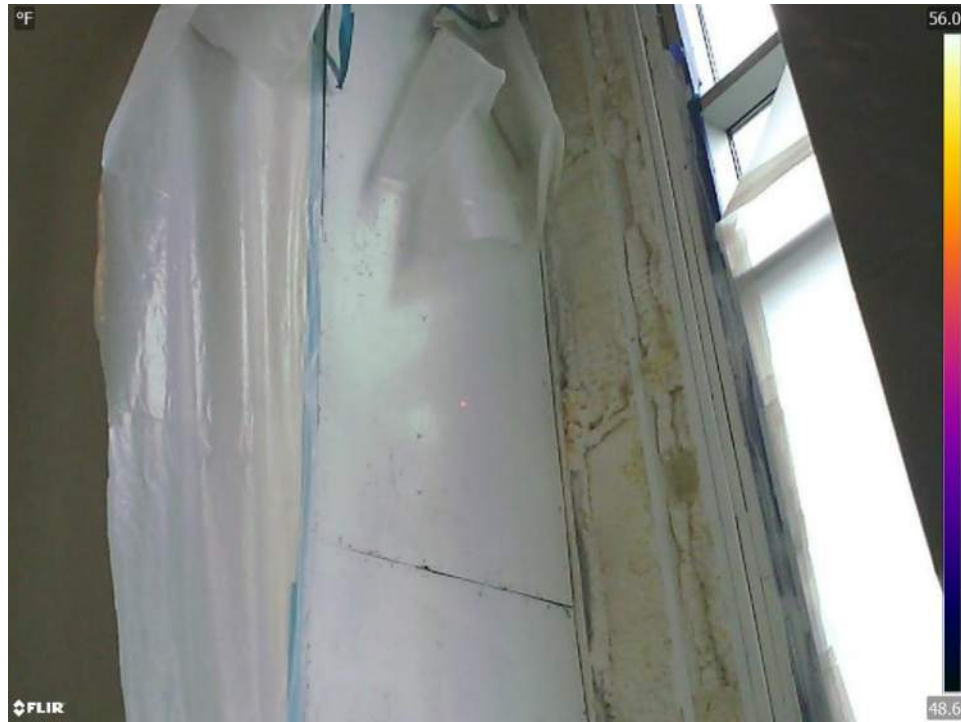
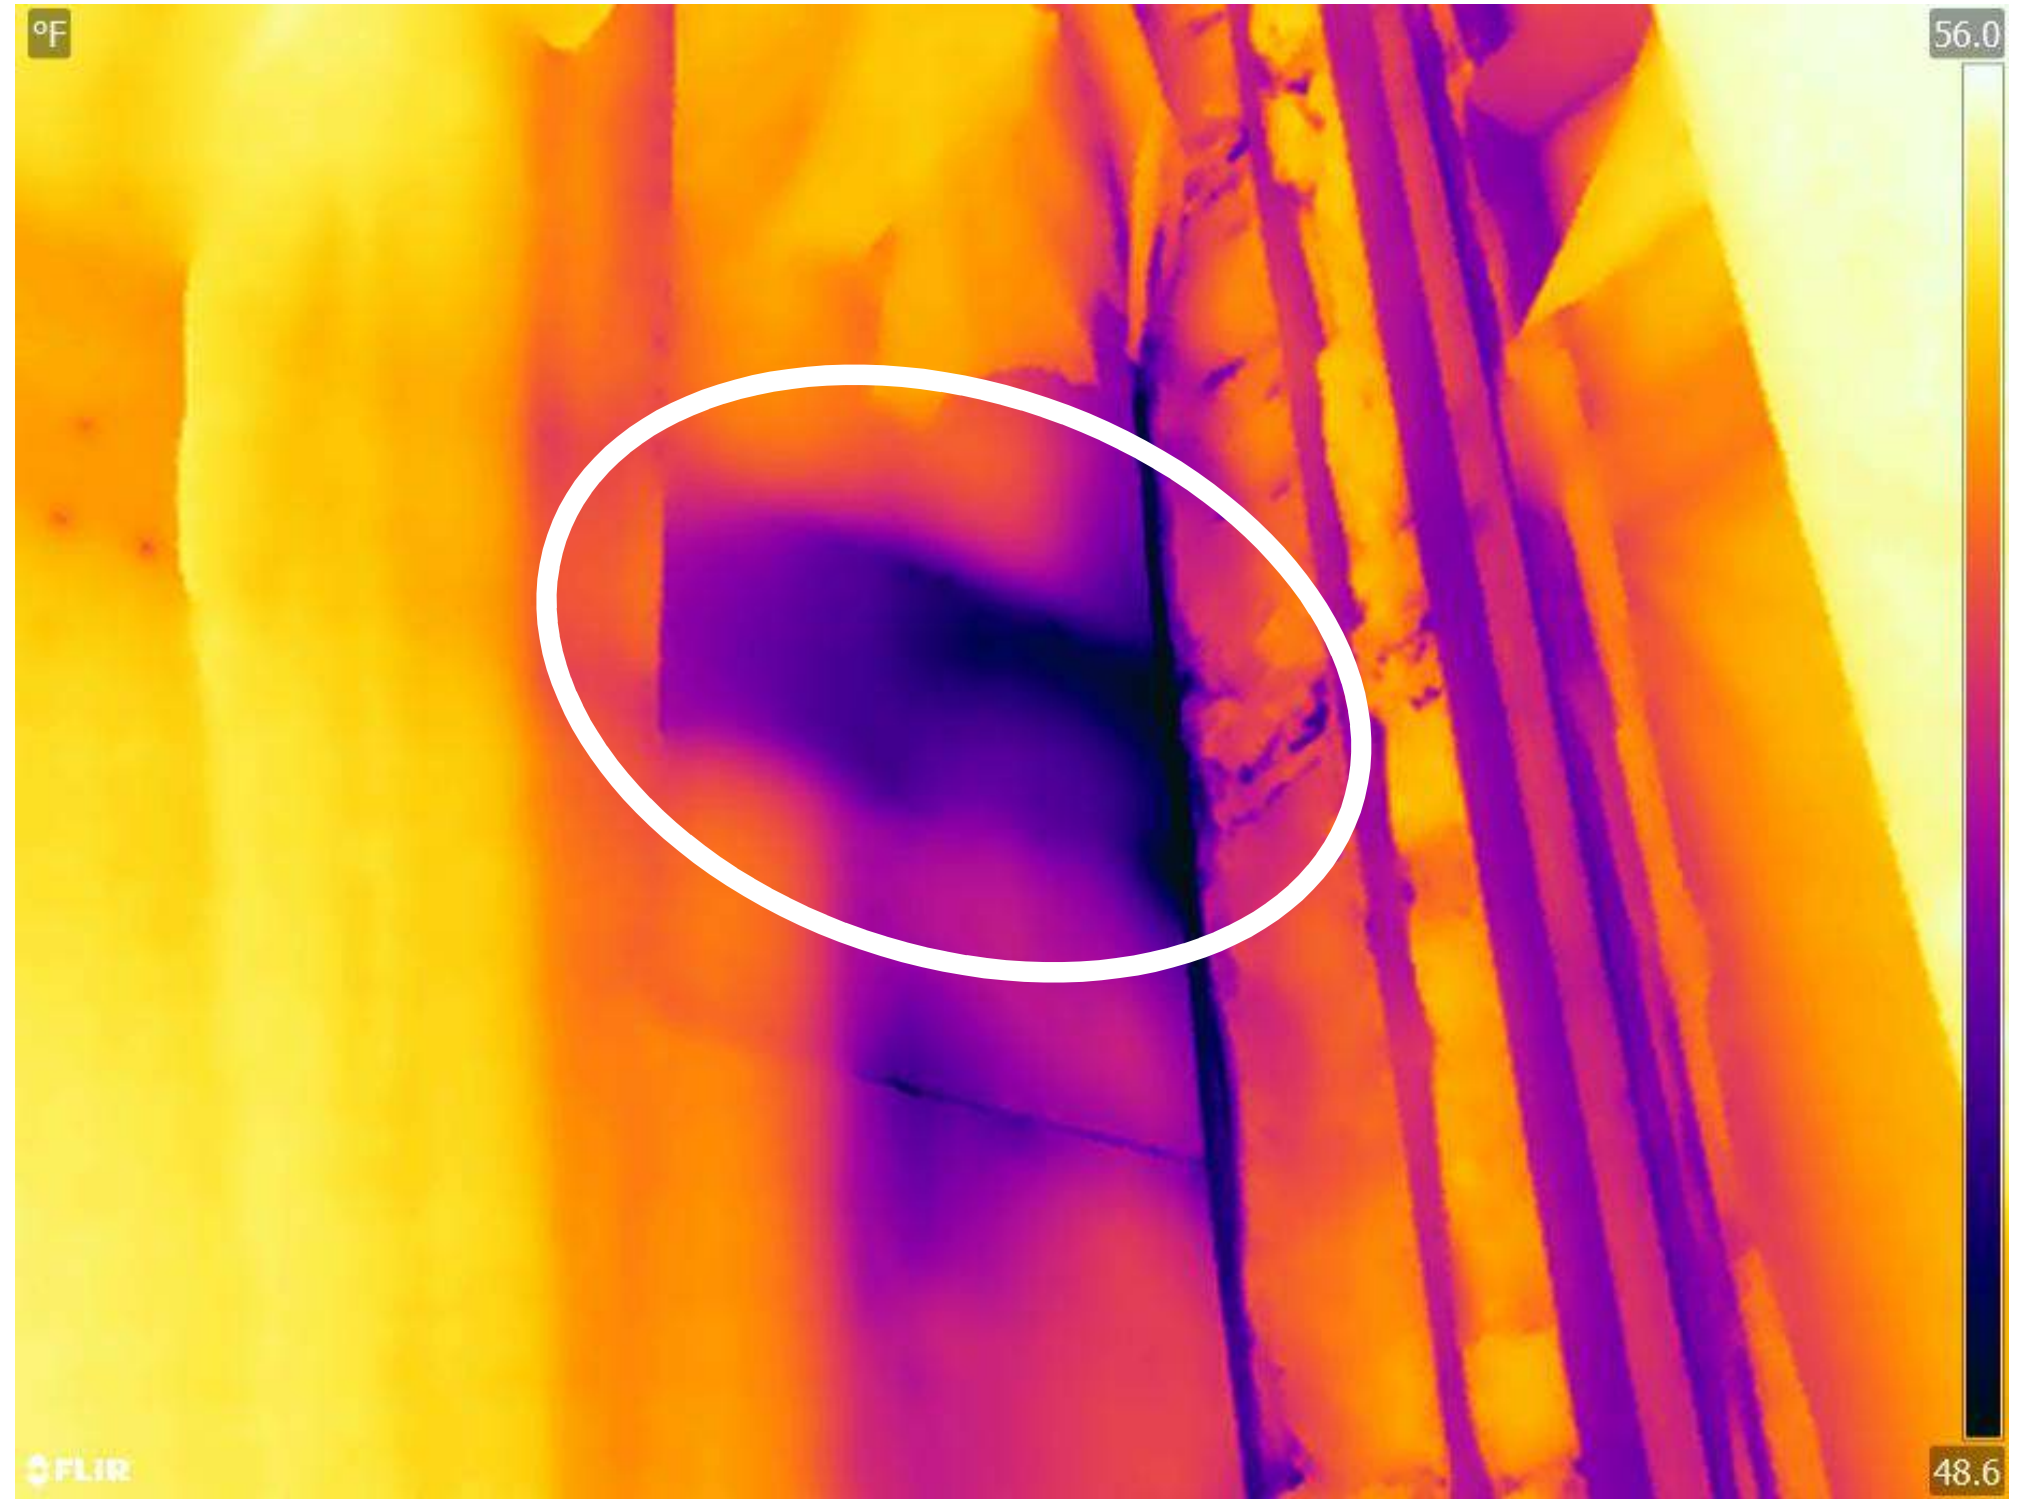
Air Infiltration and Direct Transfer from Canopy

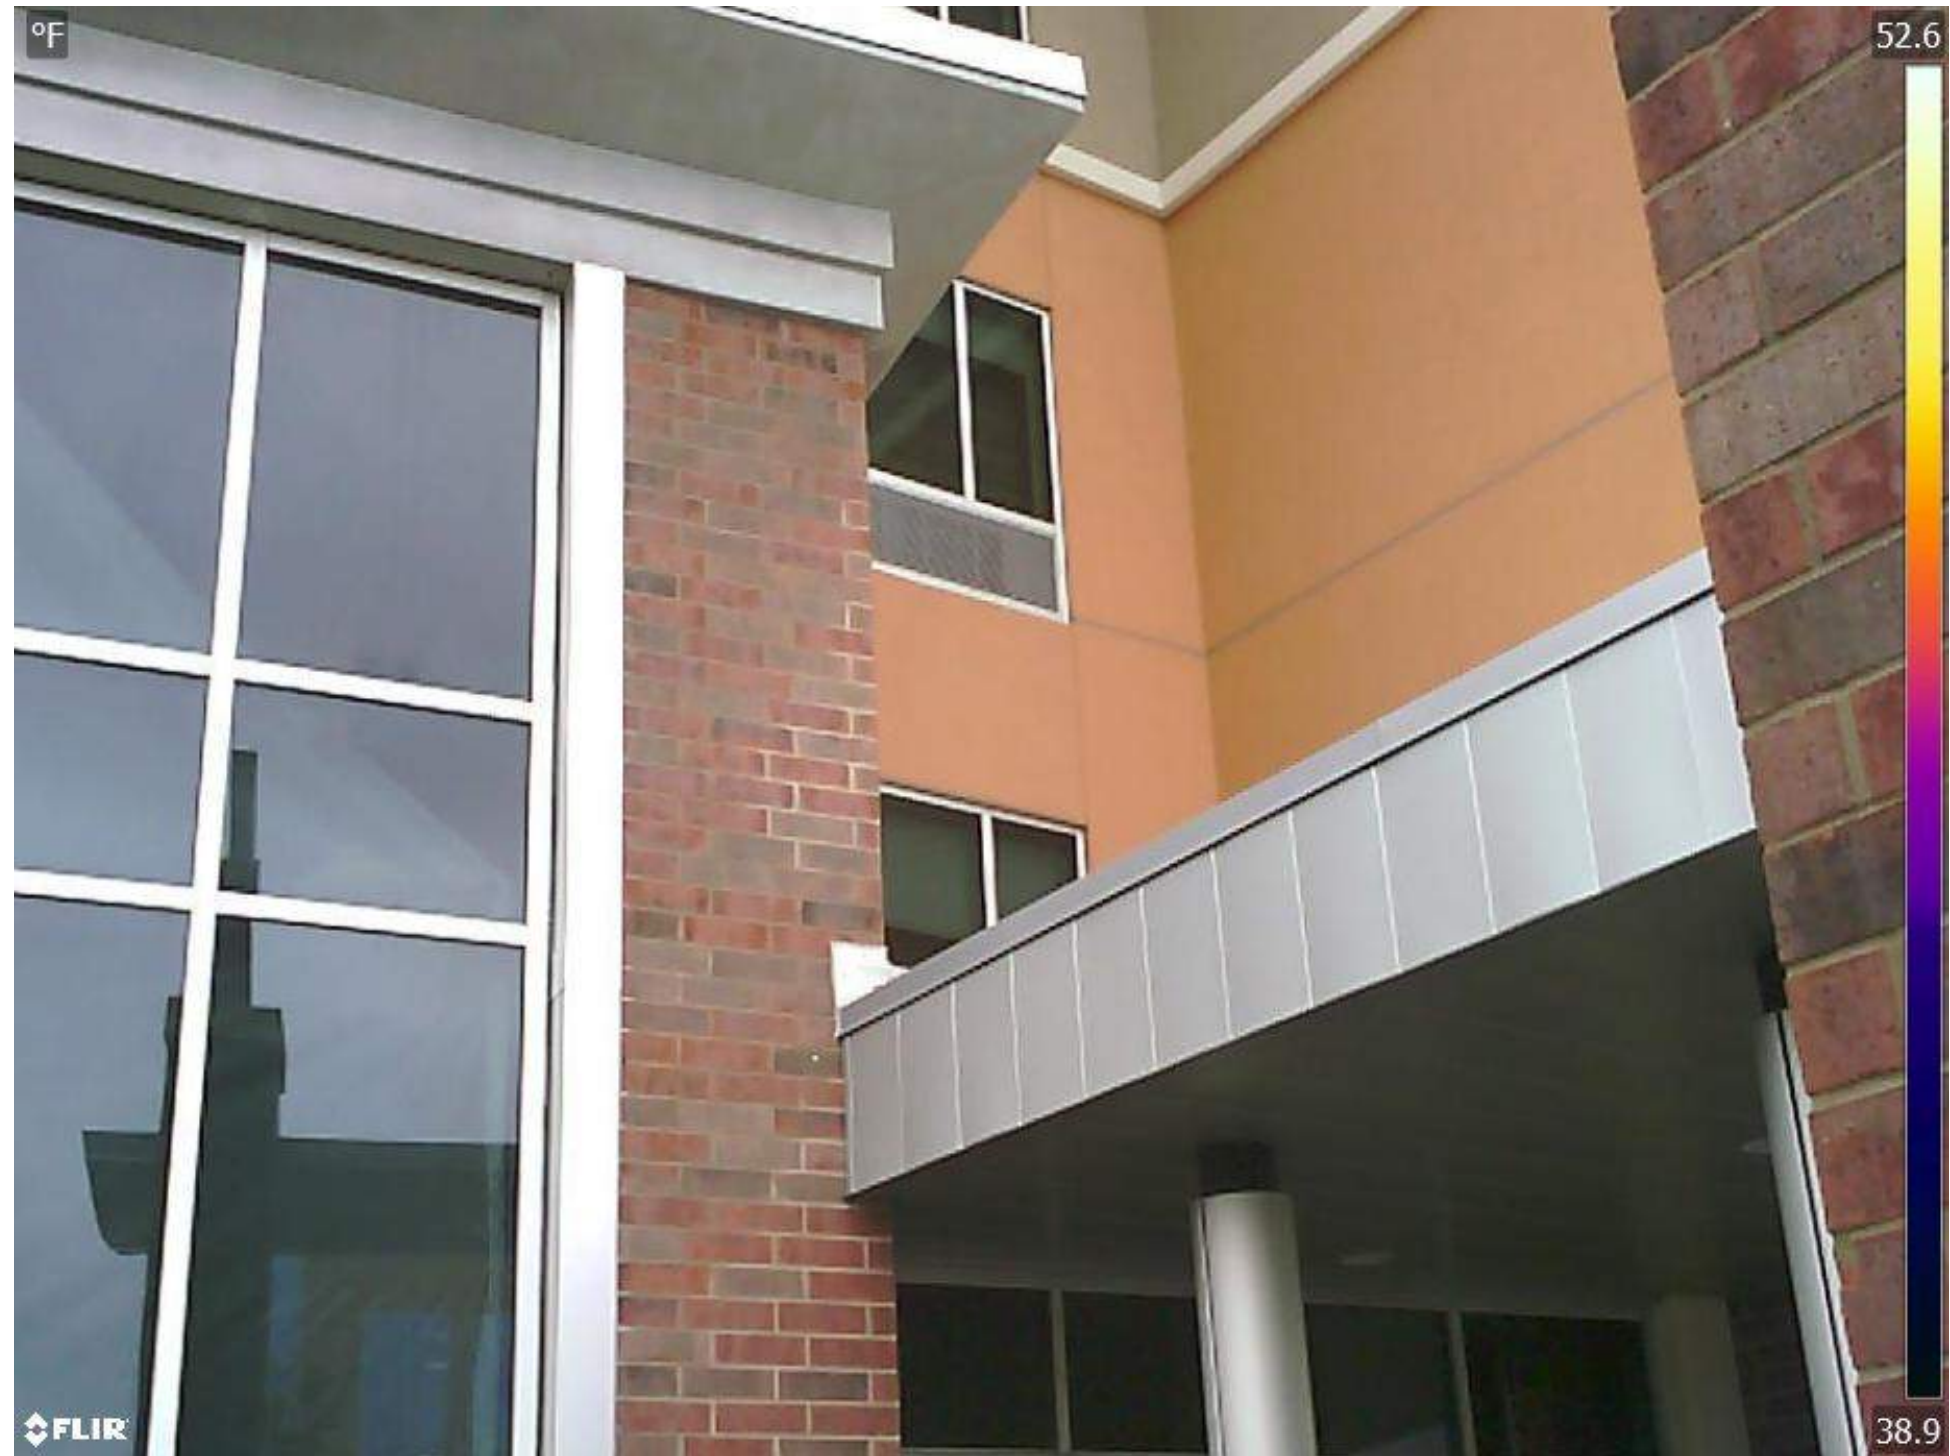
Air Infiltration and Direct Transfer from Canopy
