Non-Visible Energy – Decoding Electromagnetic Energy and Thermodynamics

Case Study 1 – CoxHealth Patient Tower Addition

Case Study 2 – Primatara Mansion

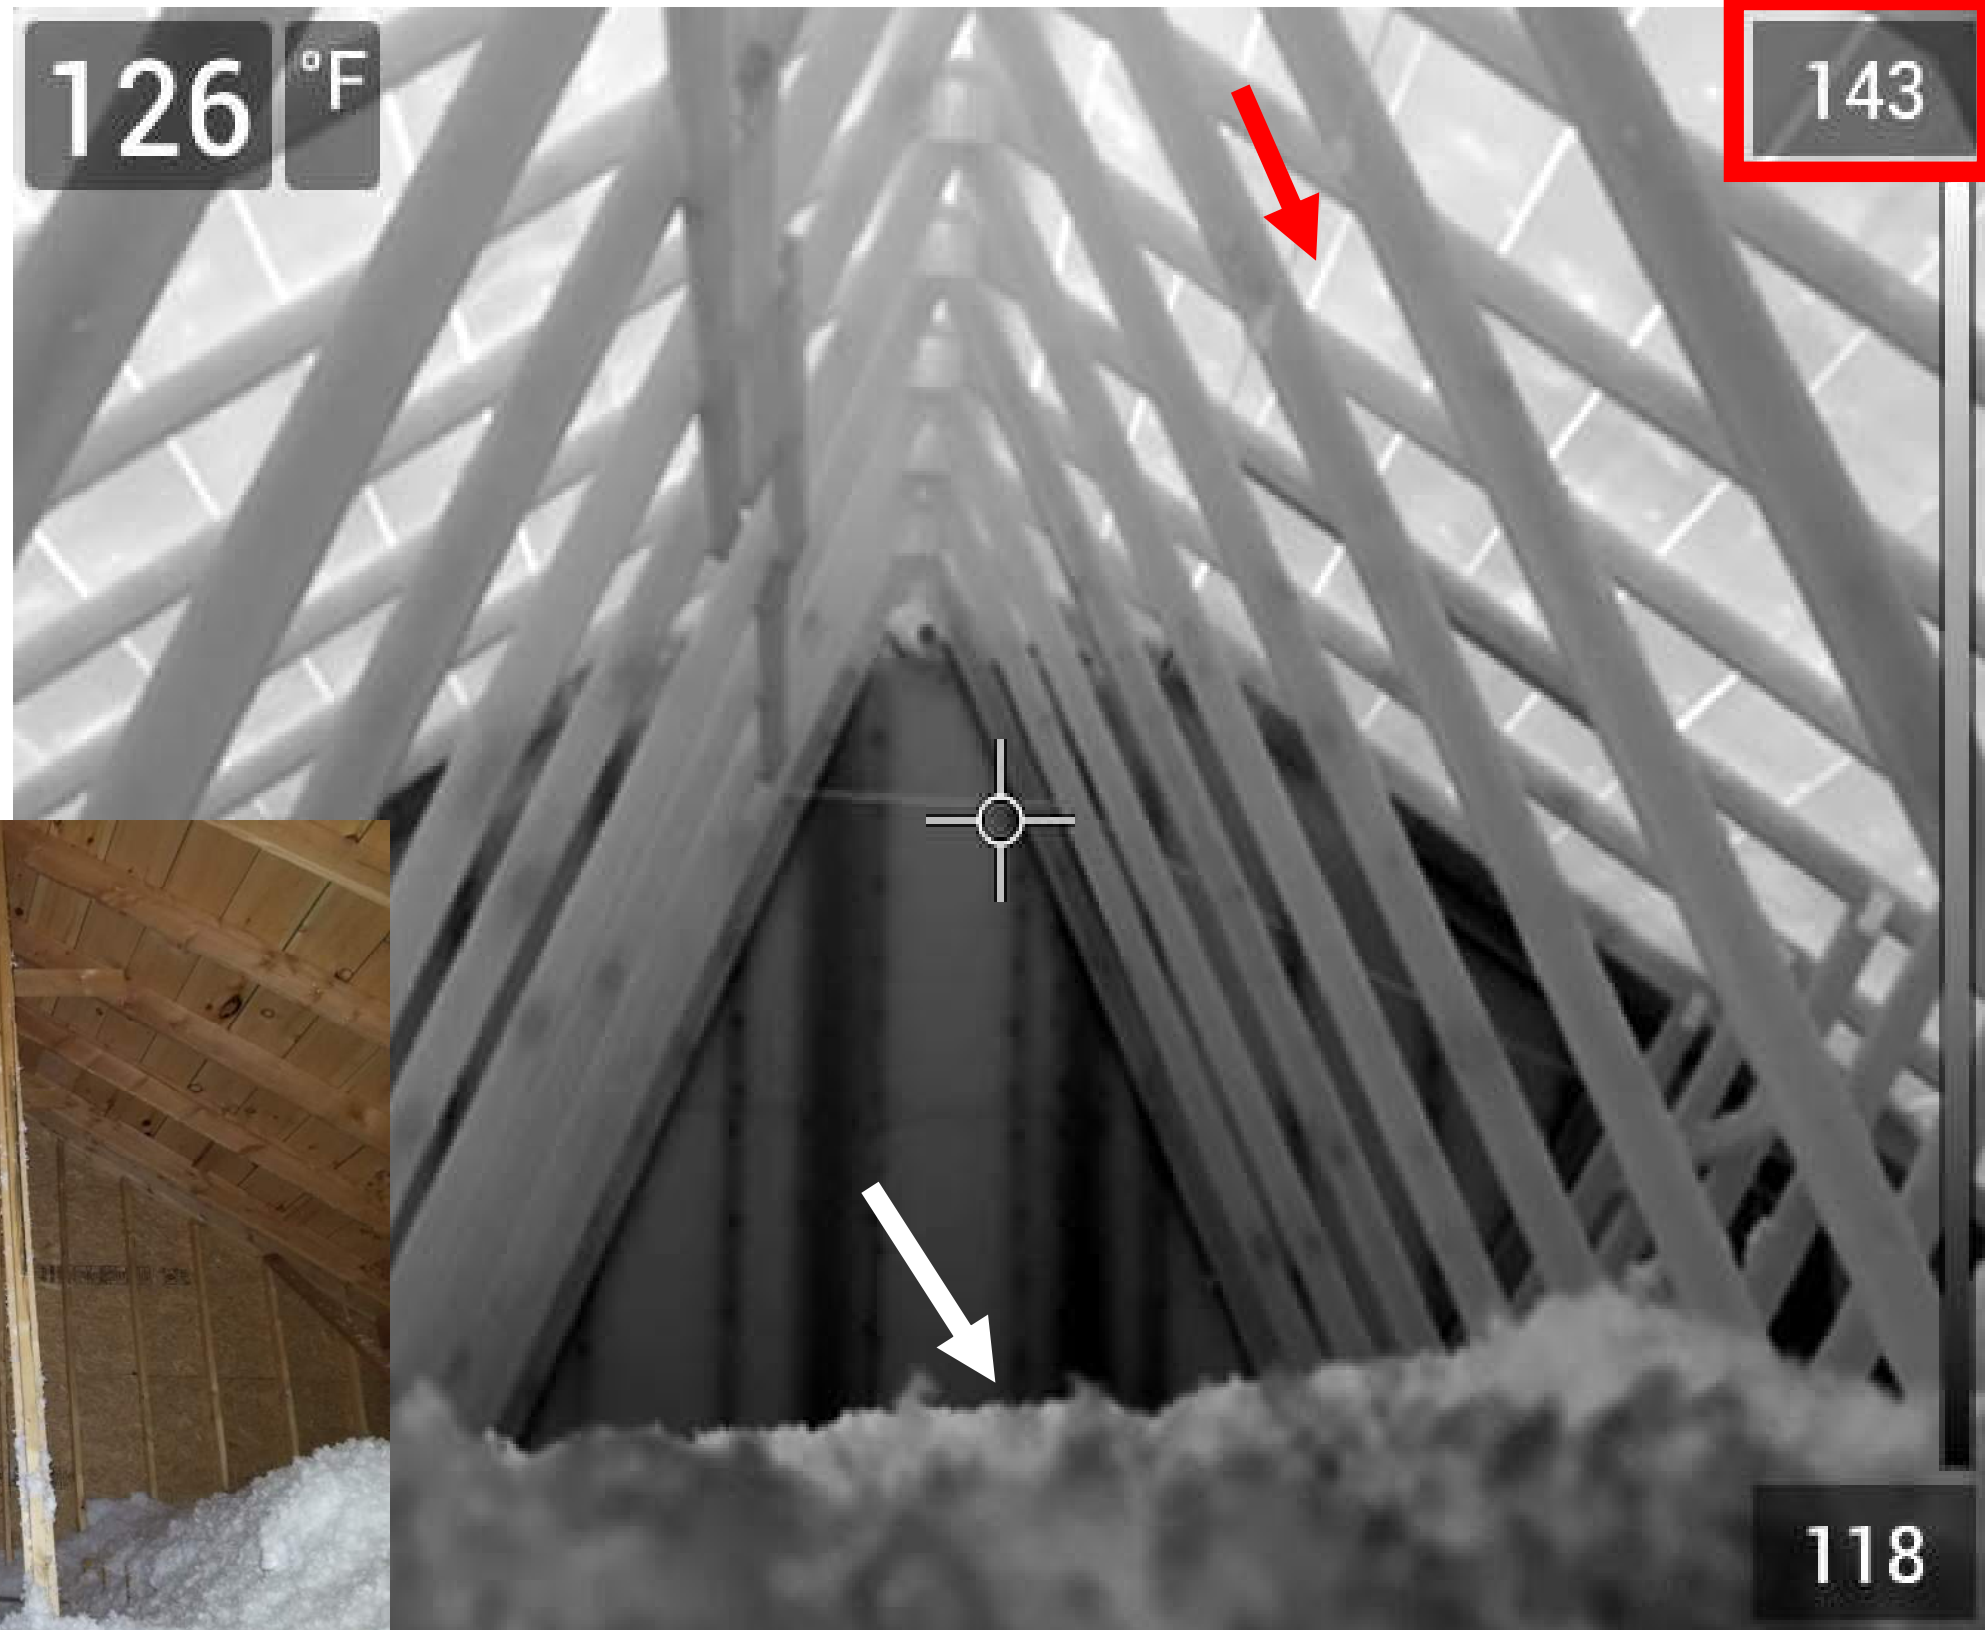
Mechanical duct temperature drop of 10°F

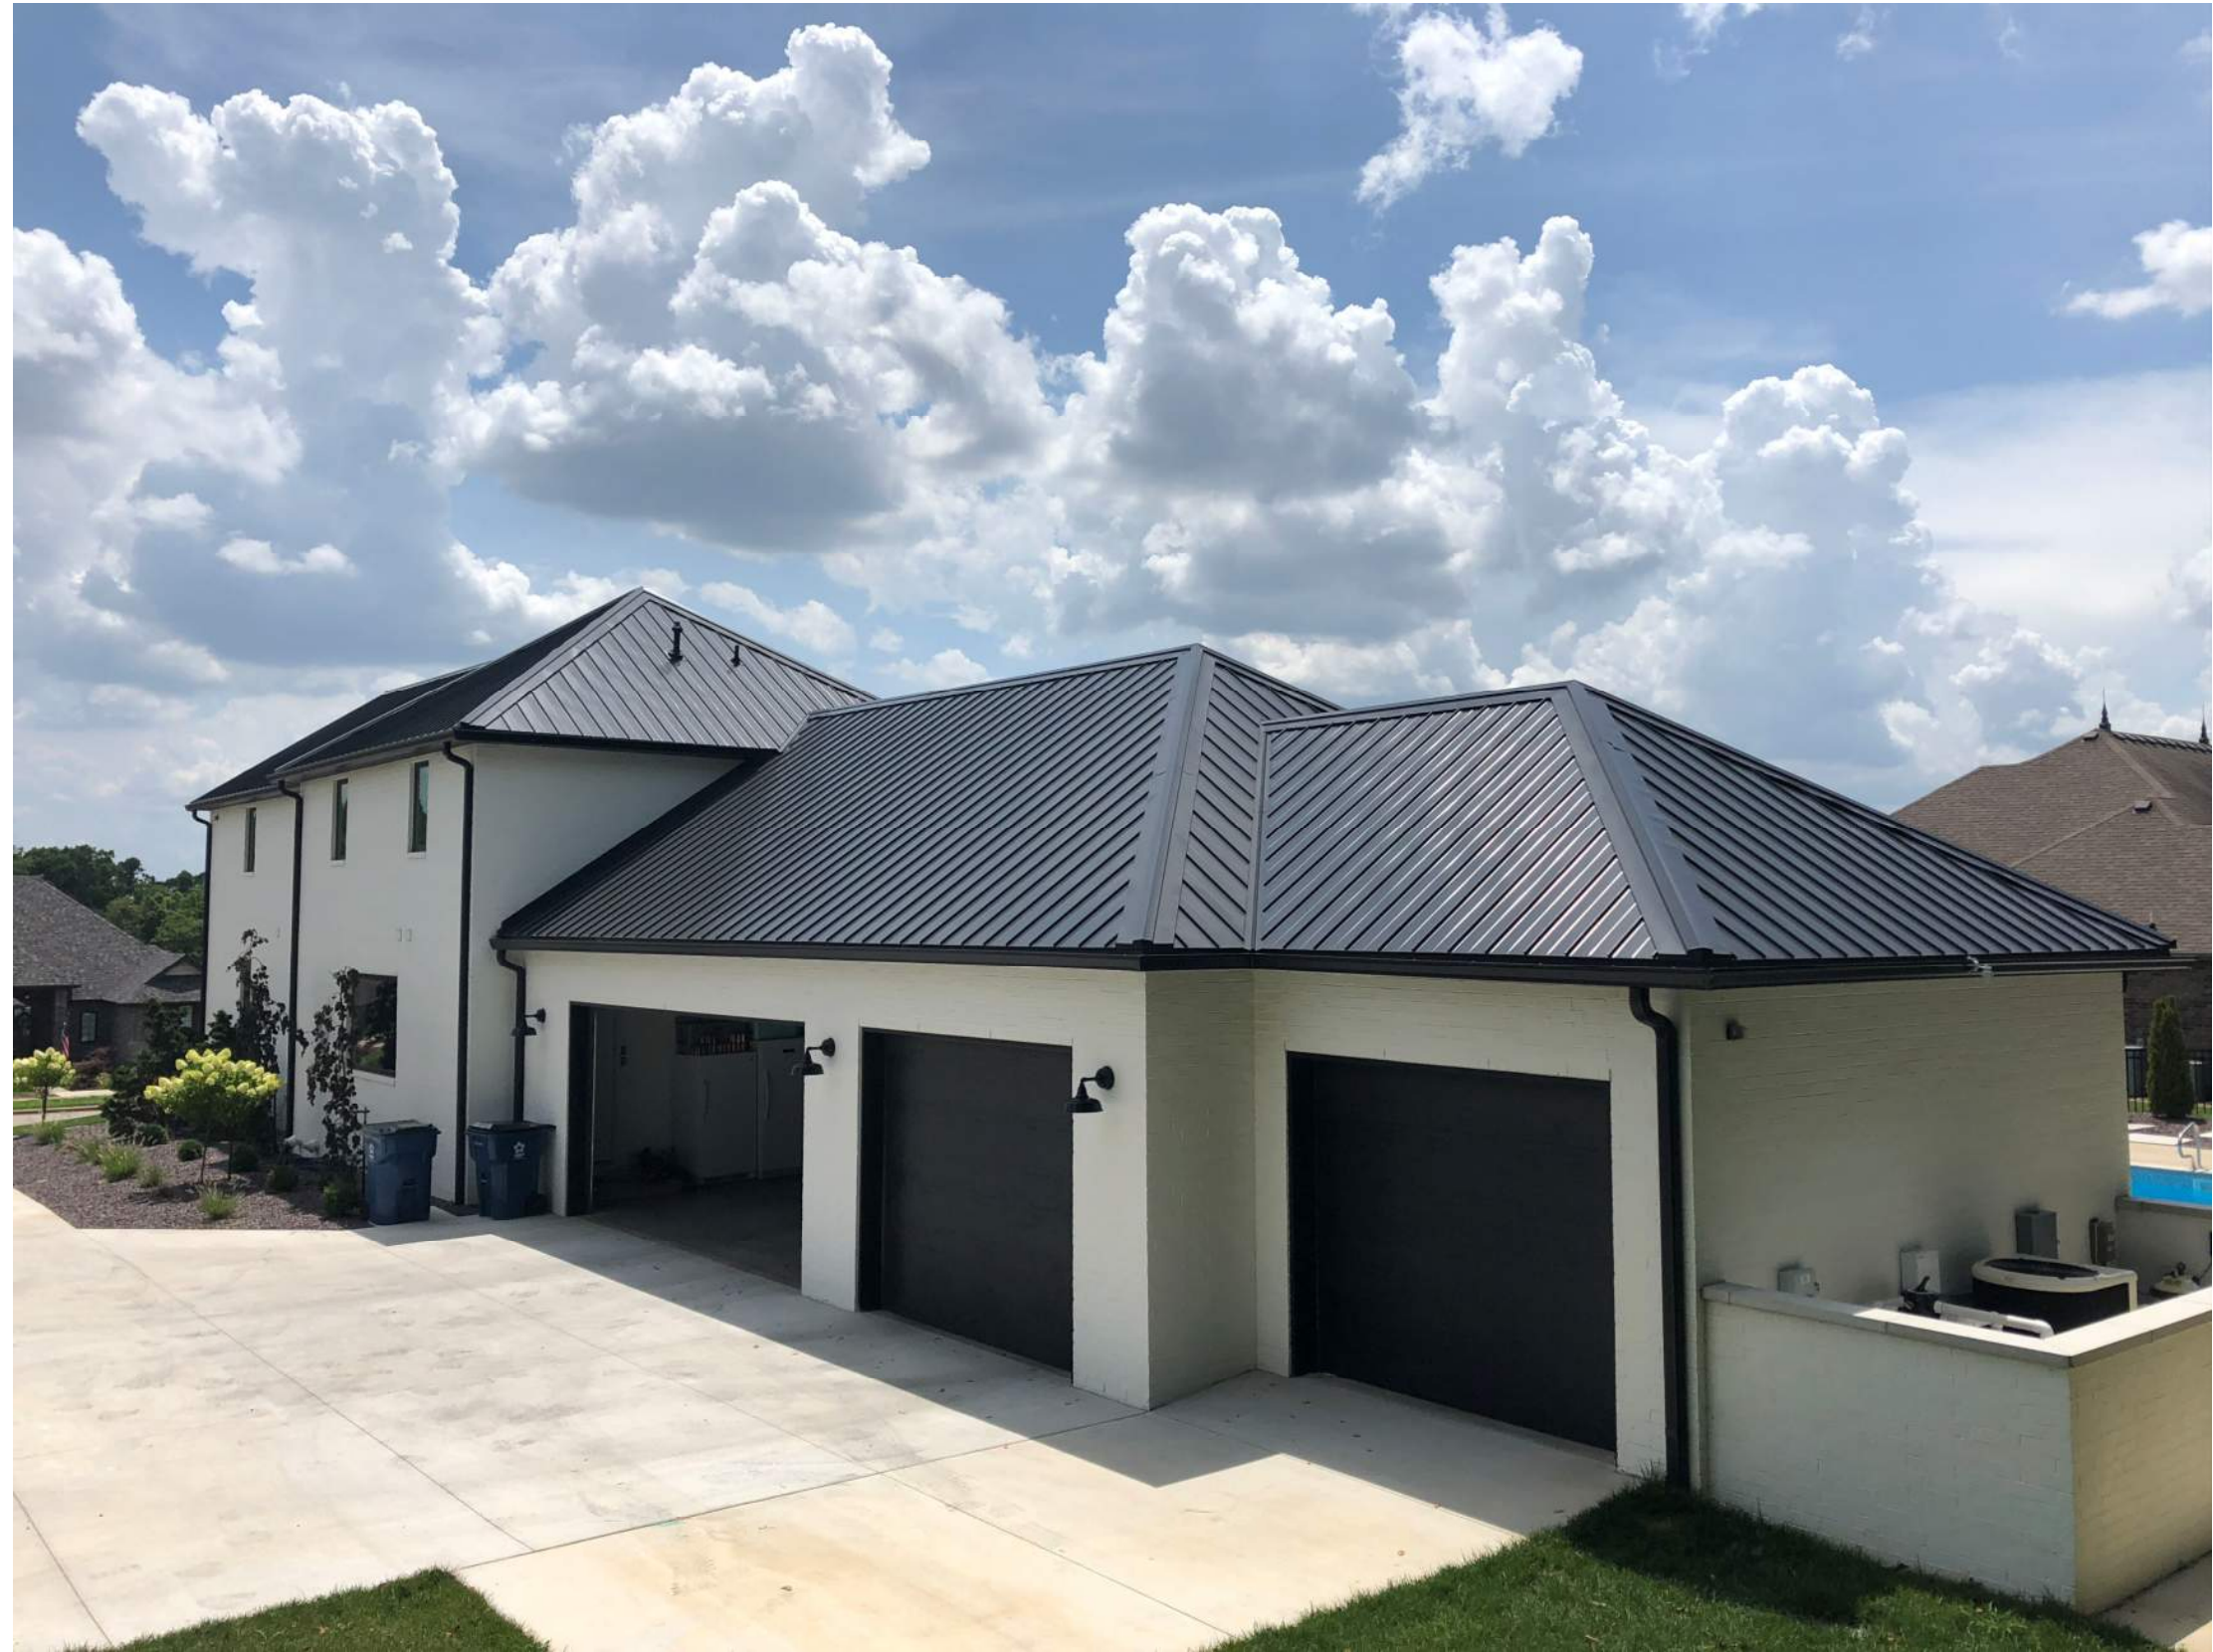
The Roof is Black!

No insulation, and
no ventilation

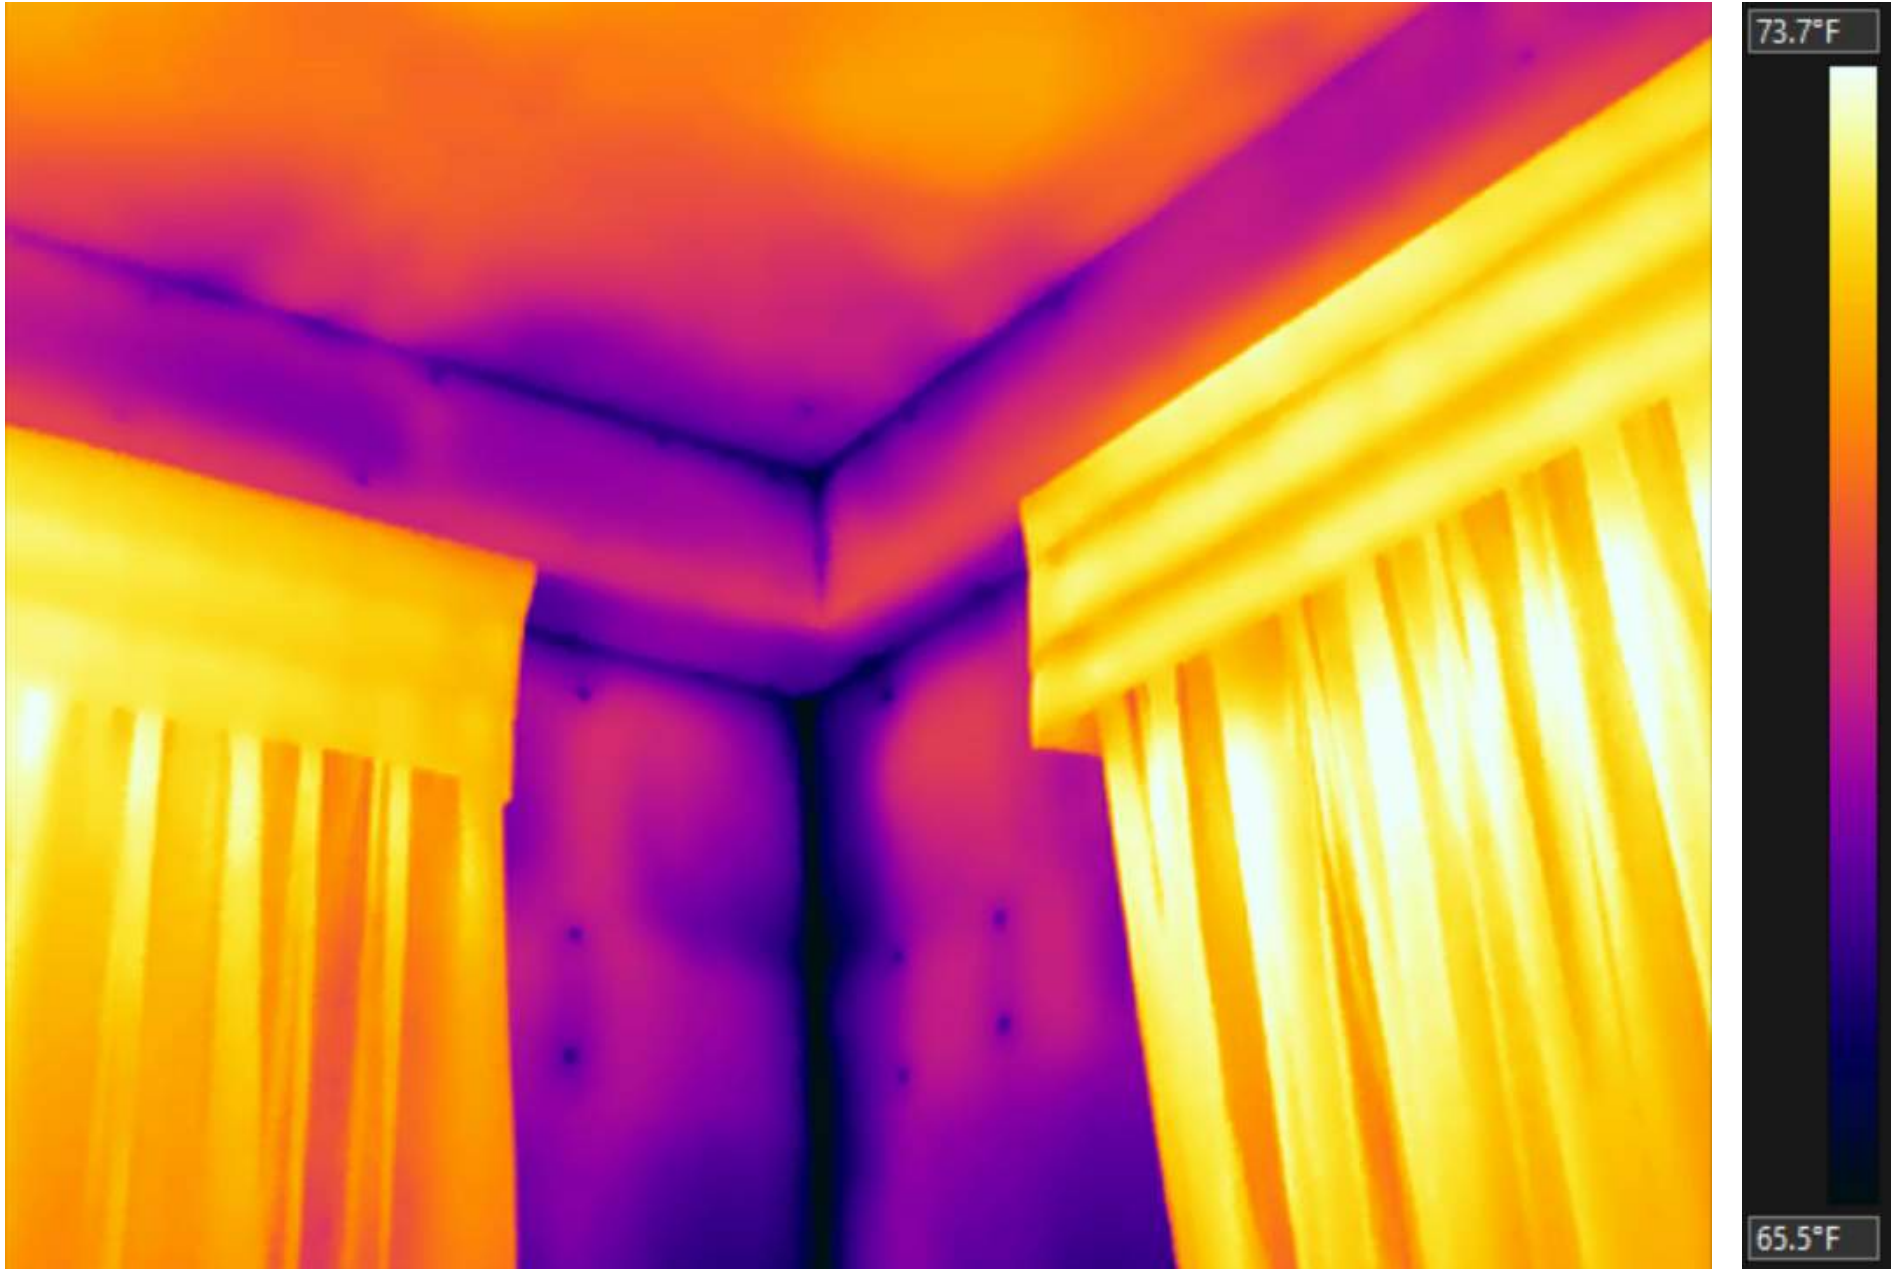
Cool Spots due to poor air circulation

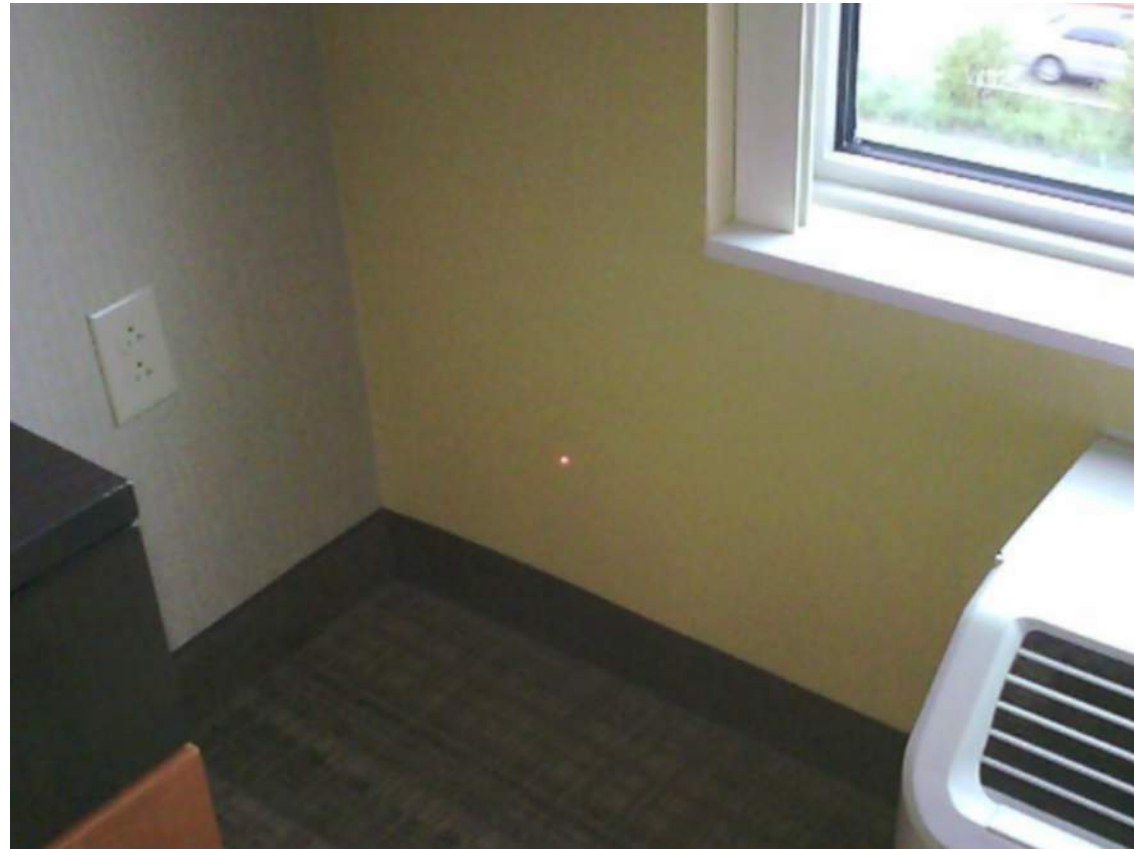
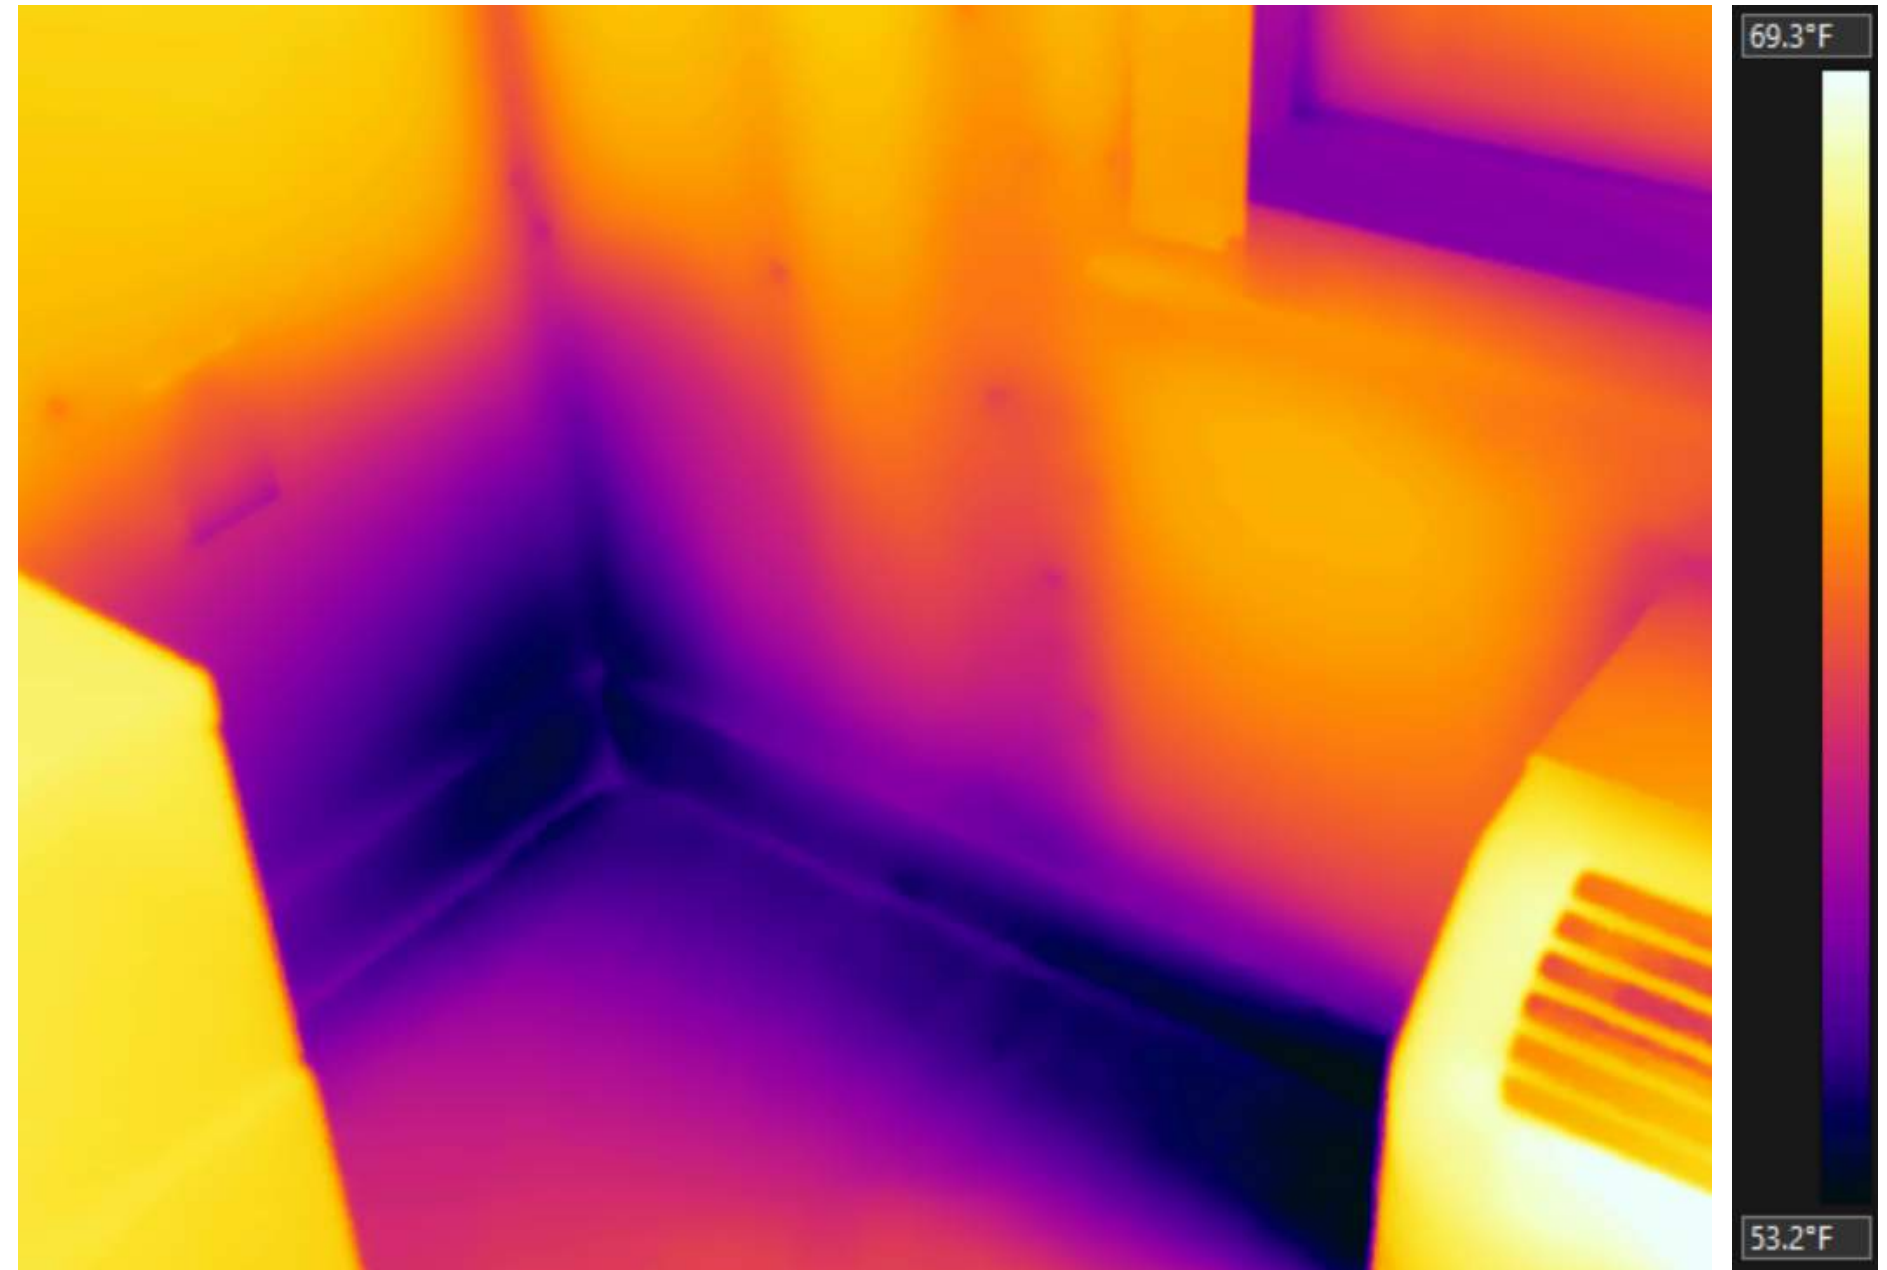
Air Infiltration from PTAC Unit

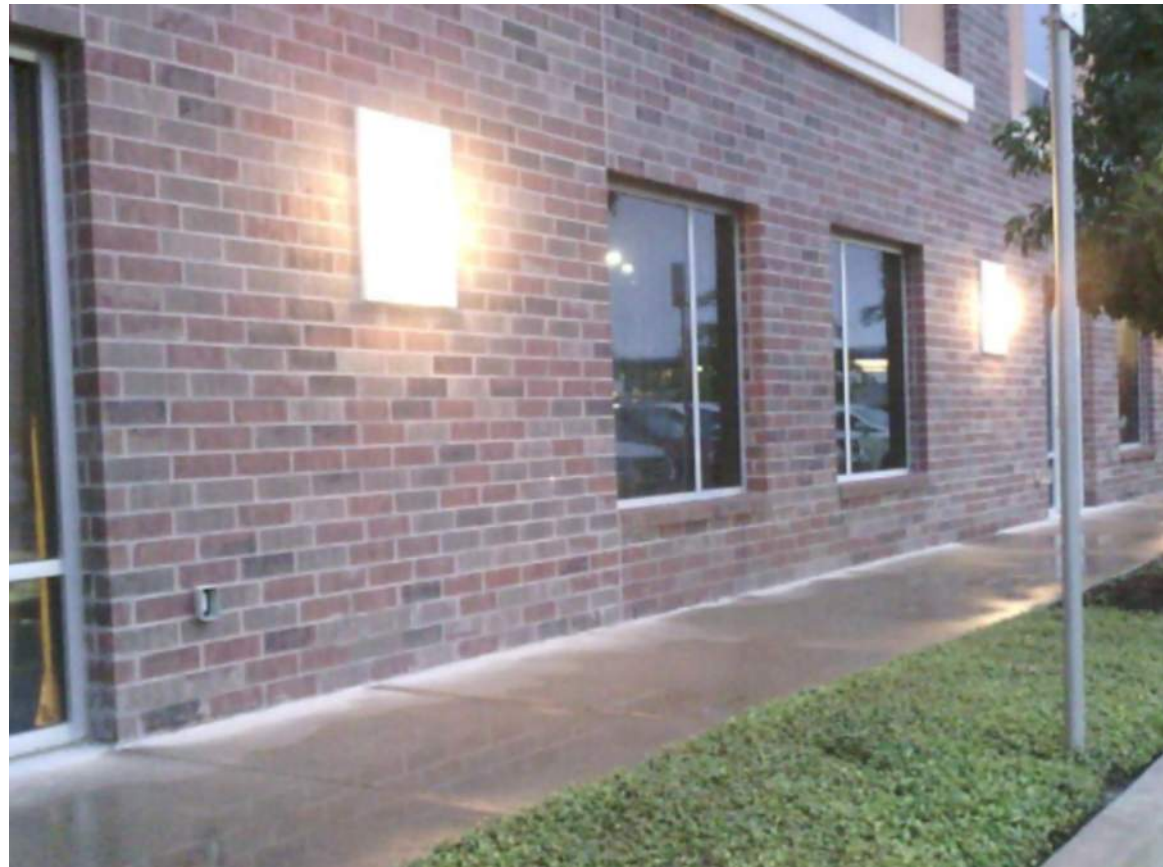
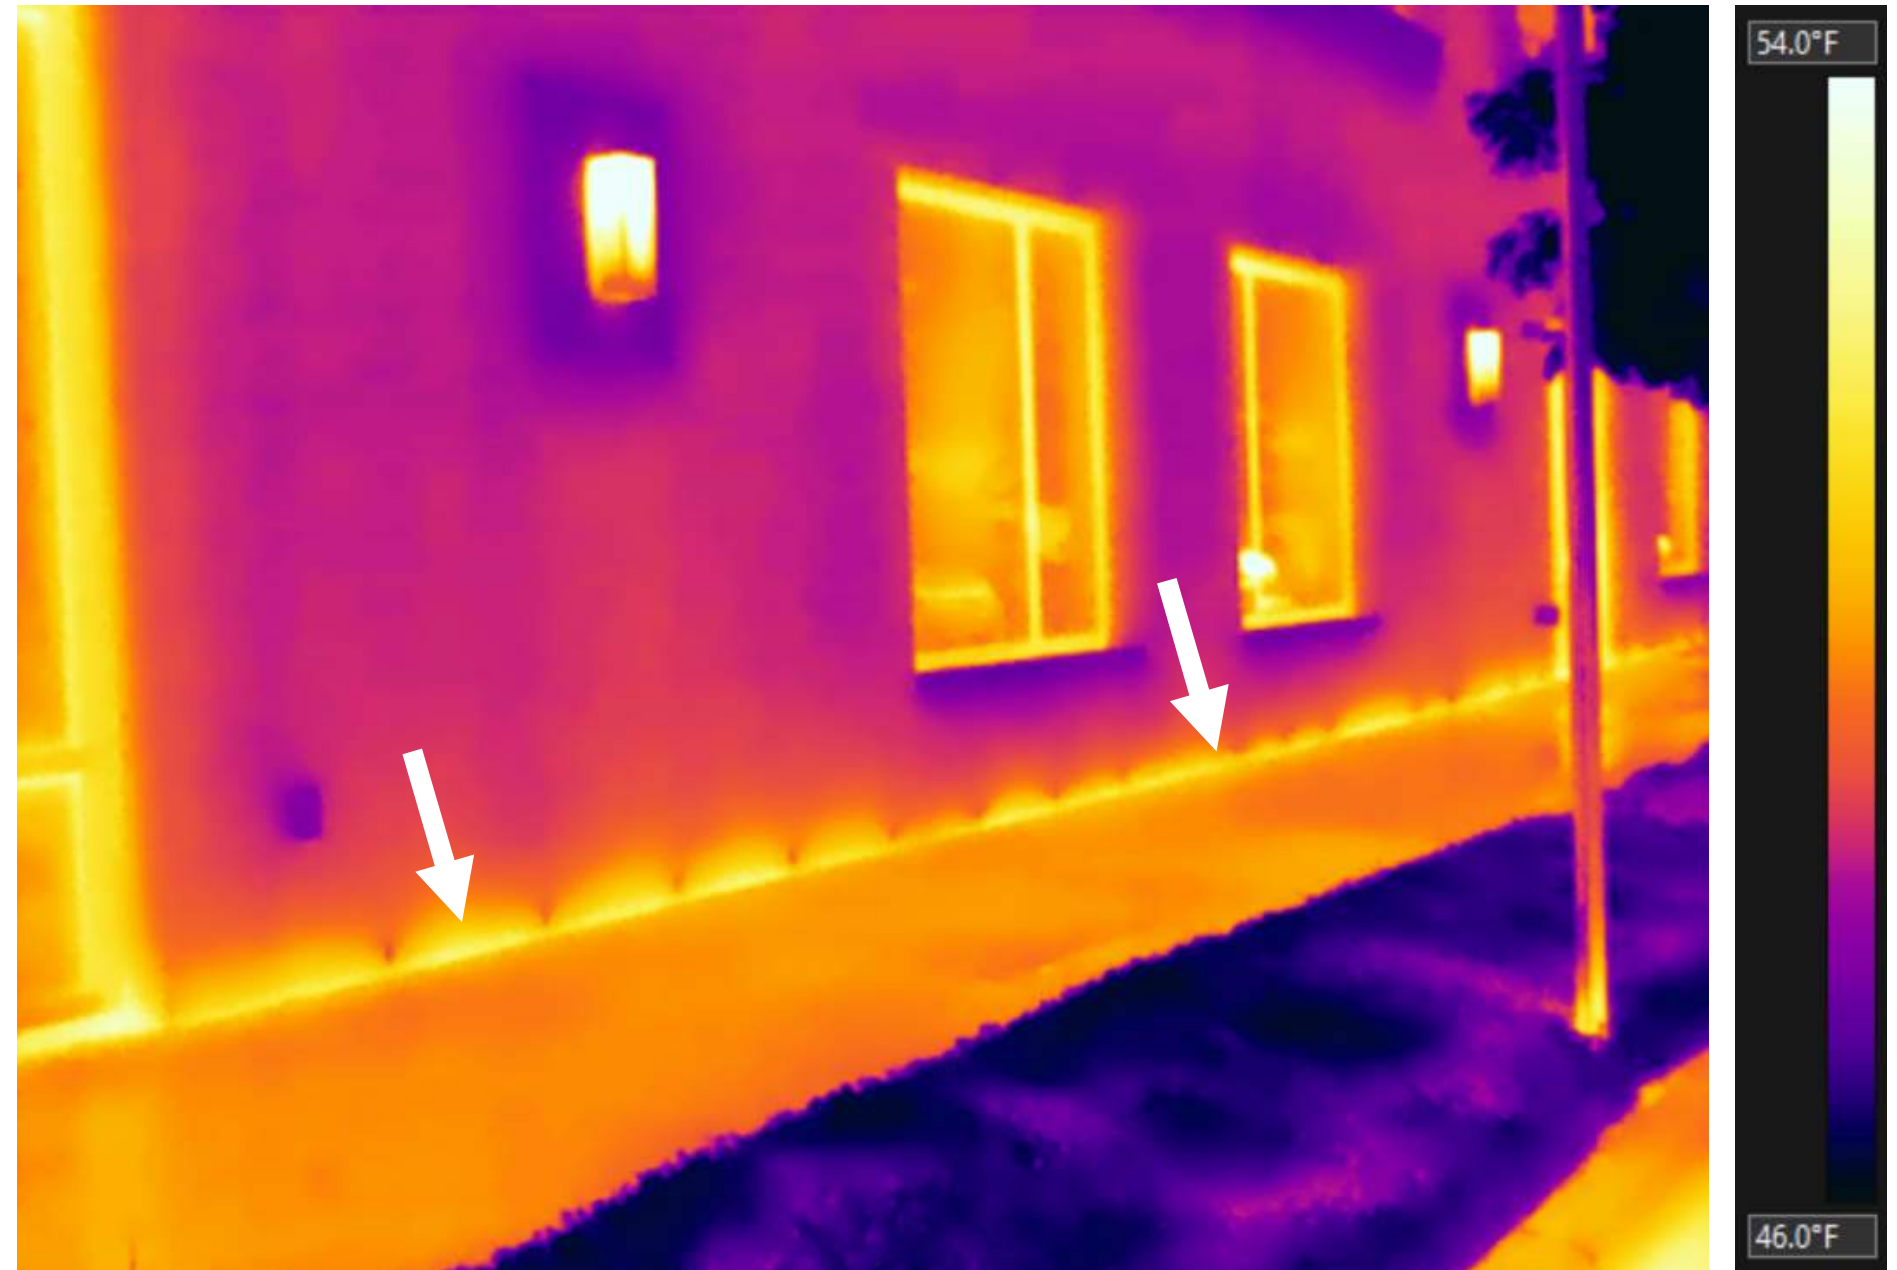
Direct Transfer – Energy Loss
