To Scan or Not to Scan? Thermography is the Answer

Melissa I. Payne, BECxP, CxA+BE, CDT, Level II Building Science Thermographer

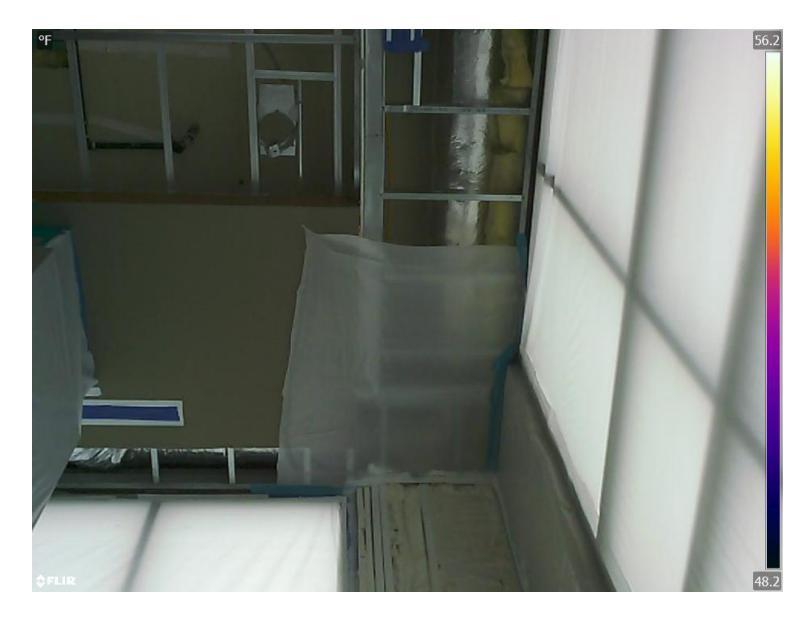
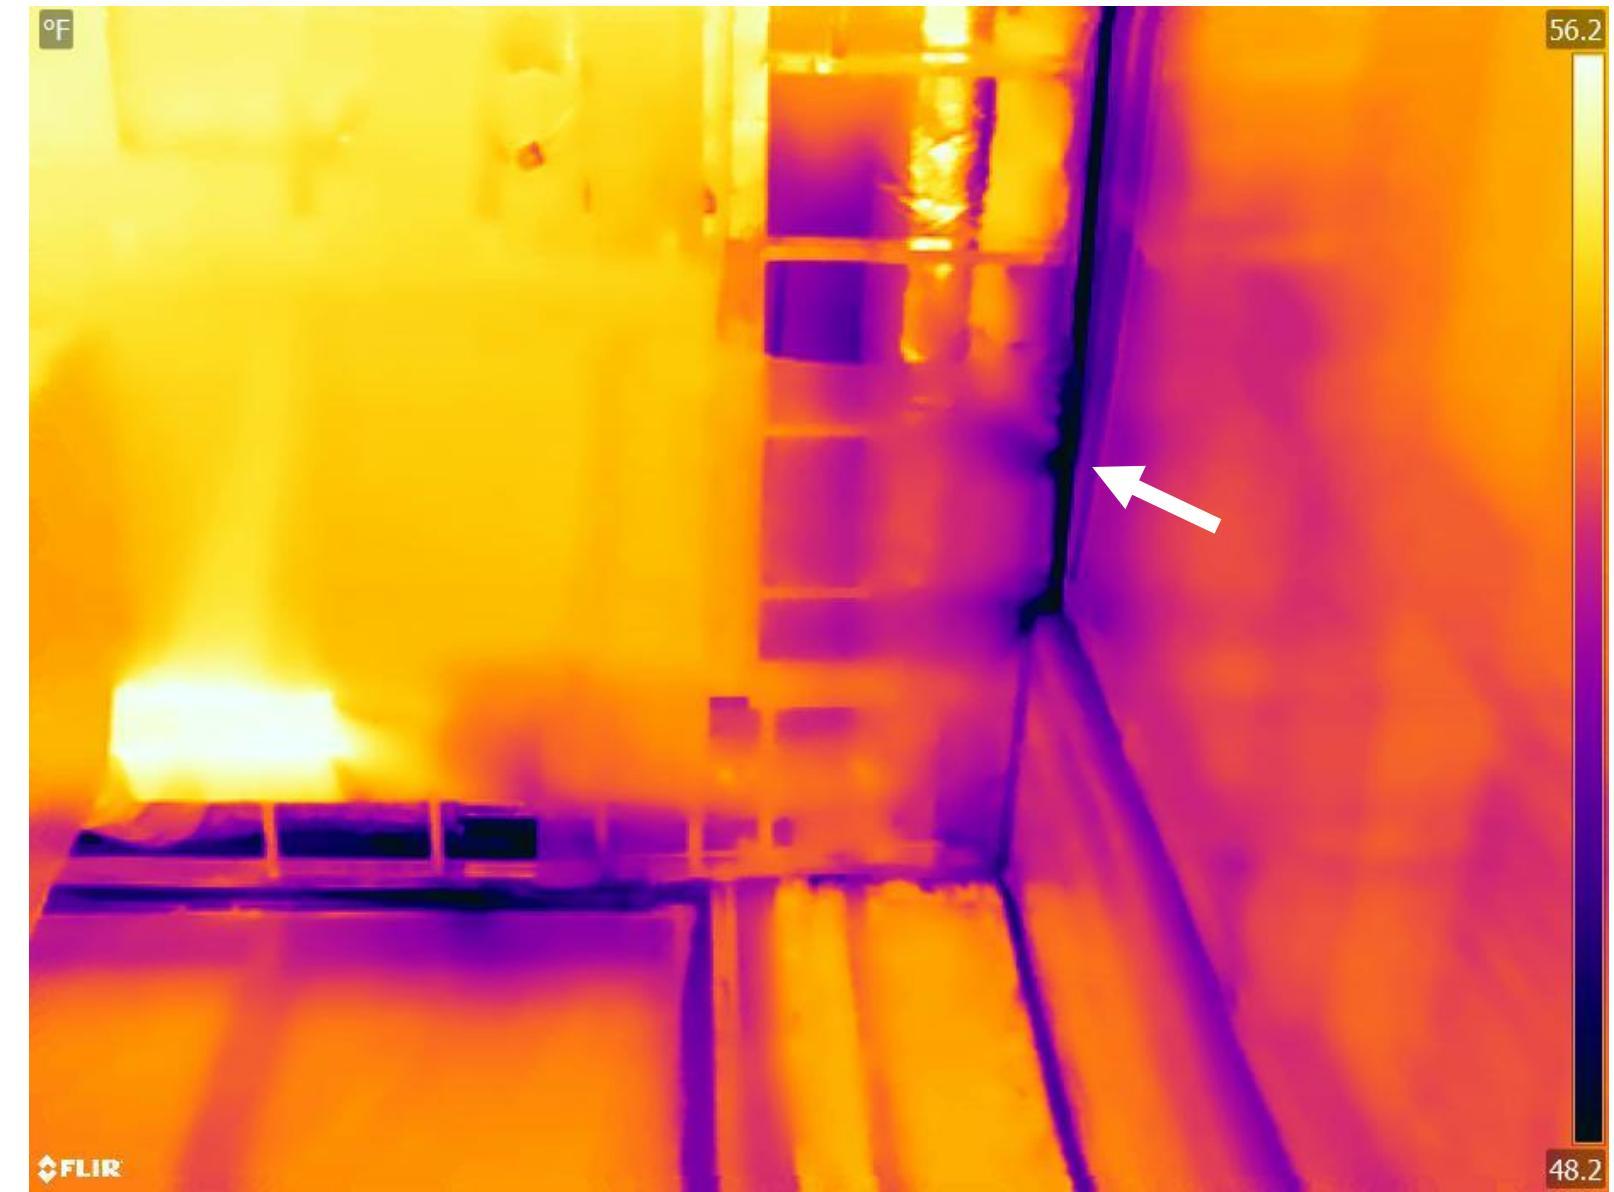
Air Infiltration at Head of Curtain Wall

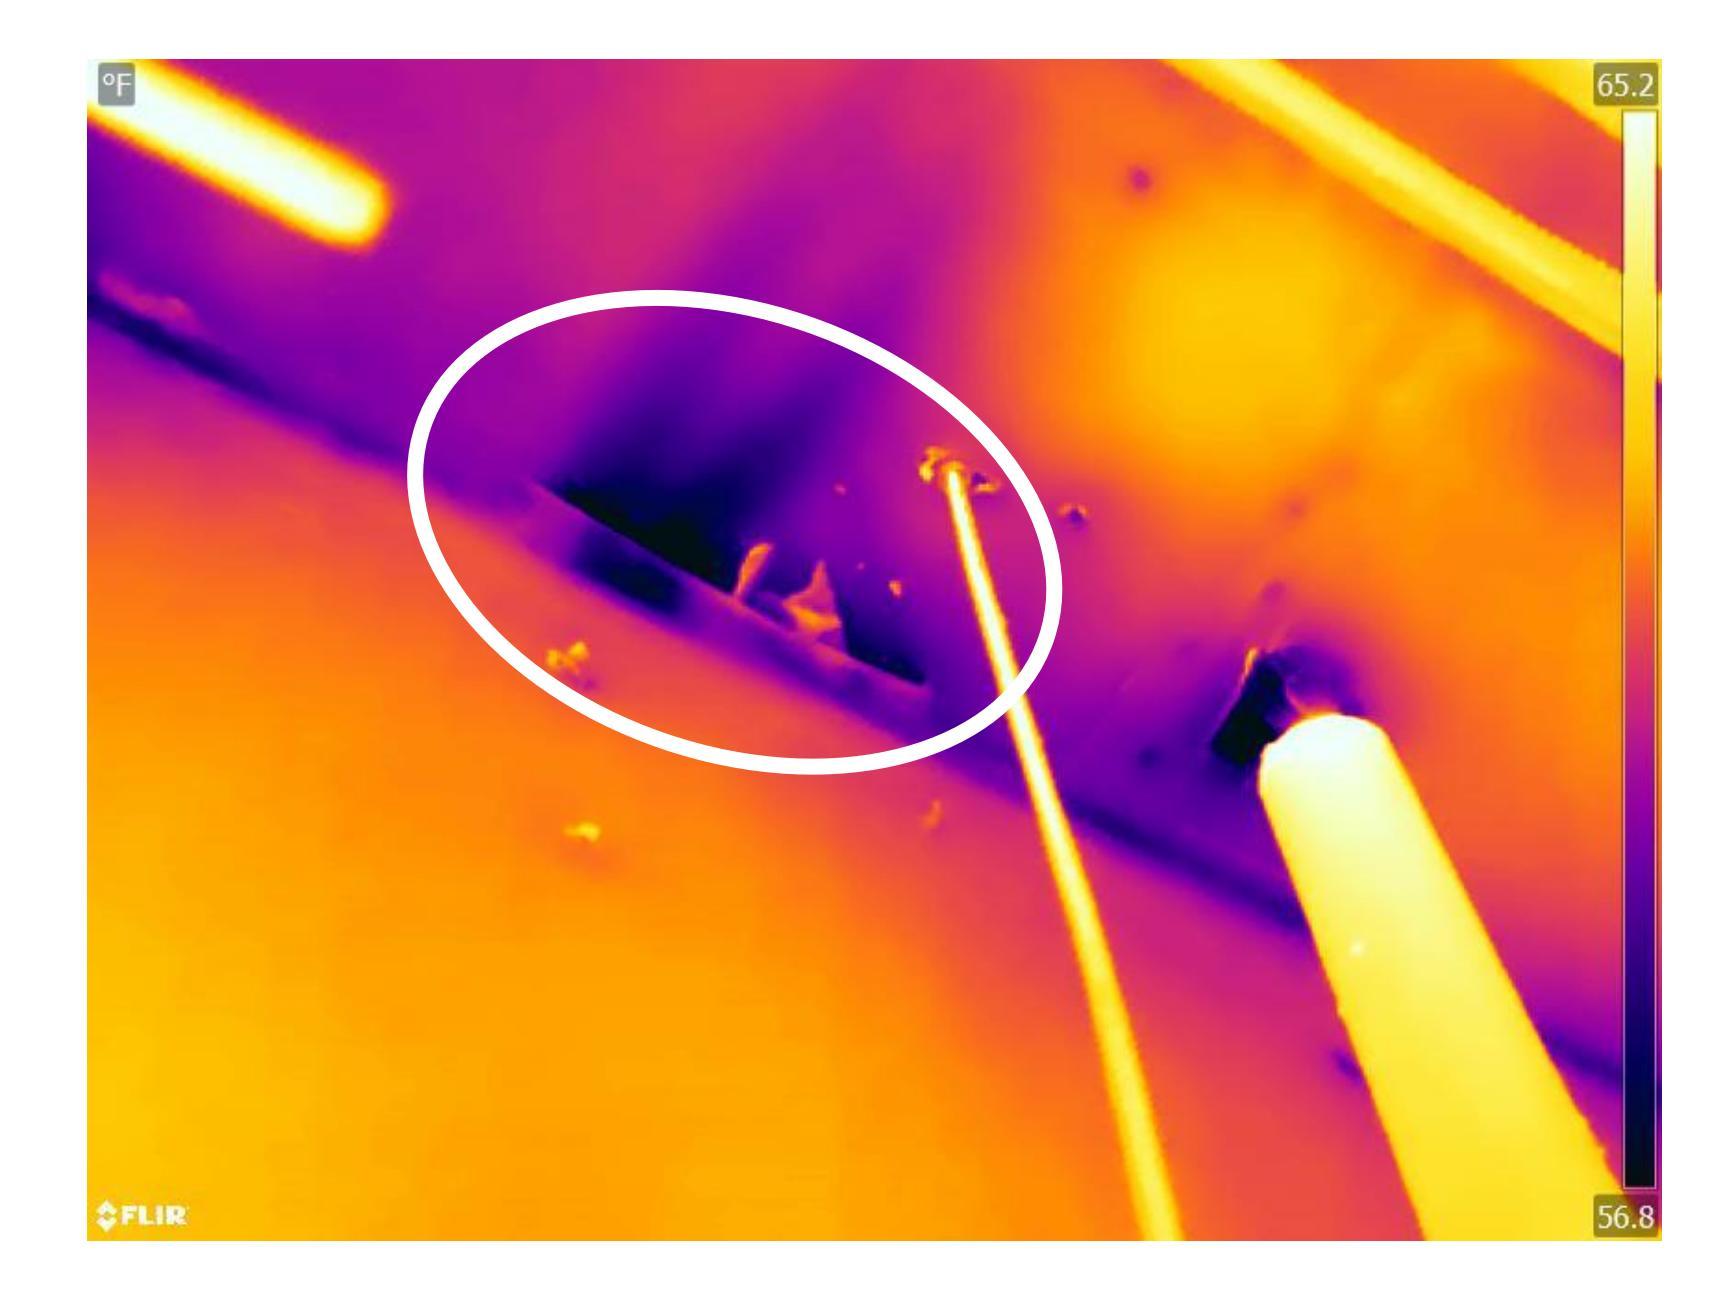
Air Infiltration on Exterior Wall in Return Air Plenum

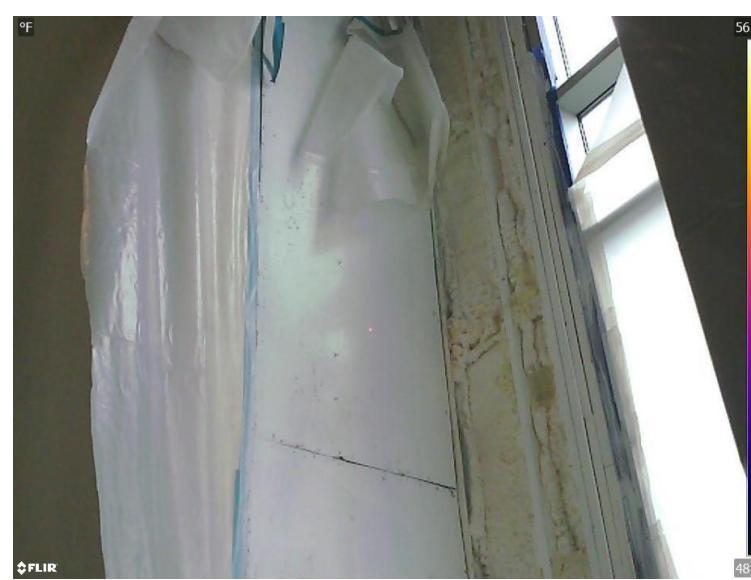
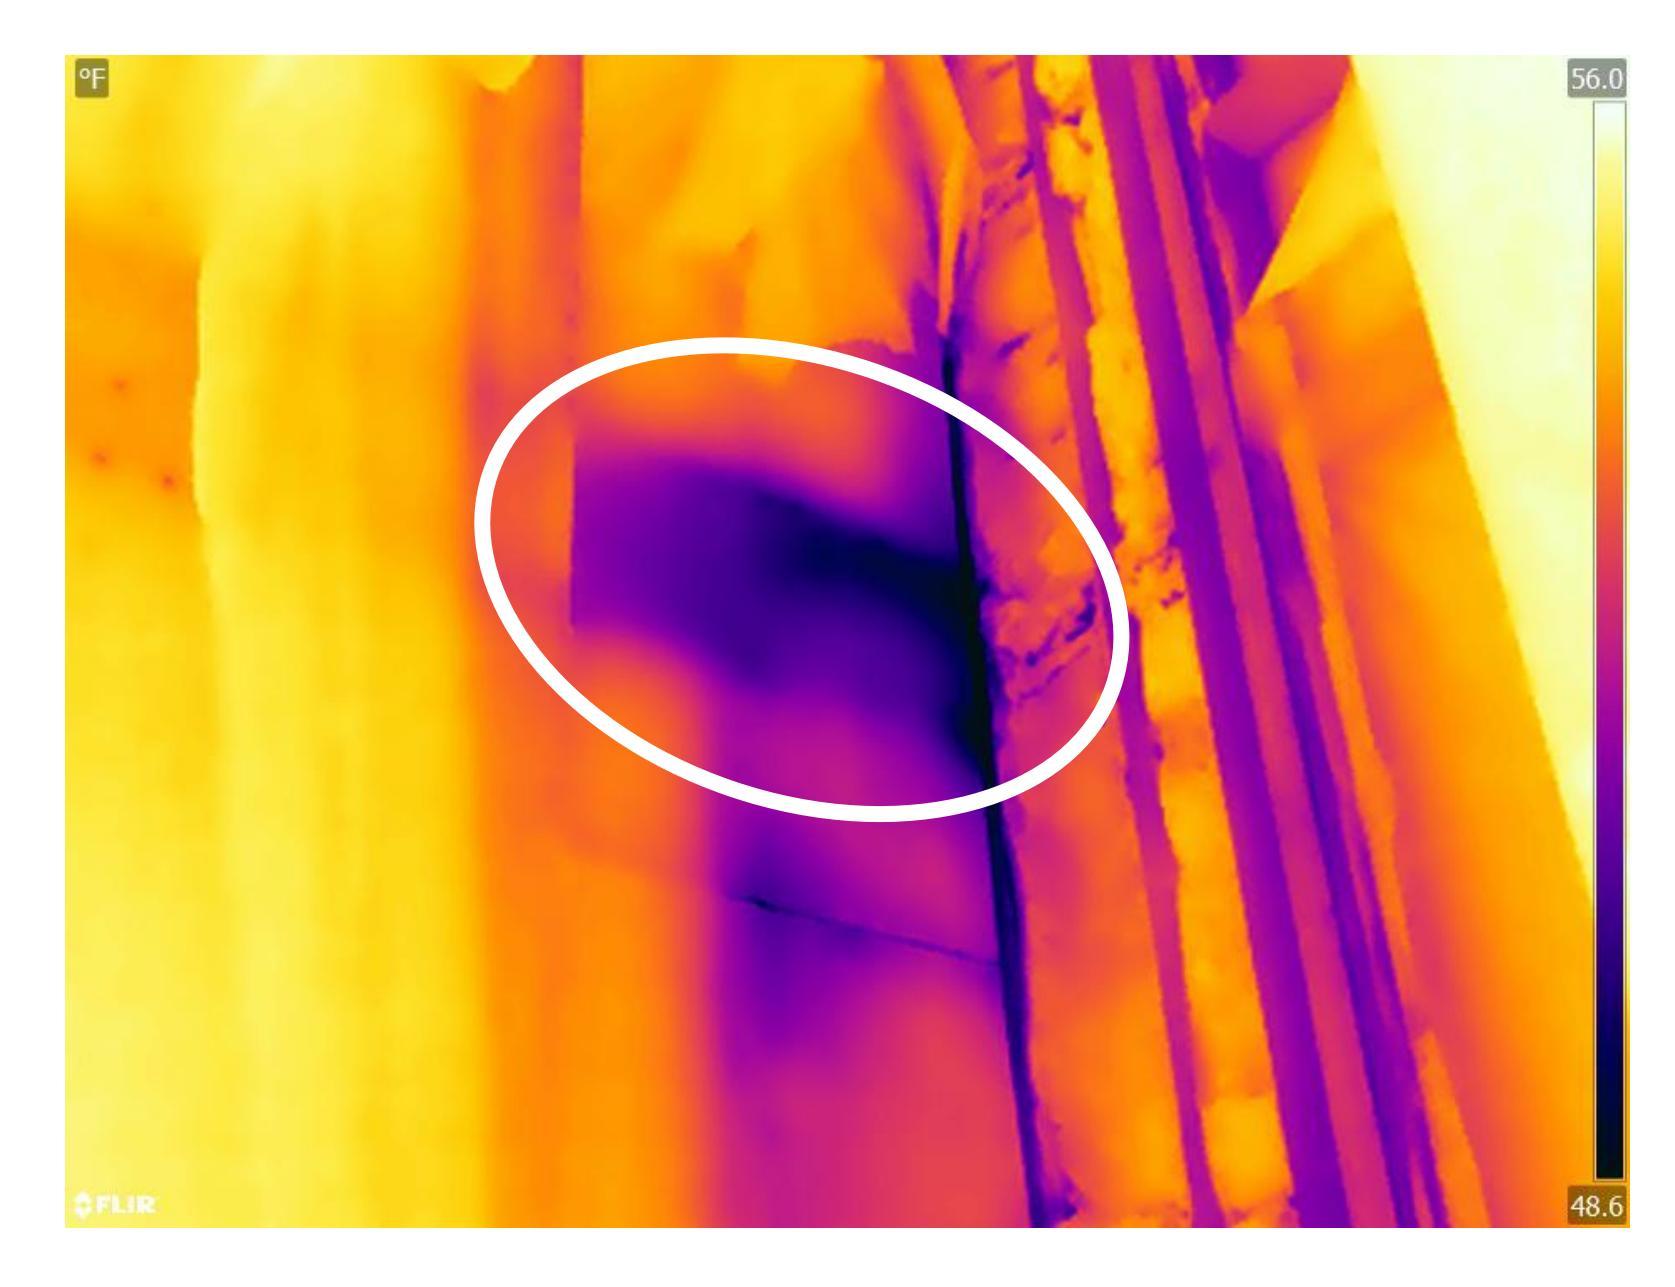
Air Infiltration and Direct Transfer from Canopy

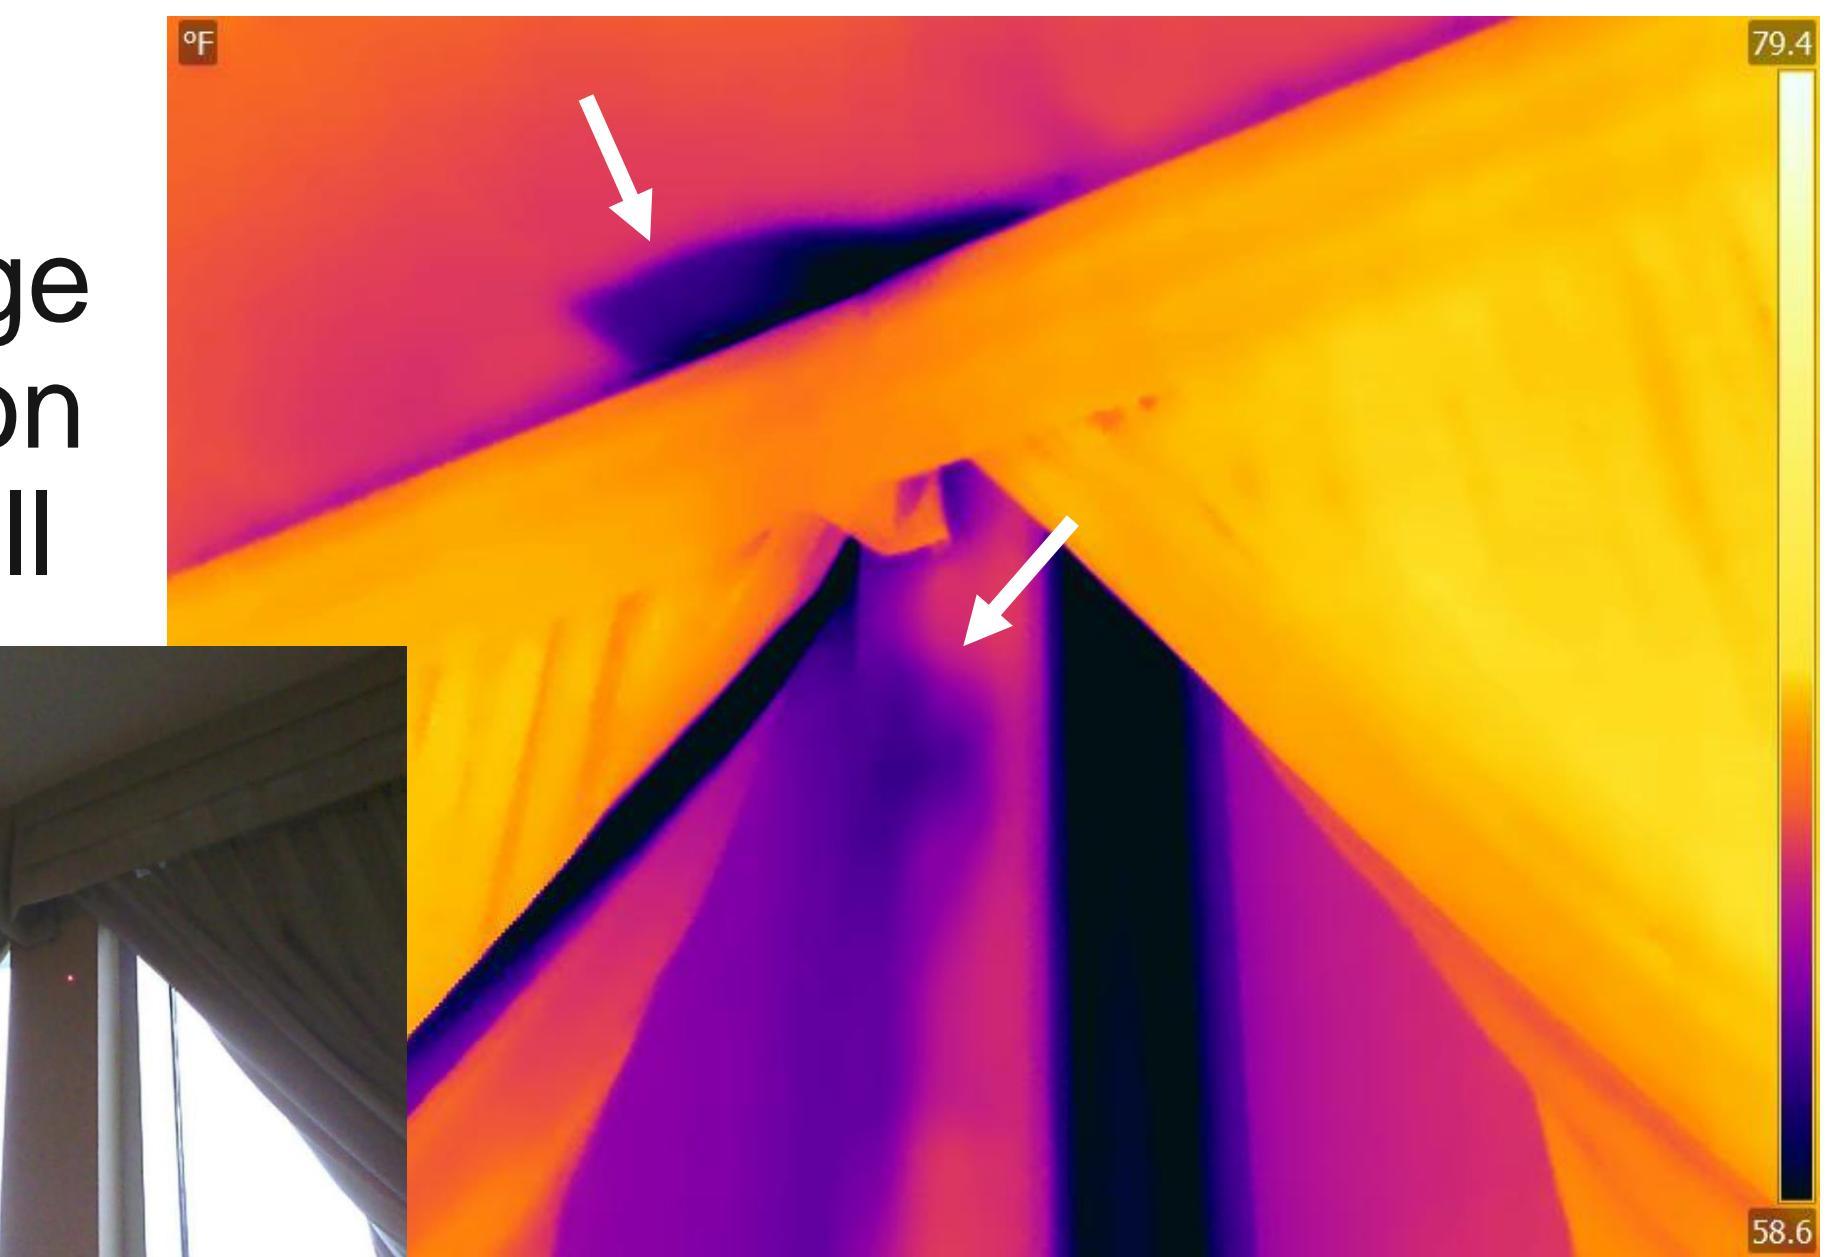
Water Infiltration from Signage Anchoring on Exterior Wall

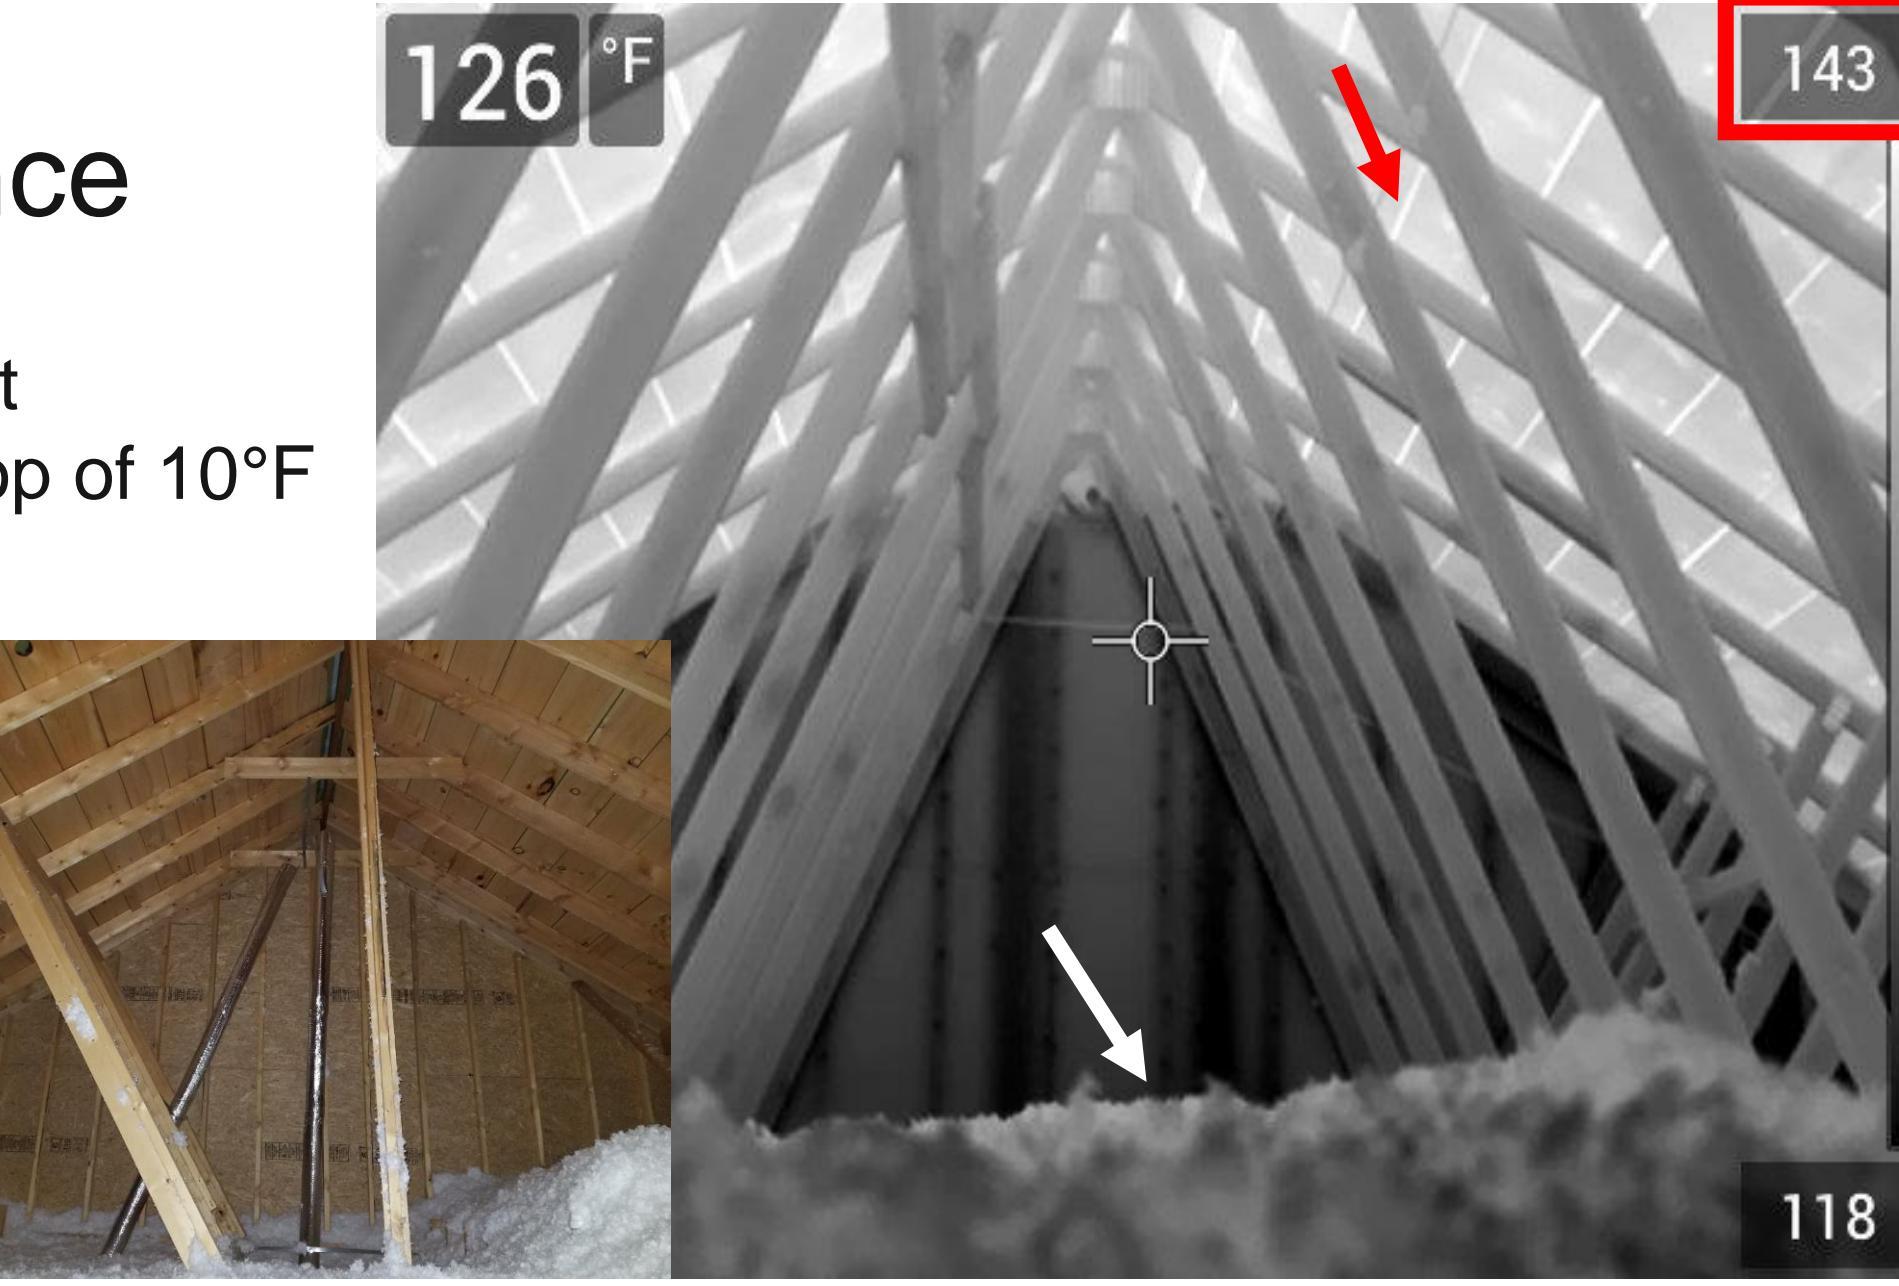
Mechanical duct temperature drop of 10°F

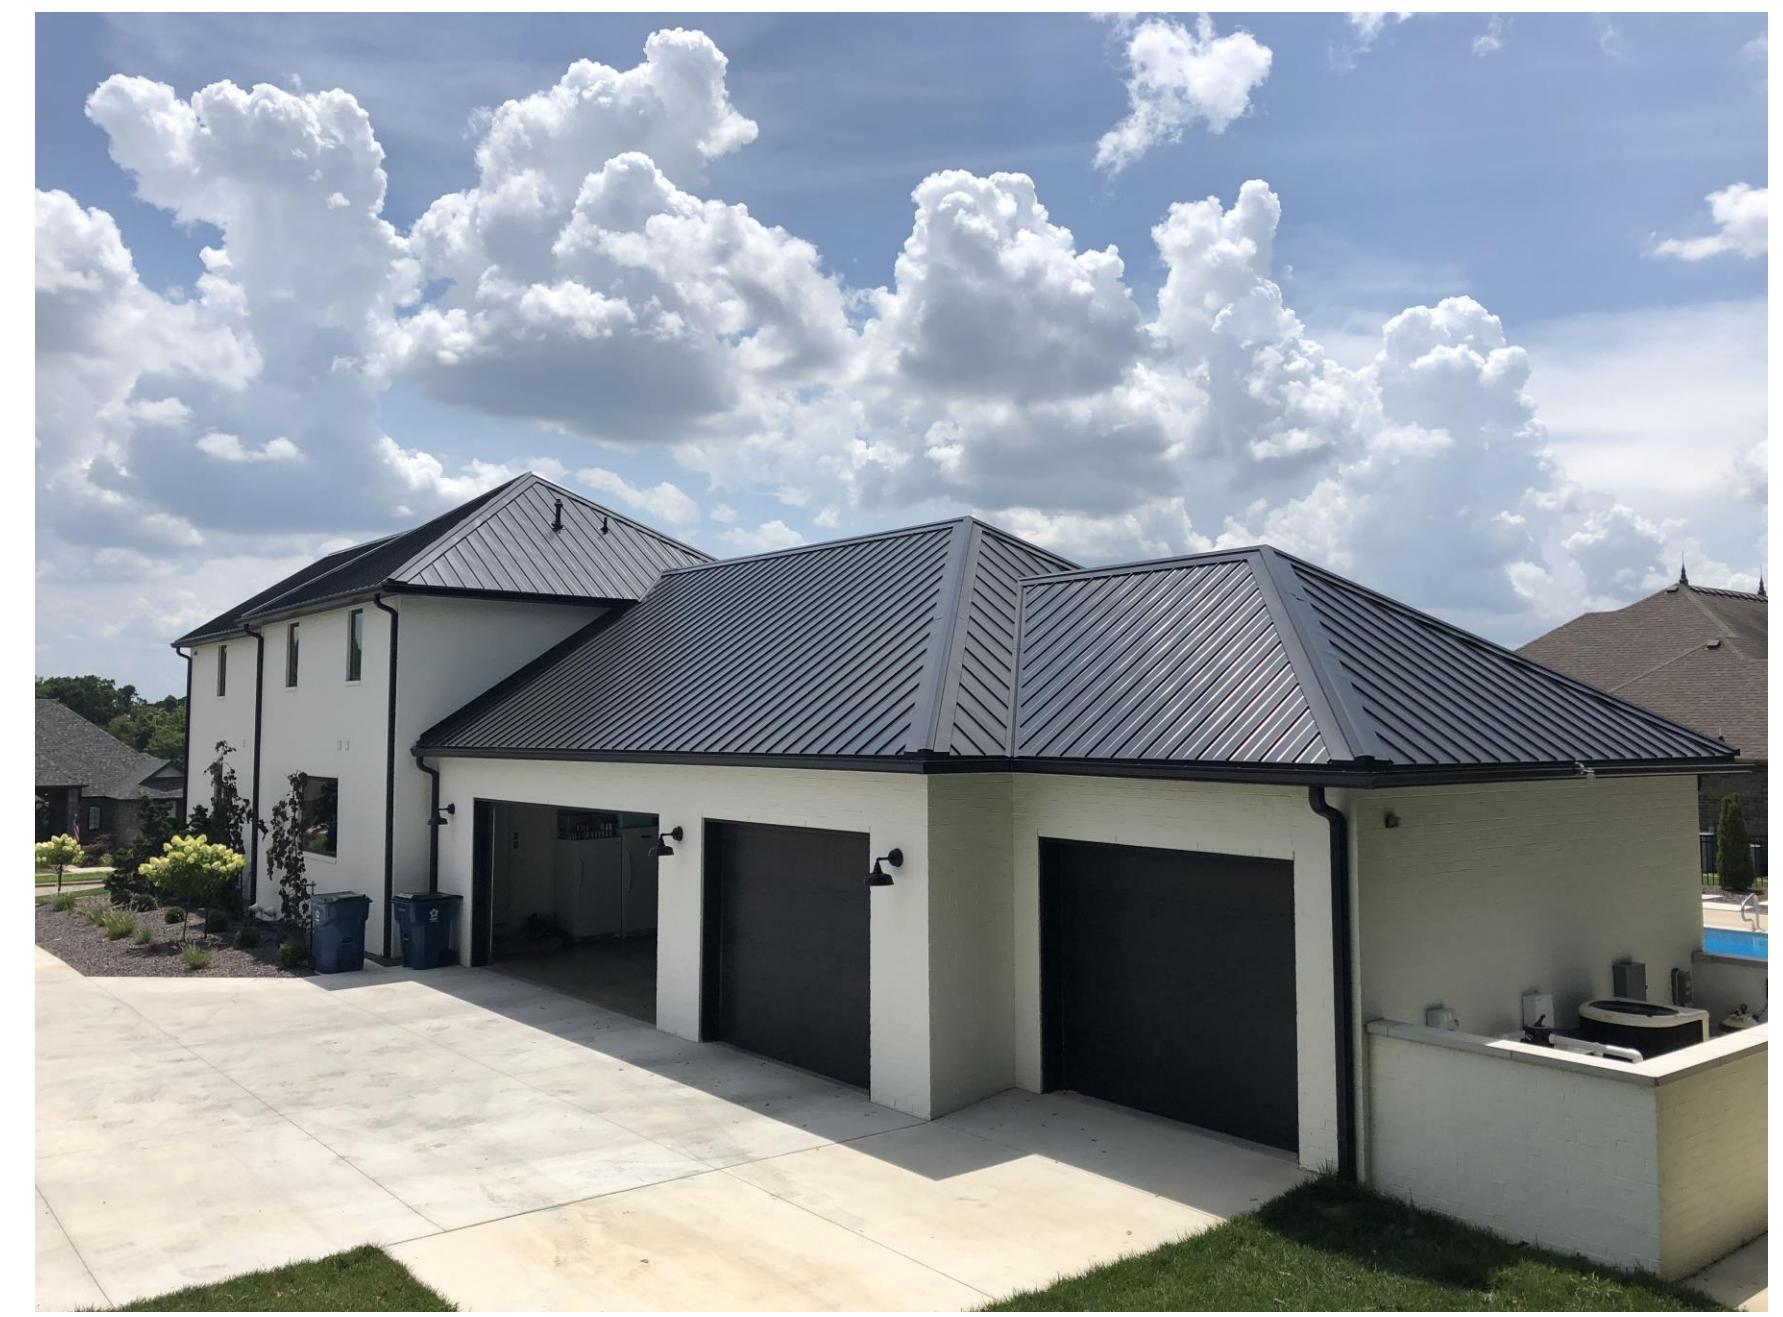
The Roof is Black!

No insulation, and no ventilation

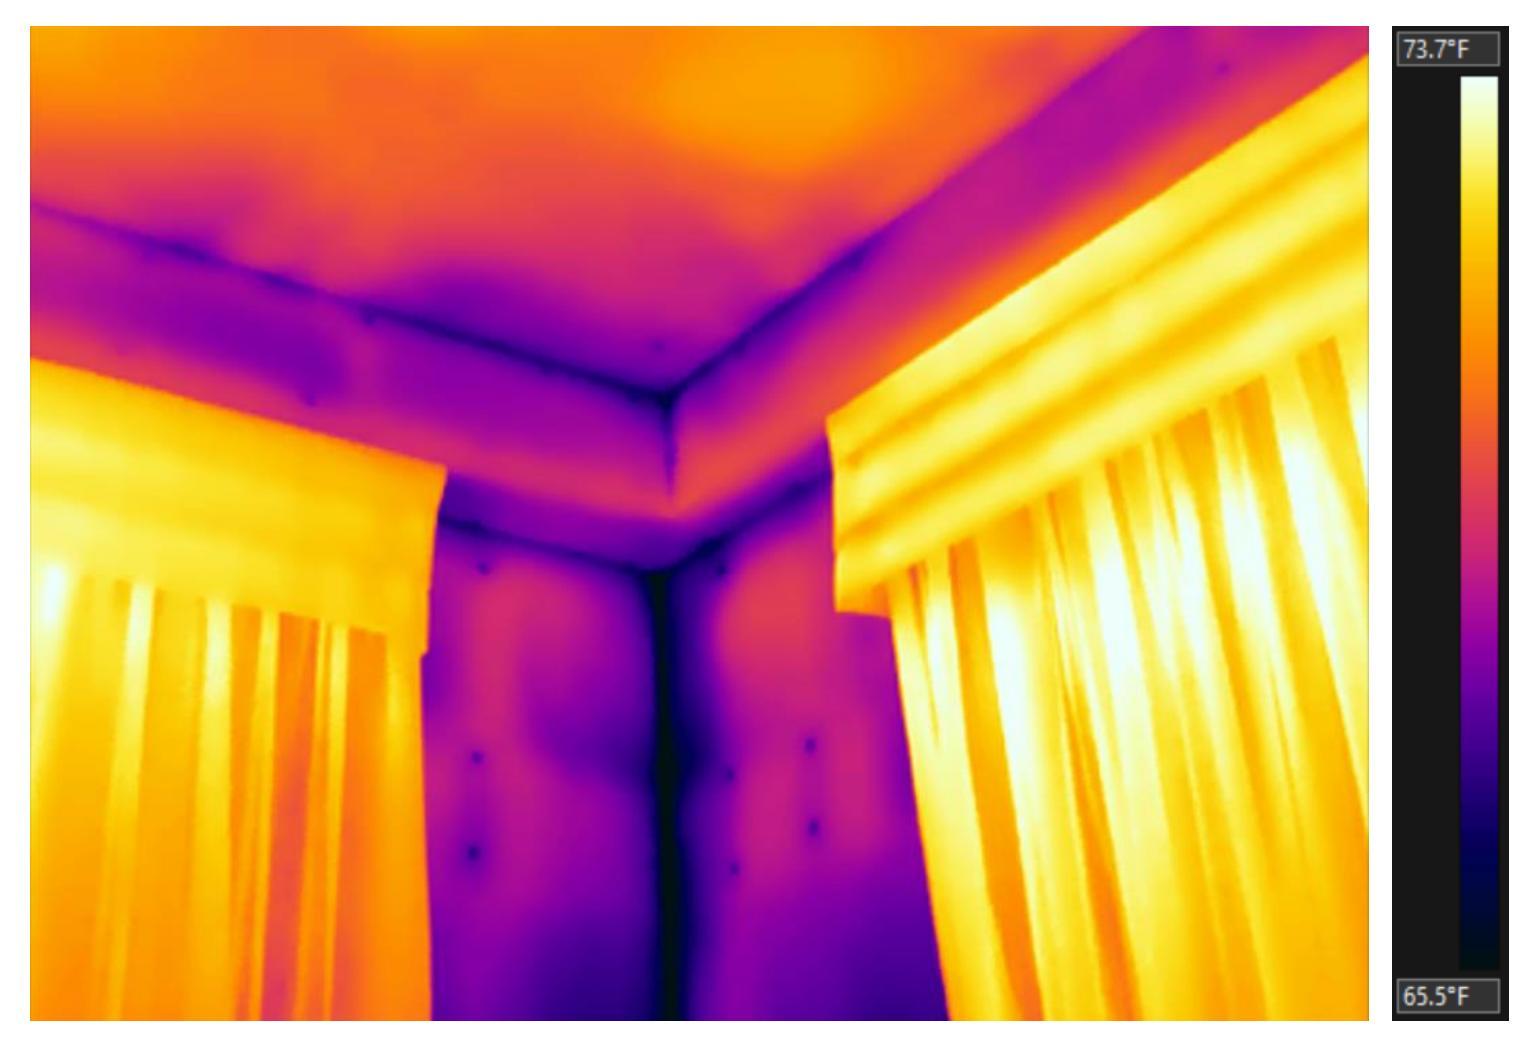
Cool Spots due to poor air circulation

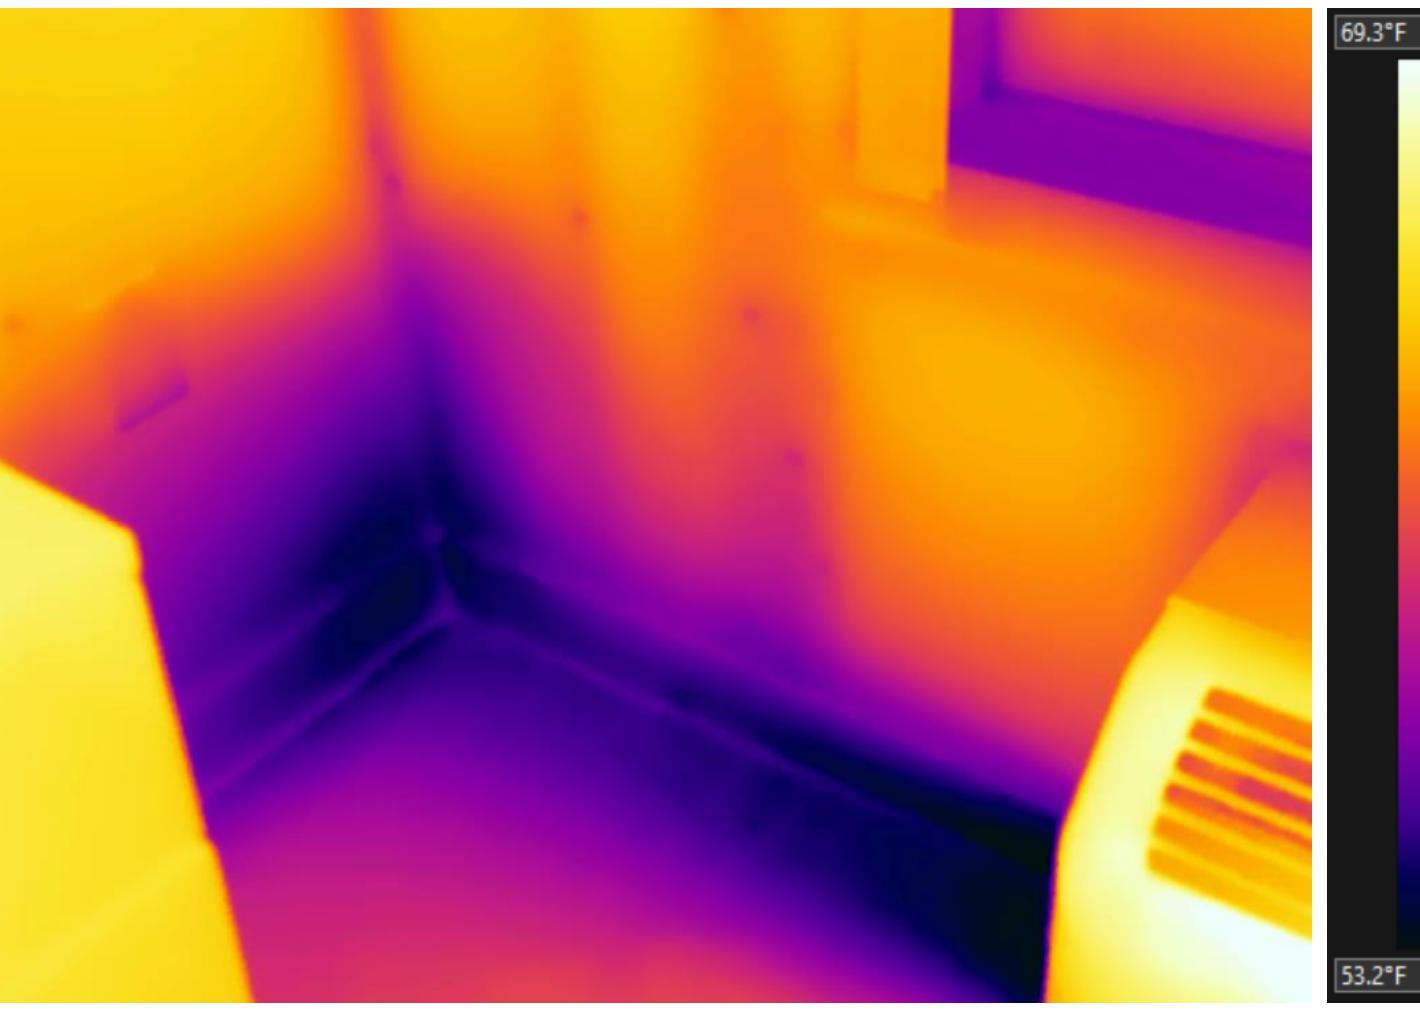
Air Infiltration from PTAC Unit

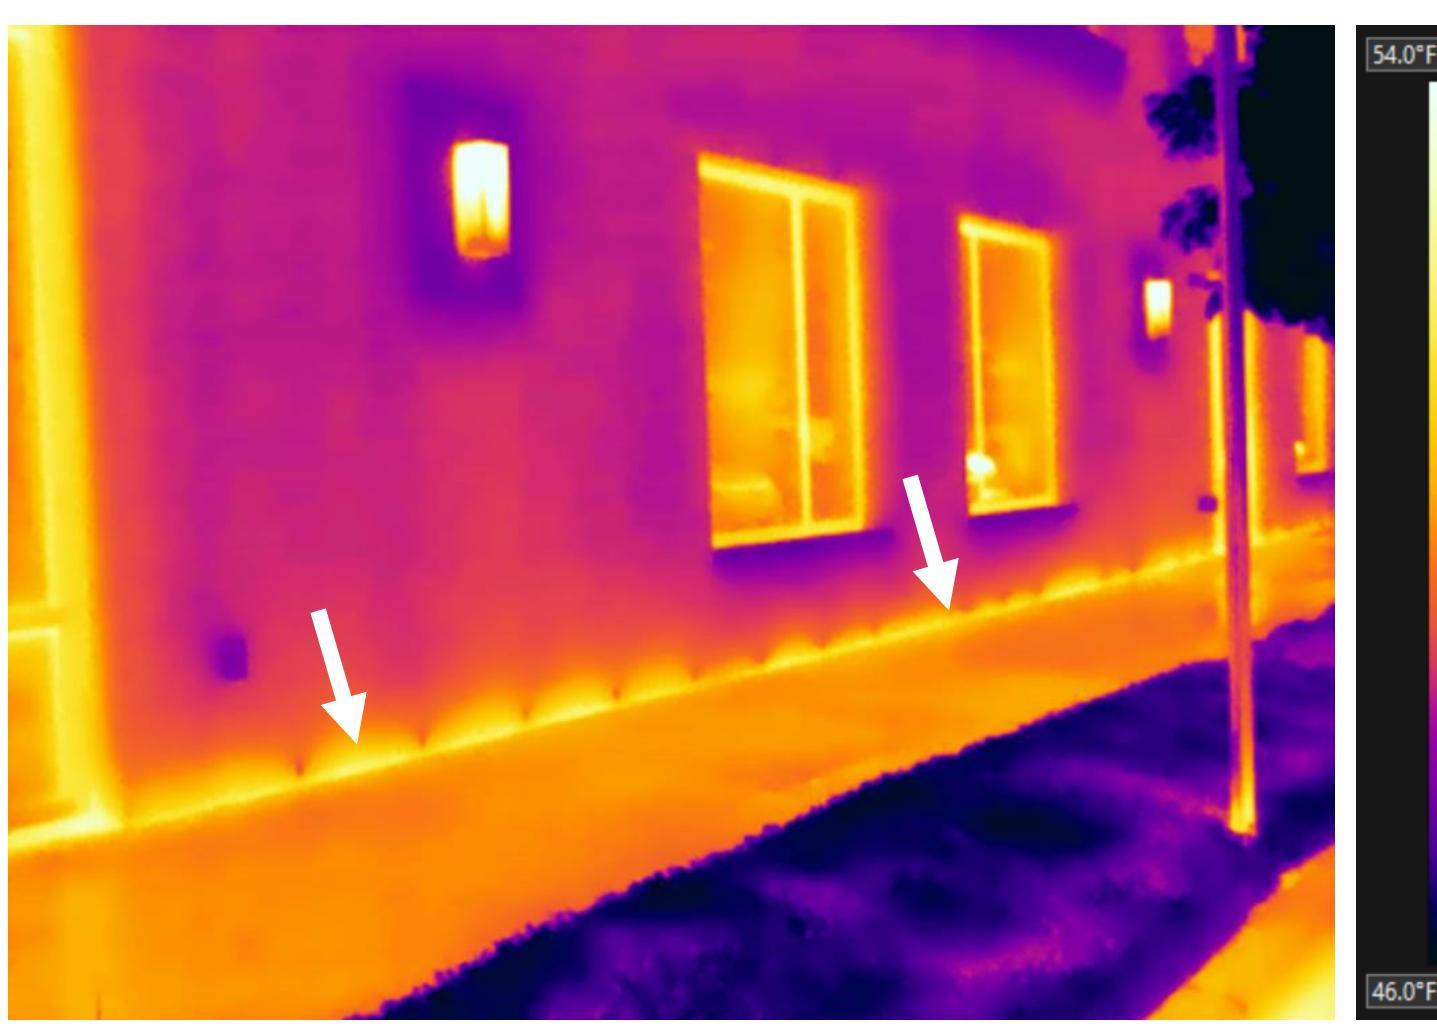
Direct Transfer – Energy Loss

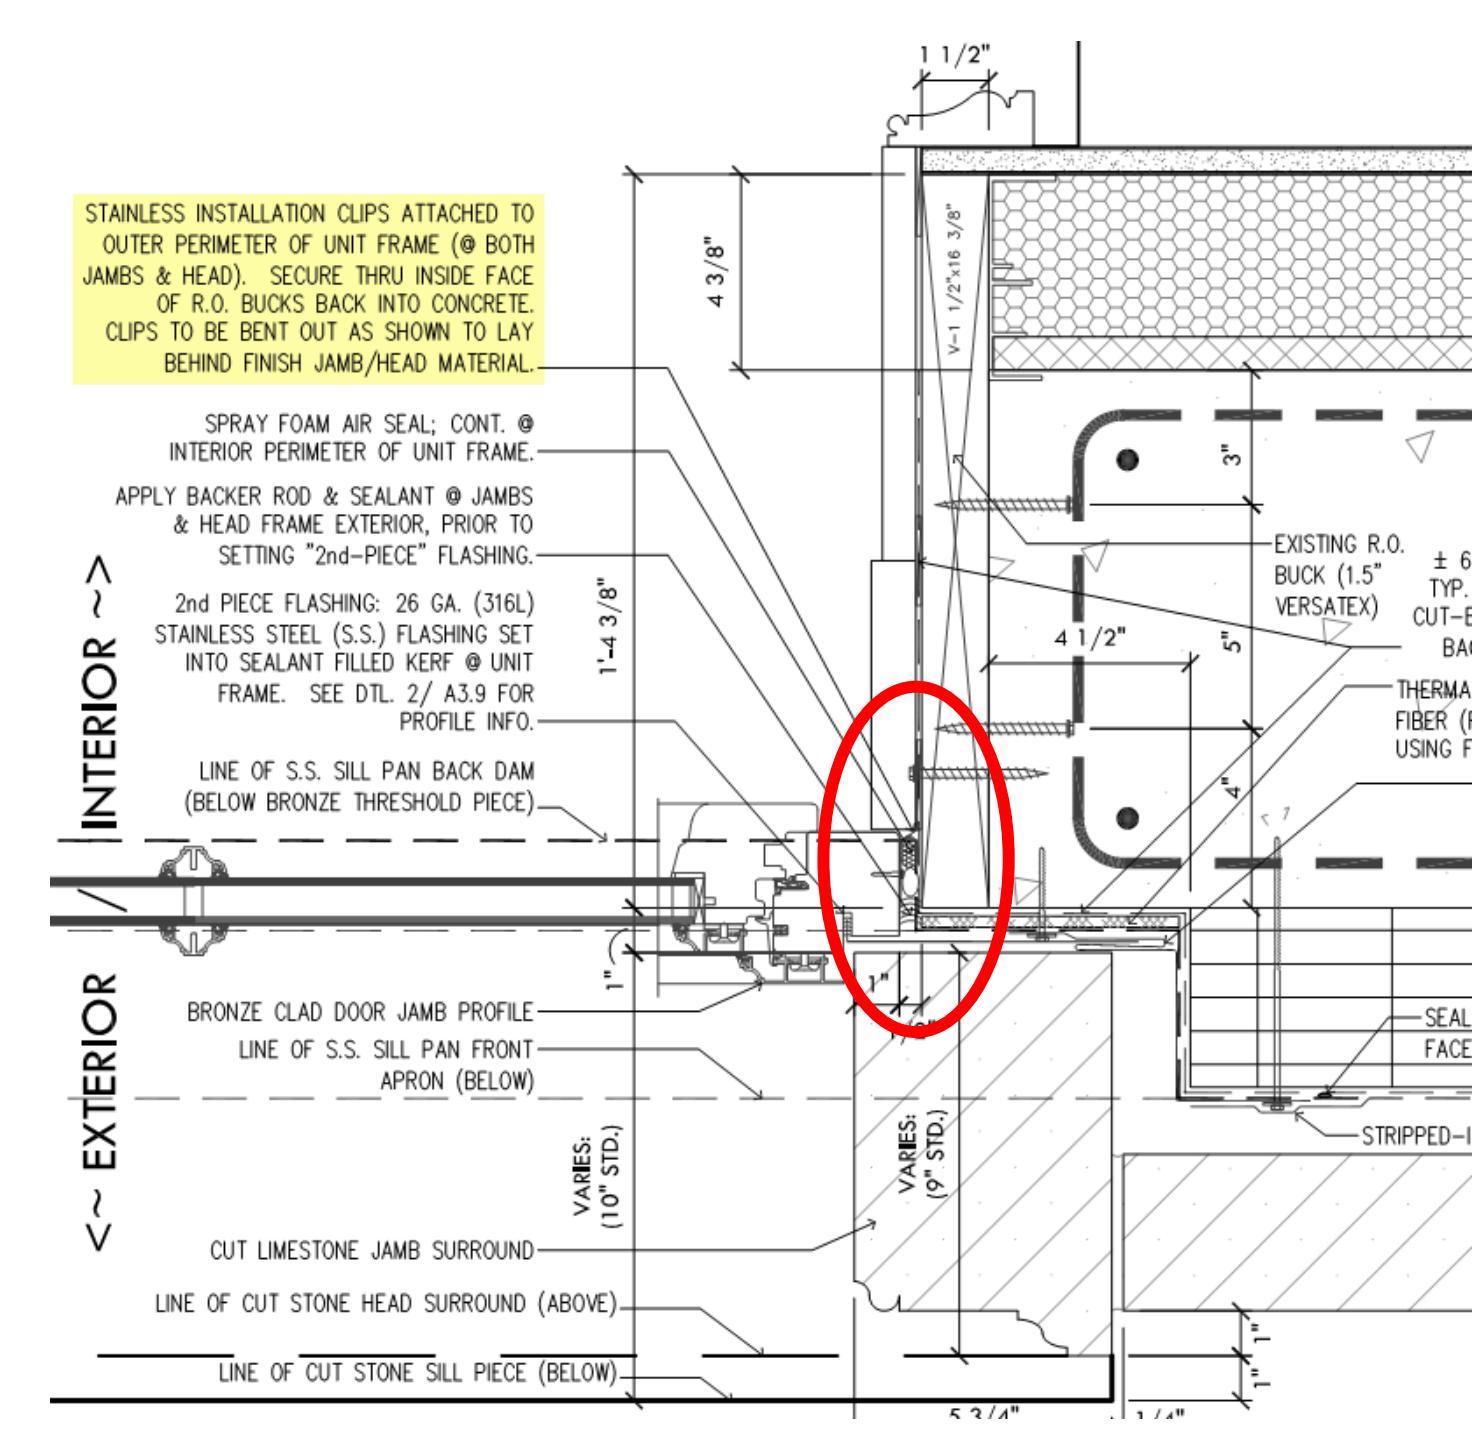
Leak Point at every window identified at the stainless clips at both the head and jambs.

Leak Point confirmed with thermography where it could not be confirmed visually.

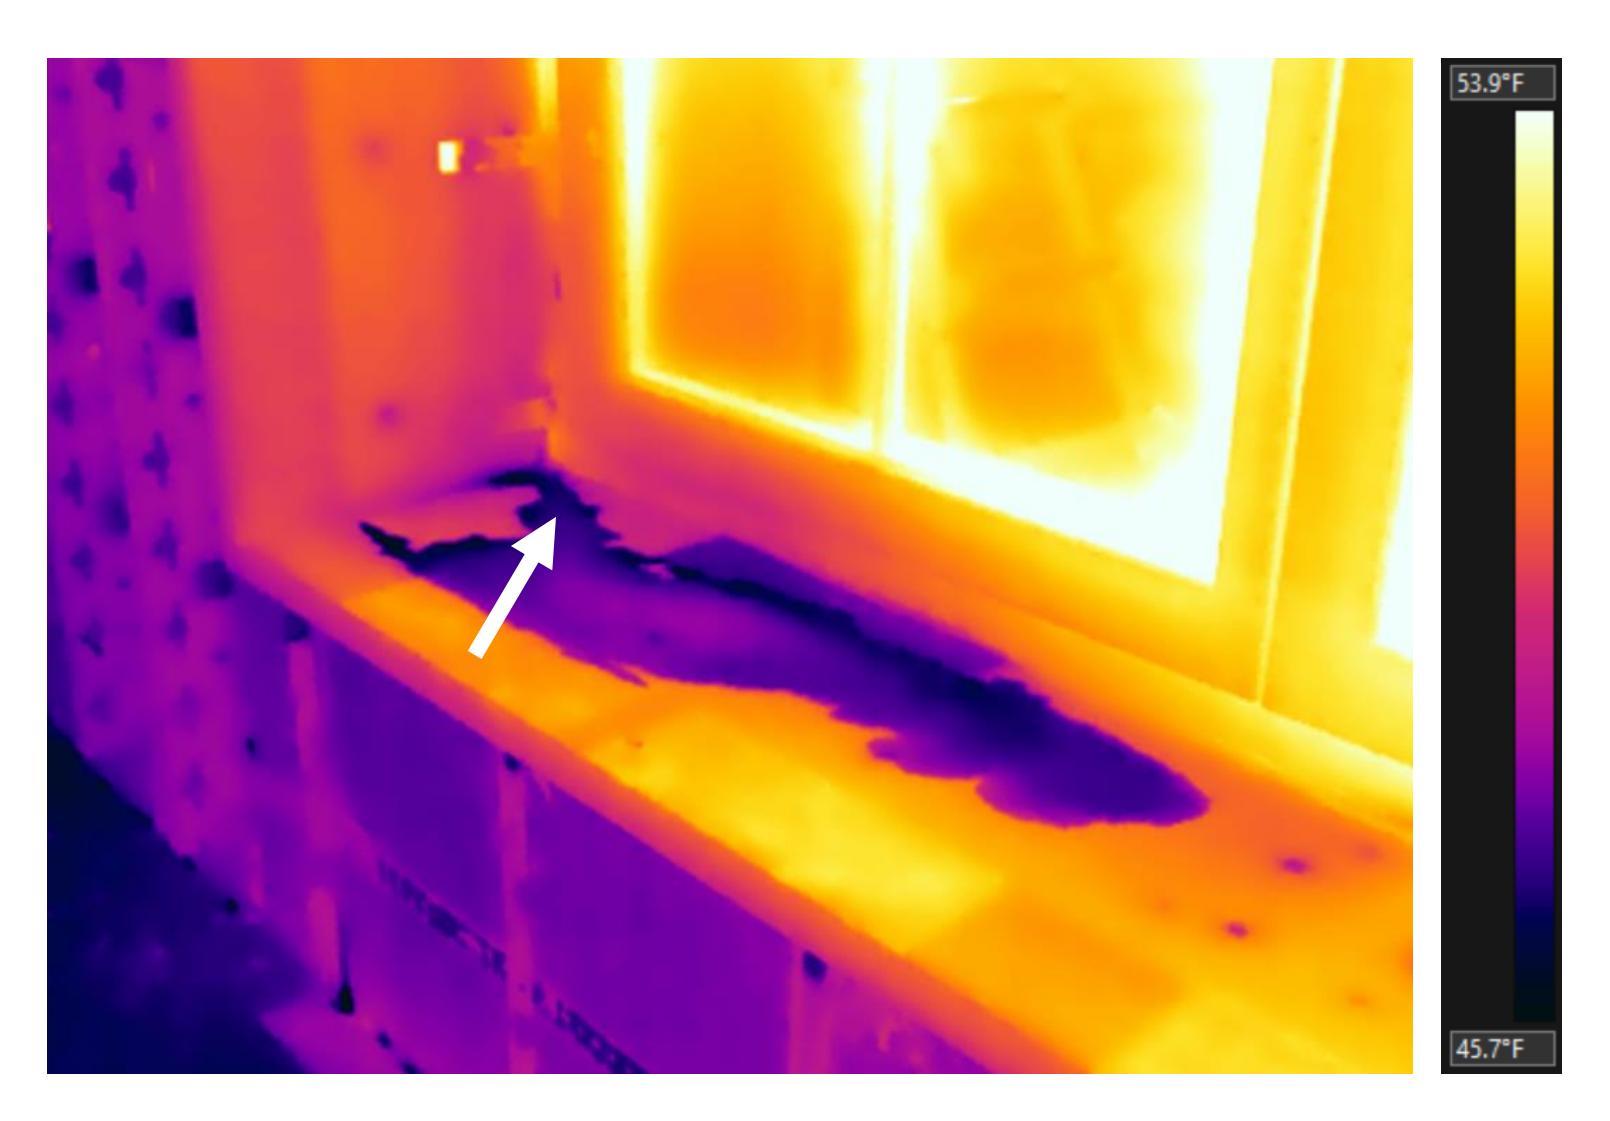
Unit failure at seals of operable windows.
