To Scan or Not to Scan? Thermography is the Answer

Melissa I. Payne, BECxP, CxA+BE, CDT, Level II Building Science Thermographer

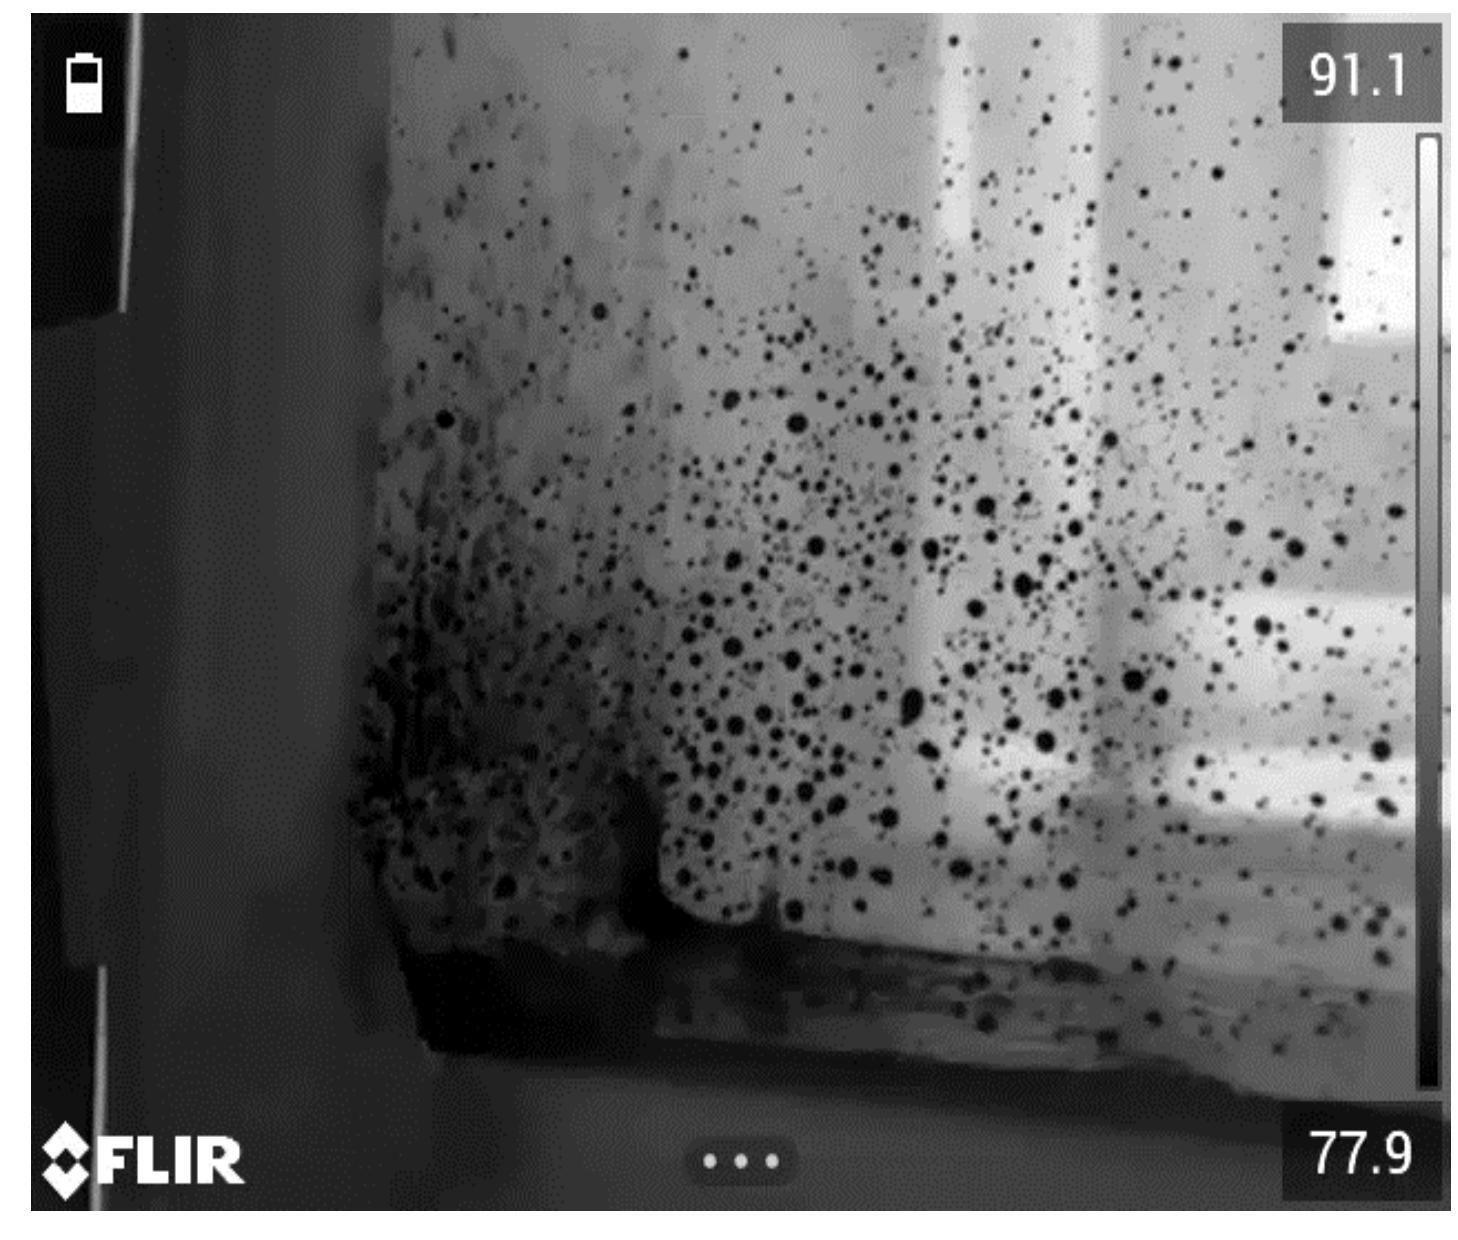
Installation failure jamb/sill flashing of windows.

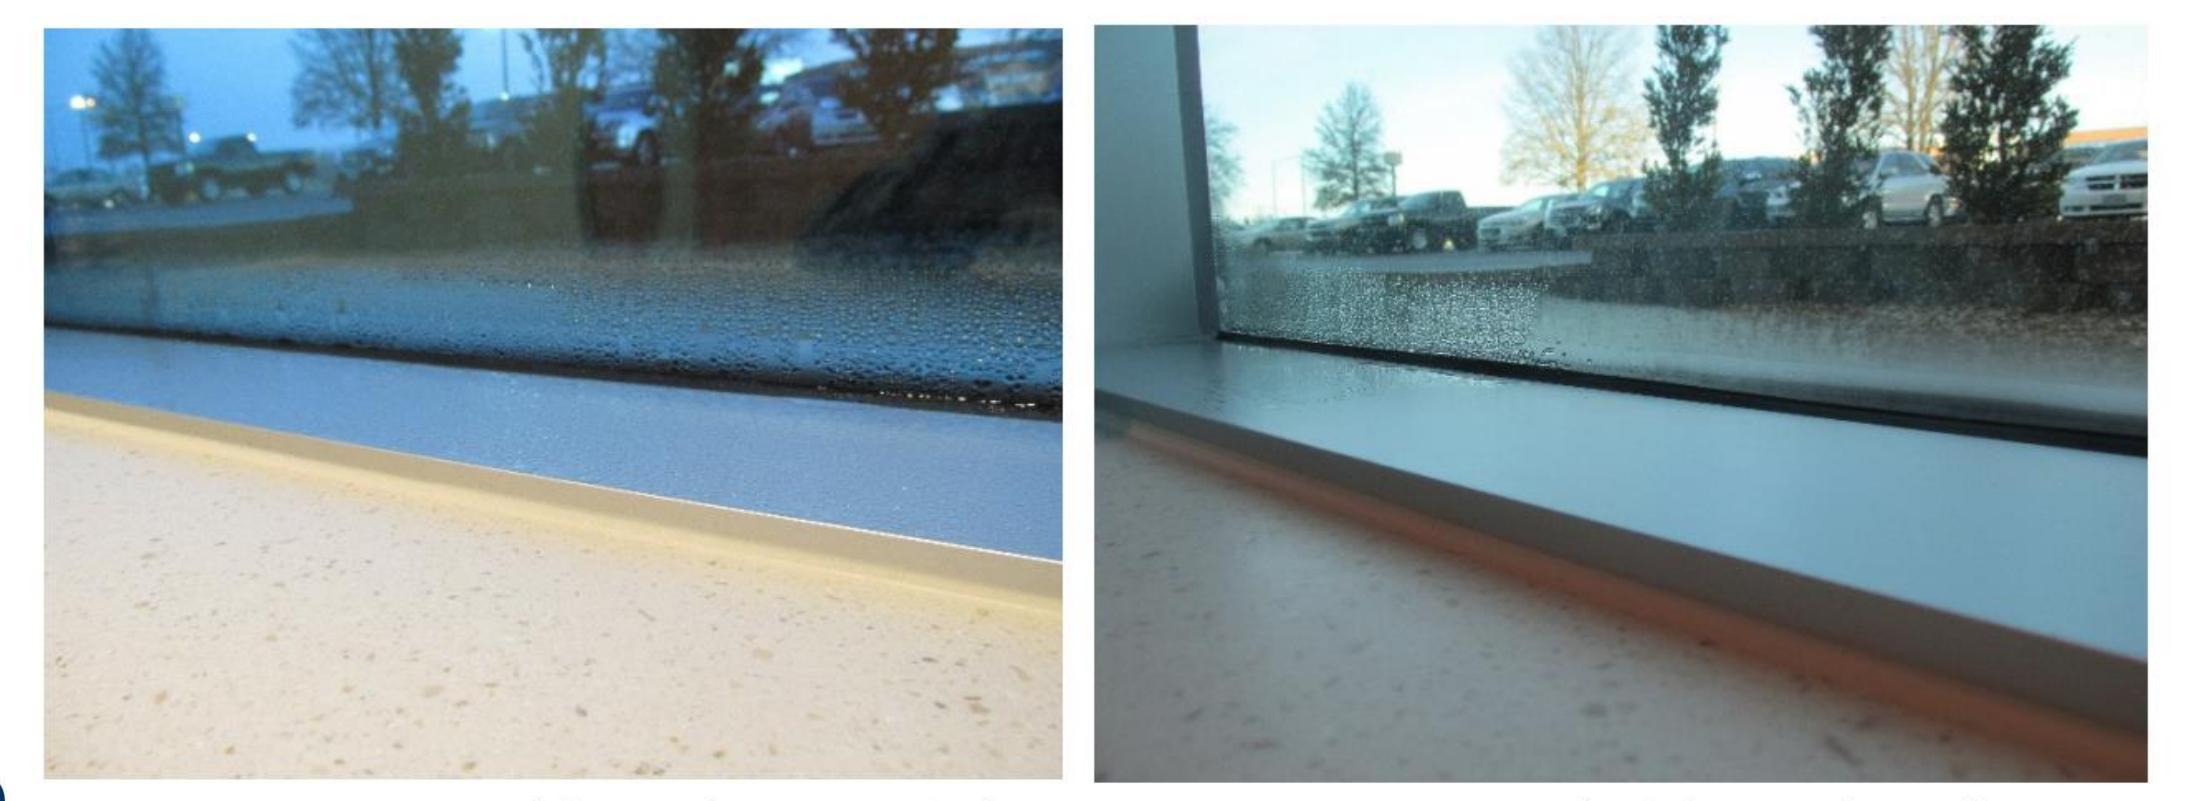
NICU Room #14: Image on left was taken upon arrival at 7:15am on 2/2/18. Image on the right was taken to document the reoccurrence of condensation within 30 minutes of drying glass and tube.

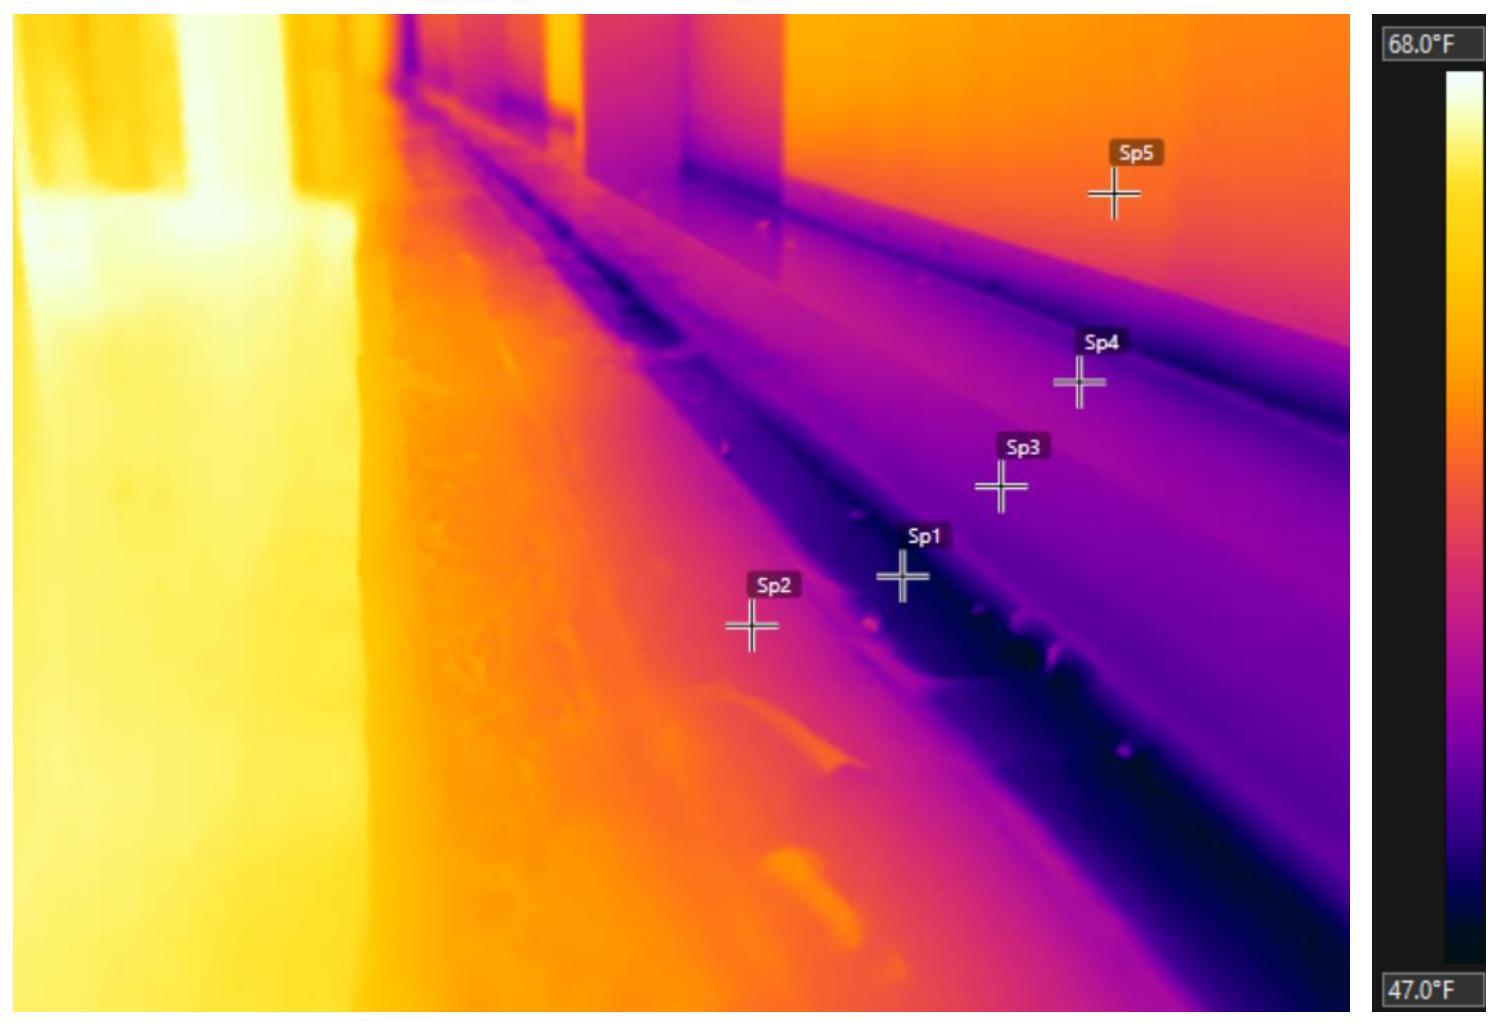
North wall 5th floor looking north, structural steel temperatures are lower than frame temperatures. This image was taken at 10:00 am when exterior ambient temperatures were approximately 22°F. This image shows the frame sitting on the cold side of the exterior wall, directly onto the steel member. The spot surface temperatures are as follows: Spot1 - 46.7°F, Spot2 - 60.0°F, Spot3 – 51.0°F, Spot4 – 51.0 °F, Spot5 – 51.8°F, Spot6 – 59.8°F.

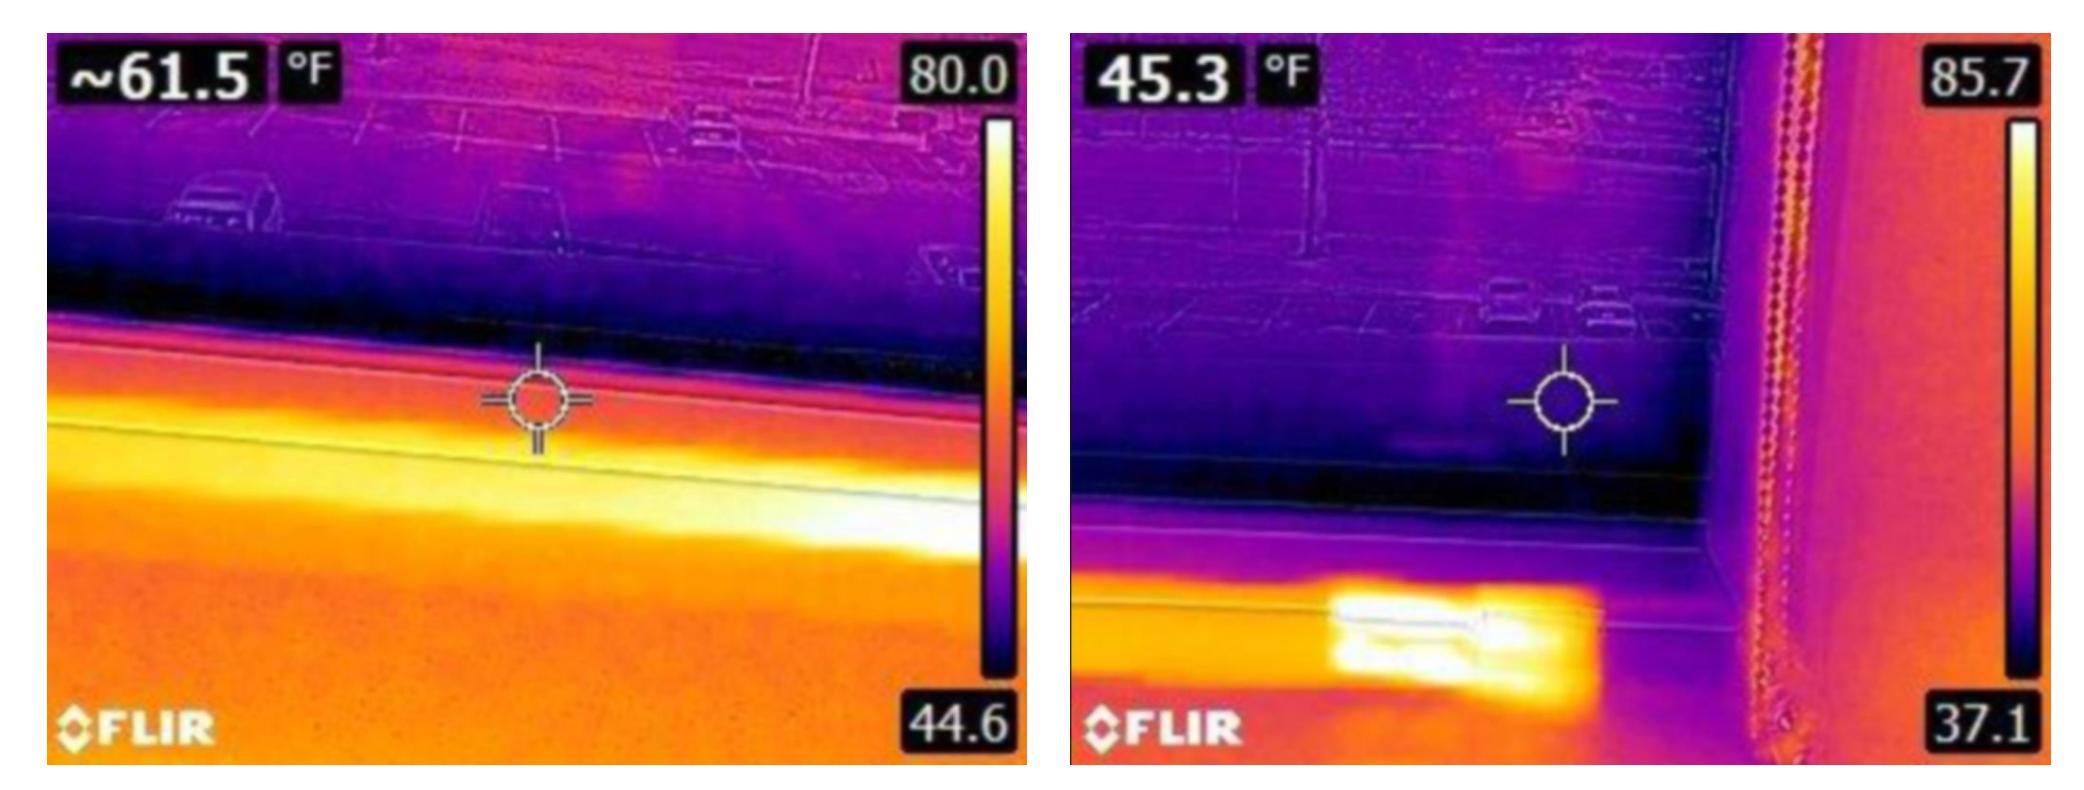
FAILURE

Introduction of Electric Heat strips were added to "warm" the window frame
