Failure is Not an Option: Air Barrier Continuity Strategies for Storefront and Curtain Wall Systems

Andrew Dunlap, AIA
SmithGroup, Inc.

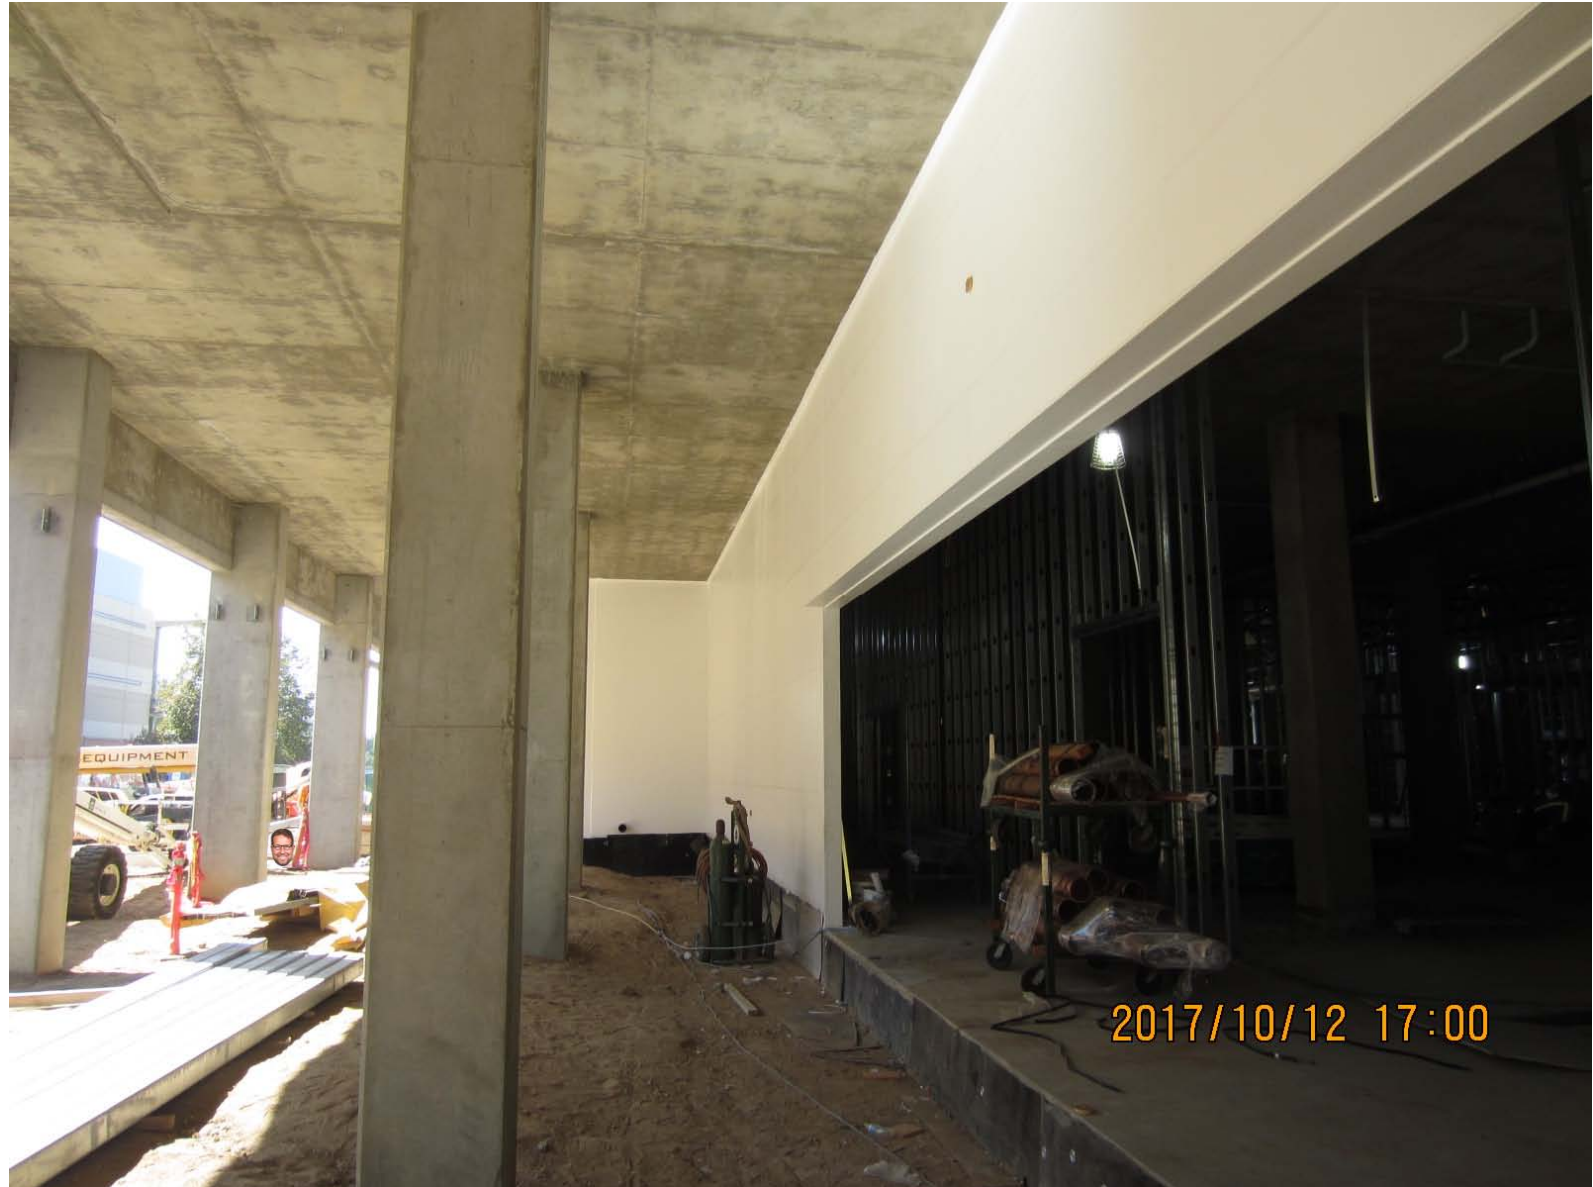
Sealant Transition

Flashing Materials

- Fluid Applied Flashing
 - STPE
 - Silicone
- Self Adhered
 - Rubberized Asphalt
 - Foil Faced
 - Butyl
 - Stainless Steel

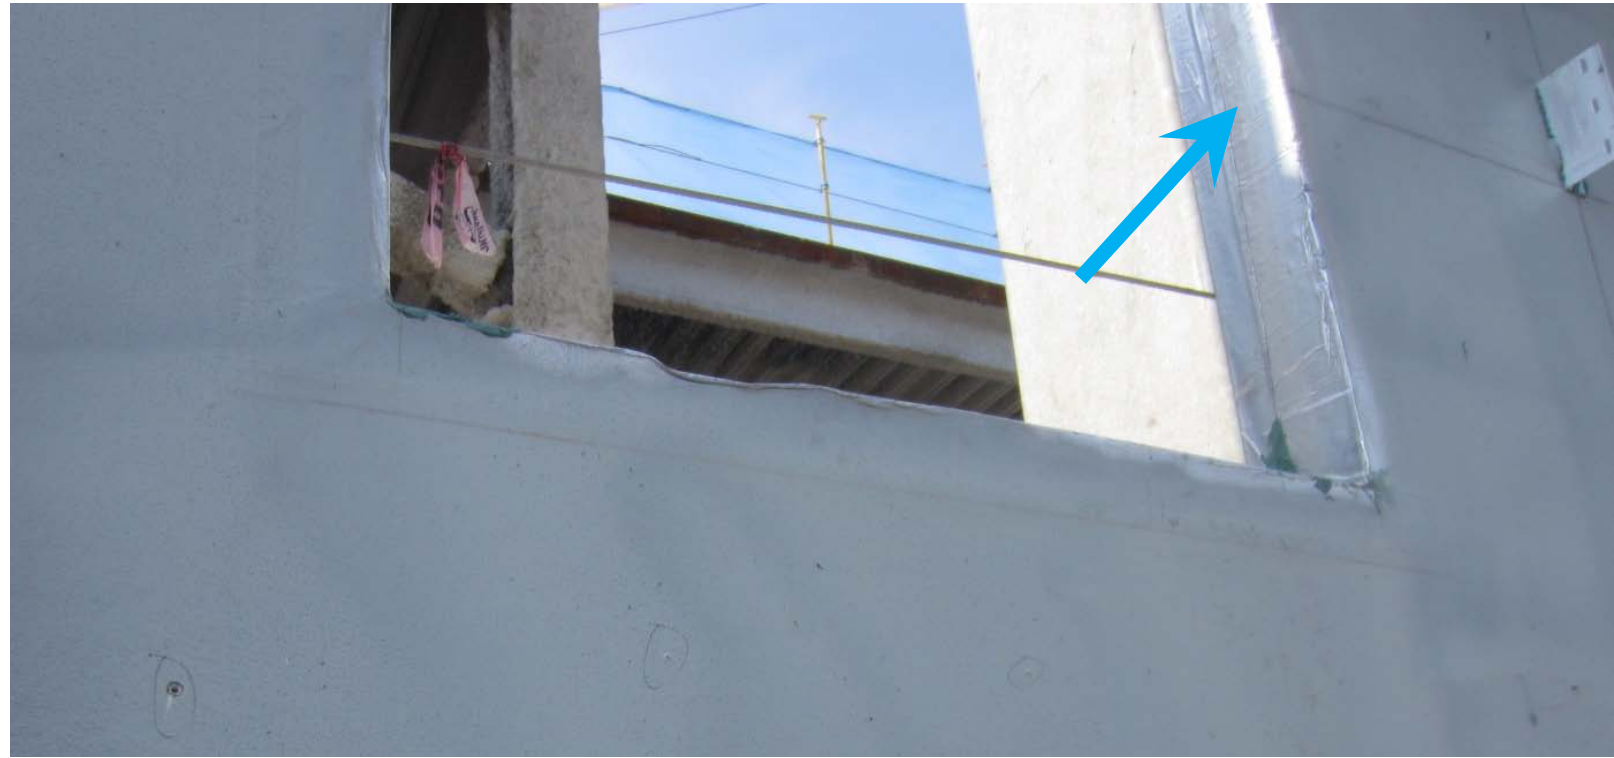
Sealant Transition

Flashing Materials

- Fluid Applied Flashing
 - STPE
 - Silicone
- Self Adhered
 - Rubberized Asphalt
 - **Foil Faced**
 - Butyl
 - Stainless Steel

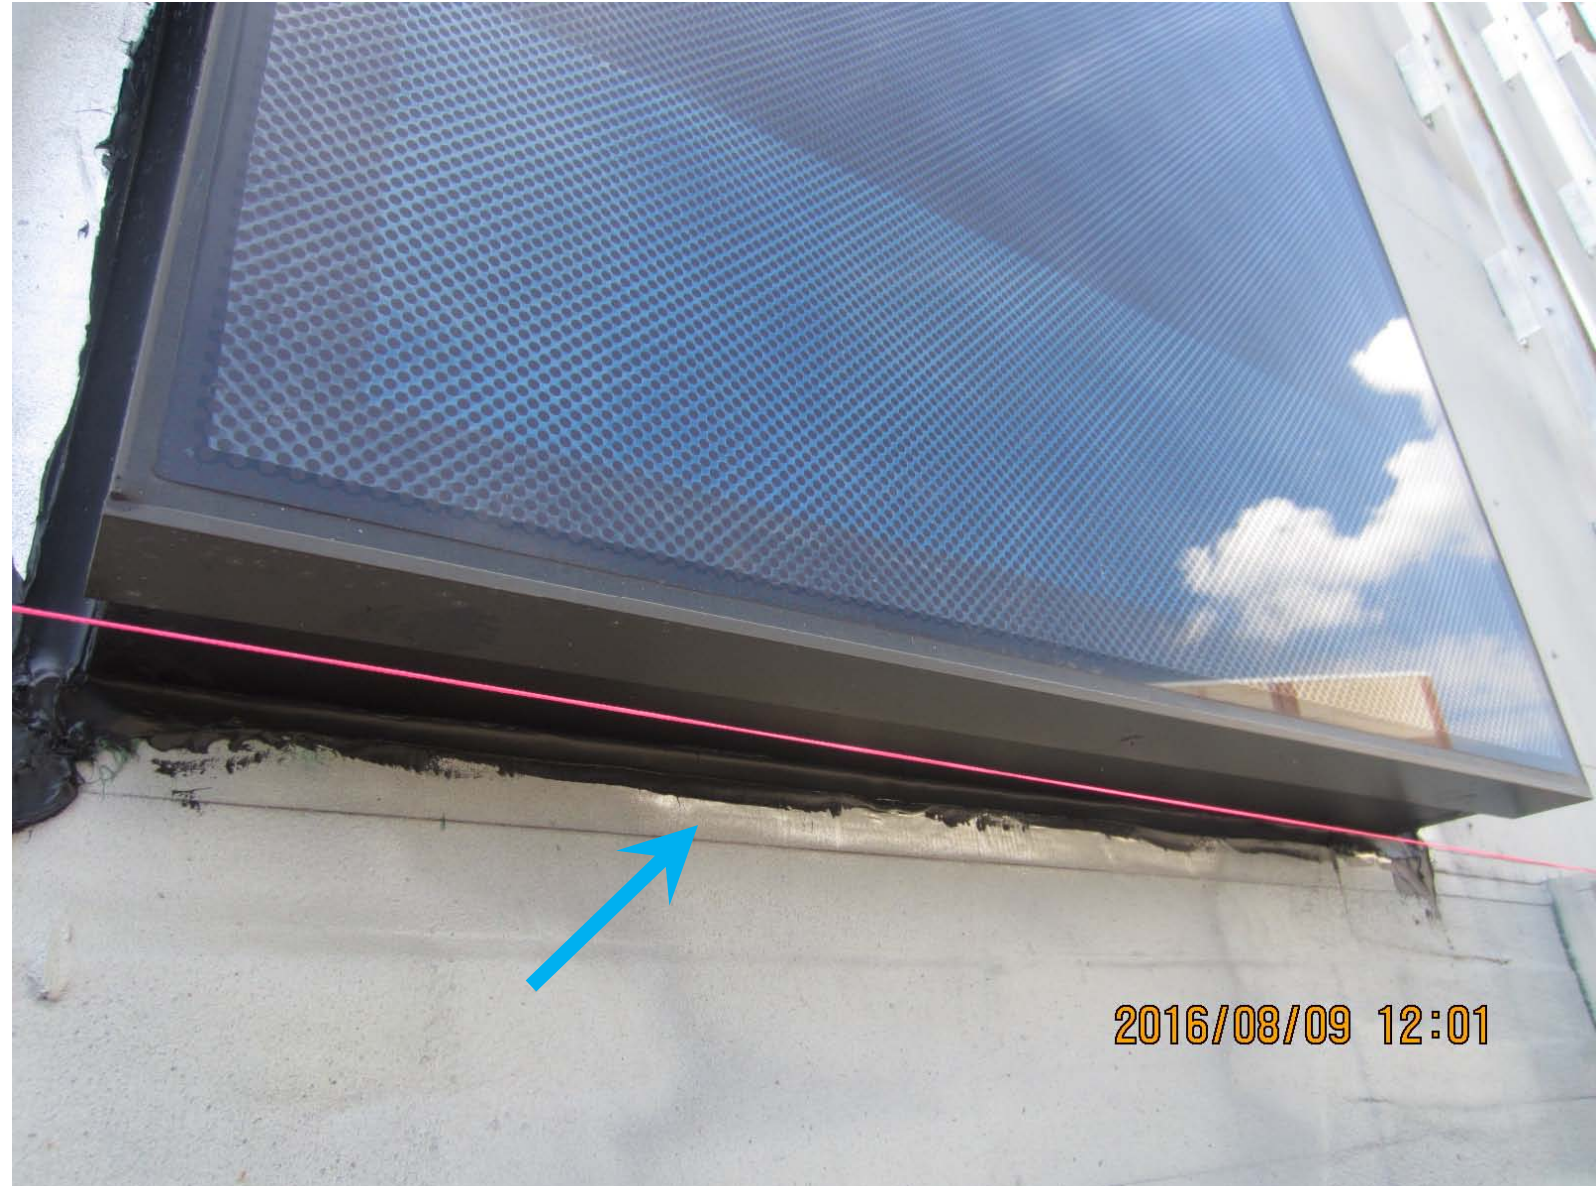
Sealant Transition

Flashing Materials

- Fluid Applied Flashing
 - STPE
 - Silicone
- Self Adhered
 - Rubberized Asphalt
 - Foil Faced
 - Butyl
 - **Stainless Steel**

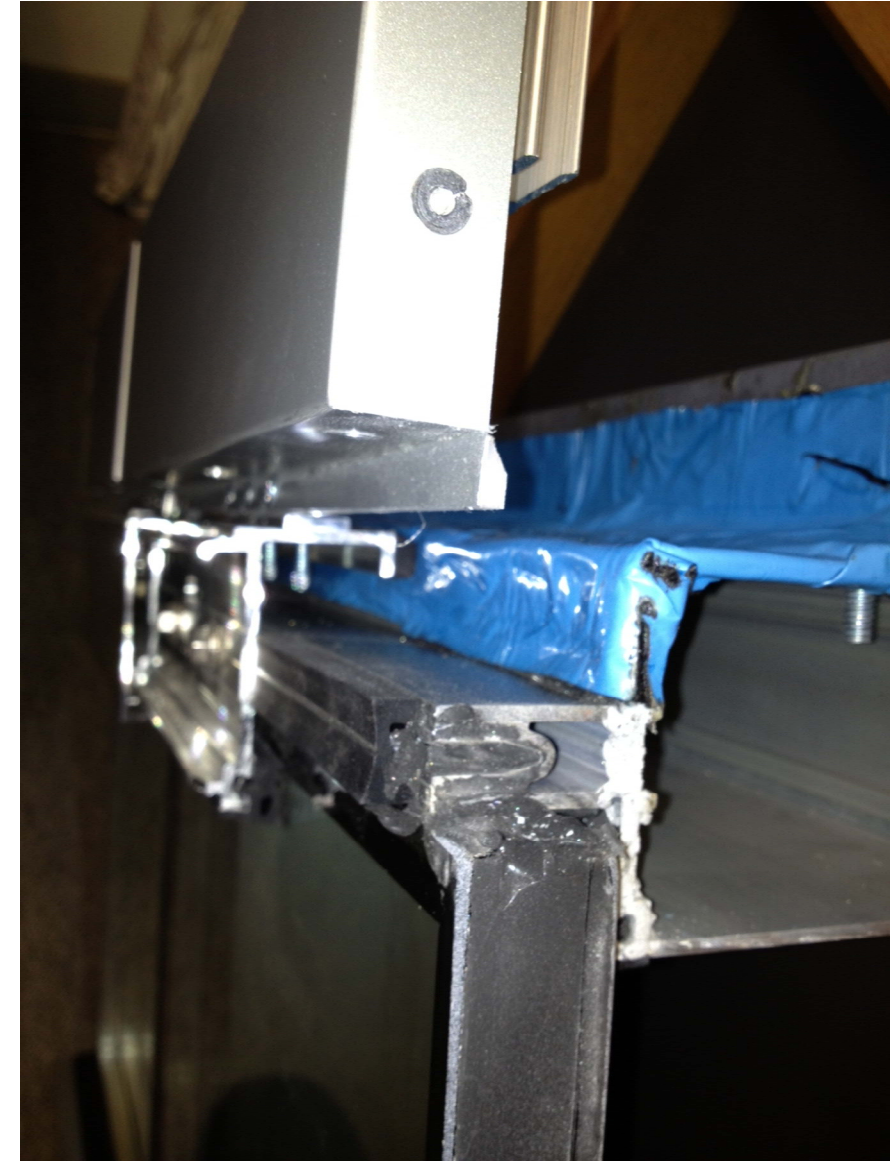
Sealant Transition

BENEFITS

- Future Sealant Repair
- Perimeter Sealant is Compatible with Curtain Wall Sealants
- Constructability / Sequence

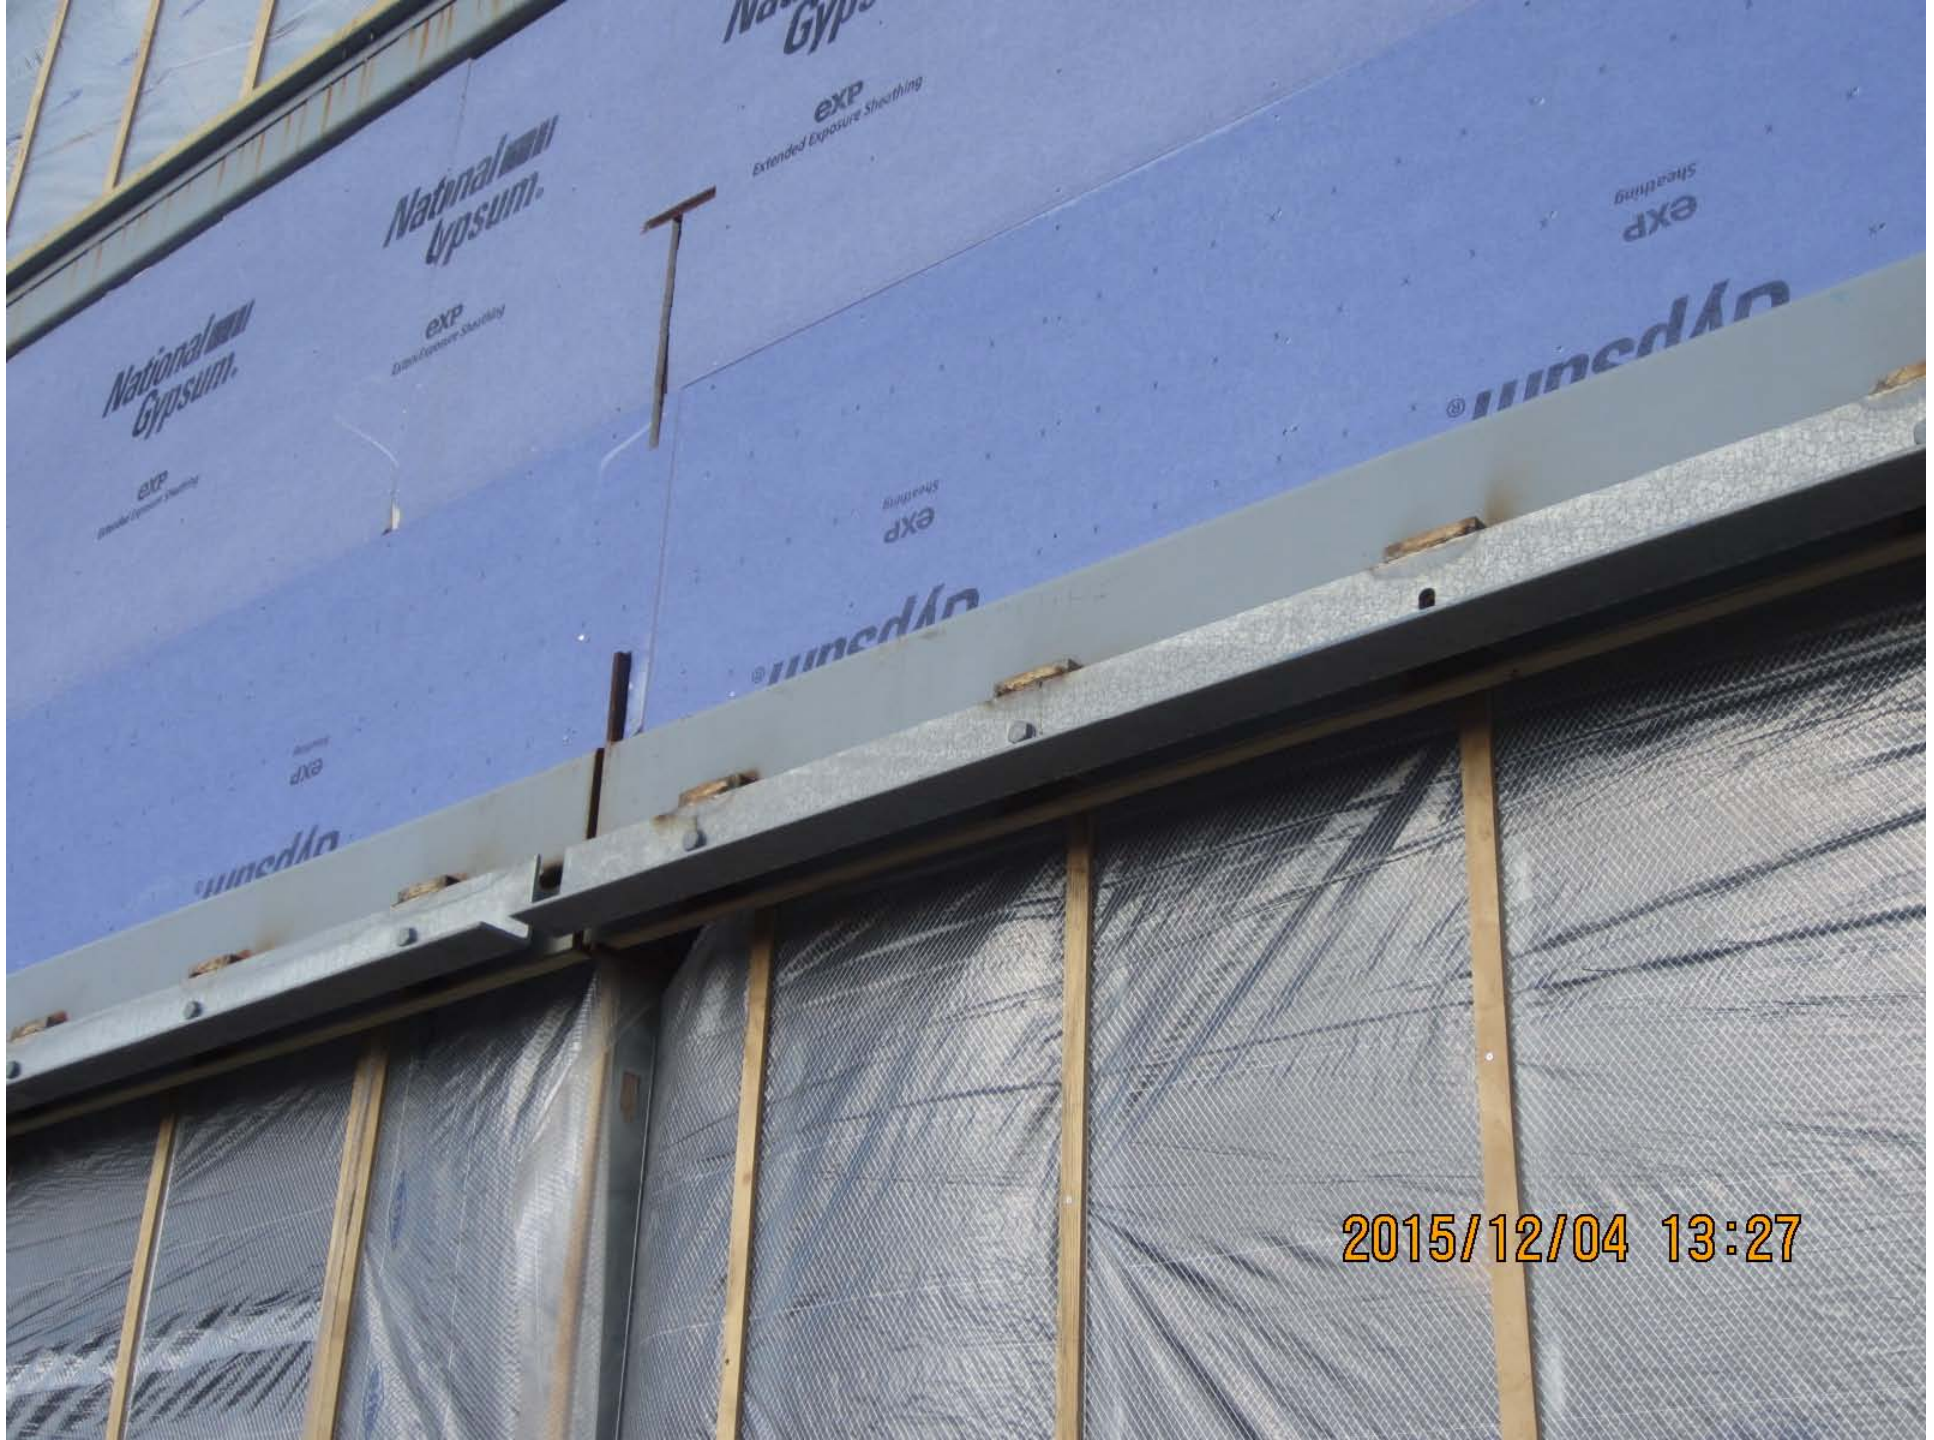
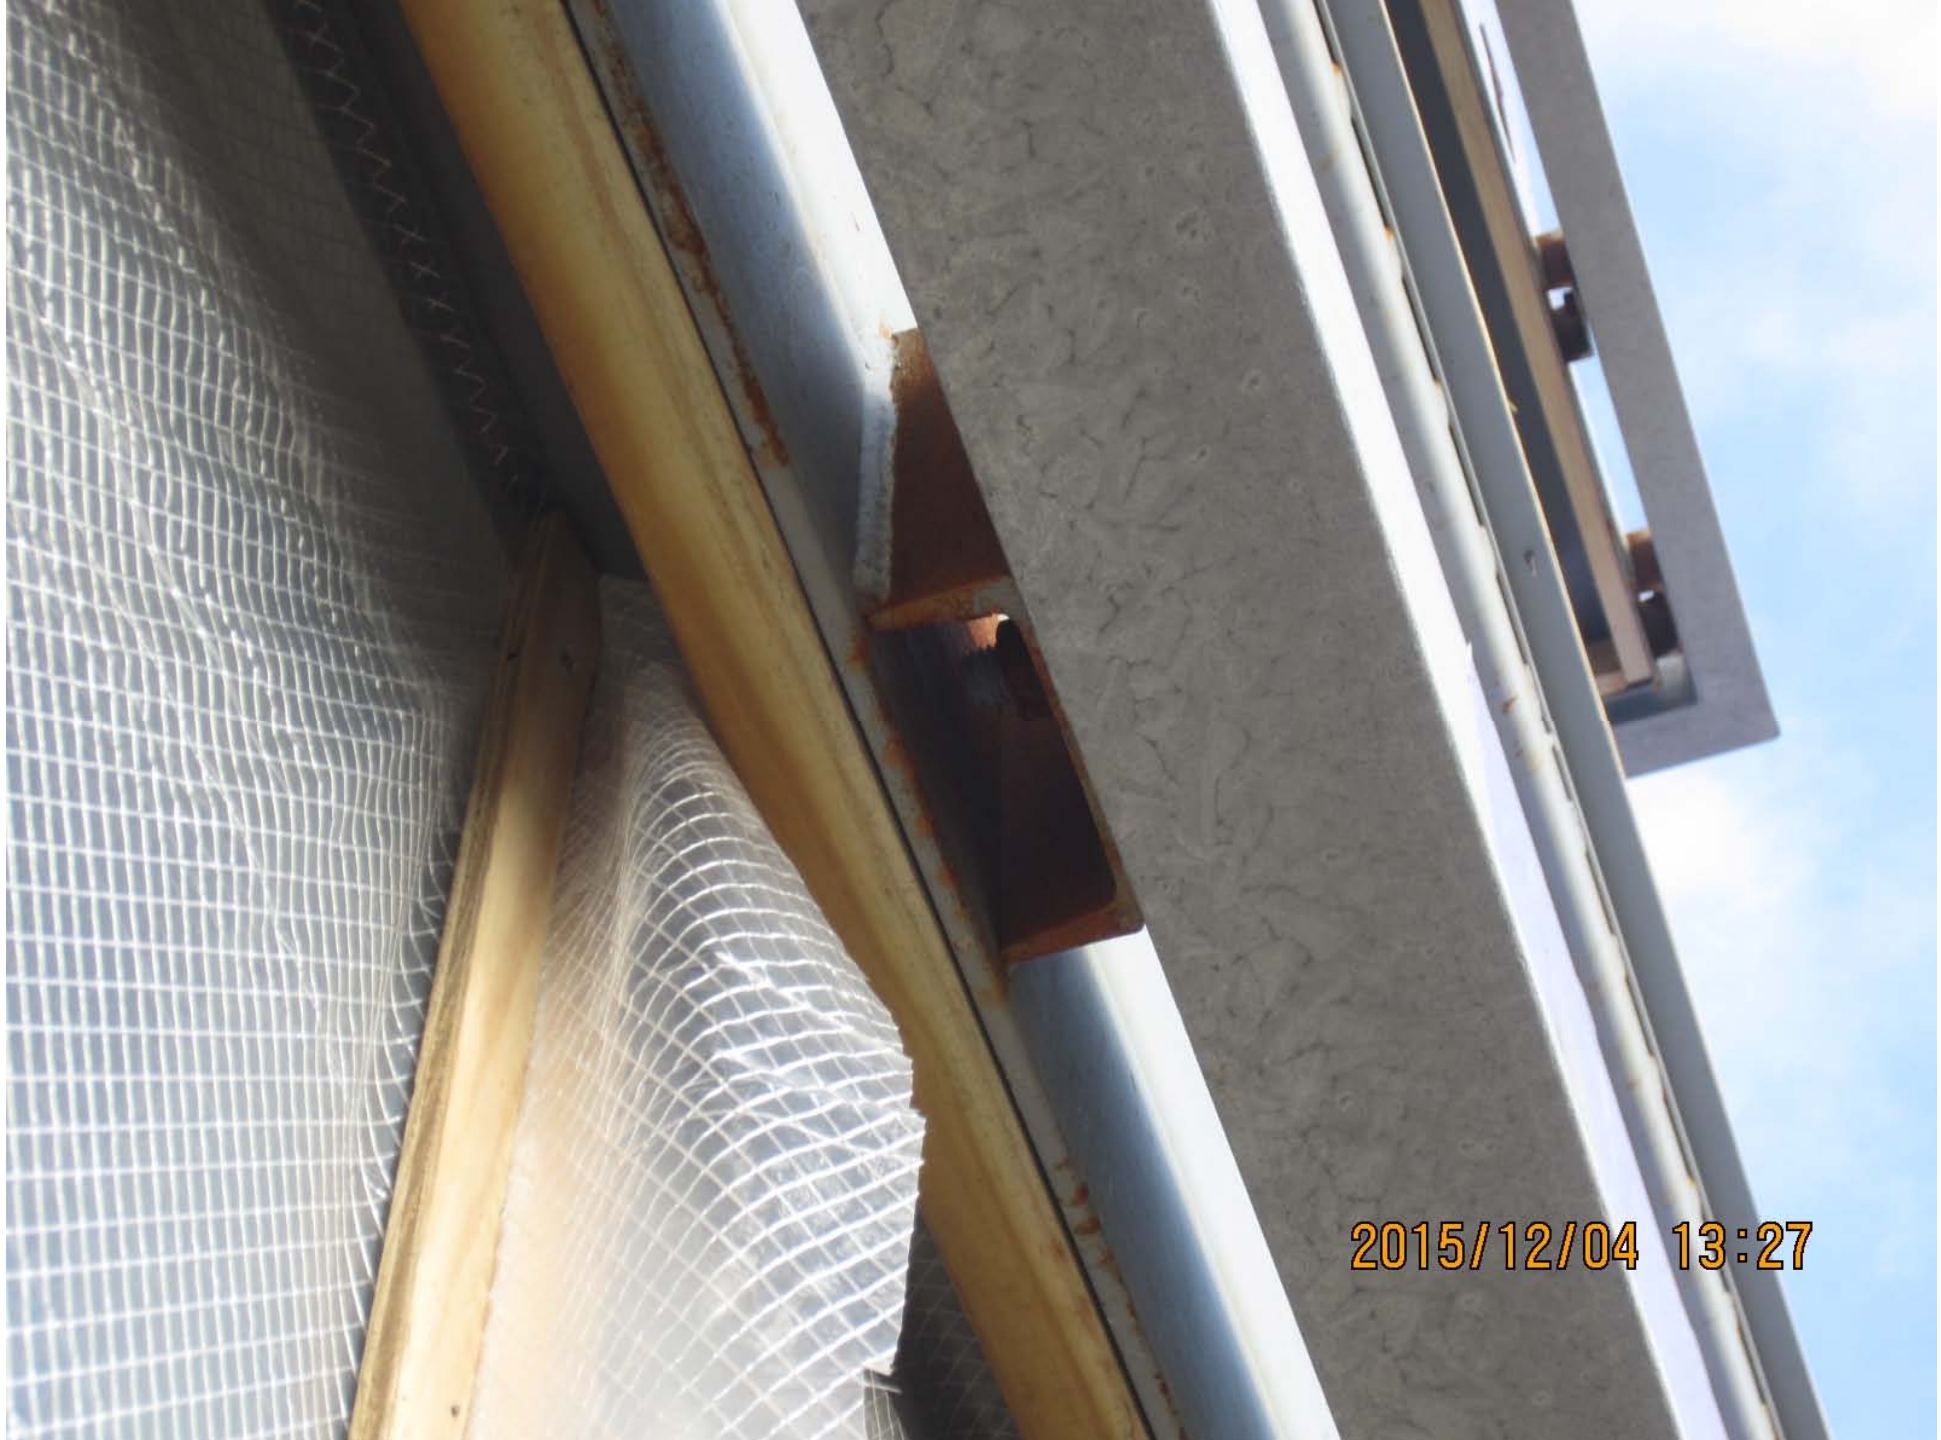
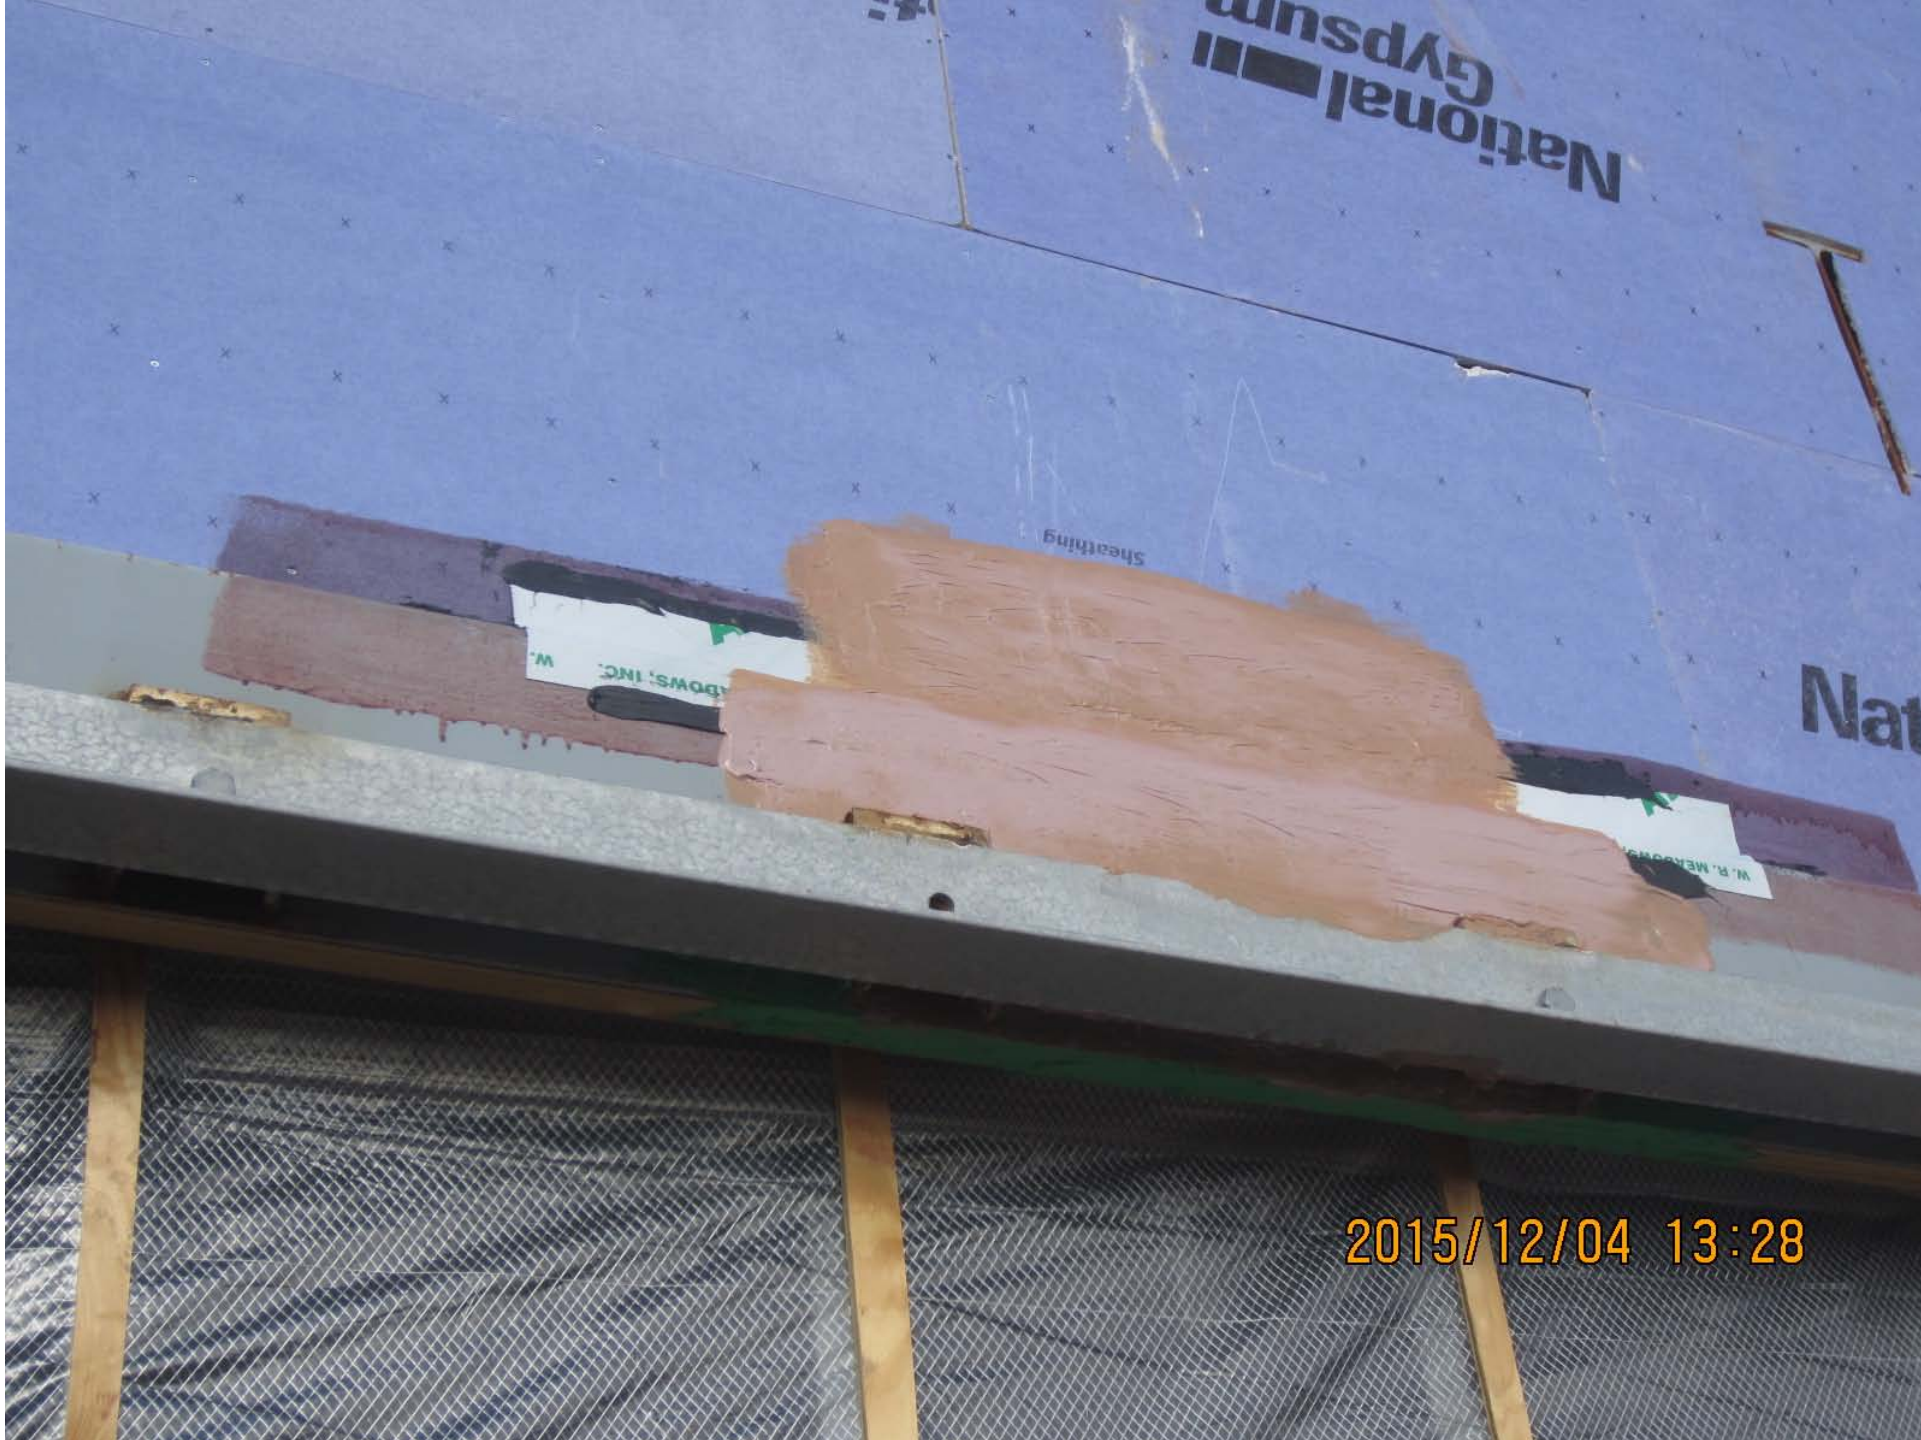
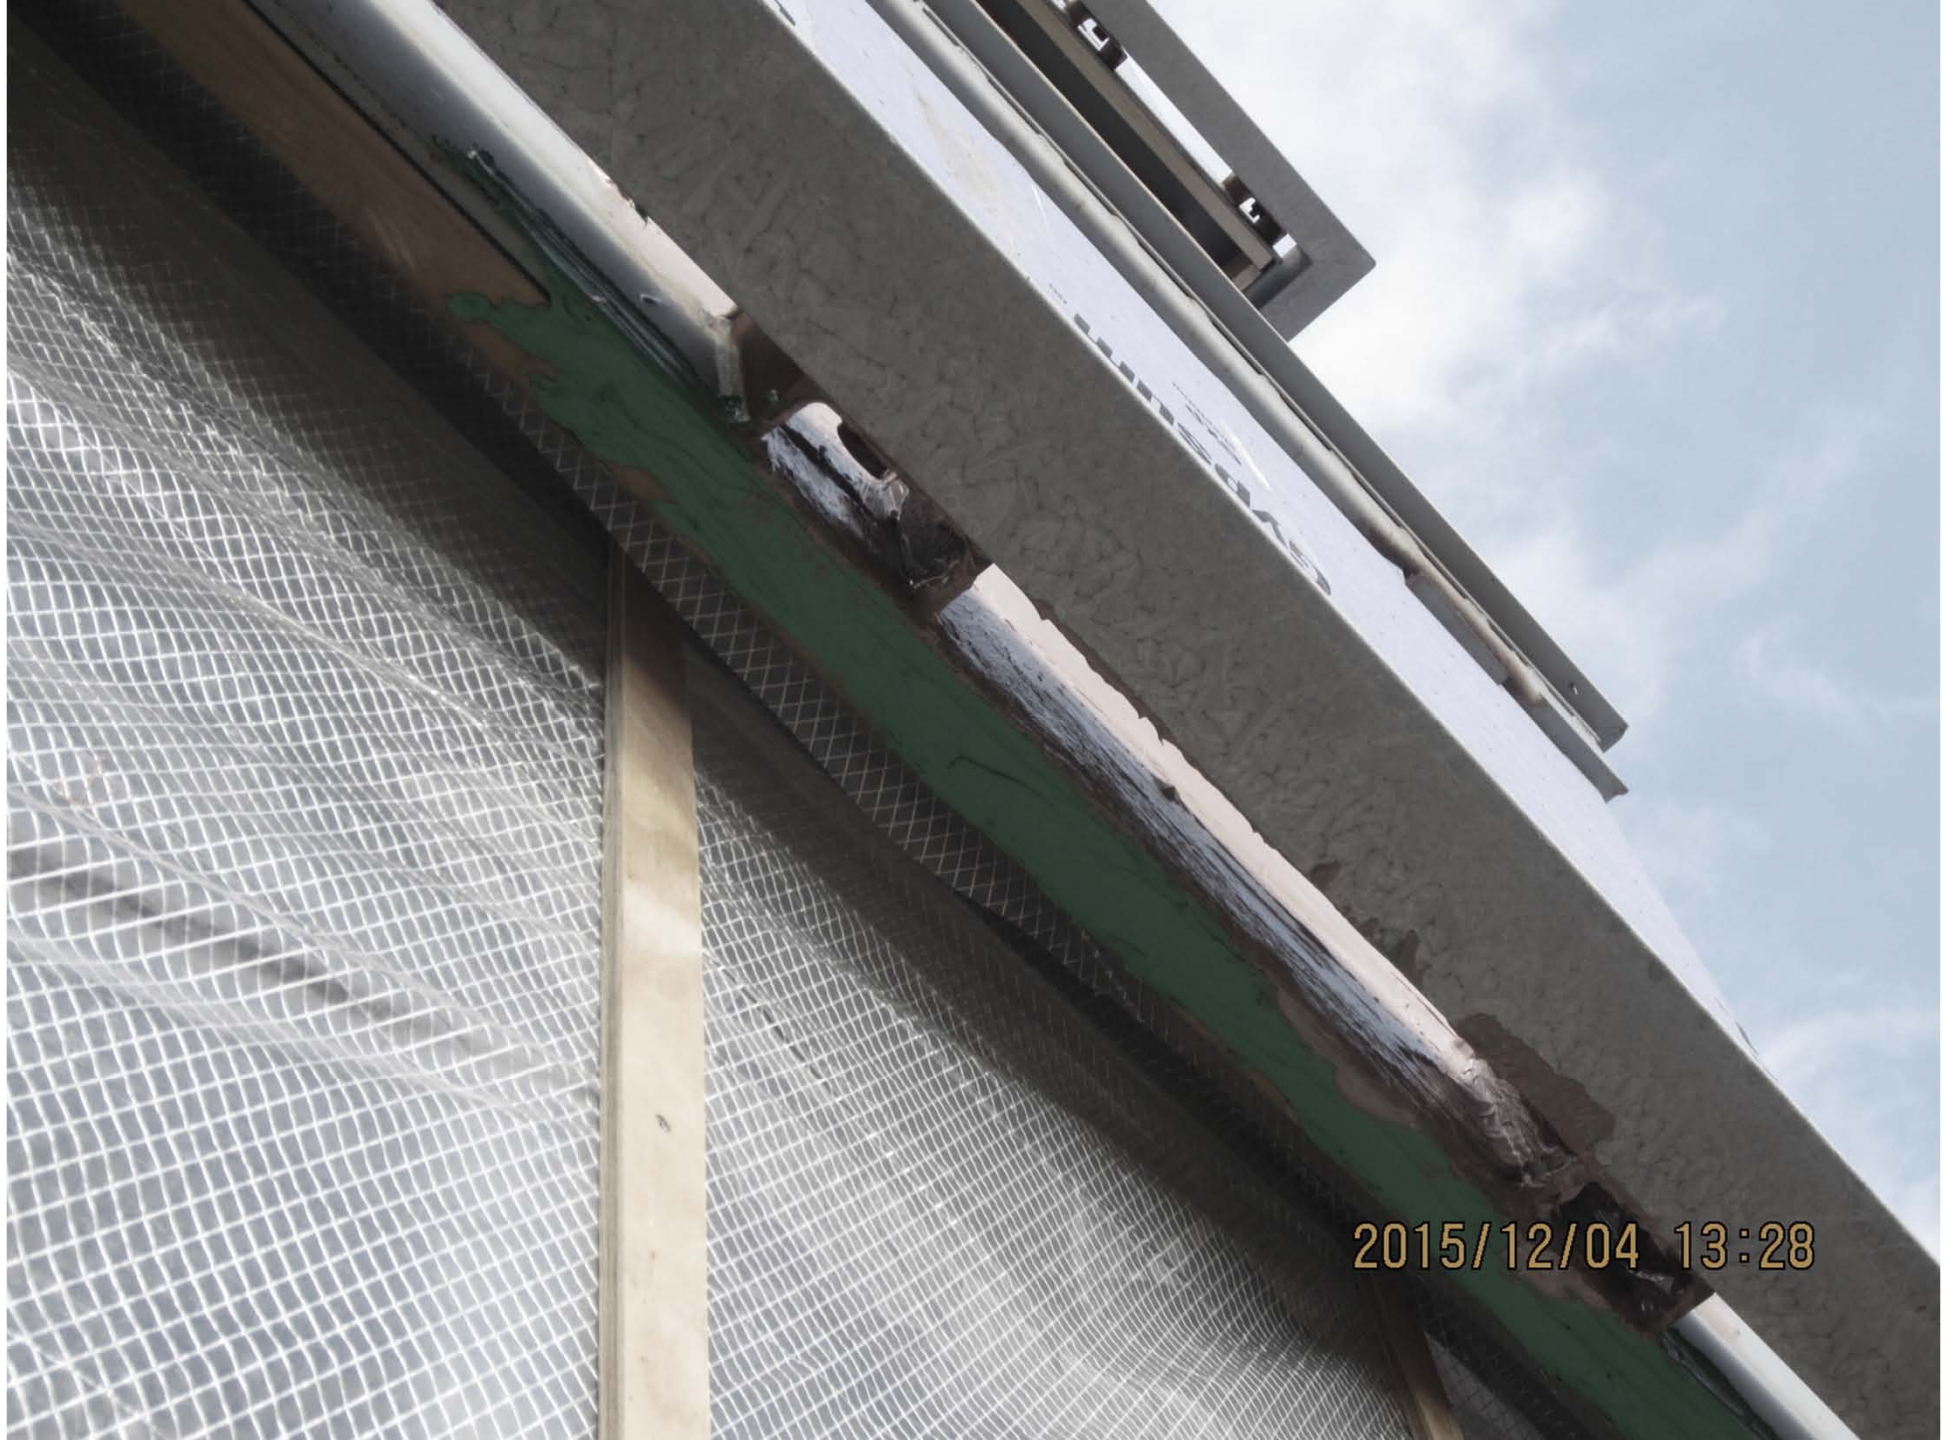
National Gypsum

Sheathing

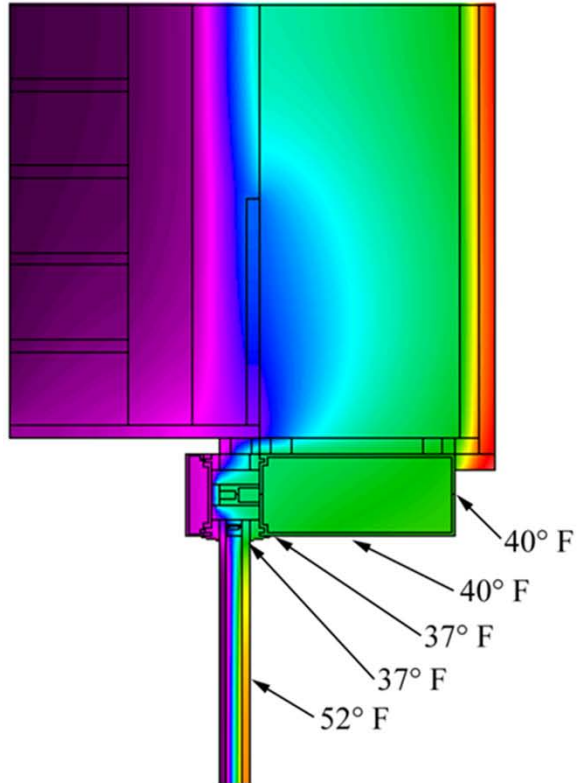
System Installed at Typical Lintel Condition
- Head Condition at Transition between Brick Cavity Wall and Enhanced Glazed Wall System

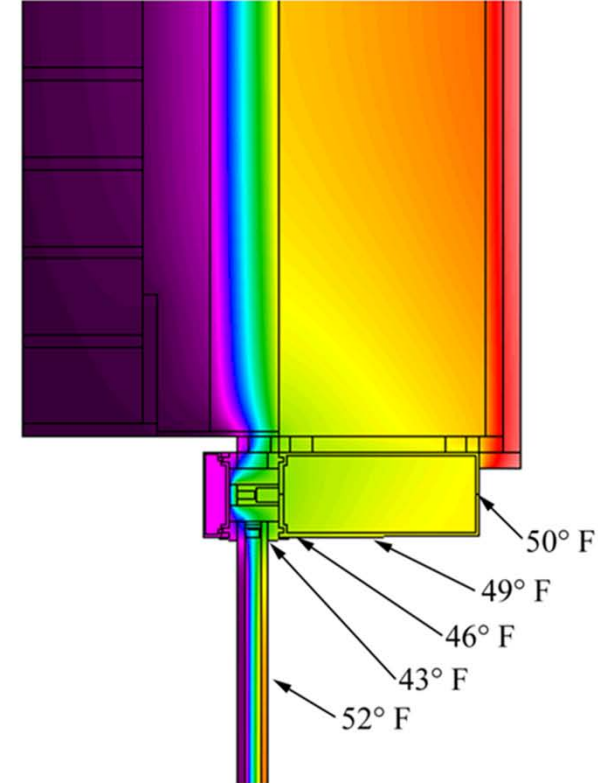
System Installed at Thermally Broken Lintel Condition
- Head Condition at Transition between Brick Cavity Wall and Enhanced Glazed Wall System

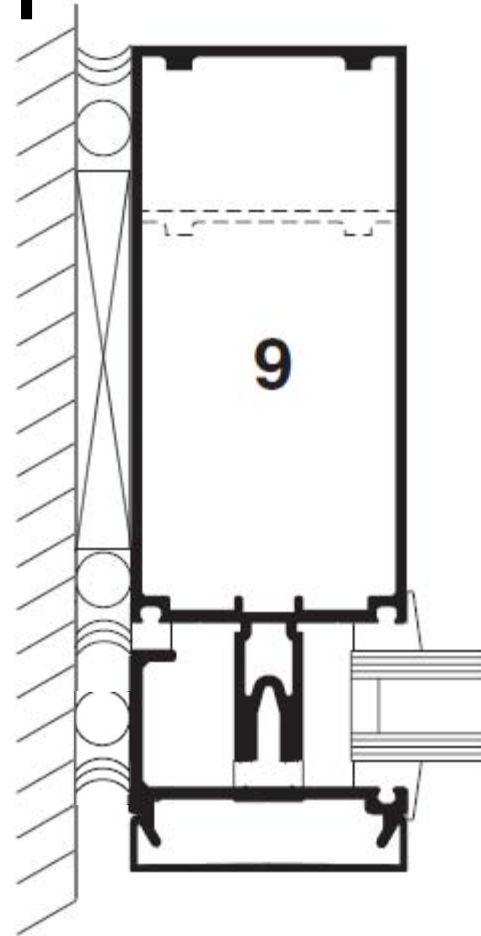
Low Humidity Only

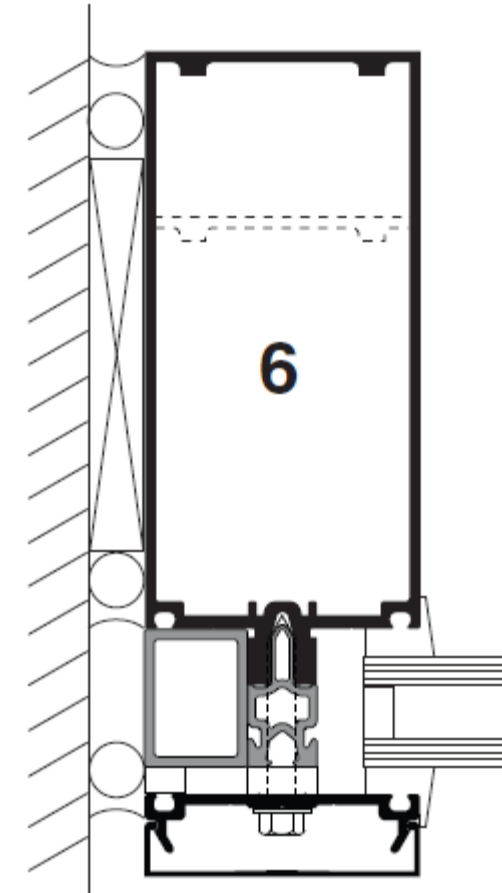
Better For Humidified Environments

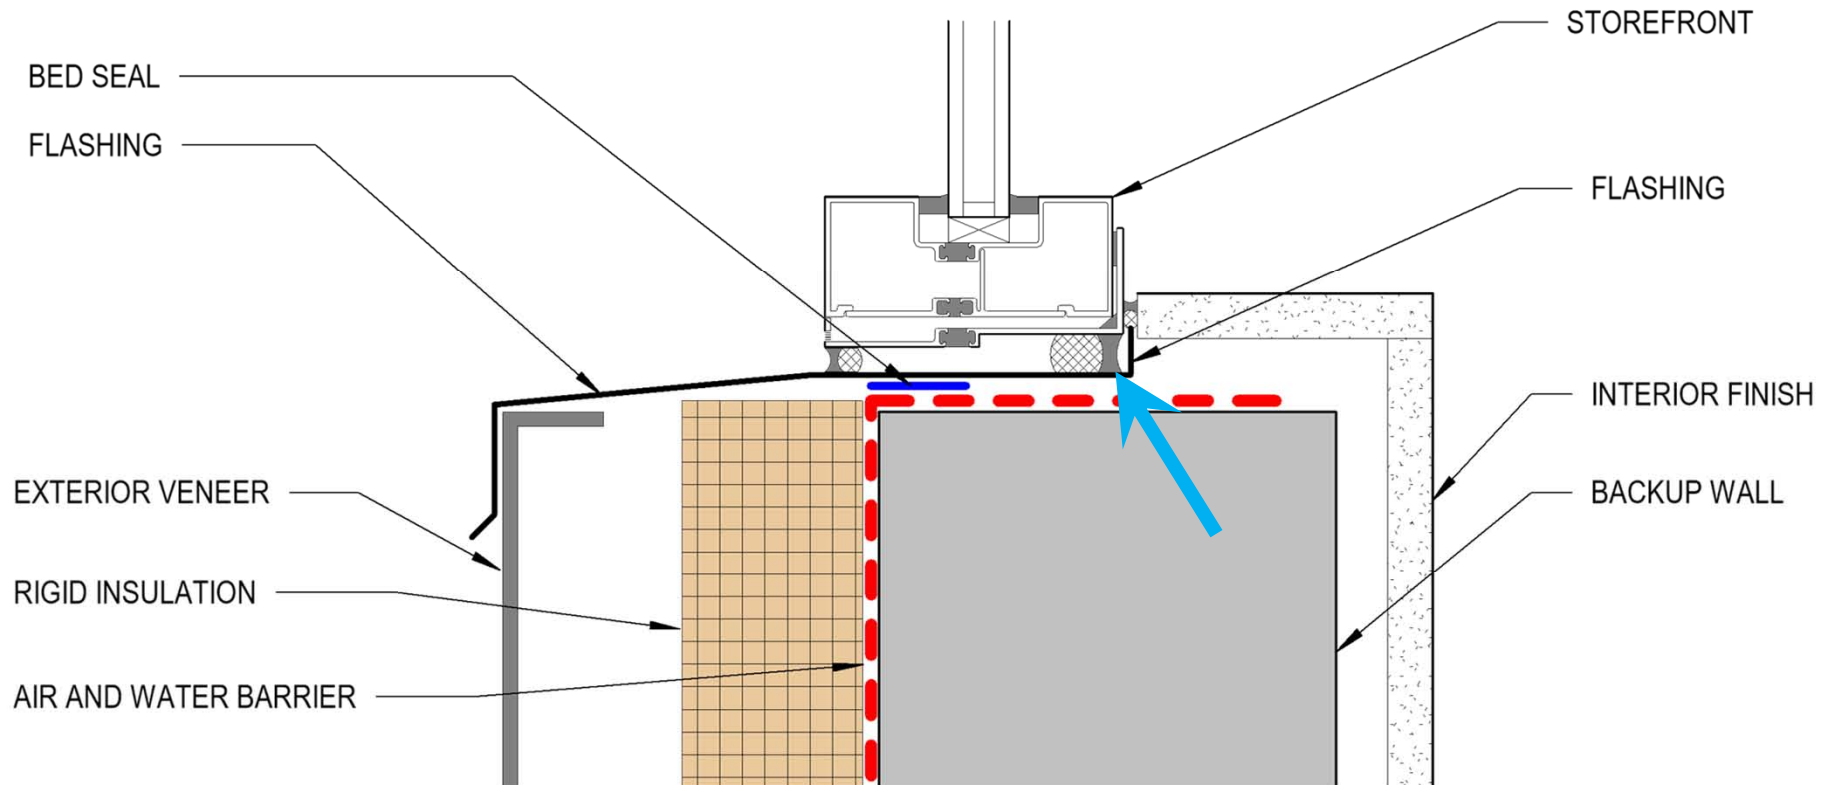
- Issues with Flashing Joints
- Reliant on Bed Sealant of Flashing
- Very Reduced Thermal Performance

- Weep required to drain
- Introduces air infiltration which can lead to condensation.

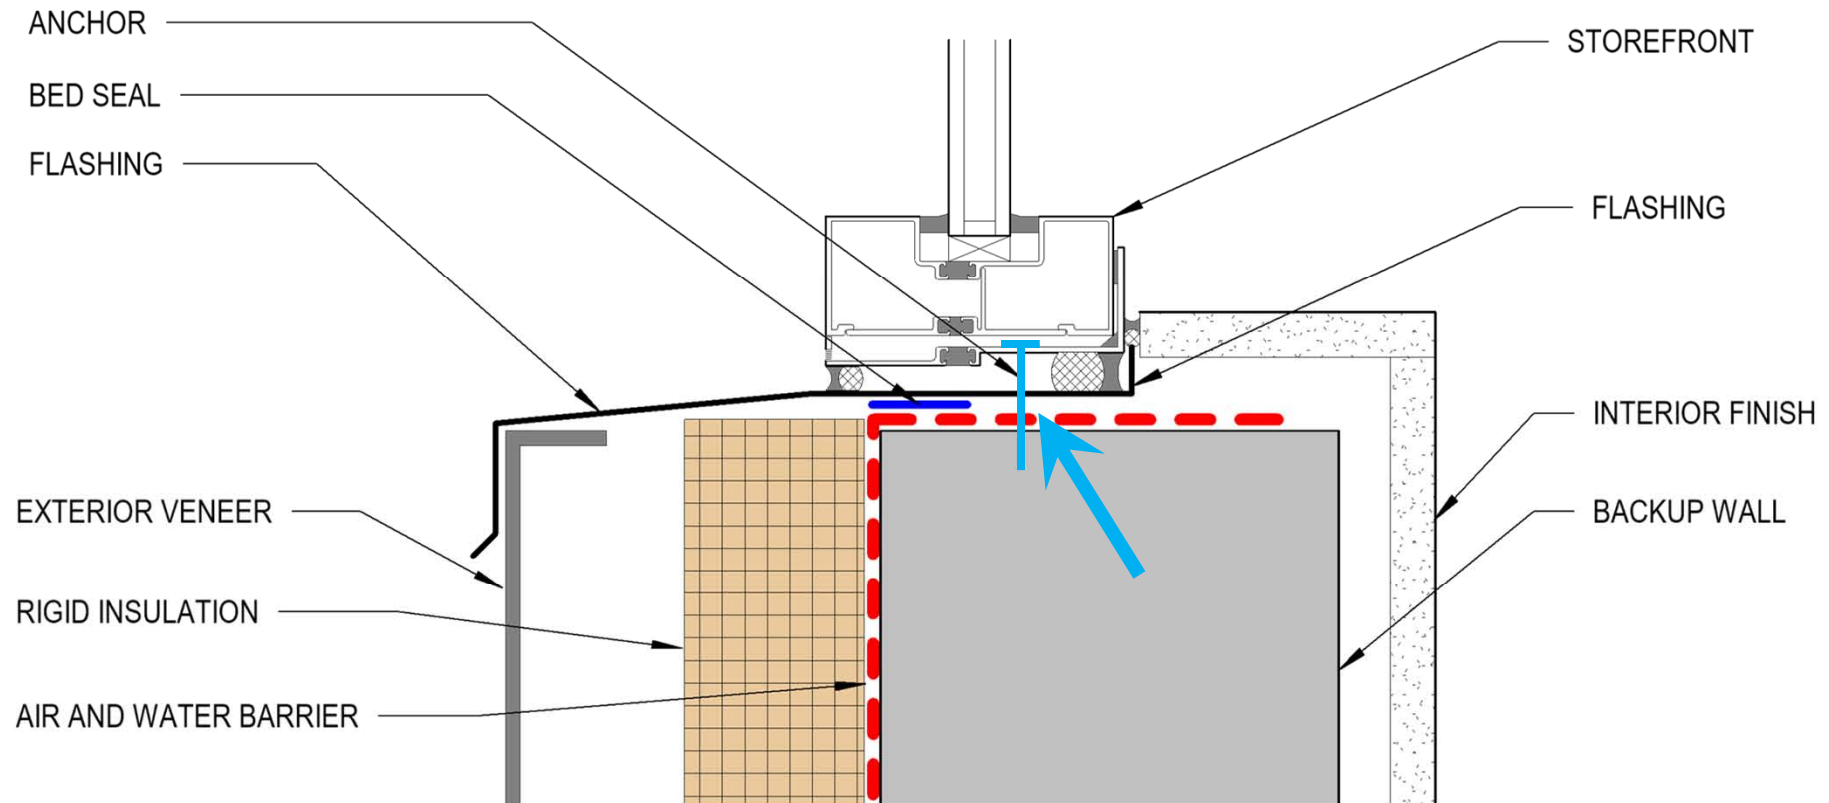
- Issues with Flashing Joints
- Reliant on Bed Sealant of Flashing
- Very Reduced Thermal Performance

- Weep required to drain
- Introduces air infiltration which can lead to condensation
- Not able to seal fastener
