Failure is Not an Option: Air Barrier Continuity Strategies for Storefront and Curtain Wall Systems

Andrew Dunlap, AIA
SmithGroup, Inc.

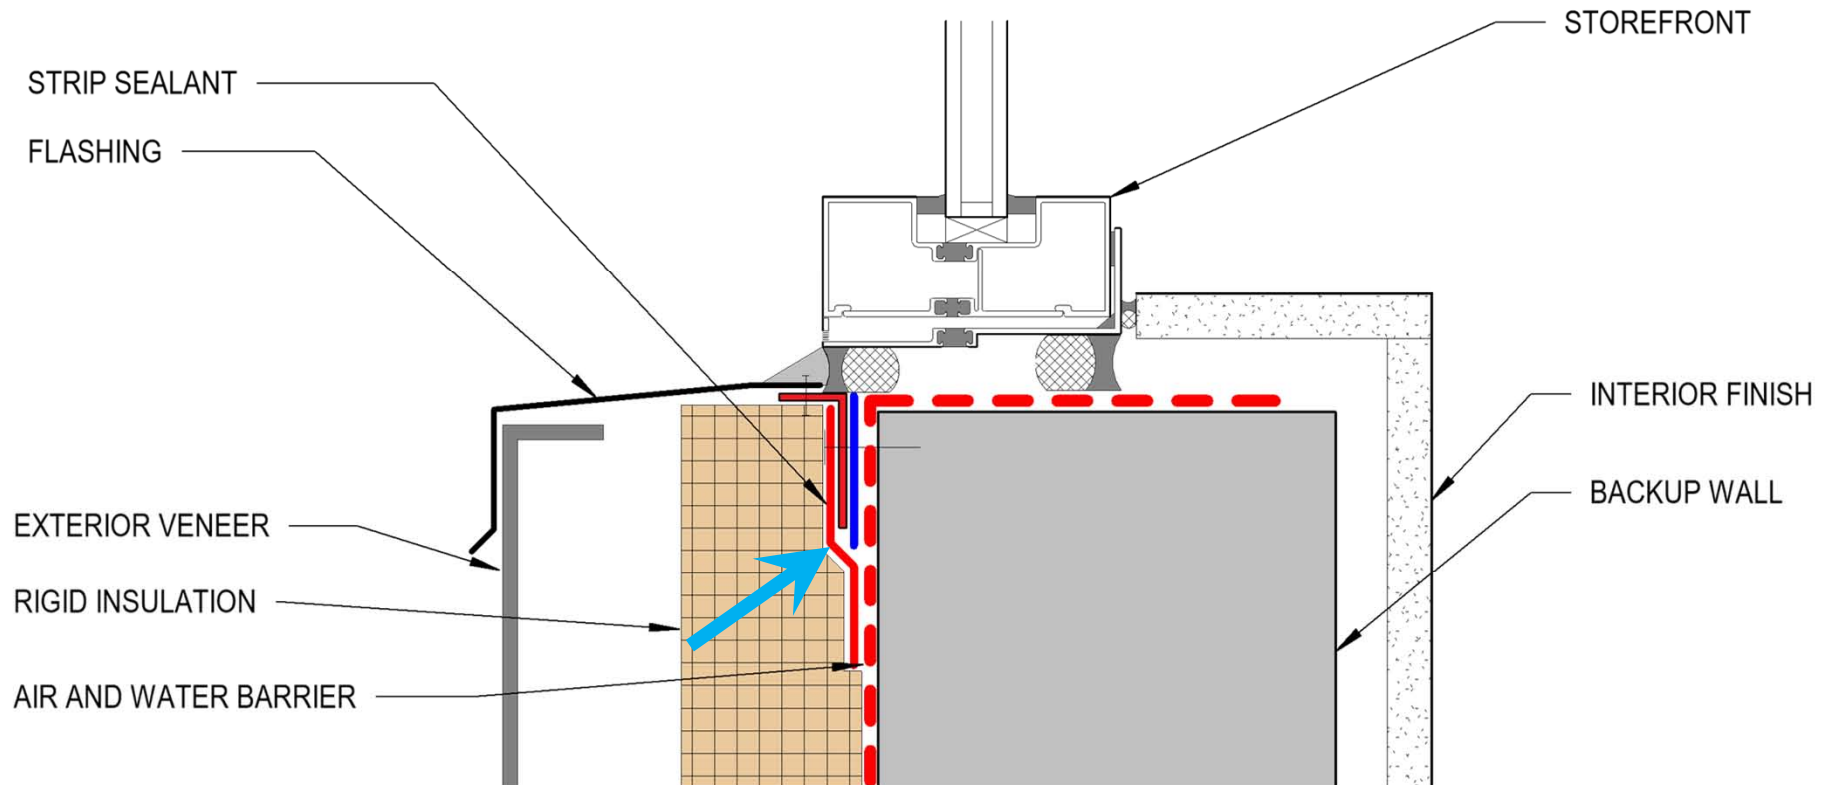
- 2 Definitive lines of Sealant Protection
- 1 added Aesthetic Sealant
- Increased Installation Tolerance
- Better Flashing Joint Appearance
- Many More Pieces
- **NOT** Reliant on Bed Sealant at Sill

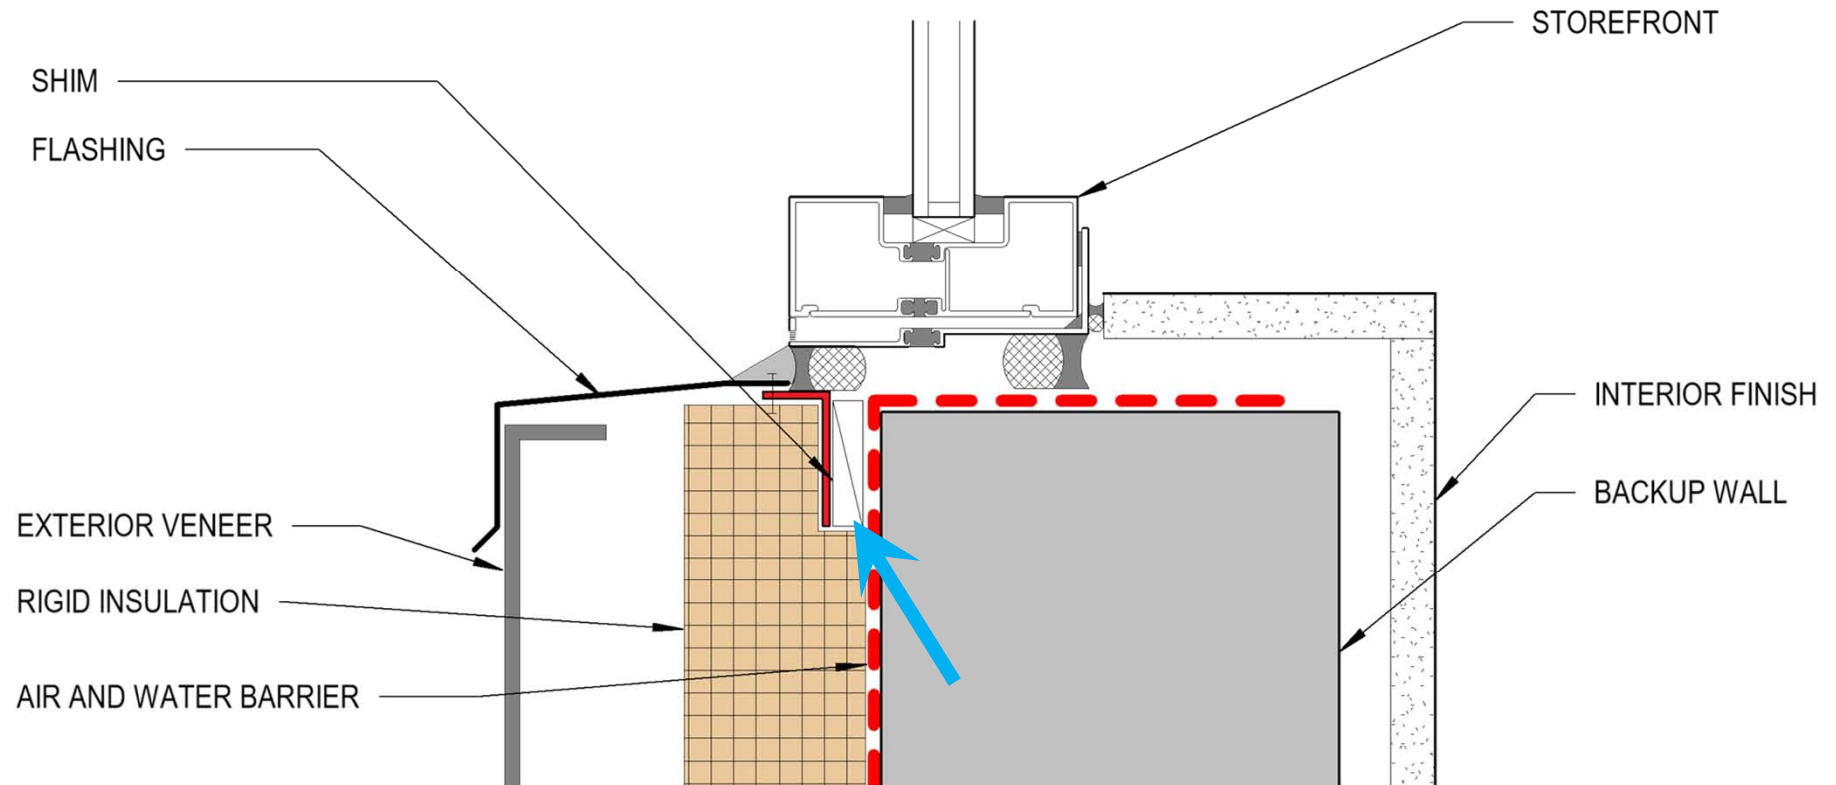
- Metal Angle with Shim
- Allows for Drainage under Sill
- Creates air infiltration path past Thermal Break
- Metal Angle does not align with Head

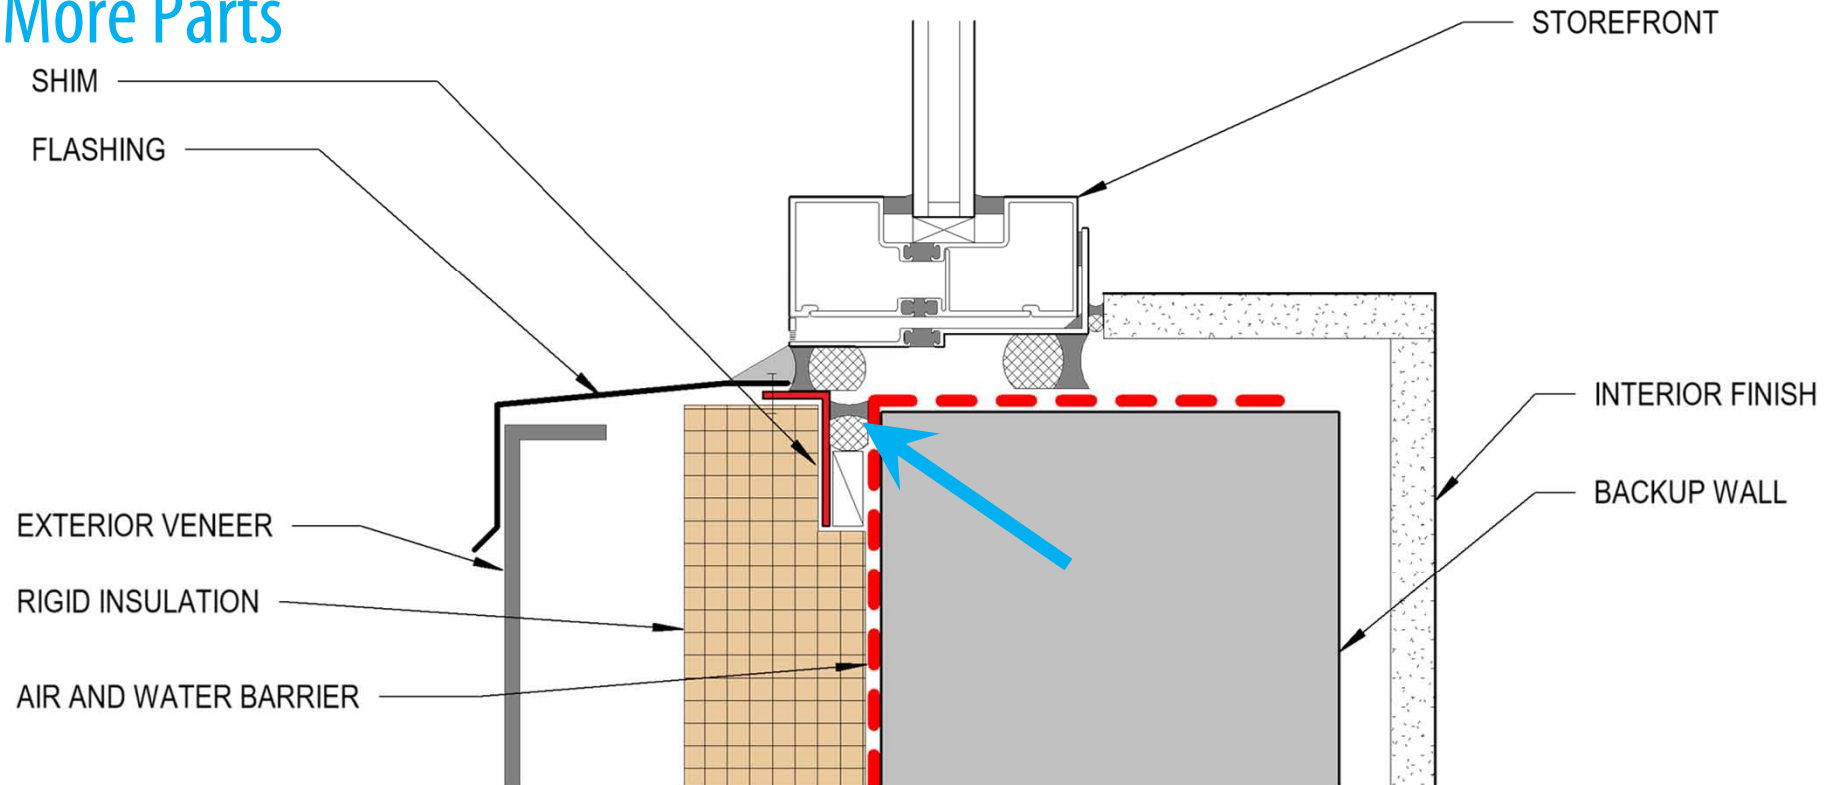
- Metal Angle with Shim and **Weeped Sealant**
- Allows for Drainage under Sill
- **Reduces** air infiltration path past Thermal Break
- Metal Angle does not align with Head
- **Many Many More Parts**

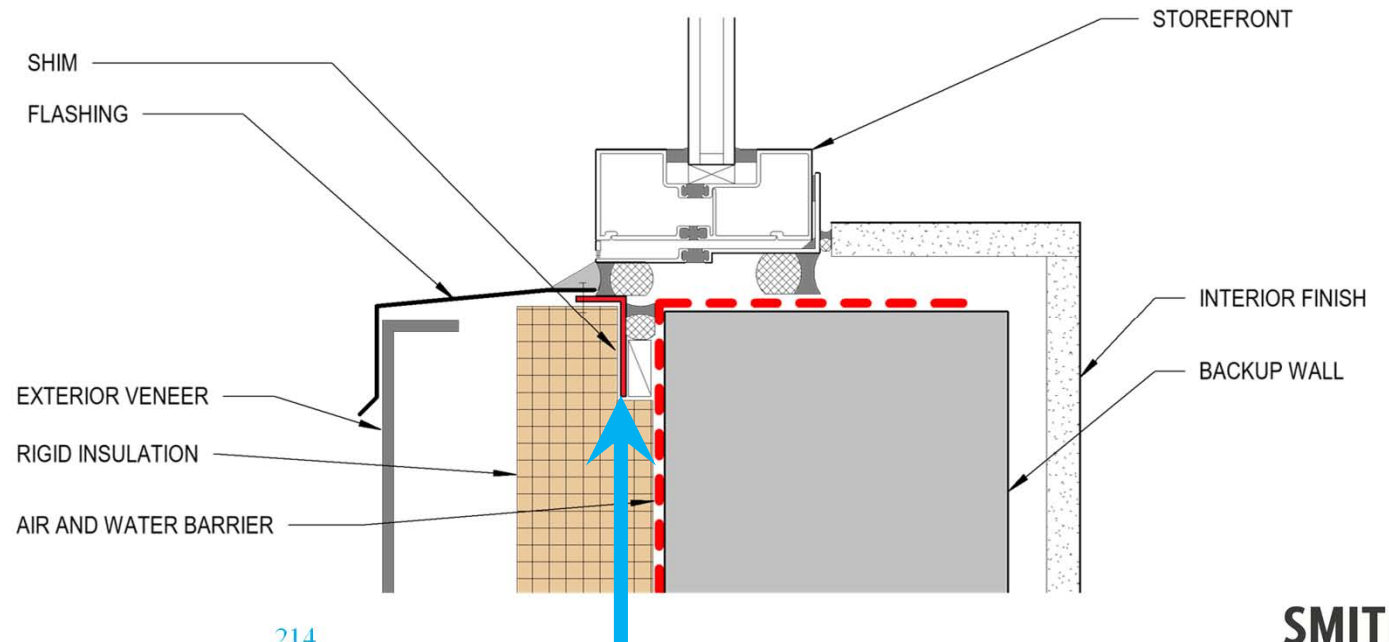
Metal angle is not in the same plane.

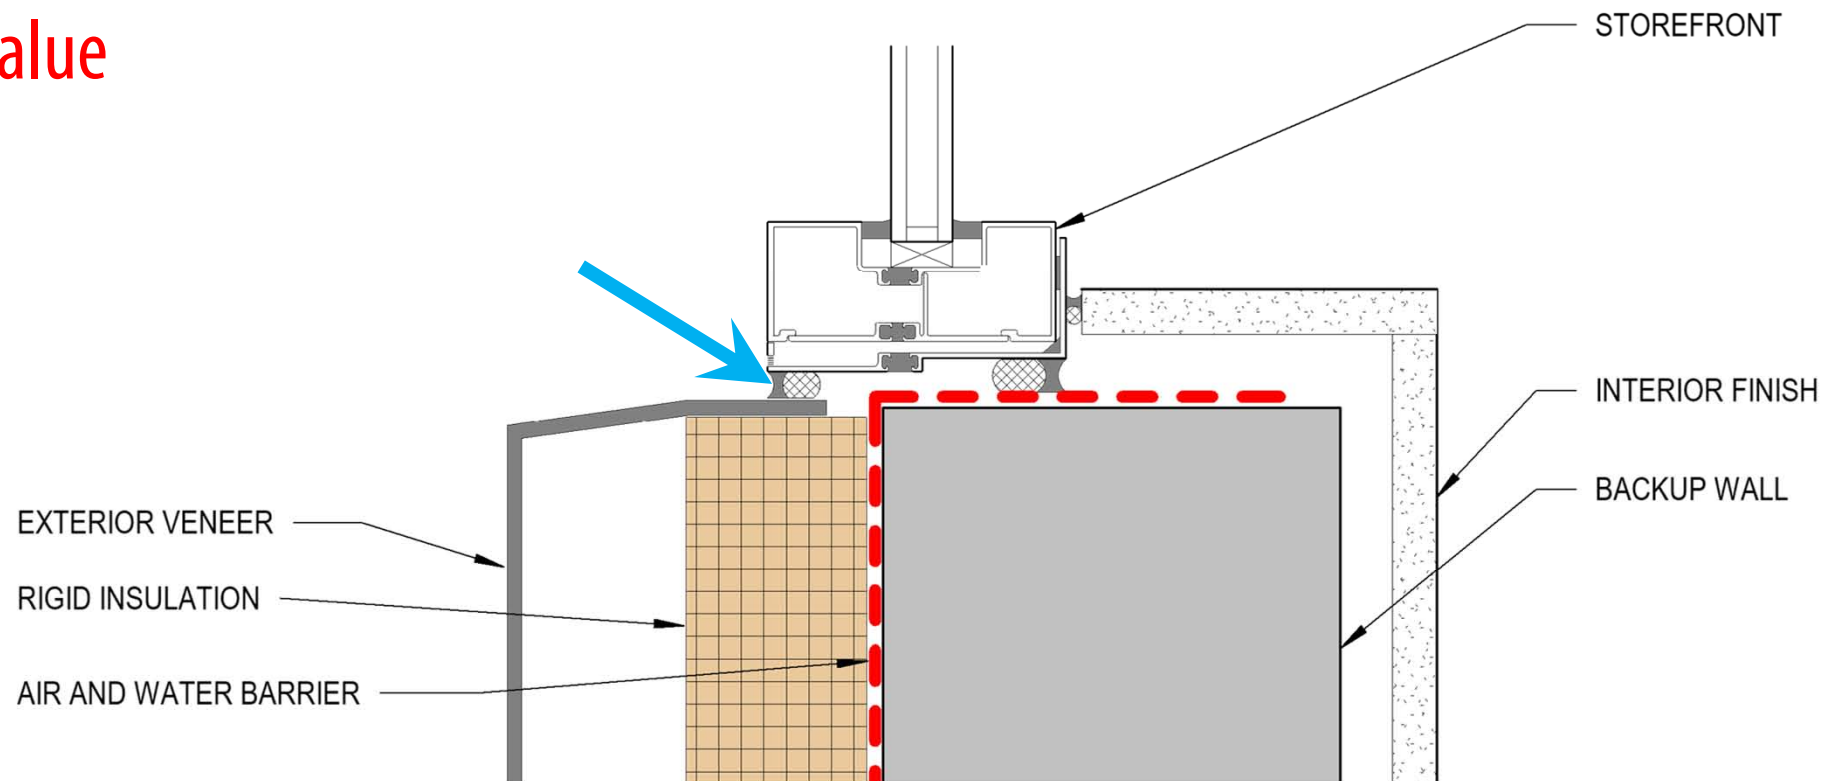
- Outer Seal to Veneer
- 1 line of Protection
- Allows for Drainage under Sill
- Creates air infiltration path past Thermal Break
- Limited Value

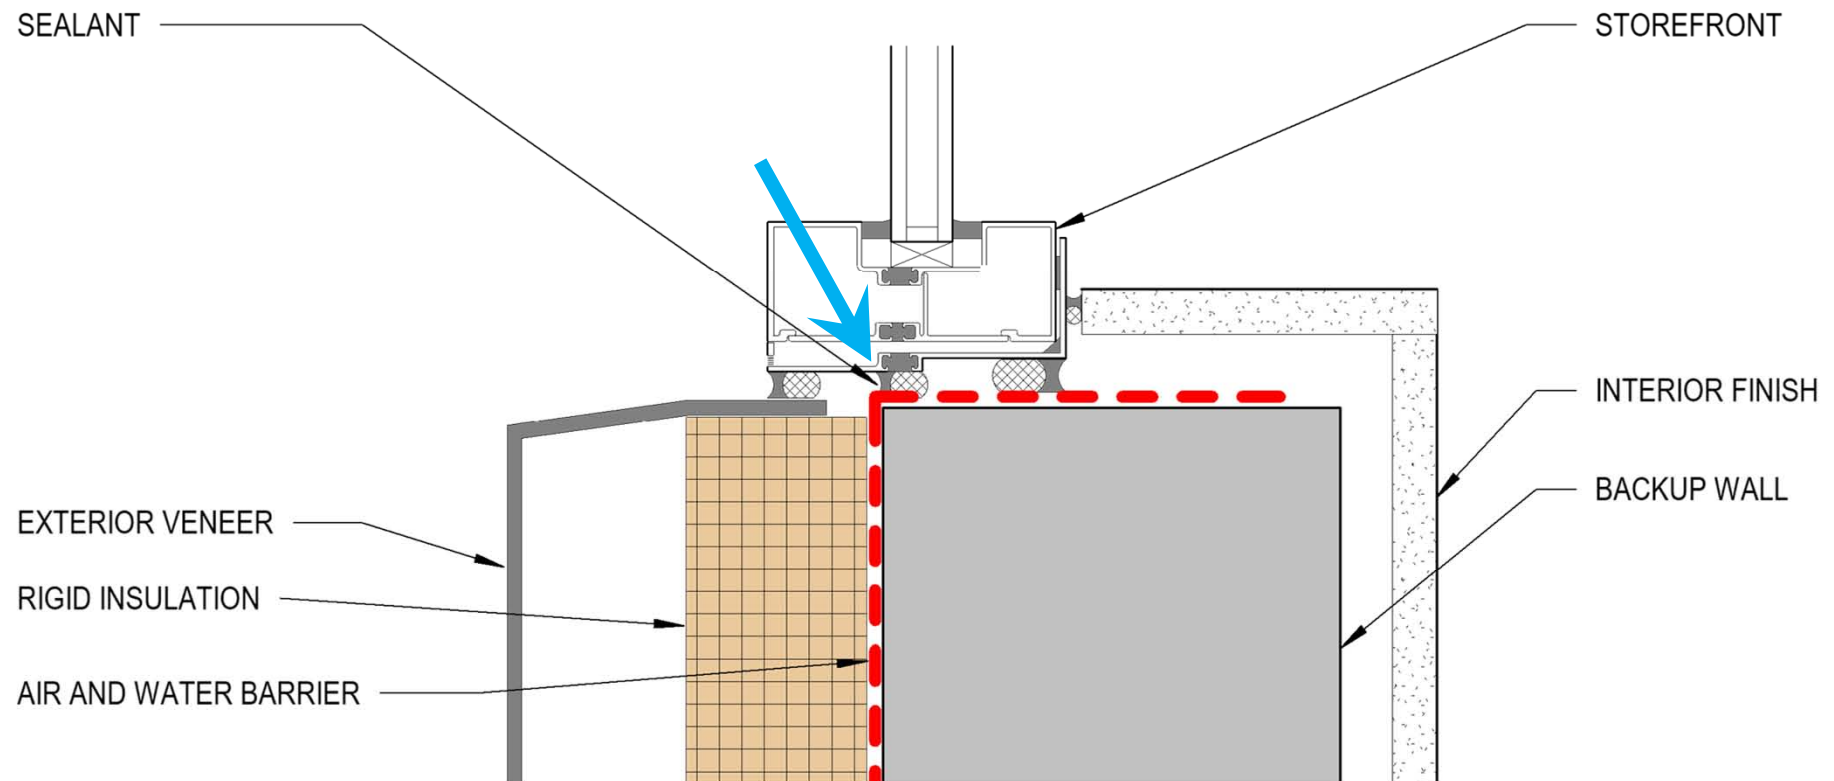
- Outer Seal to Veneer
- 2 lines of Protection
- Reduces air infiltration path past Thermal Break

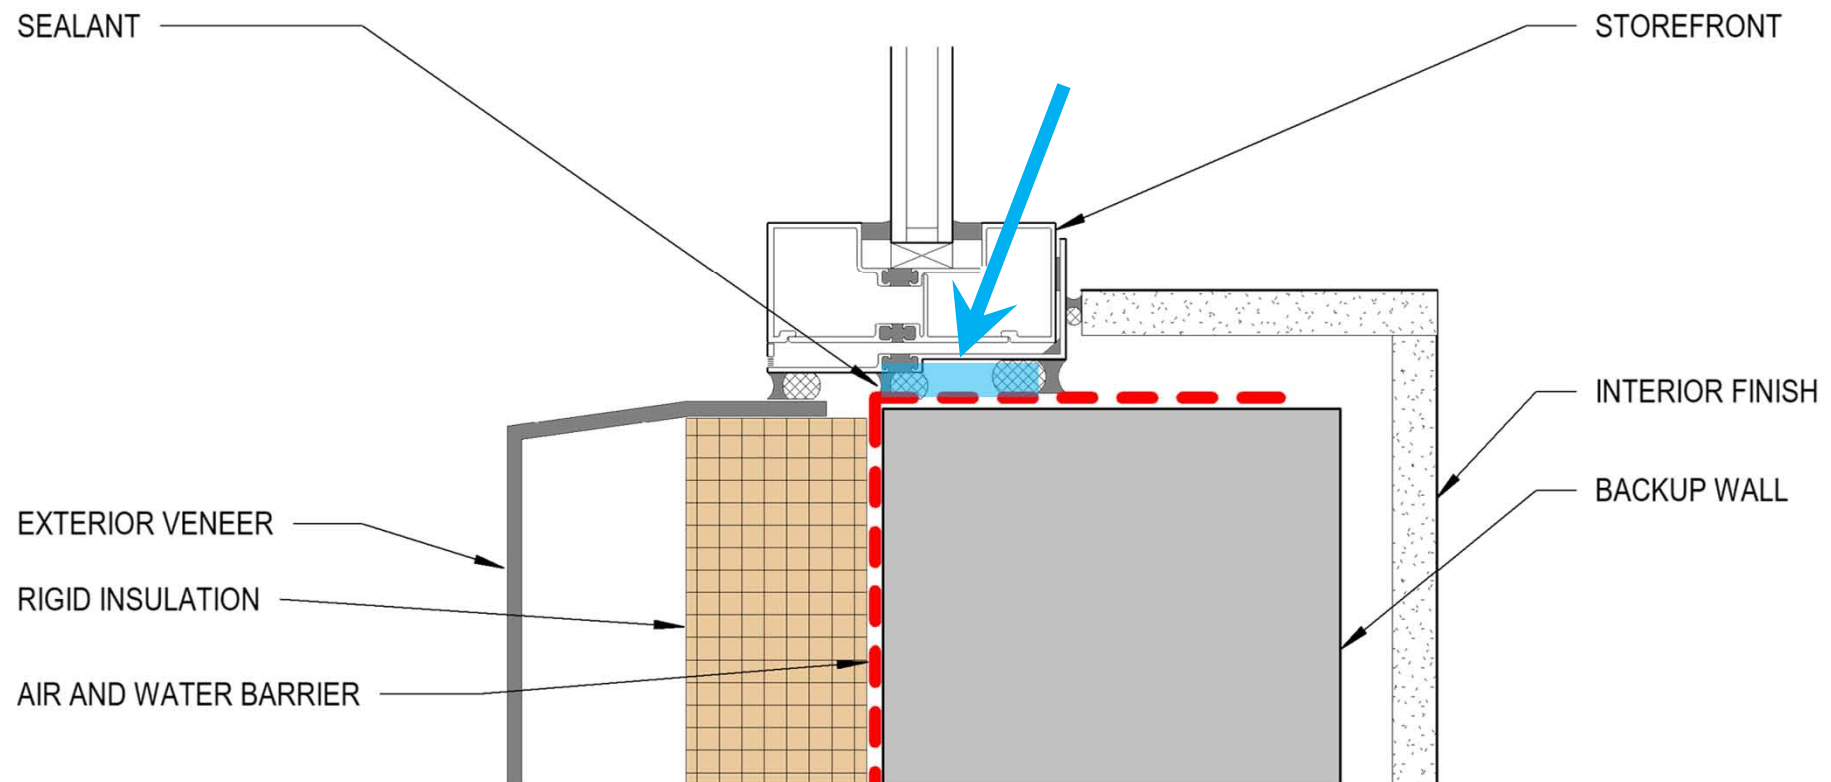
- Outer Seal to Veneer
- 2 lines of Protection
- Reduces air infiltration path past Thermal Break
- Sealant may conflict with shims
