BUILDING 20
ENCLOSURE 23
CONFERENCE

High Performance Building Envelope

Steven Tratt

WTI/ CANAM Building Envelope Specialists

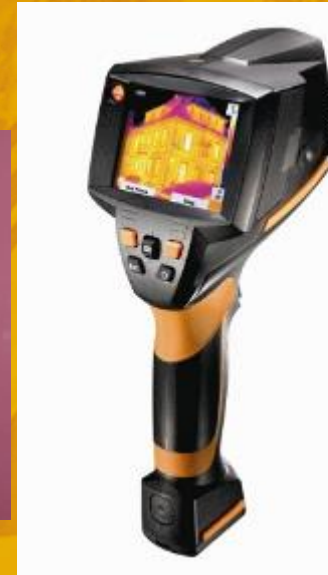
Flir E50 BX
IR camera

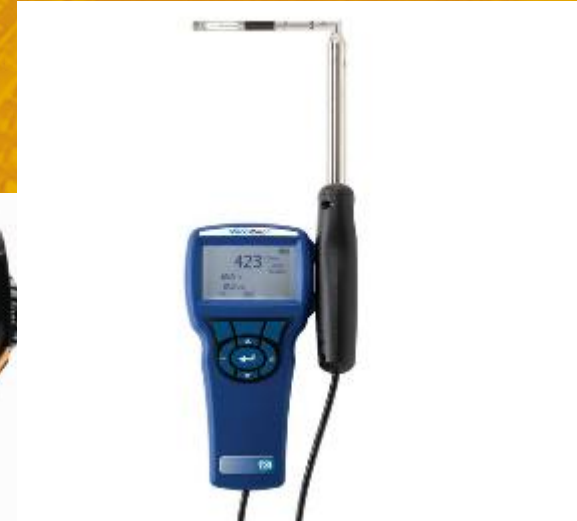
Velocicalc 9565
IAQ Probe 980 for:
Temp – RH
CO₂ – Pressure
Mold and BIO snaps

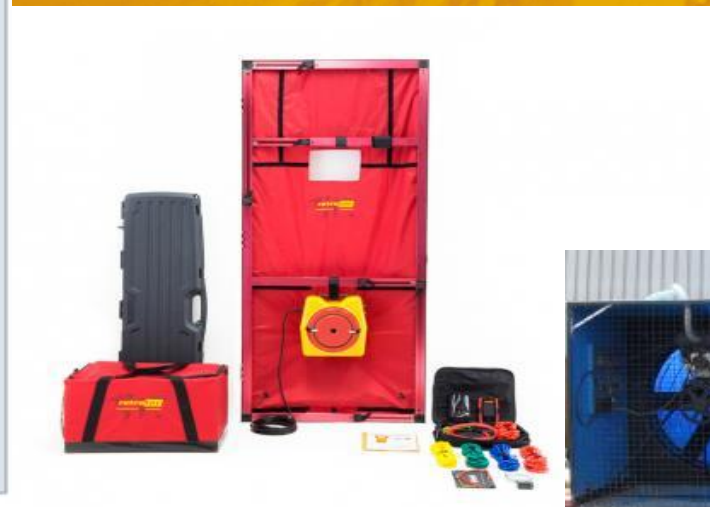
Standard Pressurization Kit and gauges used by Building Science Engineer Partner

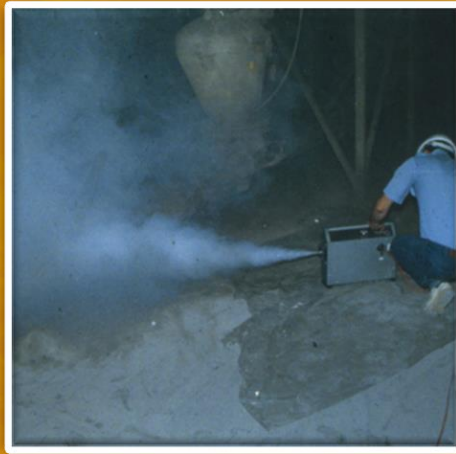
Pressurization testing

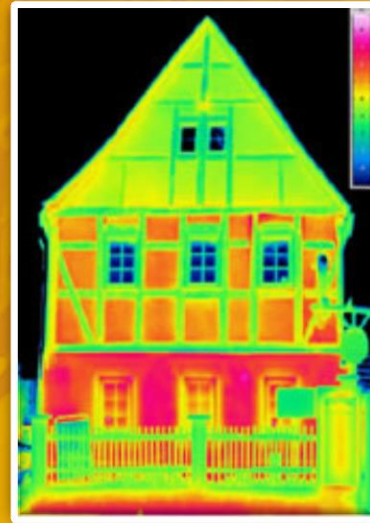
Infrared thermography

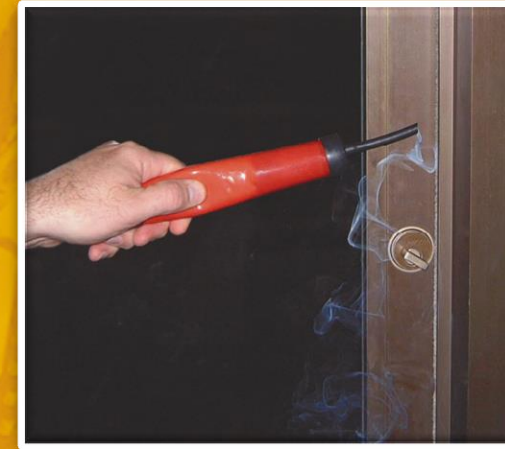
Smoke Puffer (Pencil)

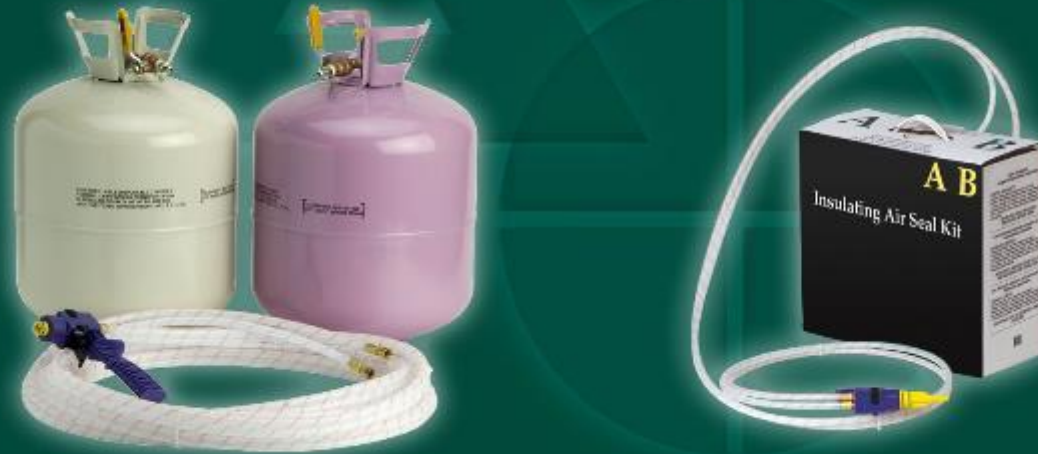
2-component polyurethane foam
insulating air seal kits

Must meet requirement of ULC Standard S711.1

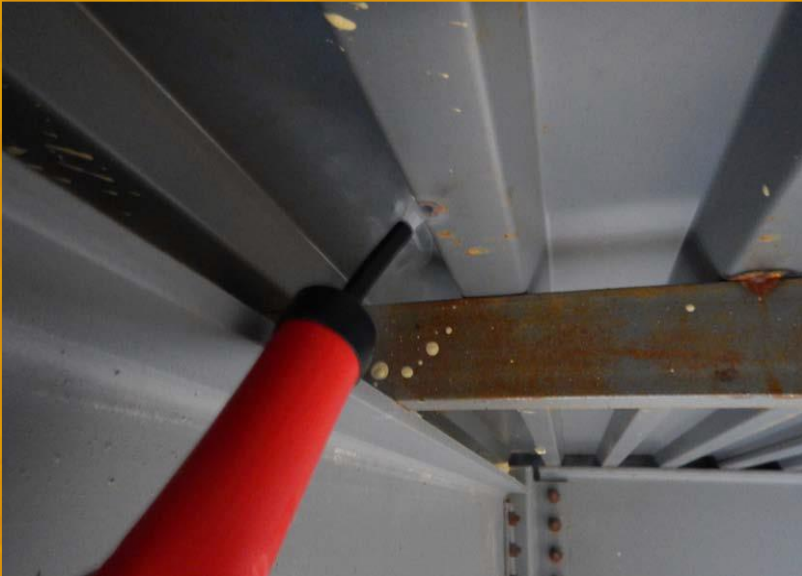
Knee wall attic, many holes in roof deck below attic space. Condensation issues

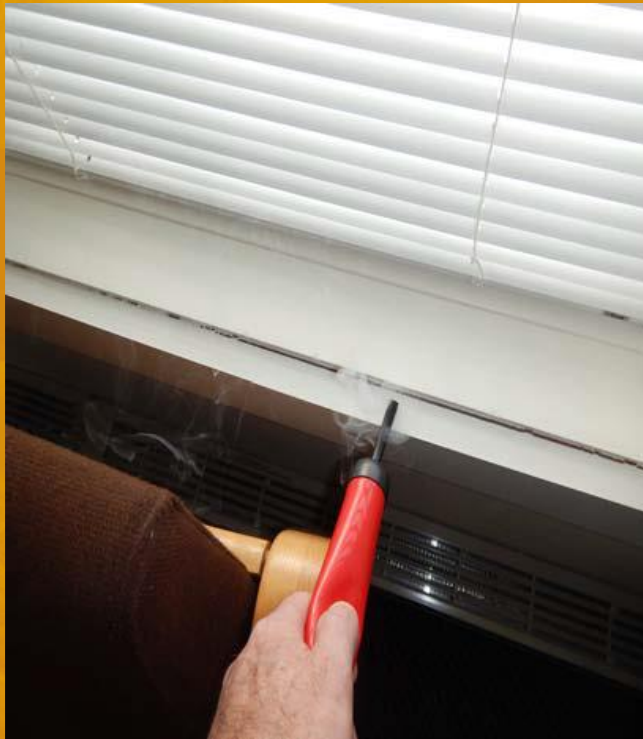
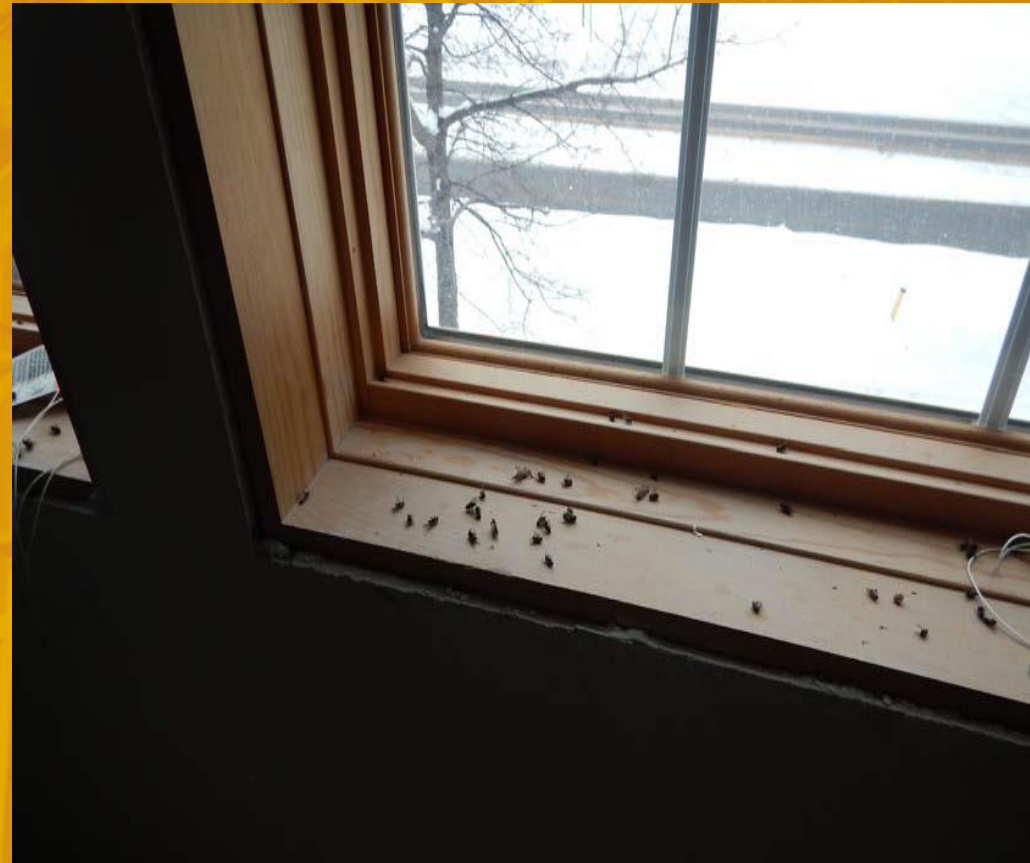
Window Trim- signs of insect migration

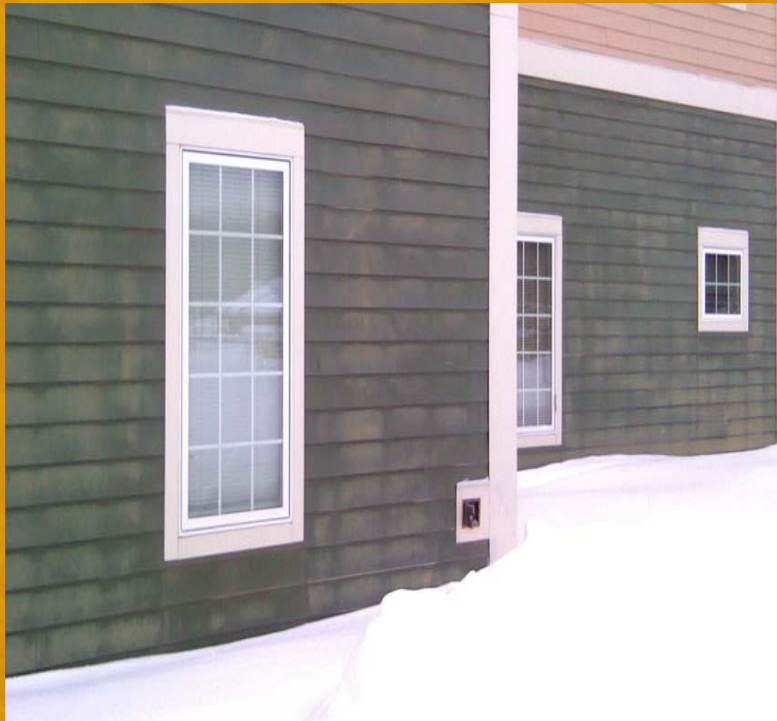
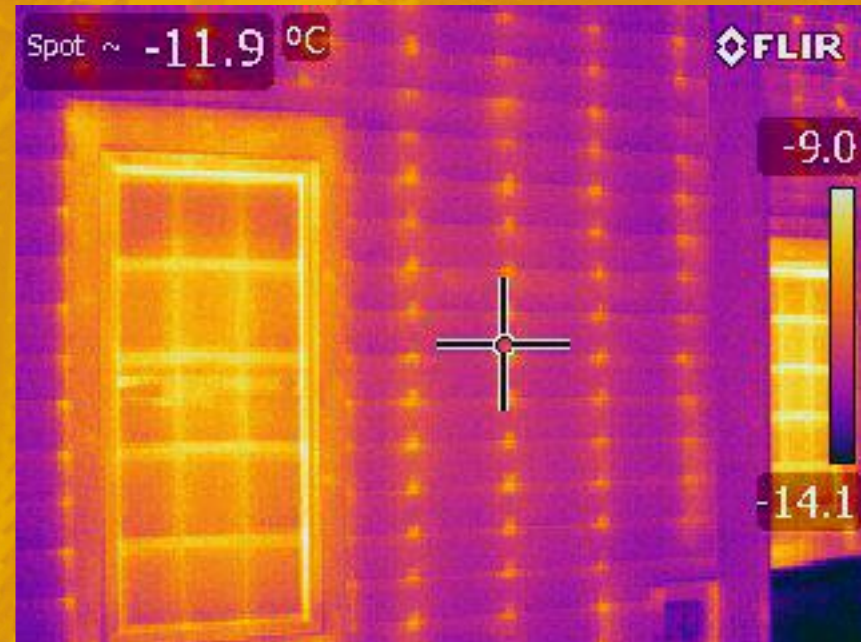
Exterior Façade Issues-Thermal bridging

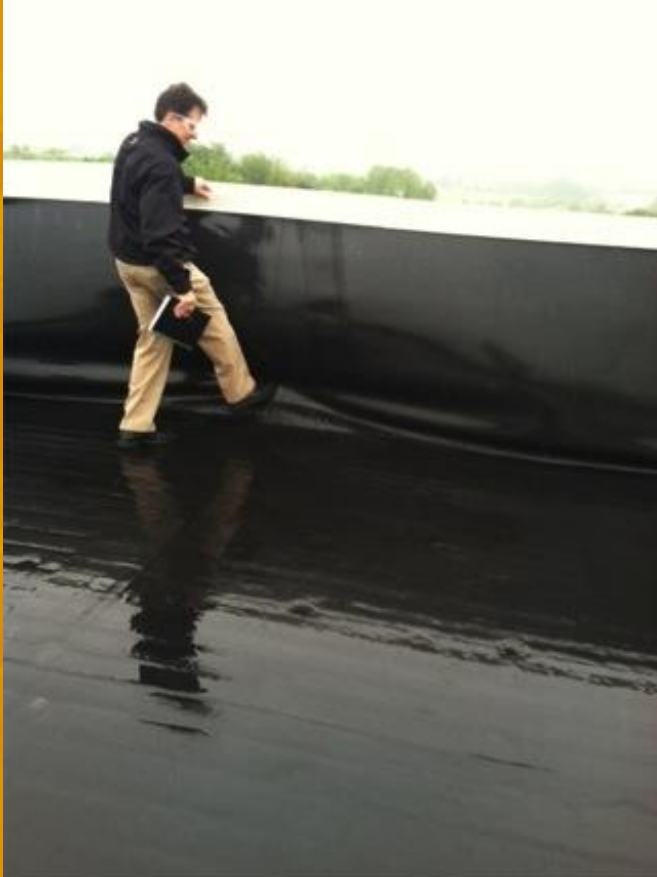
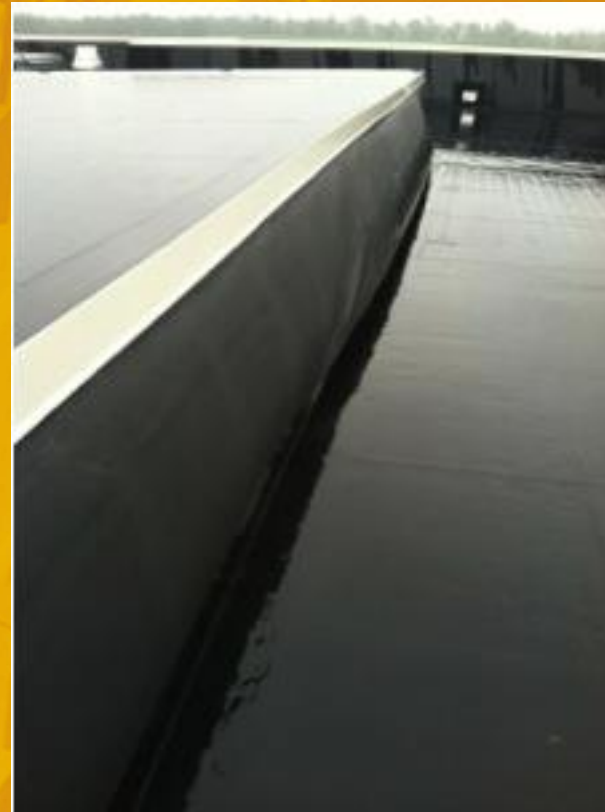
Issue: Manufacturing Company with pressure blowing roof into roof flashings causing failure

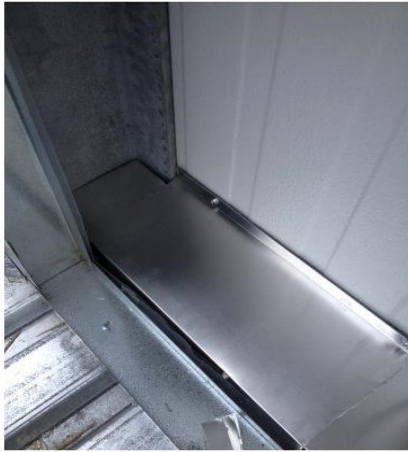
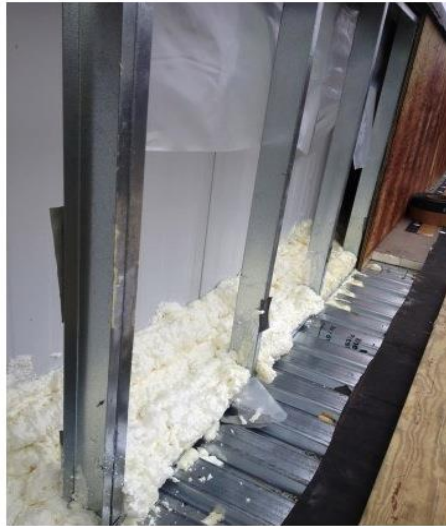
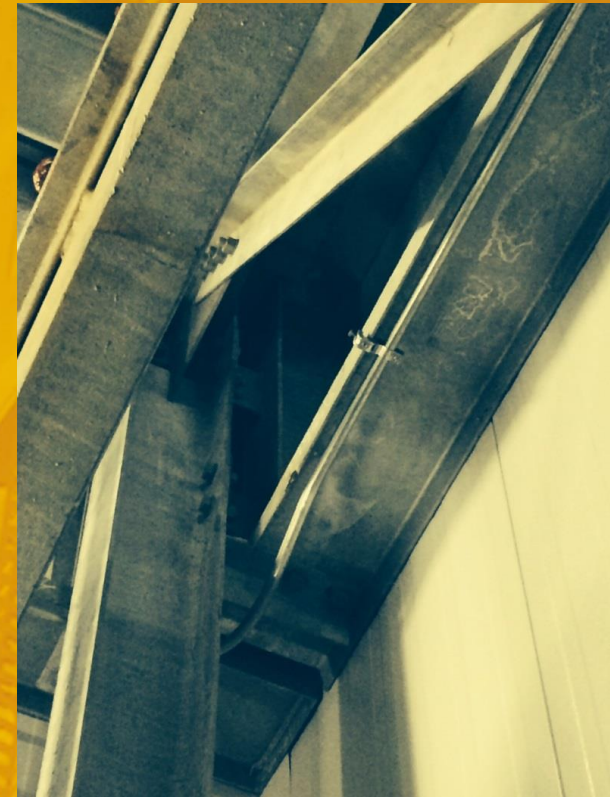
Results: Project coordinated with Roofing contractor to install metal wall panels and remediate air leakage at Roof Wall connection.

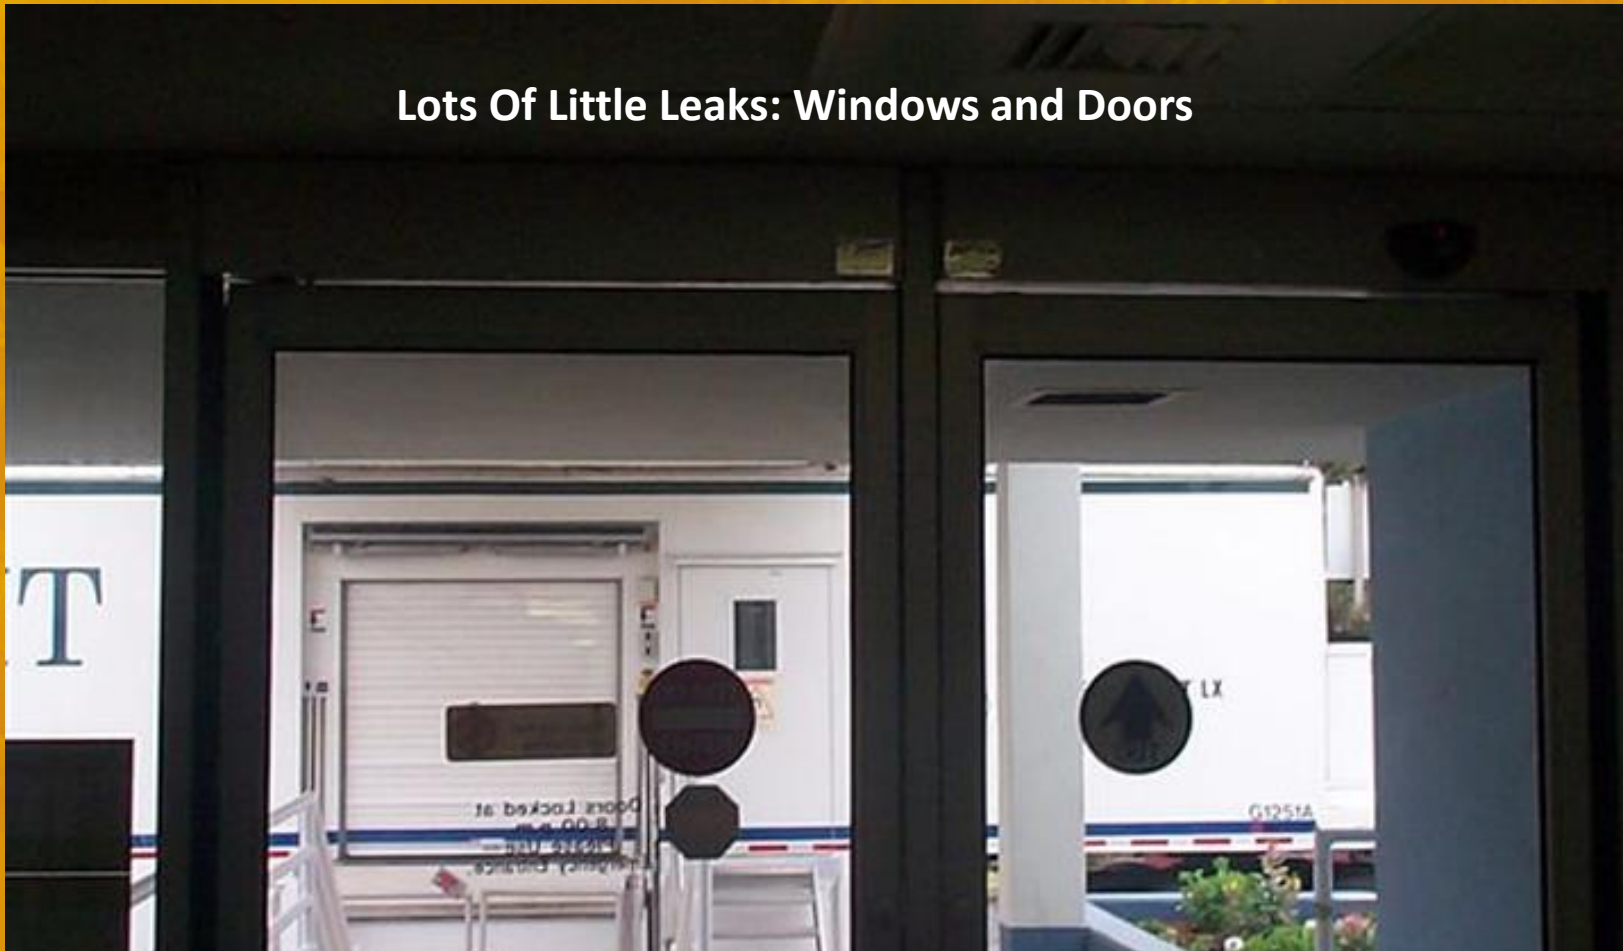
Lots Of Little Leaks: Windows and Doors

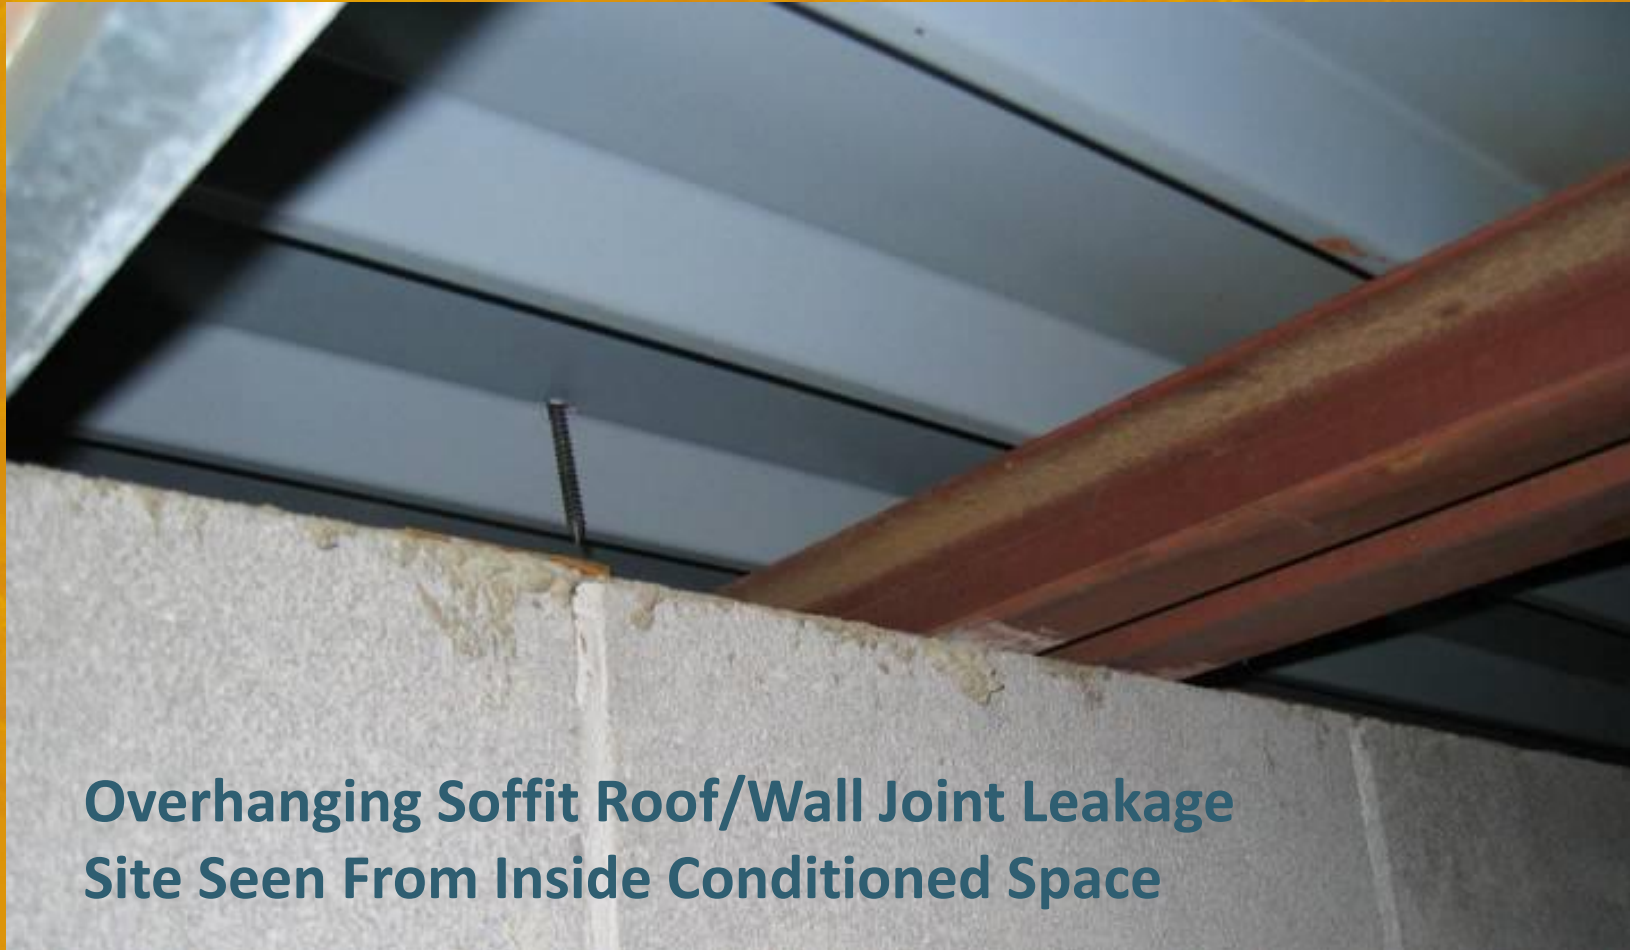
**Overhanging Soffit Roof/Wall Joint Leakage
Site Seen From Inside Conditioned Space**

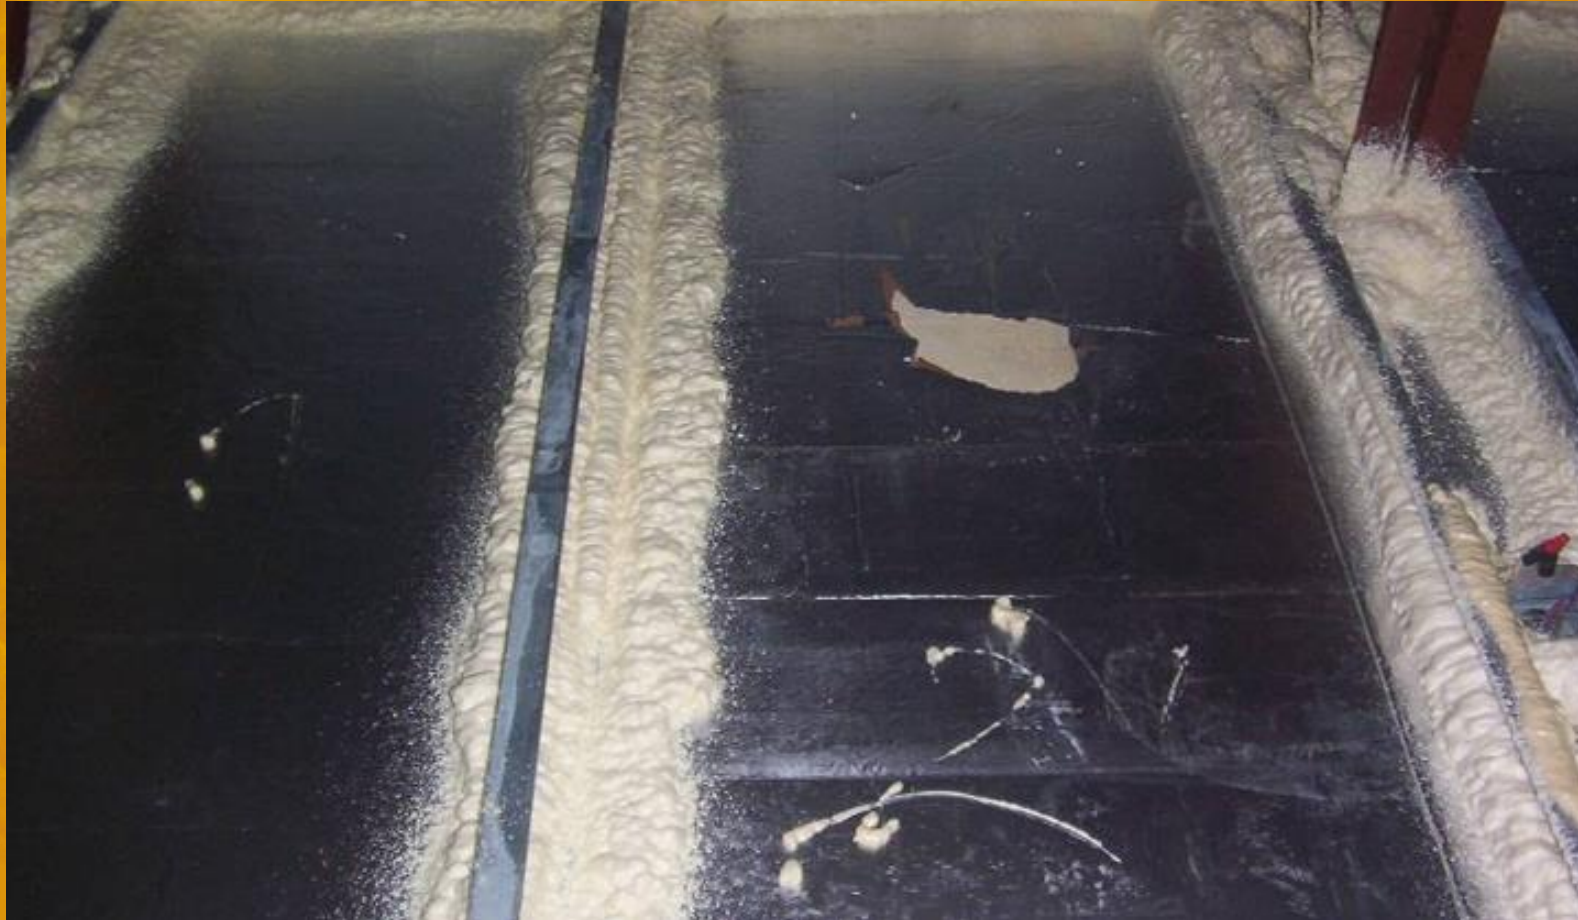
Metal soffit panel seams, sealed with foam sealant
