# Whole Building Airtightness: A 439 Building Study of Performance

**Mike Poirier**

QED Lab  
Troutdale, Oregon

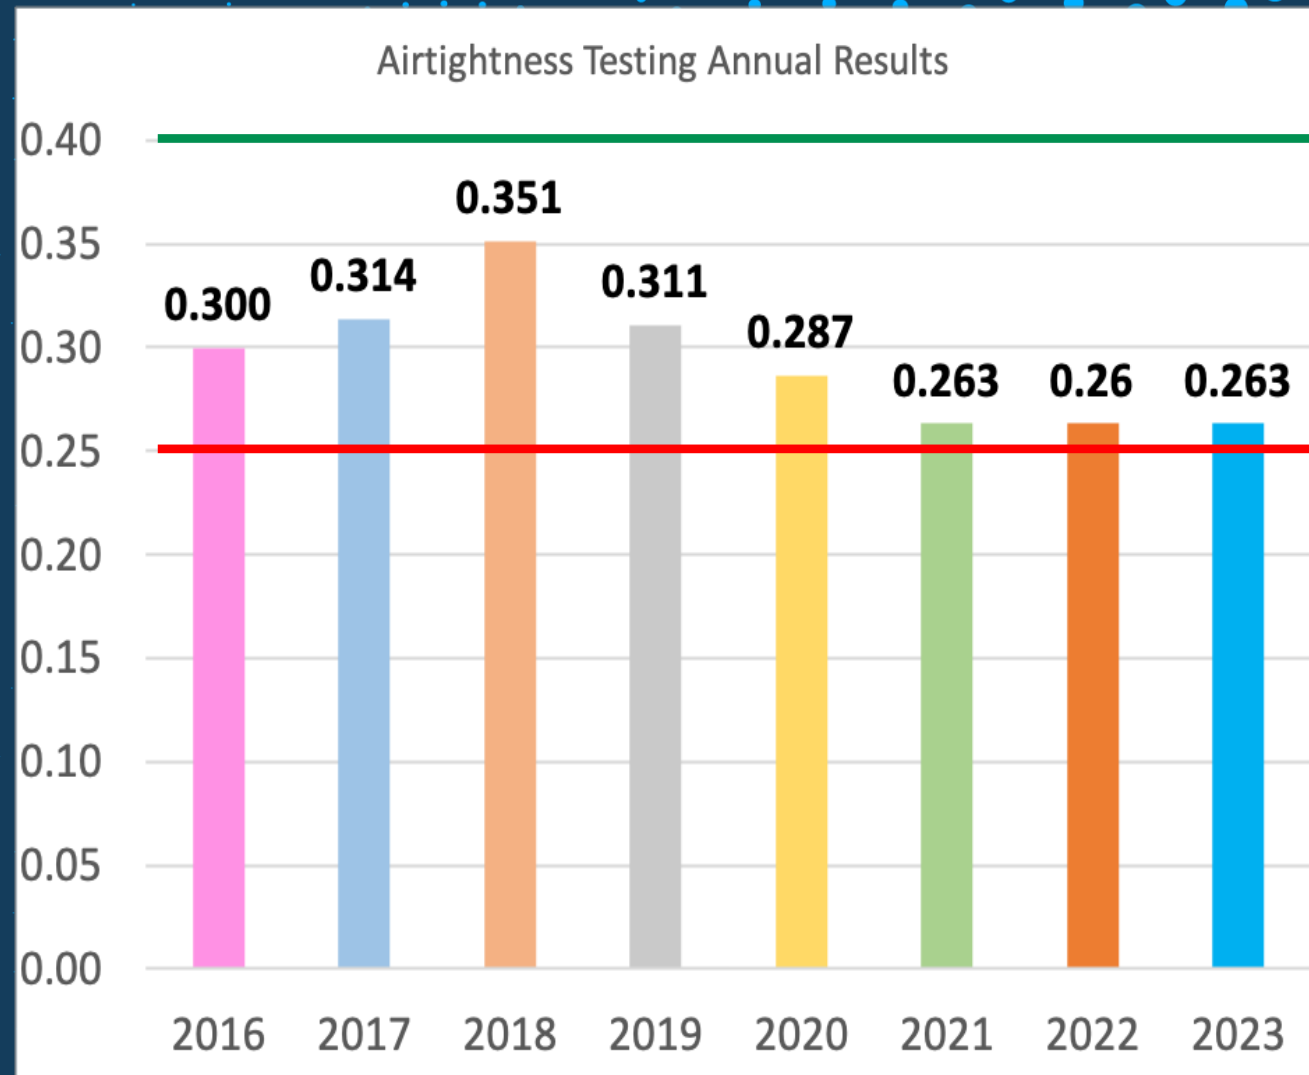
# Actual Building Performance

Year	Best (CFM/SF)	Worst (CFM/SF)	Average	Specimens Tested
2016	.037	.478	.331	48
2017	.073	.518	.294	53
2018	.065	1.05	.328	59
2019	.039	.553	.336	76
2020	.043	.961	.305	83
2021	.074	.569	.284	120
2022	.051	.505	.283	102
2023 (Jan – Mar)	.150	1.31	.366	38

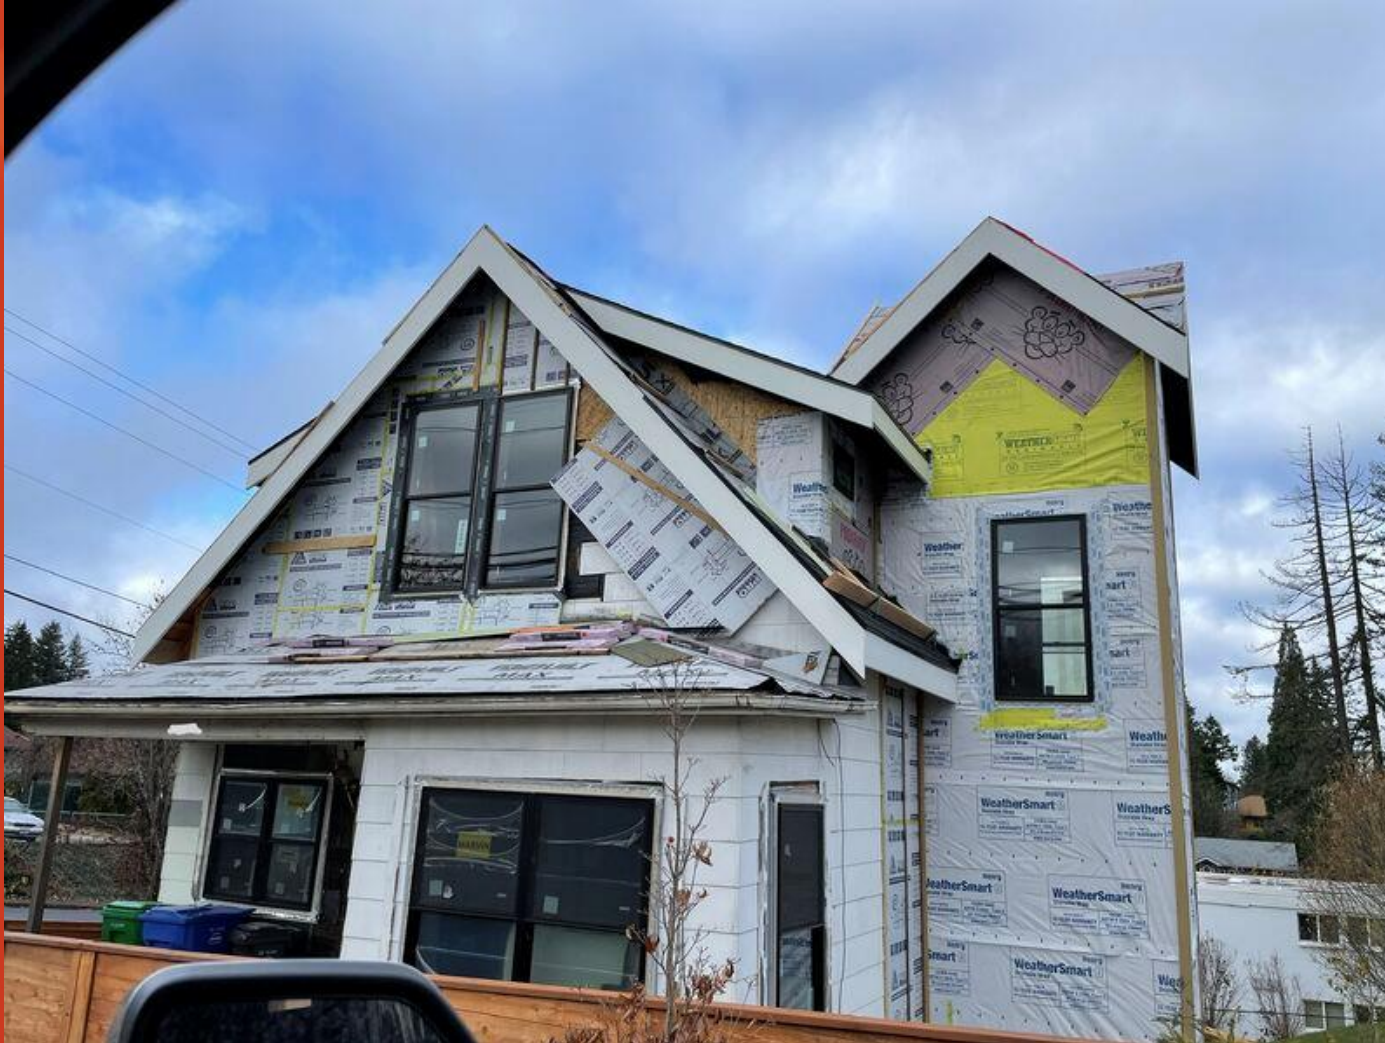
# Failure Rates

## What happened in 2022 / 2023?

- Supply chain problems
- Product substitutions
- Labor shortages
- Rushed installations
- Code changes

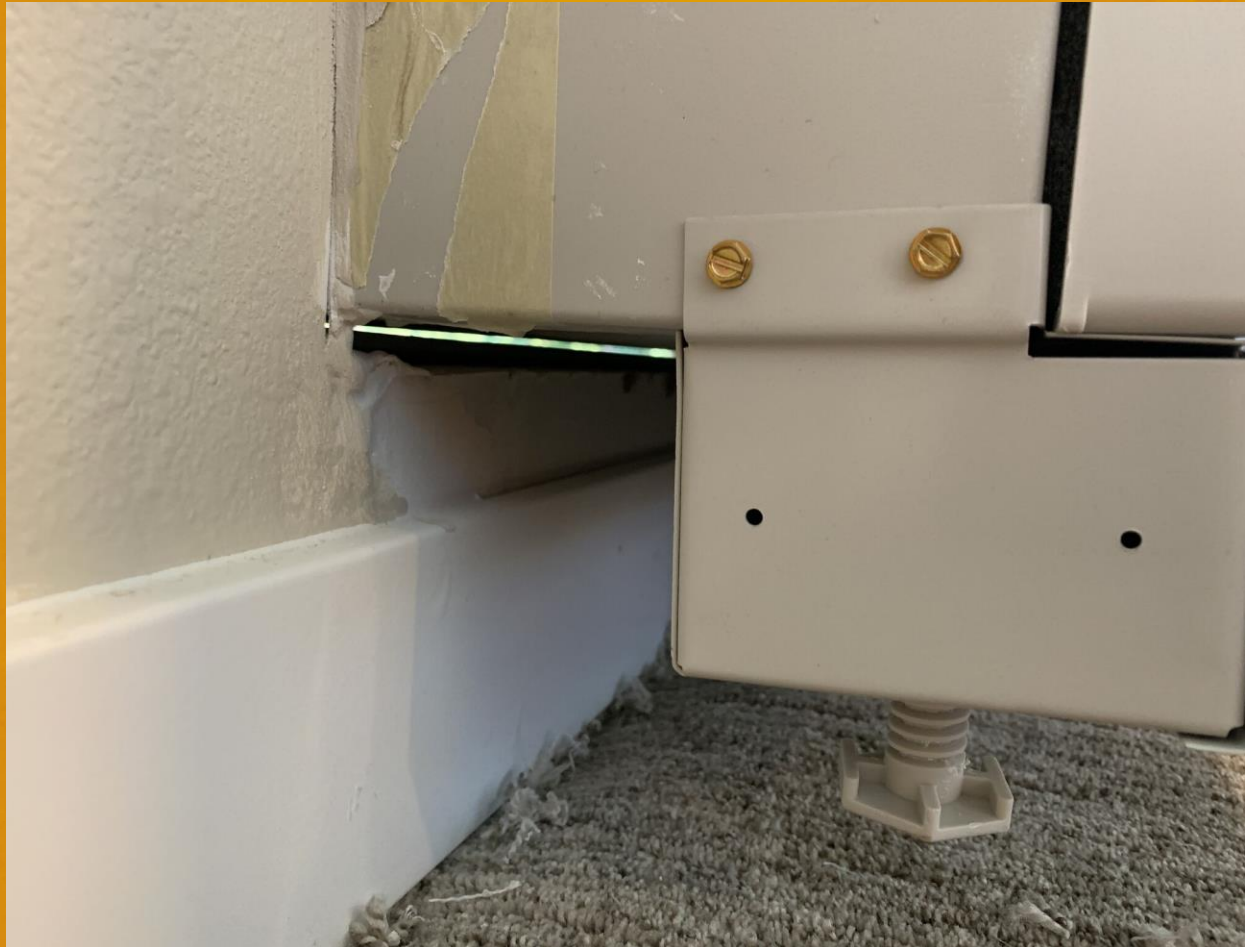
## #3 PTAC and VTAC Units

# Most Common Air Leakage Sources

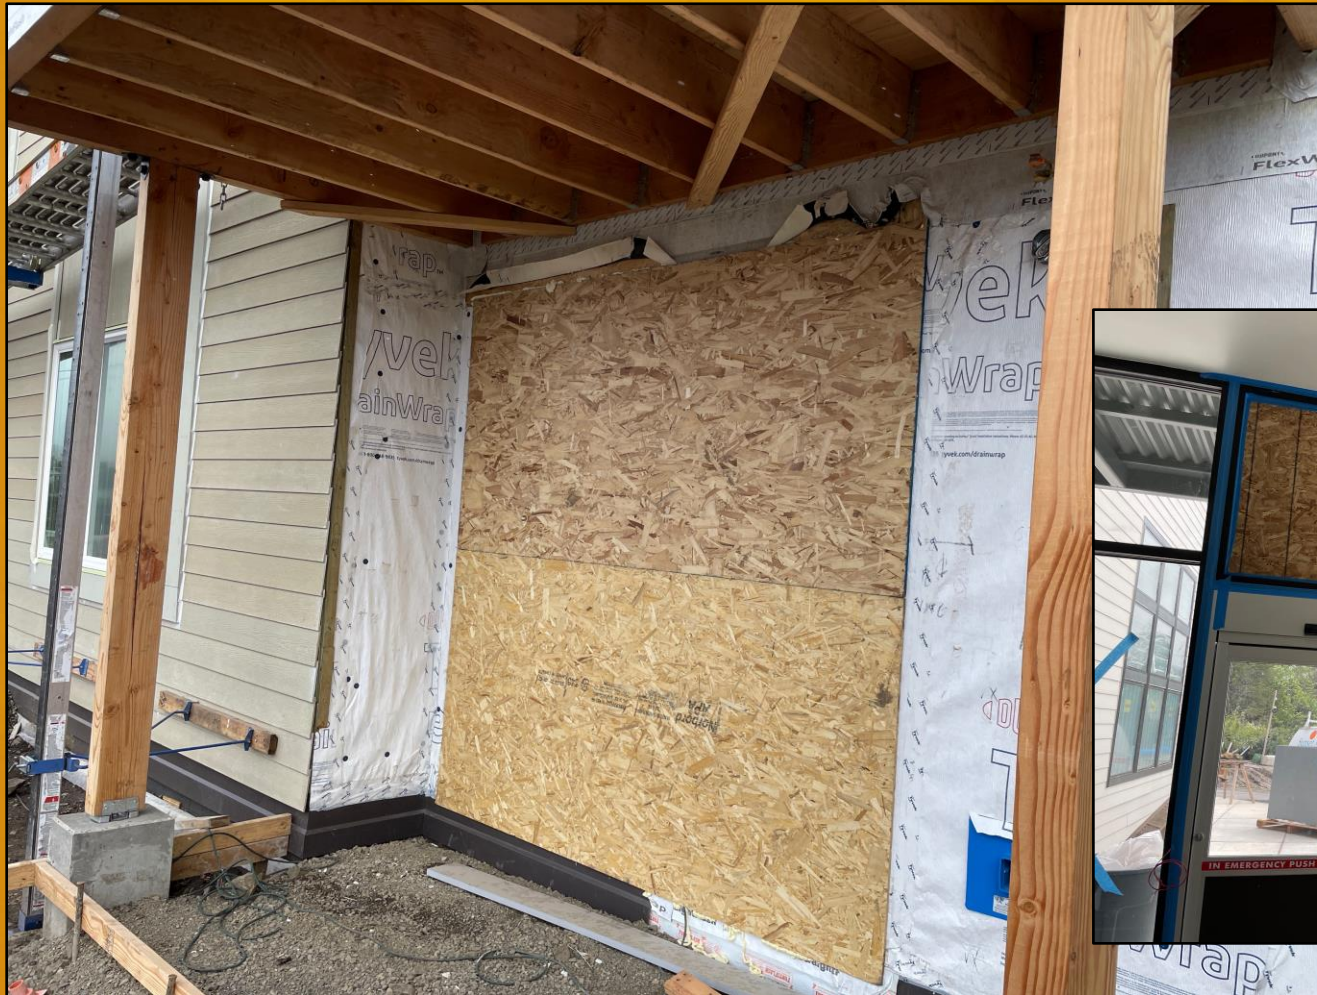
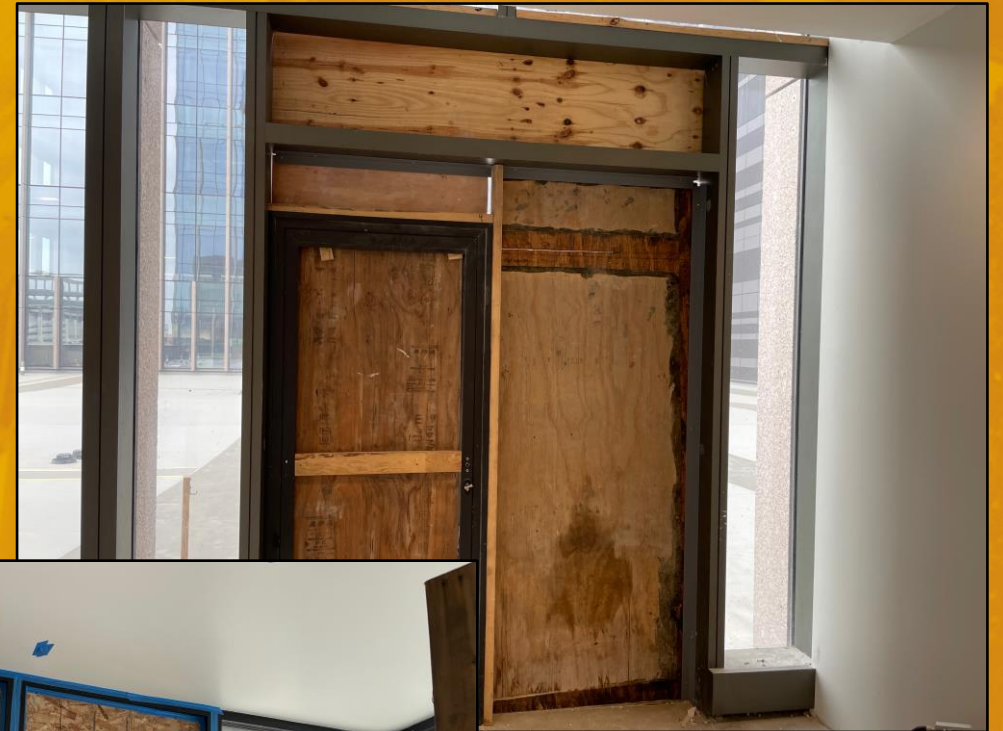
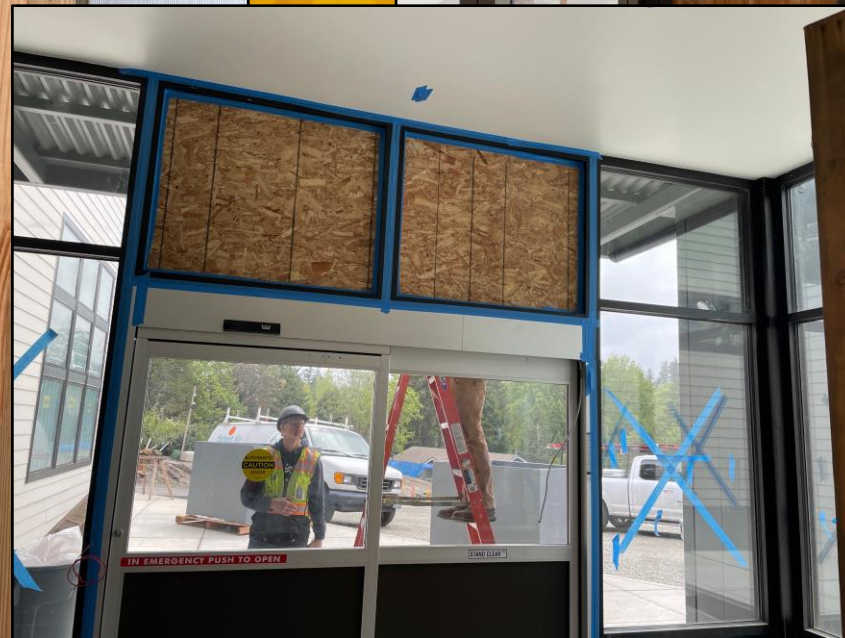
## Incomplete Enclosure

# Most Common Air Leakage Sources

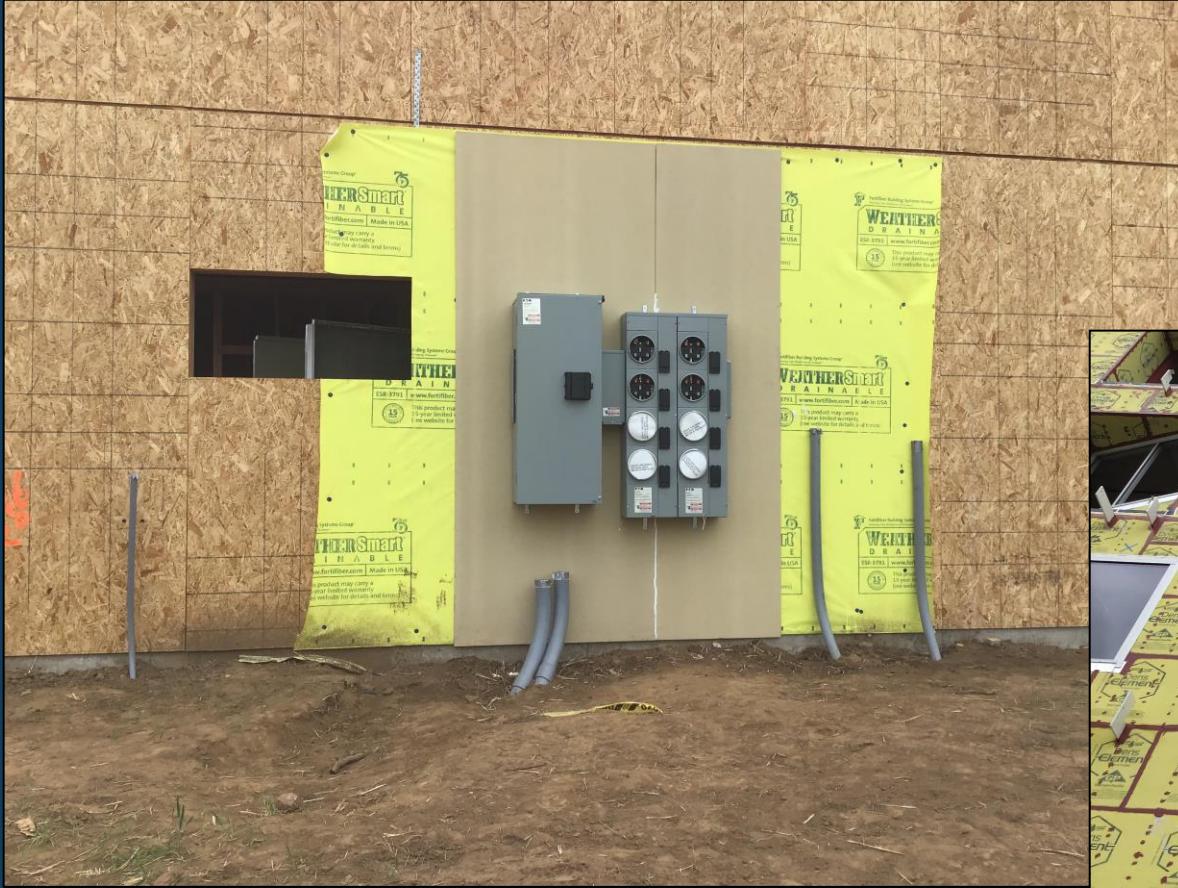
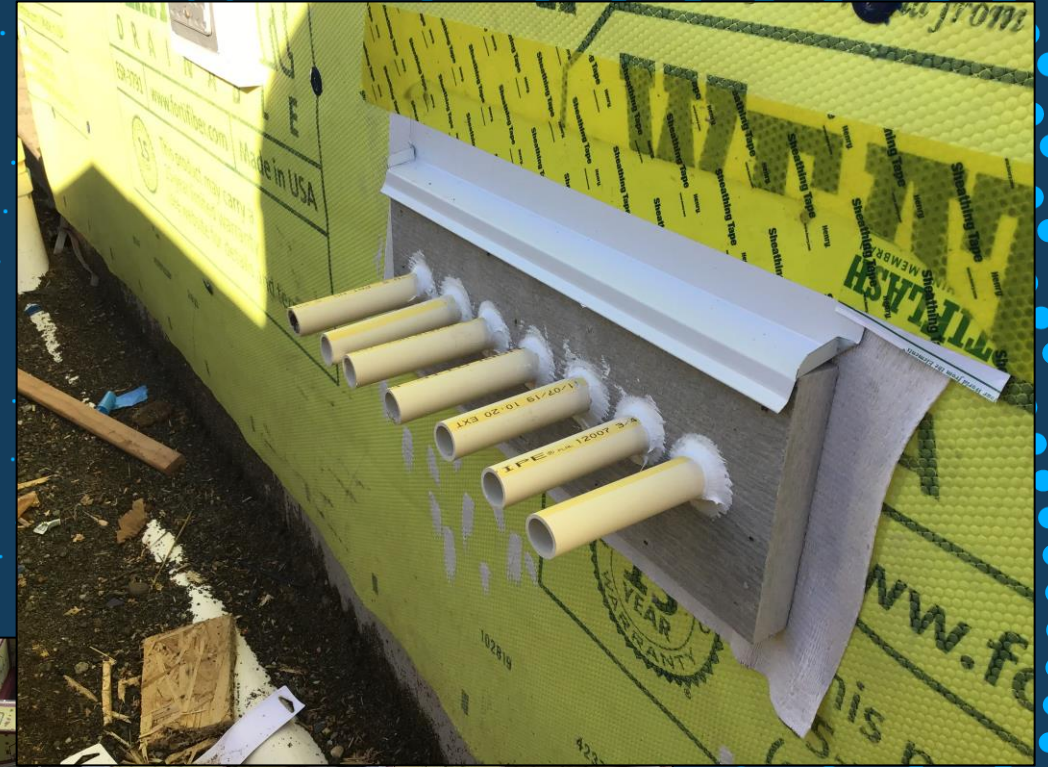
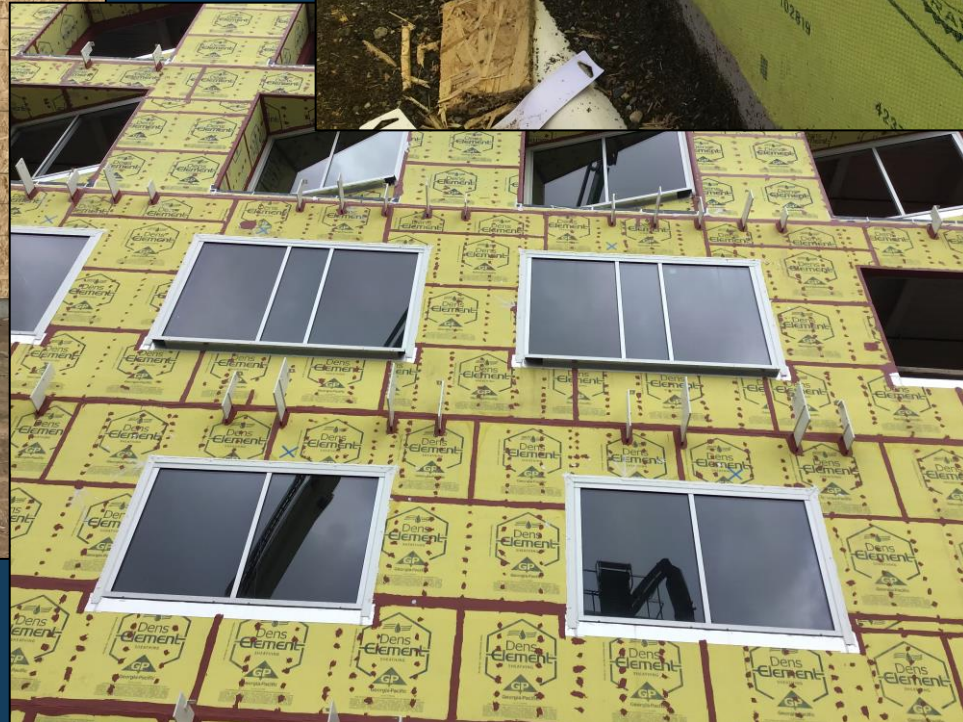
# Details Proven to Perform: Wall Systems

- Seal all penetrations prior to cladding installation
- Install air barrier prior to electrical meter mounting
- Seal all seams and transitions

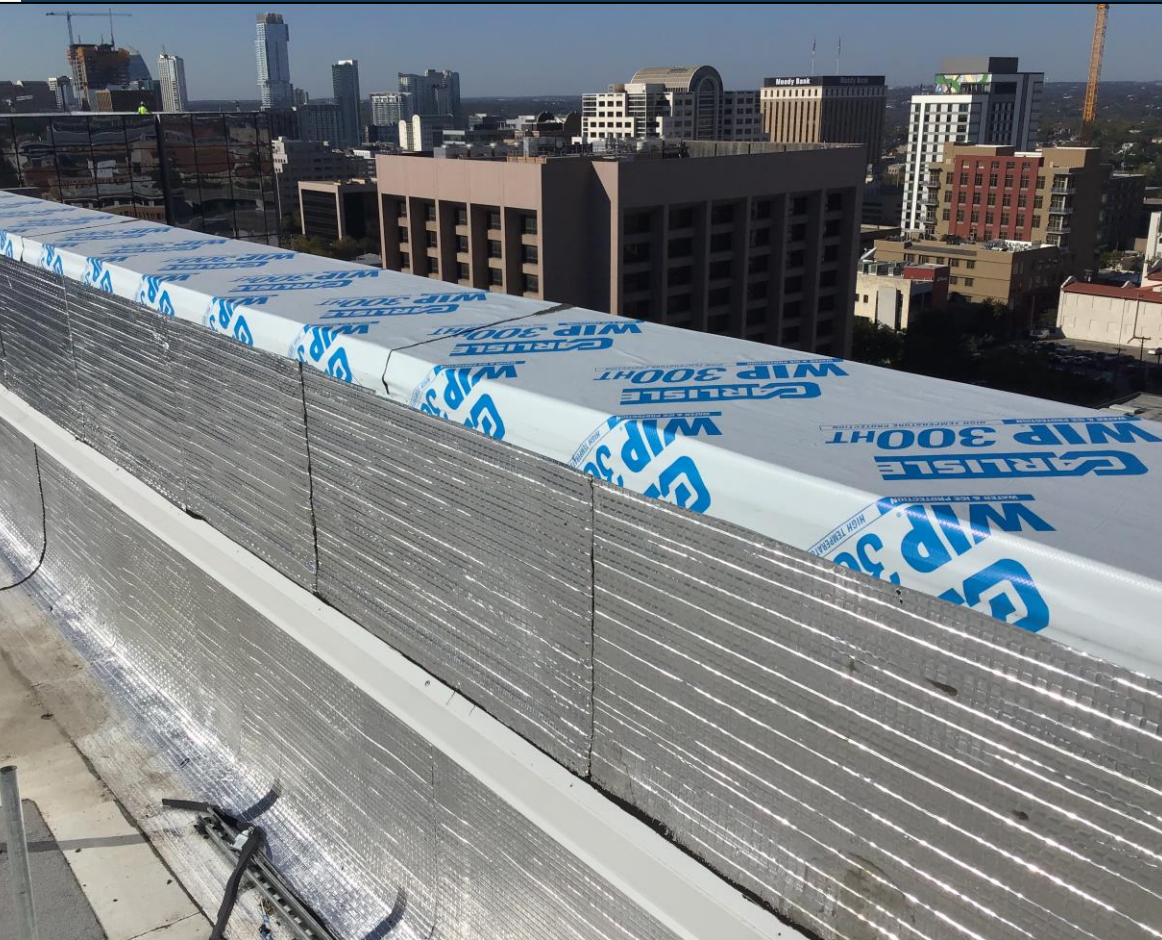
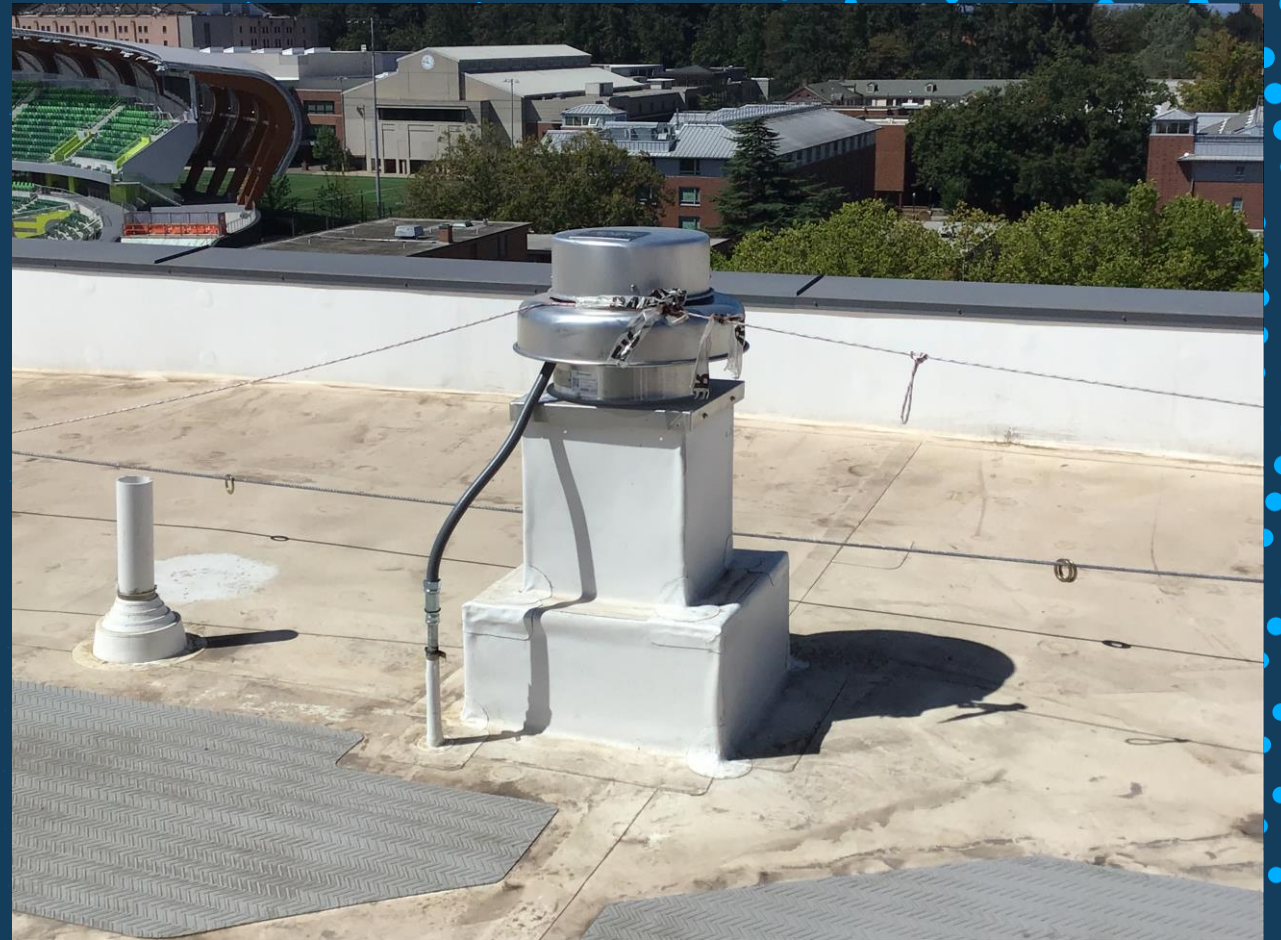
# Details Proven to Perform: Parapets & Roofs

- Seal parapet walls to roof and wall air barrier
- Welded seams at TPO roof, cinch bands on pipe penetrations
- Extend roofing up parapet wall for wall air barrier connection

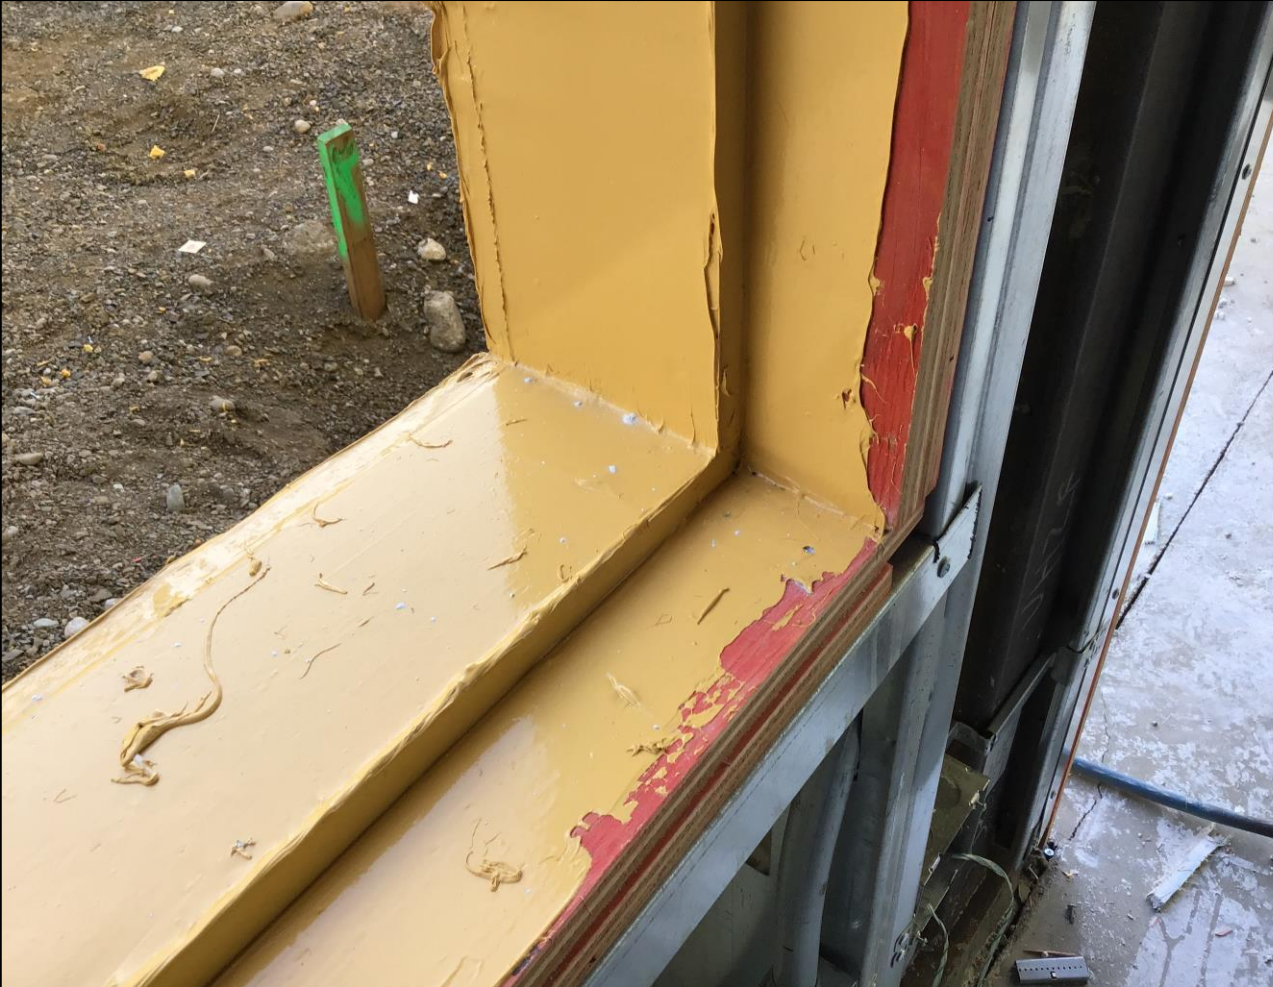
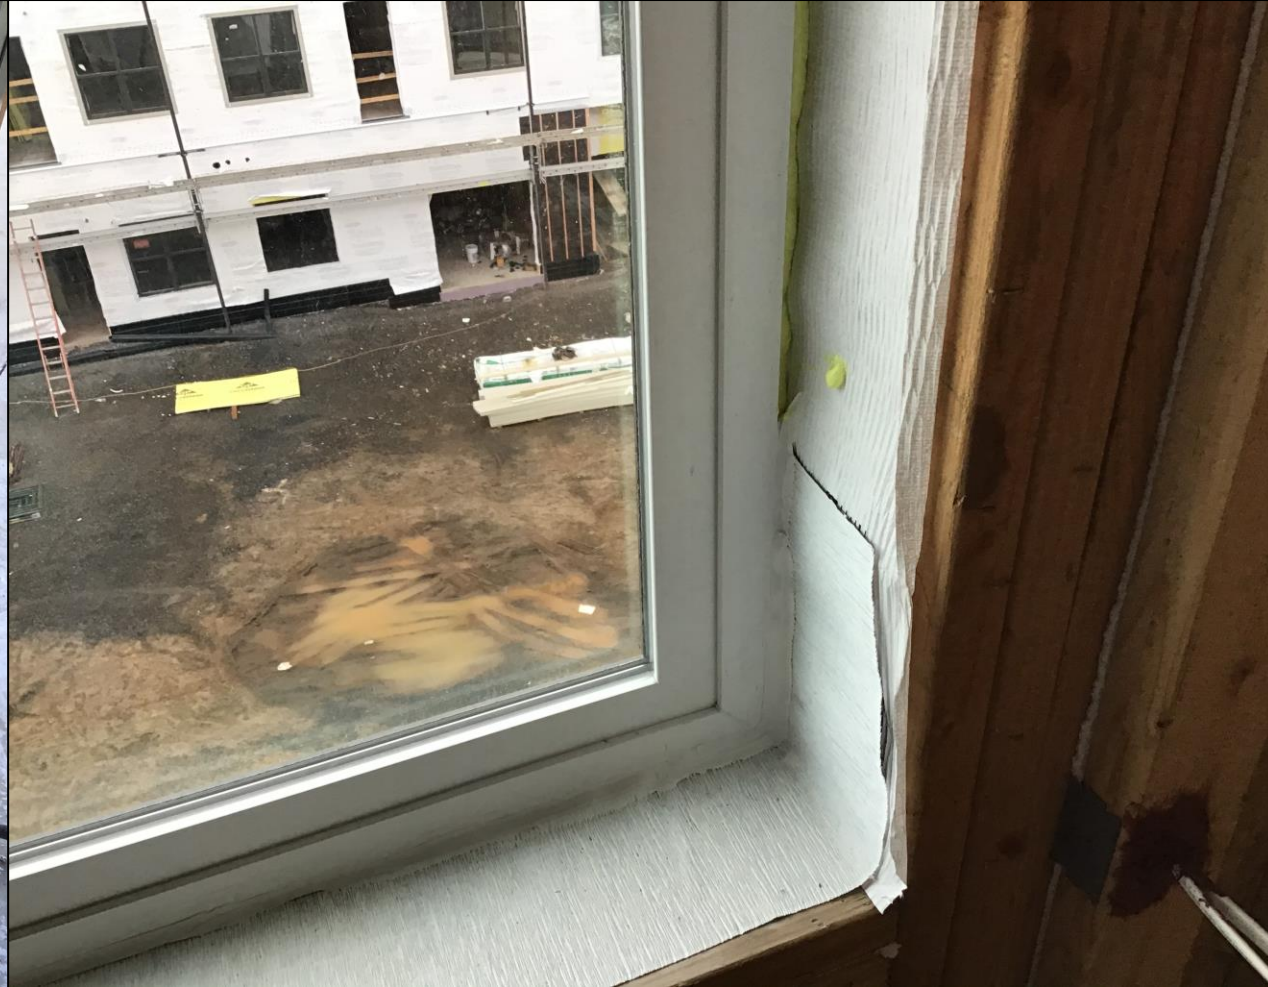
# Details Proven to Perform: Windows & Doors

- Extend air barrier from RO to interior
- Seal window to RO air barrier
- Set door thresholds in sealant, or use sill pan with interior back-dam to accept a sealant joint
