air barrier  
**abaa**  
association of  
america  
**CONFERENCE  
& TRADE SHOW**  
MARCH 26-27  
**2019**  
NORFOLK  
**VA**  
AIR BARRIER EDUCATION TRACKS FOR  
THE CONSTRUCTION INDUSTRY

# Avoiding Building Enclosure System Failures

Len Anastasi

*EXO-TEC Consulting, Inc.*

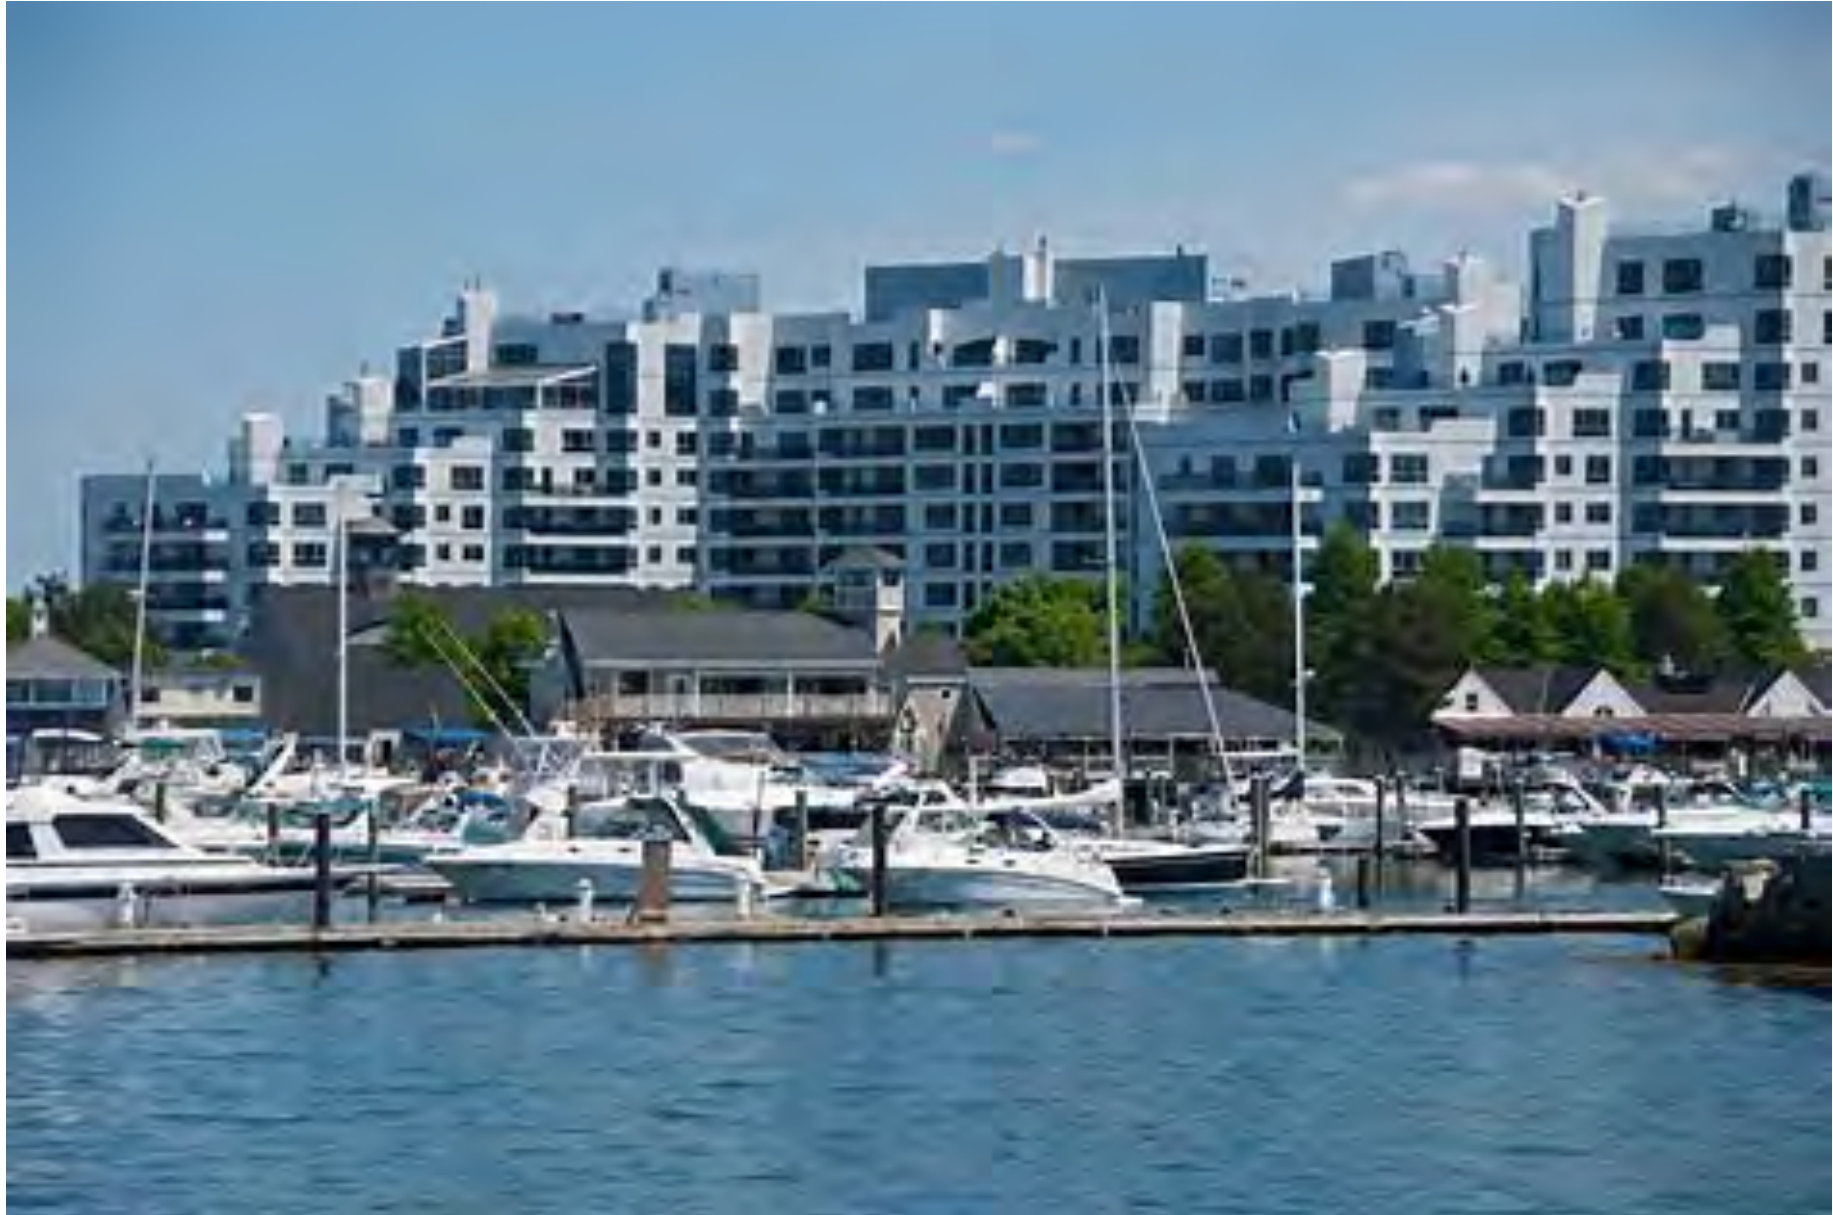
# The Condo Building

**Multitude of water leaks through the above grade vertical building enclosure.**

**Water damage to the building enclosure components.**

1. Water leakage through the existing windows.
2. Water leakage into the LGMF stud cavity.
3. Water leakage into the condo units.
4. A structural code issue???

1. Built in the late 1980's with an EIFS veneer.
2. The building enclosure assembly experienced leaks from day one.
3. Was repaired and re-clad with an ACM panel veneer.
4. The existing windows that were determined to leak by many consultants were not replaced due to budget issues.
5. The building still leaked after the repairs and re-cladding.

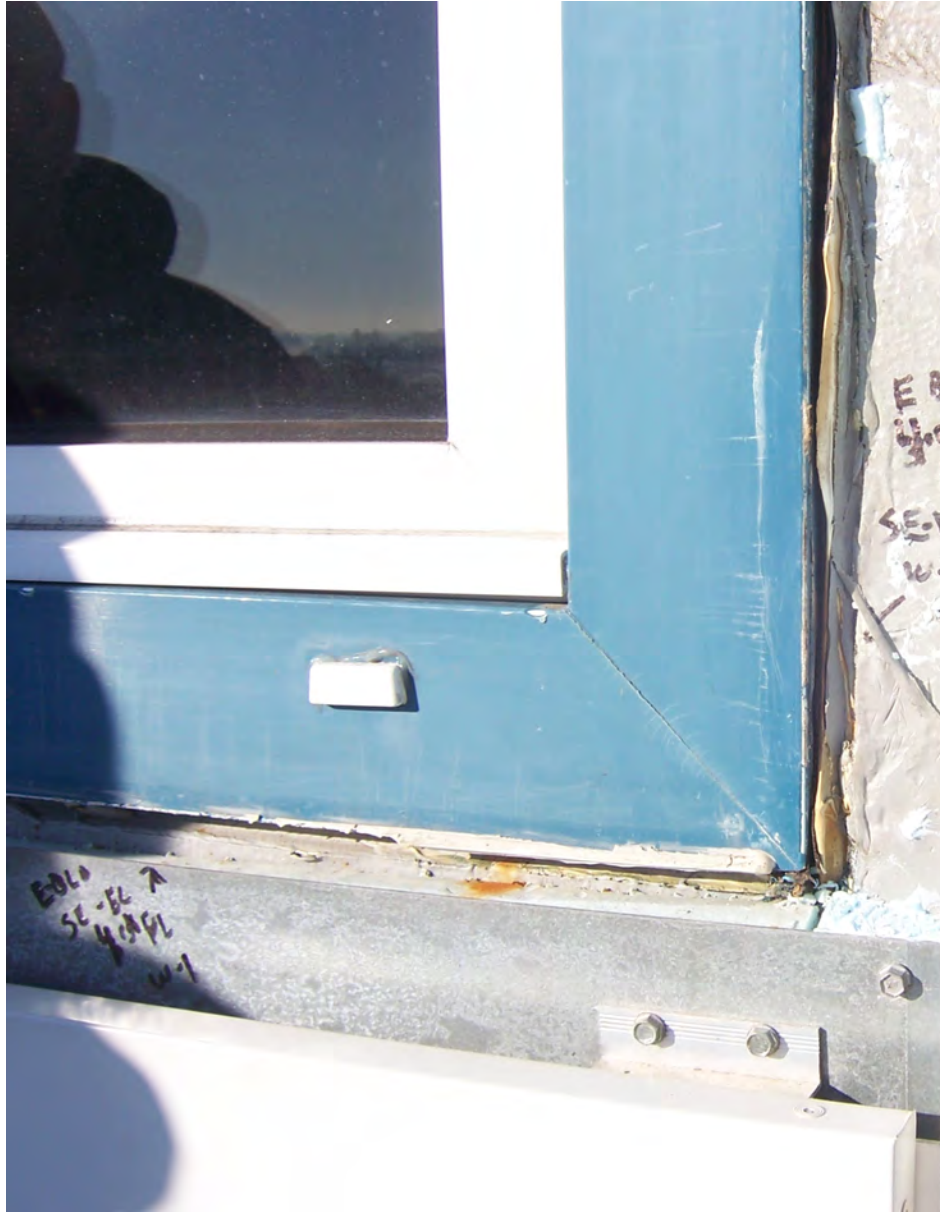
The adhesion of the S/A detail membrane was failing at many locations

**Why did the adhesion of the  
detail membrane to the  
substrate fail???**

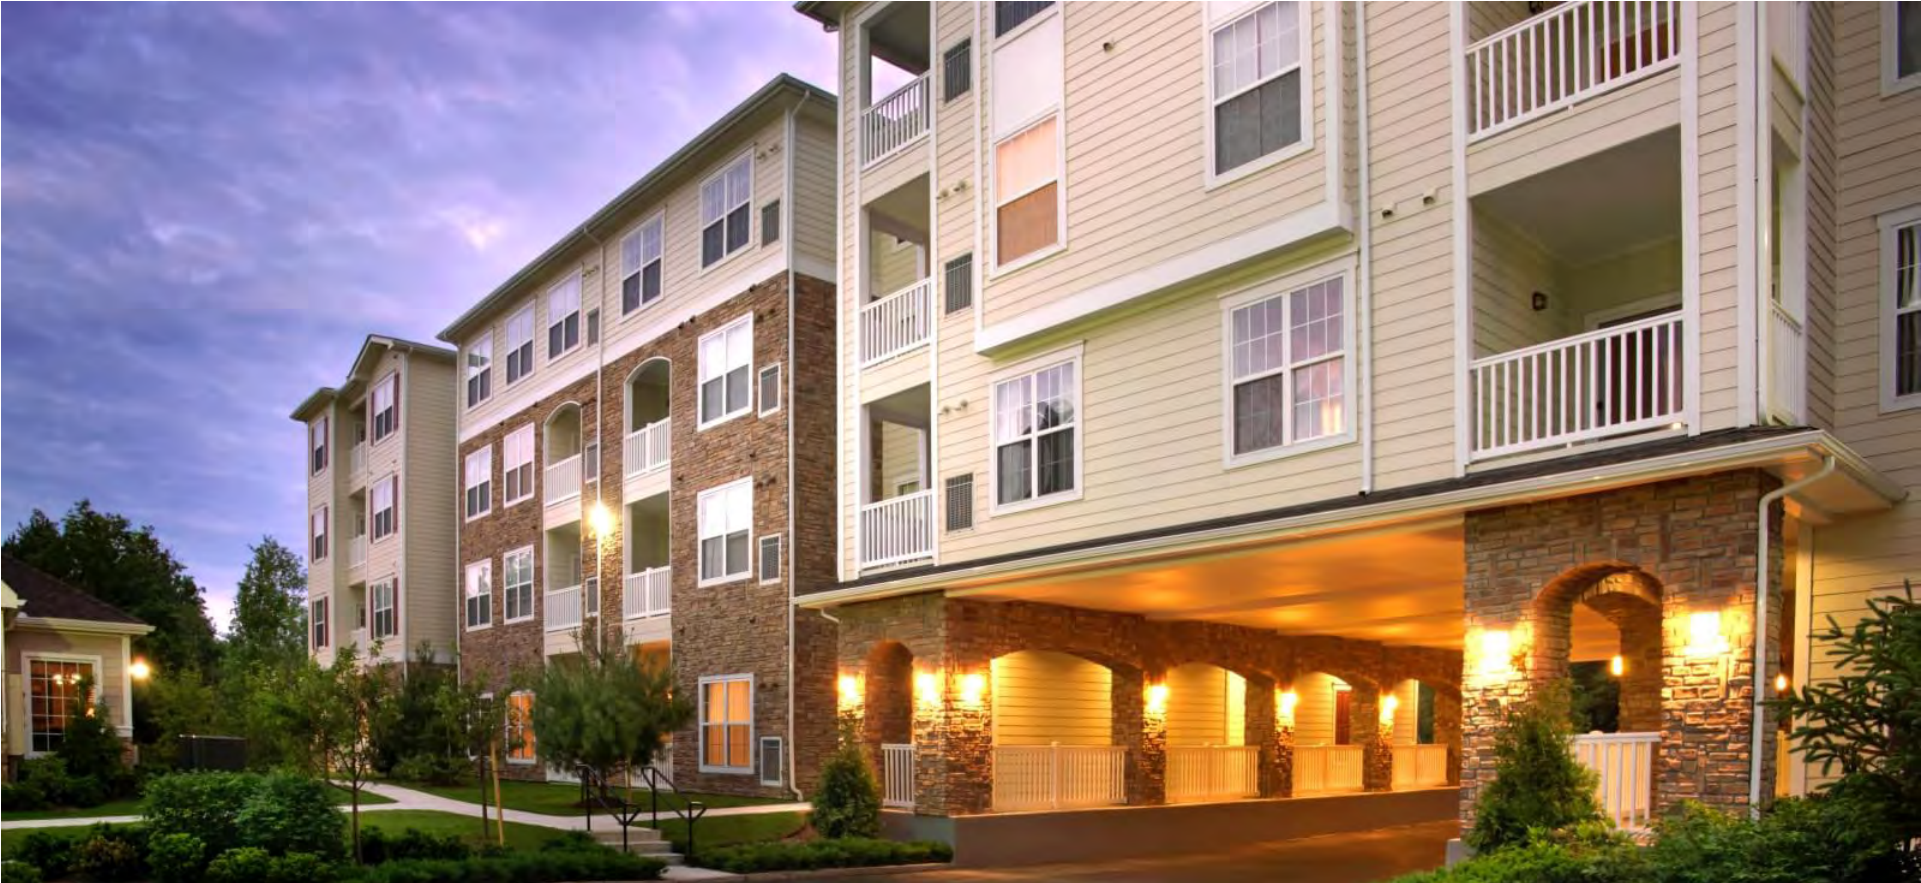
# The Apartment Building

**Multitude of water leaks through the above grade vertical building enclosure.**

**Water damage to the building enclosure components.**

1. Water leakage into the building from several sources.
2. Rotting OSB sheathing.
3. Design issues.
4. Developer issues.

**All of the sheathing behind the thin stone veneer exhibited water damage and had to be replaced.**
