Can A Poor Air Seal Cause Roof Failure?

Timothy A. Mills, P.E., LEED AP, CIT II

TAM Consultants Inc.

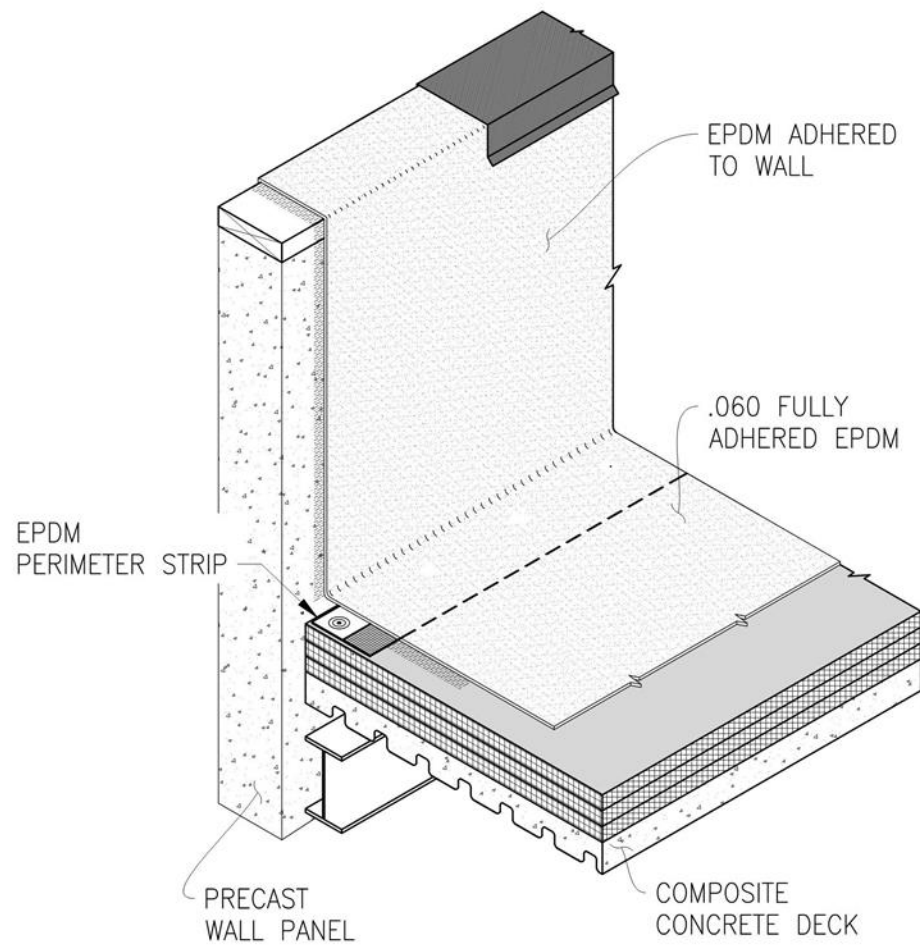
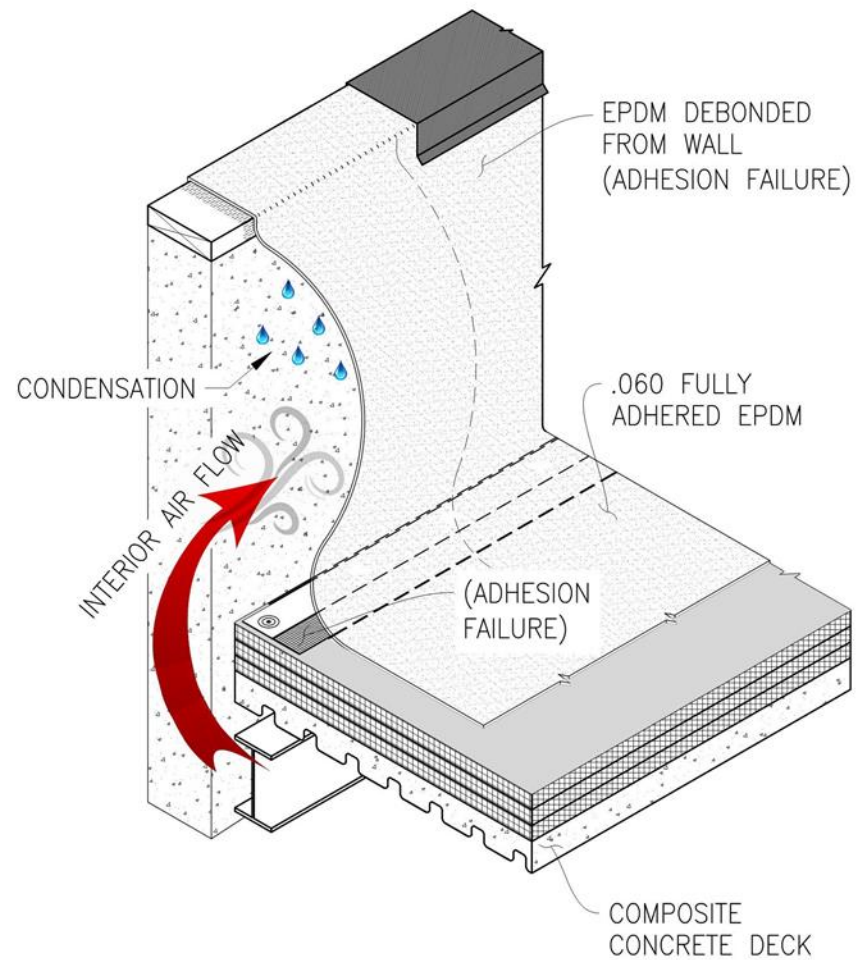
Findings

- It can be assumed that a considerable amount of condensation might occur within the roof assembly during the cold winter months with a certain amount of drying occurring during the warmer seasons or warmer days. This amount of air flow and subsequent water vapor transfer combined with direct water leakage in a few of the steel columns that are exposed to the weather had a significant impact to the poorly installed insulation greatly exacerbating the failure condition that occurred.
-
