# This Won't Go Away – Mold In Office Buildings

Timothy A. Mills, P.E., LEED AP, CIT II  
*TAM Consultants, Inc., A Terracon Company*

This presentation is reprinted with permission from the IIBEC Building Enclosure Symposium, November 11-12, 2019, Louisville, Kentucky. IIBEC is an international association of building envelope consultants whose members specialize in design, investigation, repair, and management of building envelope systems. For more information, visit [www.iibec.org](http://www.iibec.org).

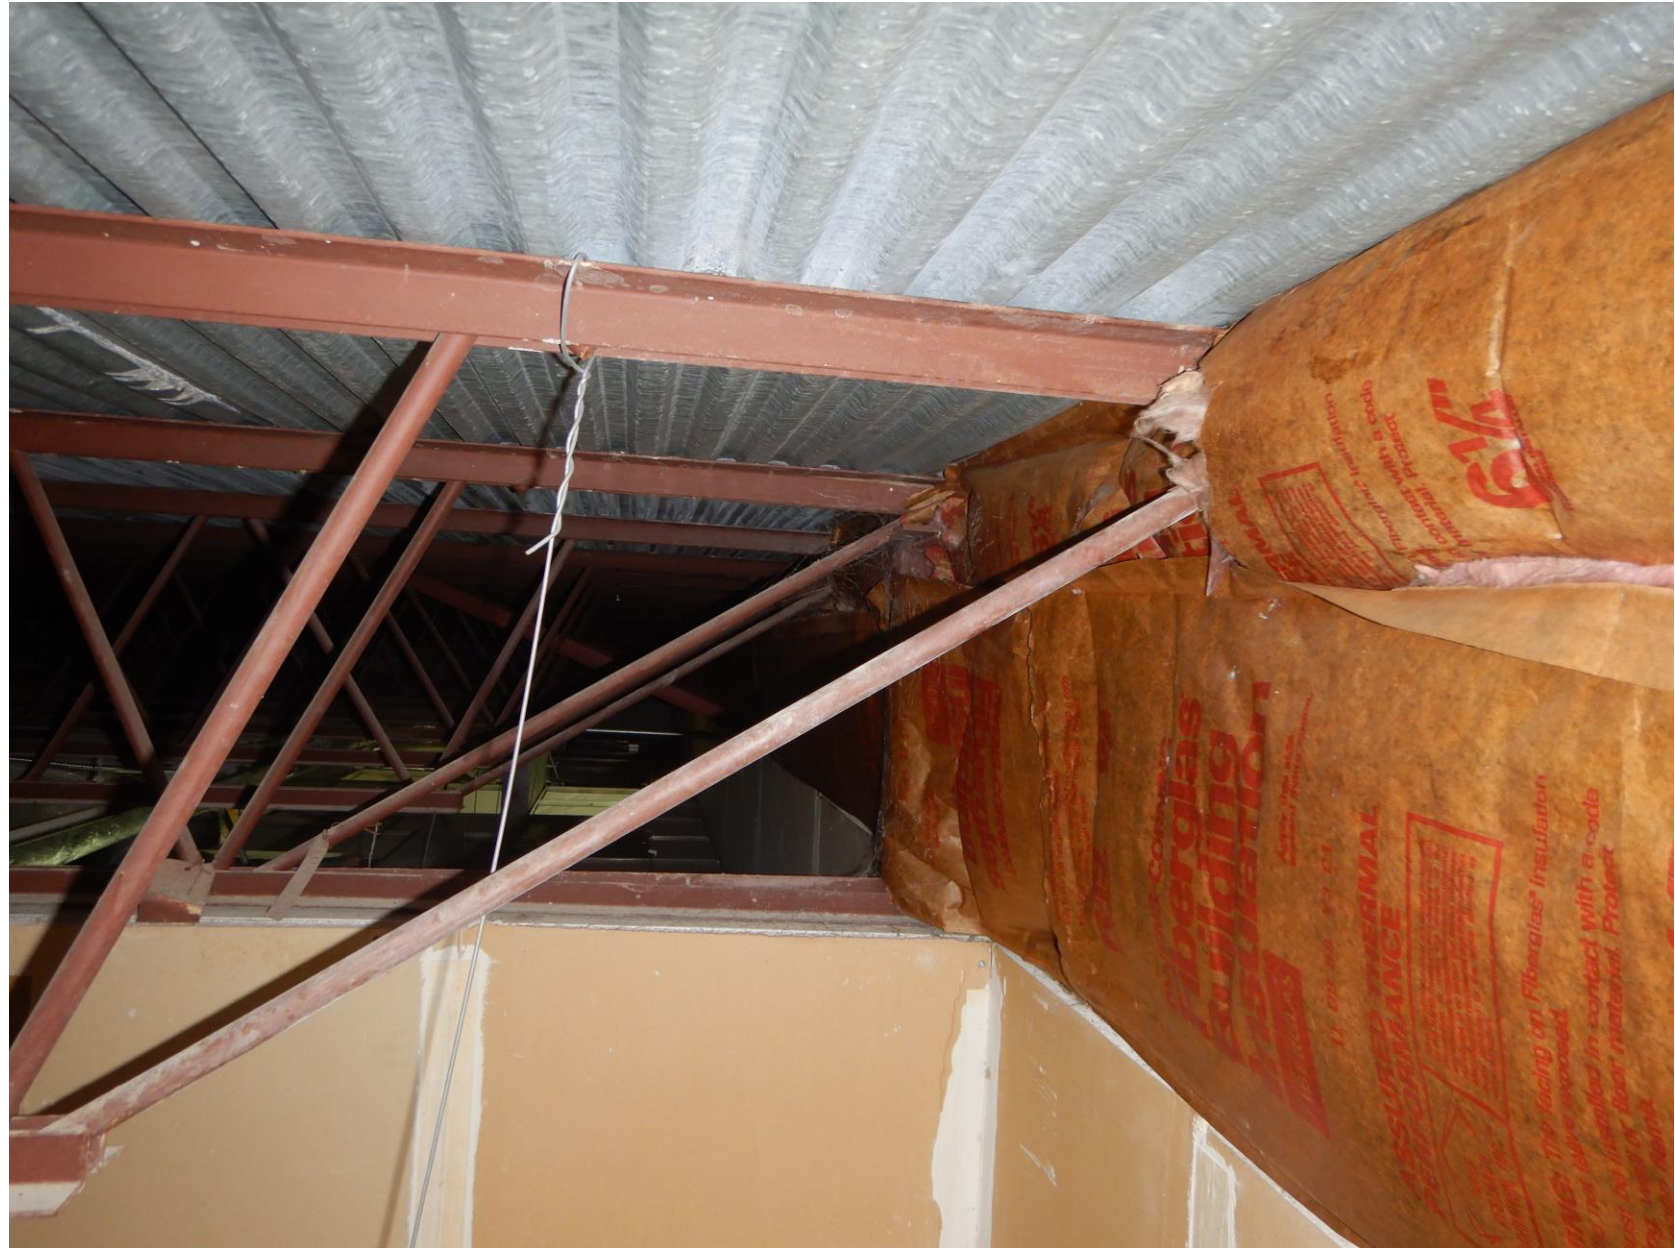
Second Floor structural system at slab perimeter, bar joists, metal form deck and concrete topping slab.

As-built condition where second floor joist bears on exterior structural steel perimeter beam providing an annular slot around the entire perimeter of the building which is open to the masonry cladding cavity. Smoke pencil used to verify unintended air infiltration at this location.

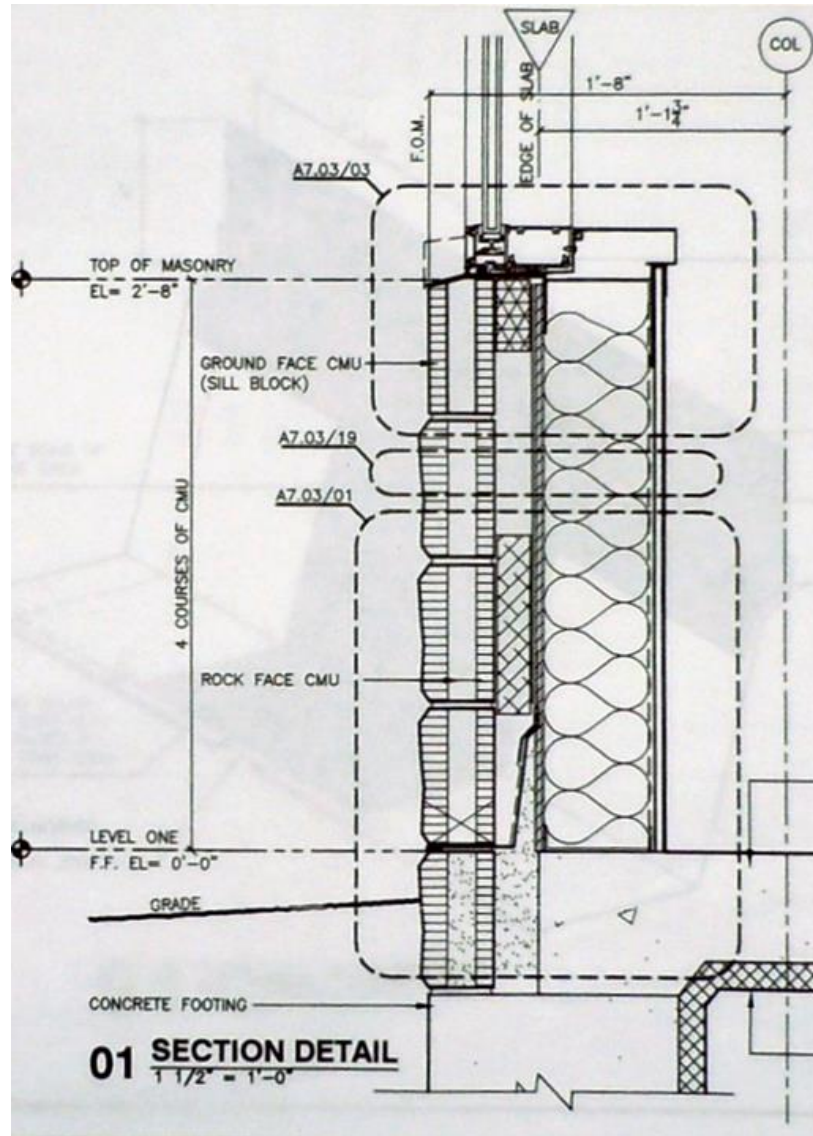
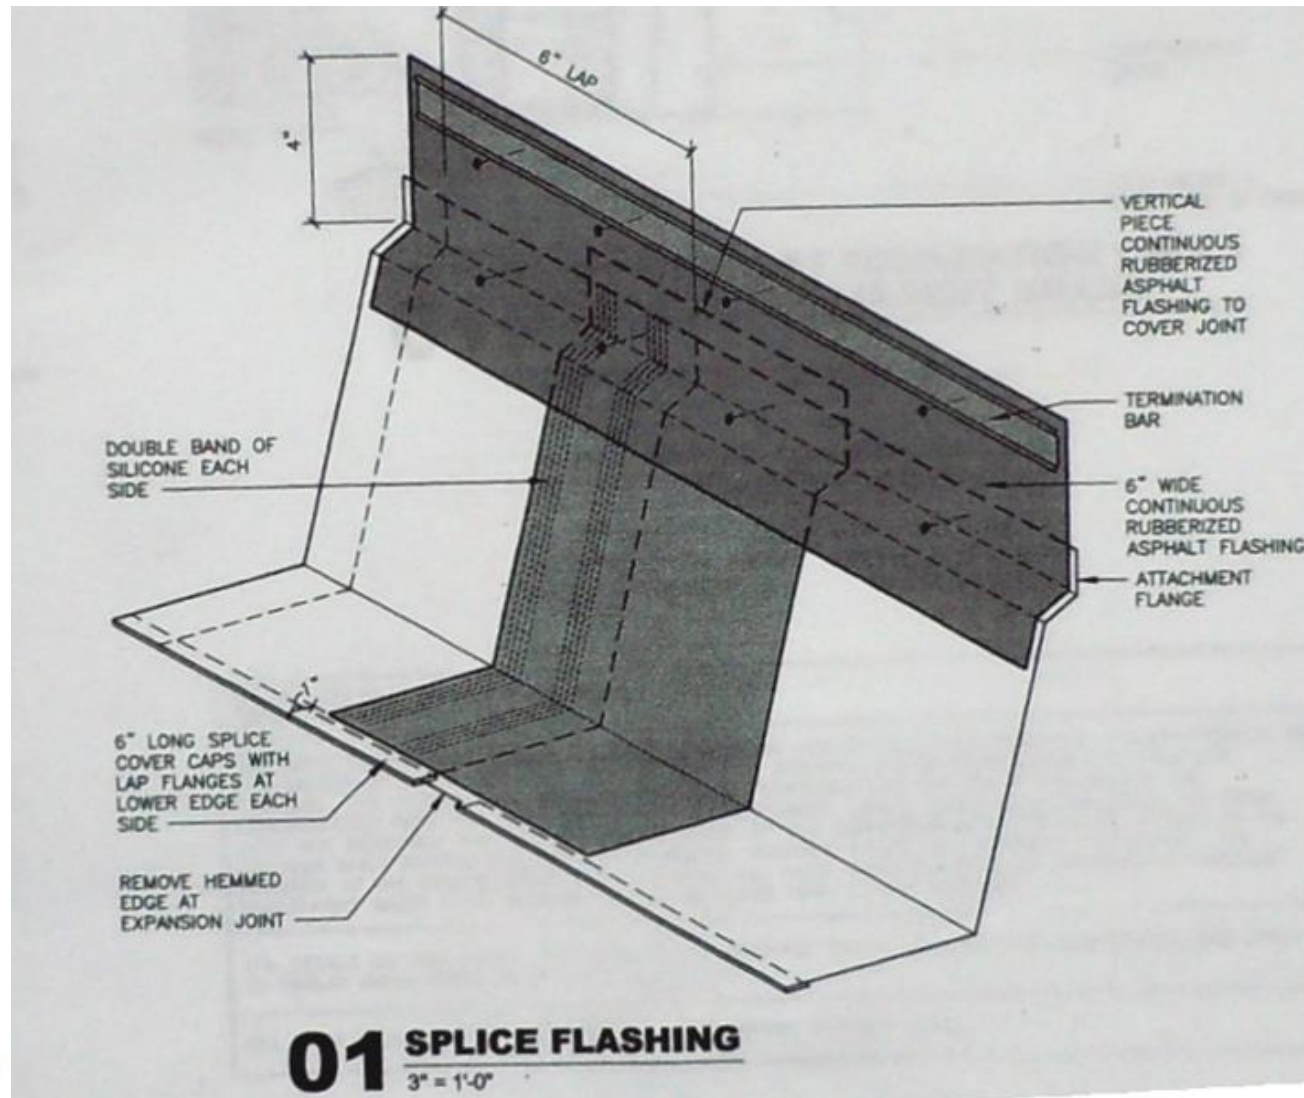
## Base of Wall Detail

The best plans and details don't always perform as you might expect.

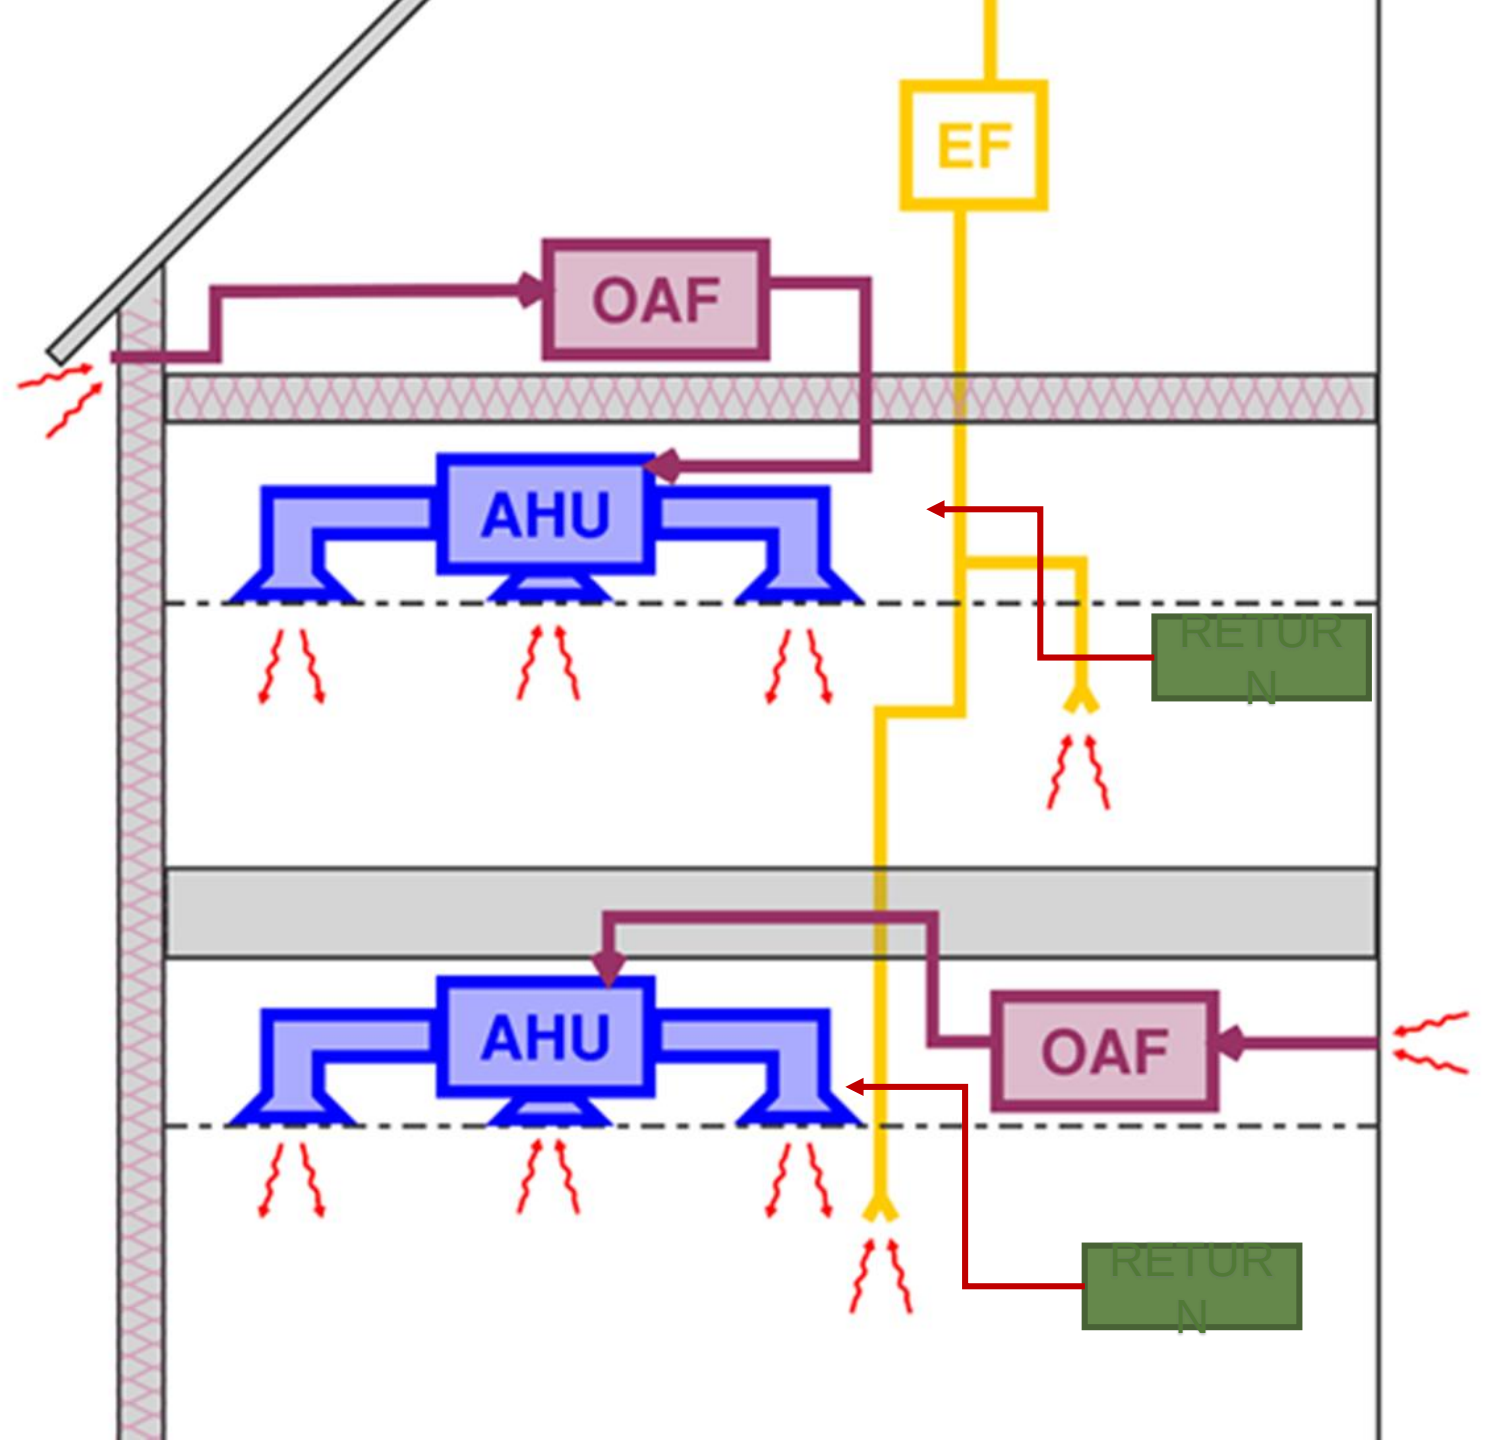
Schematic diagram depicting where intentional air flow across the building envelope occurs including the introduction of outside air (Outside Air Fan) and building exhaust (Exhaust Fan).
