To Scan or Not to Scan? Thermography is the Answer

Melissa I. Payne, BECxP, CxA+BE, CDT, Level II Building Science Thermographer

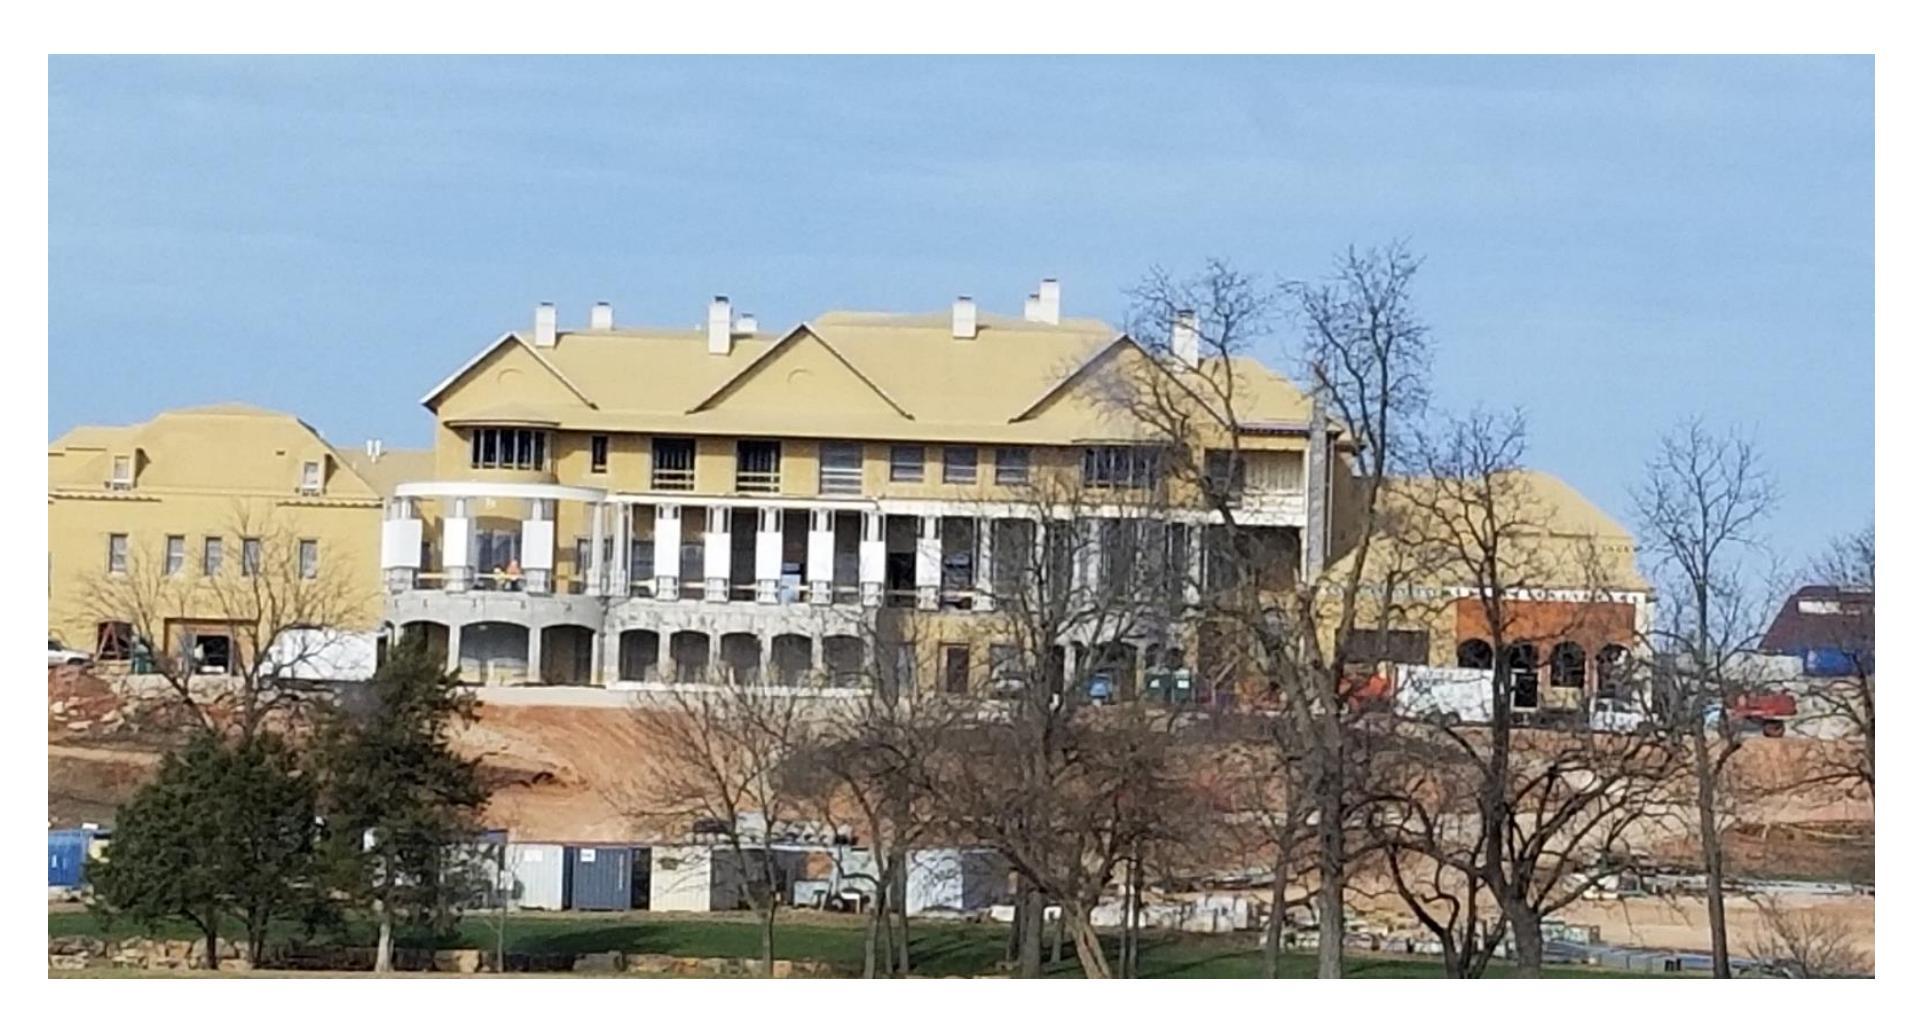
Every window and door on the project was to be tested and required to pass with no water infiltration criteria

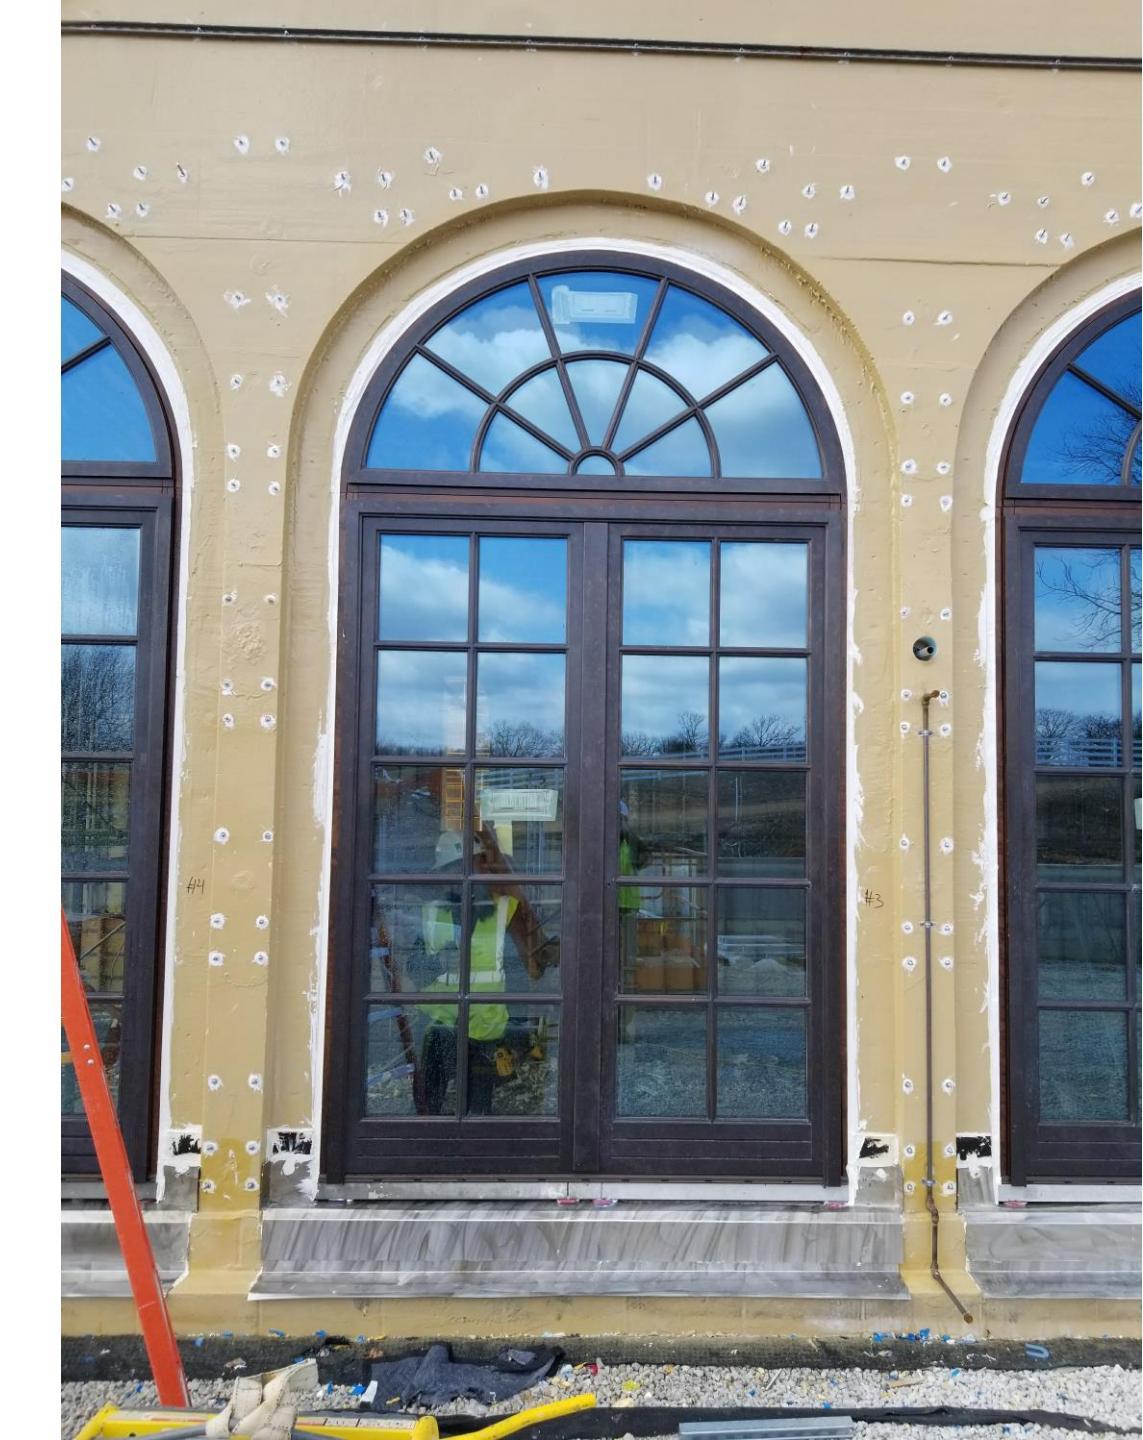
Modified AAMA 501.2 Water Testing with No-Water Penetration/Infiltration Criteria Conducted

A leak occurred at the north jamb where a shim/anchor strap is located just below the window head.

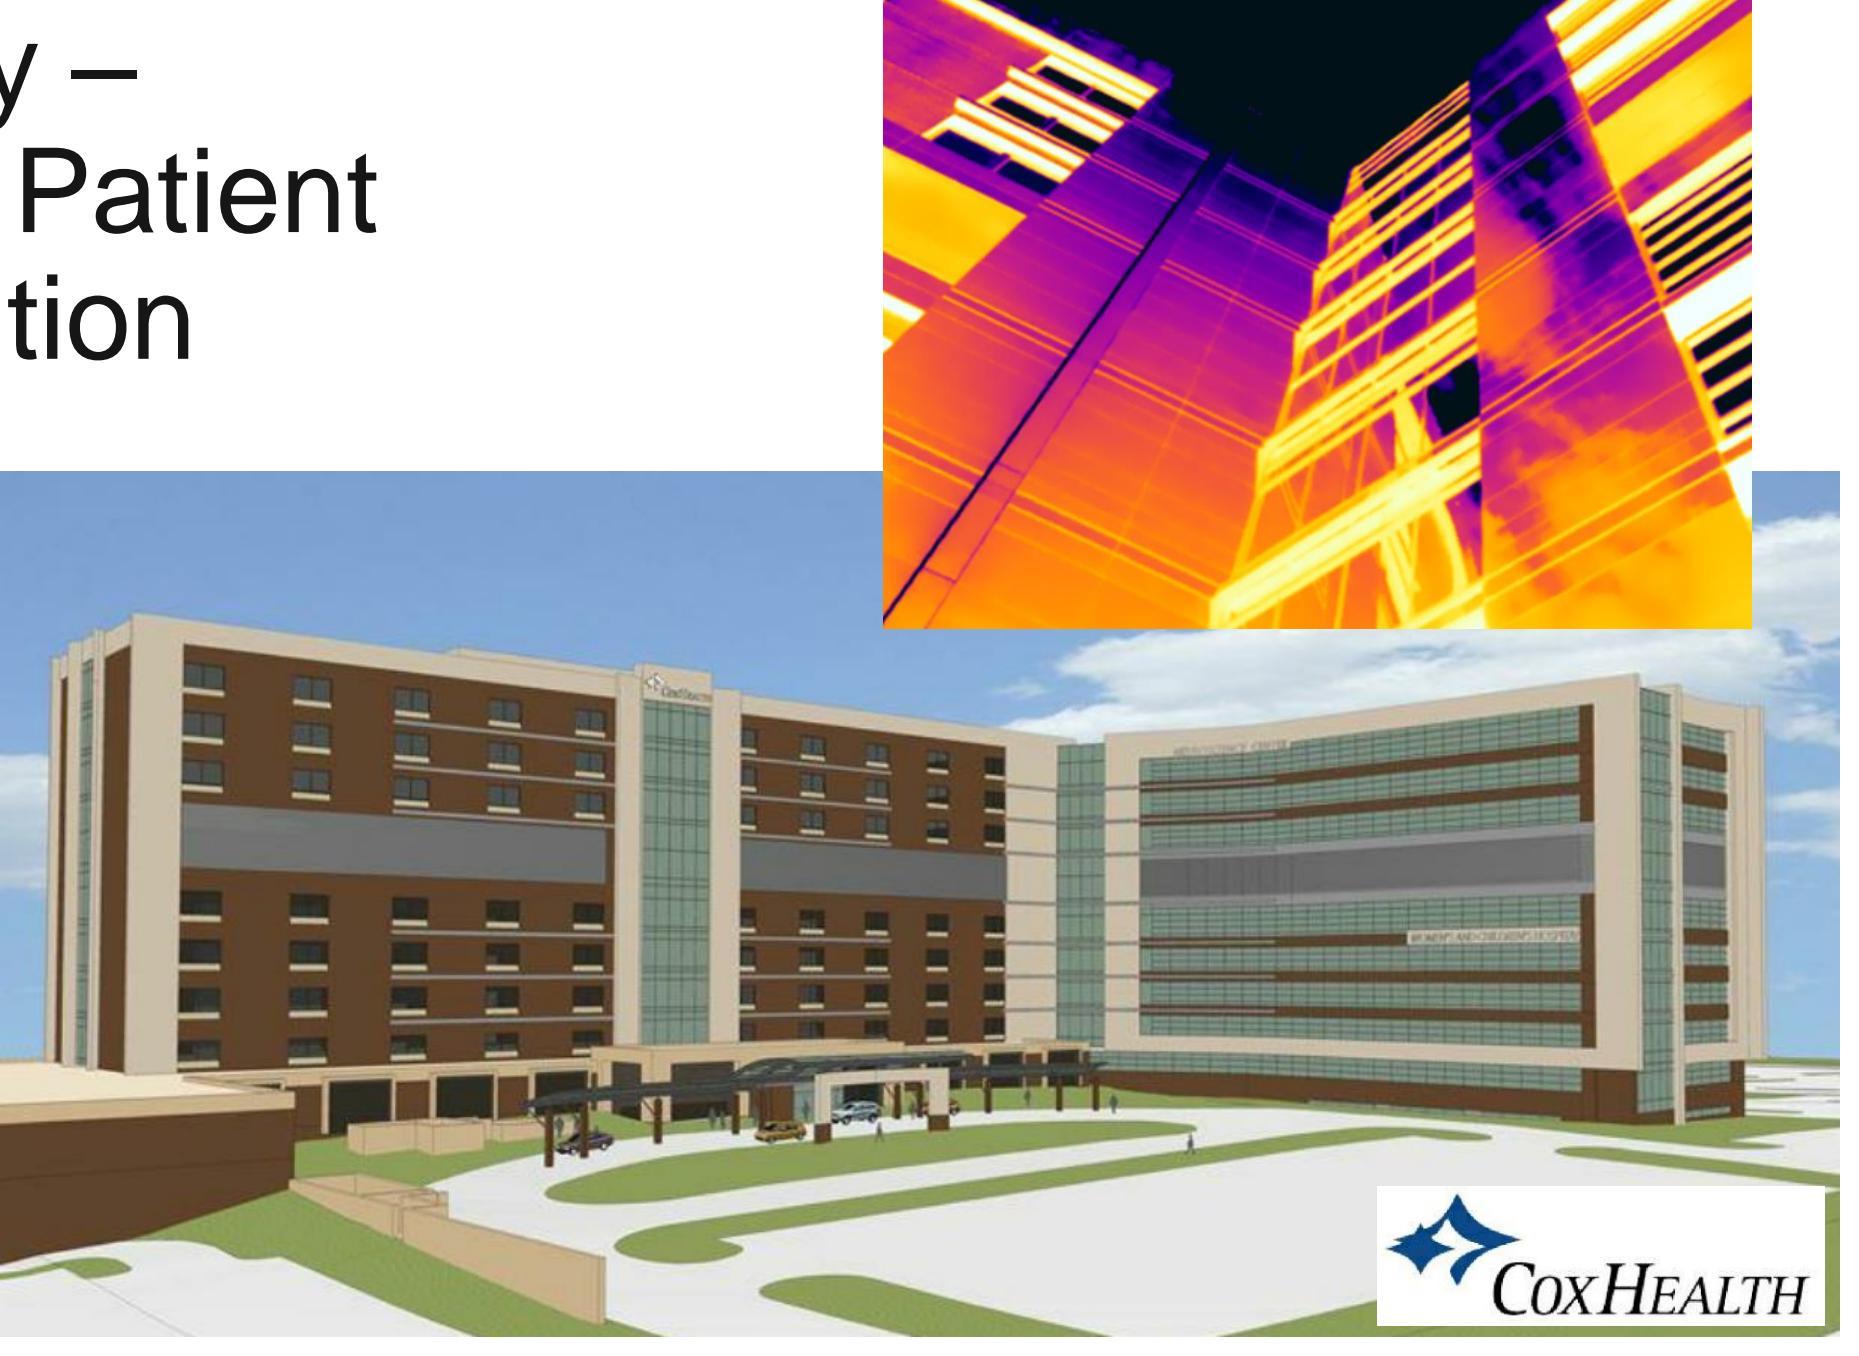
Thermal Performance of Curtain Wall System was studied and reviewed.

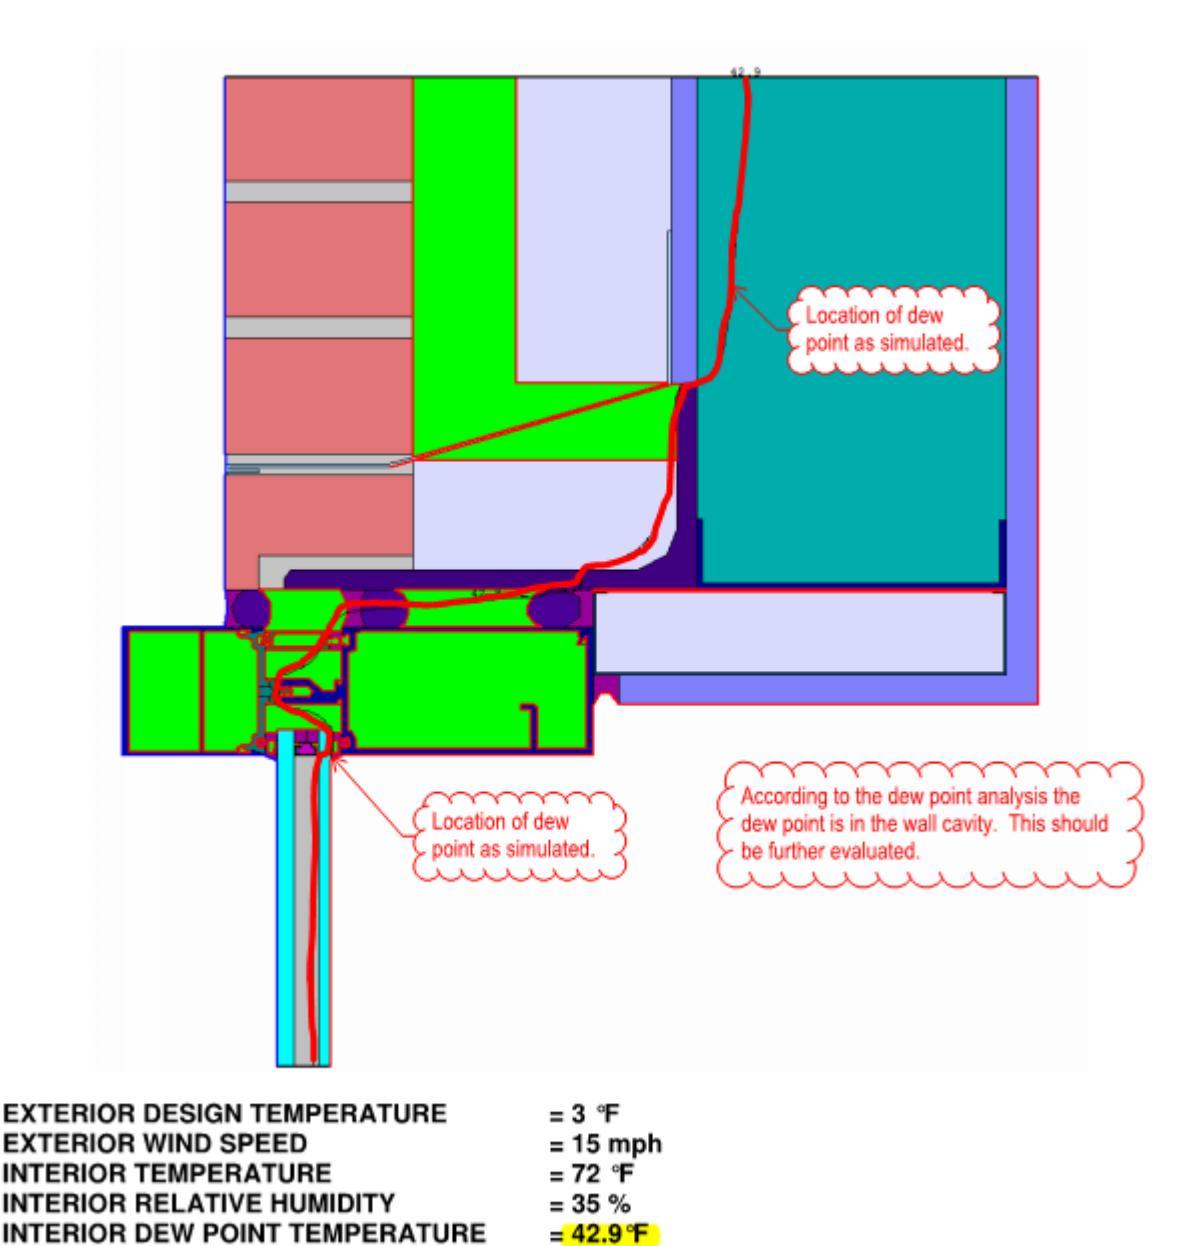
Brick Spandrel Over Vision Head (R.H.=35%) Detail Color Image of Material Assignments wit Isotherm at Dew Point Temperature

Predicting surface temperature and condensation of the building enclosure assembly is critical in understanding how components will maintain inside surface temps when thermal bridging in present.

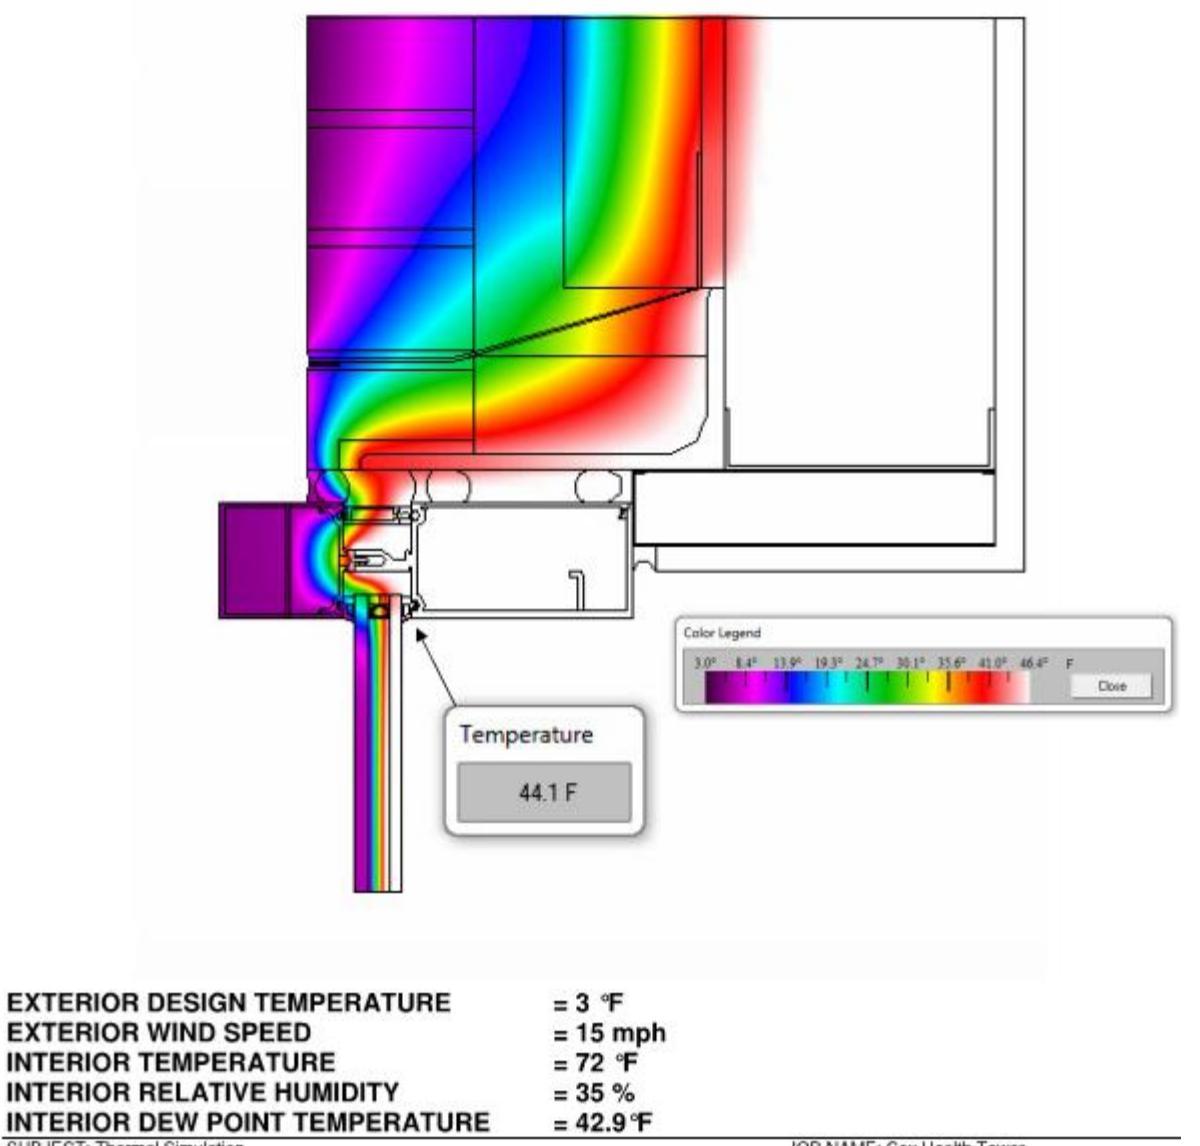
Brick Spandrel Over Vision Head (R.H.=35%) Detail Color Infrared Image with Temperatures at or Below the Dew Point and Lowest Interior Surface Temperature

What is the anticipated surface temperature with heating design temperature of 3°F with a 15mph wind?

Note: According to the design criteria used of: 3°F exterior temp, 72°F interior temp, wind velocity of 15 mph, relative humidity at 35% and dew point temperature of 42.9°F the projected surface temperatures of the frames above would result in surface condensation.

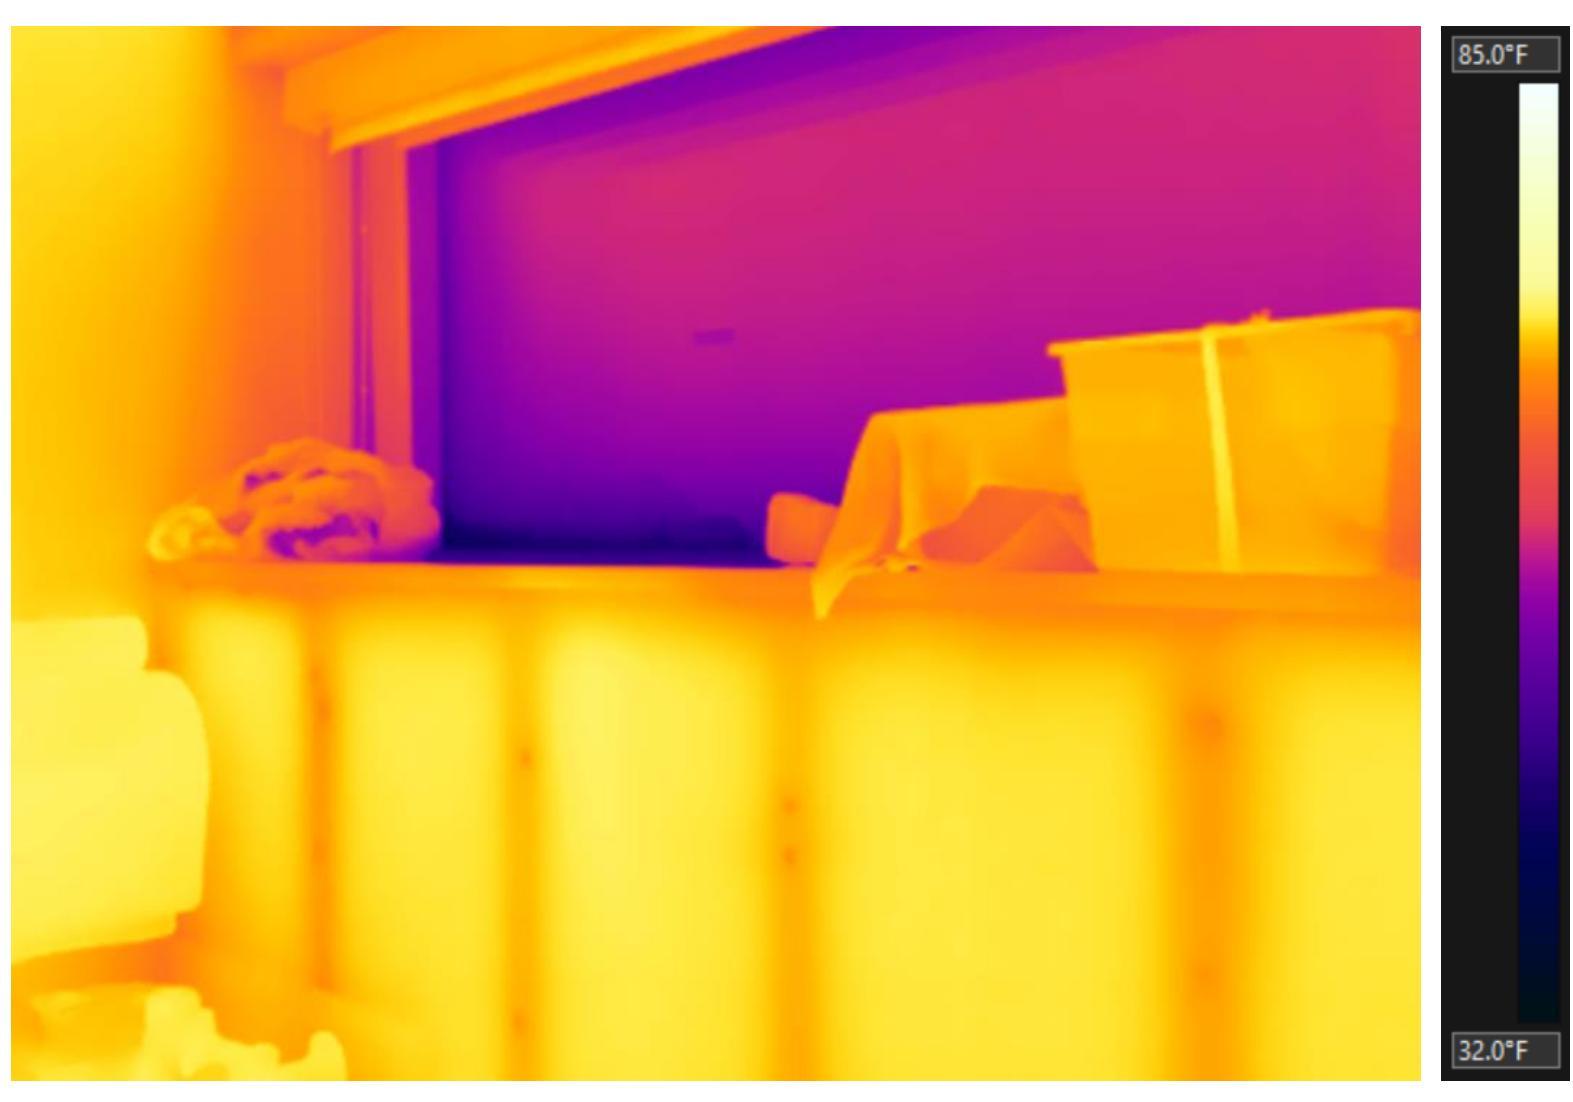
NICU Room 14 – Baseline Reference

West light @ sill tube		
Measurements		
Sp1	46.4 °F	
Sp2	49.0 °F	
Sp3	49.0 °F

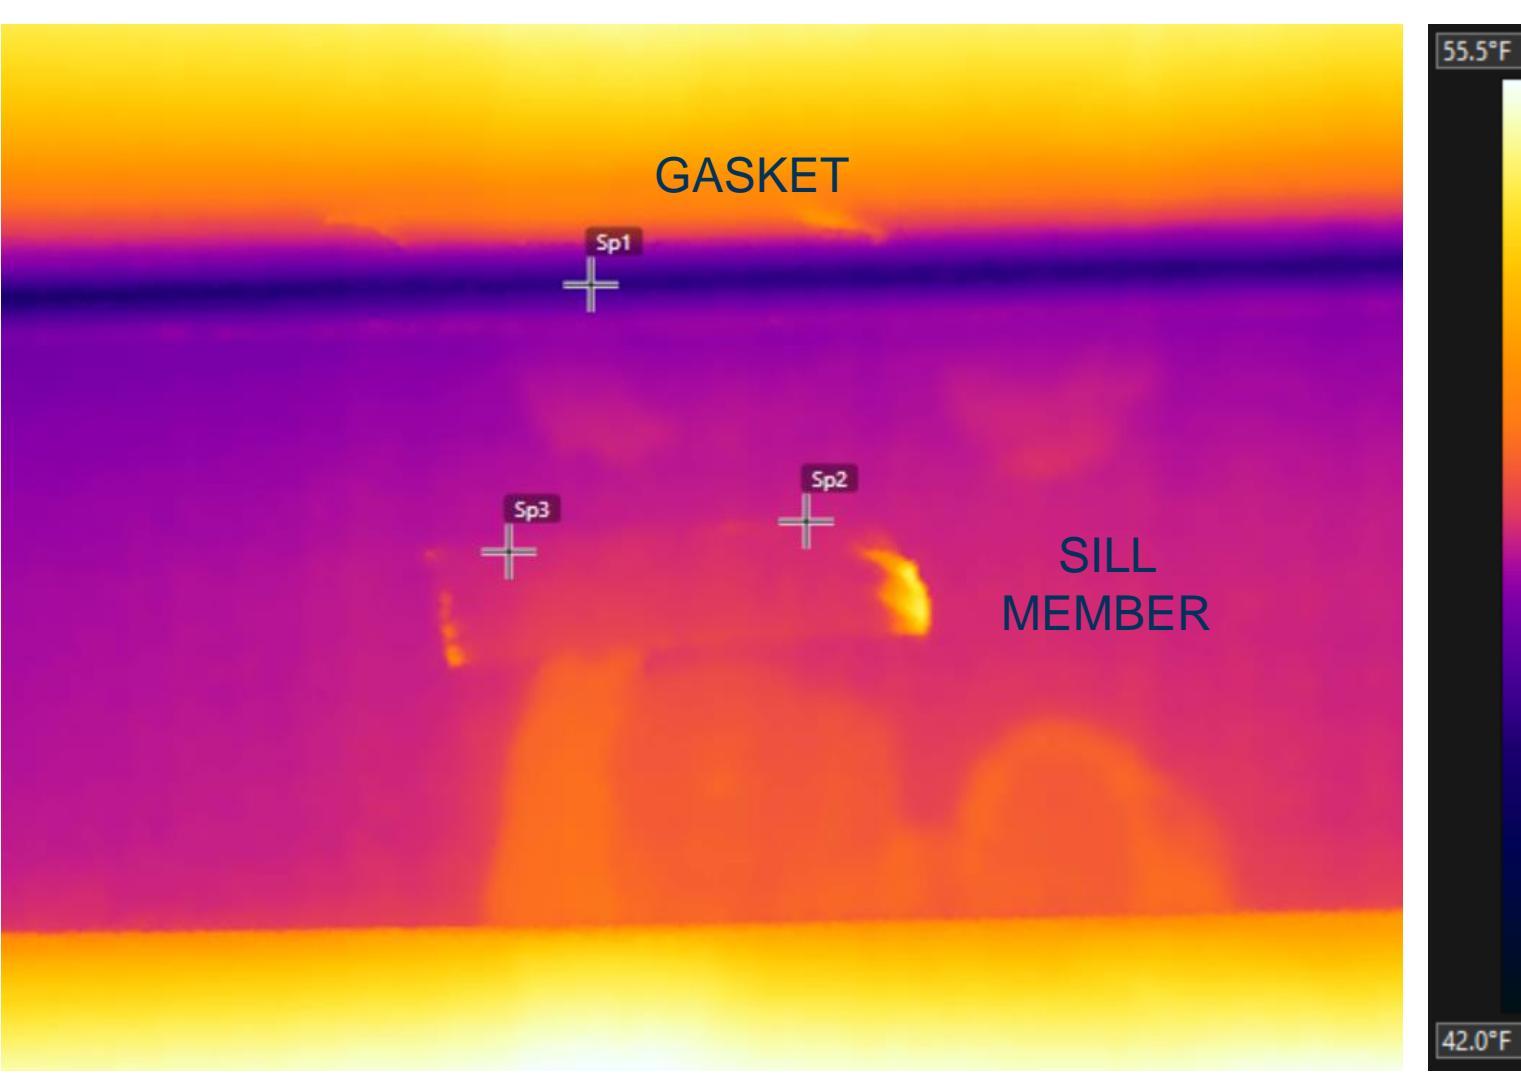
NICU Room 14 – Interior at Sill Tube

West side mid lite			
Measurements			
Sp1	50.8 °F		
Sp2	46.7 °F		
Sp3	46.6 °F

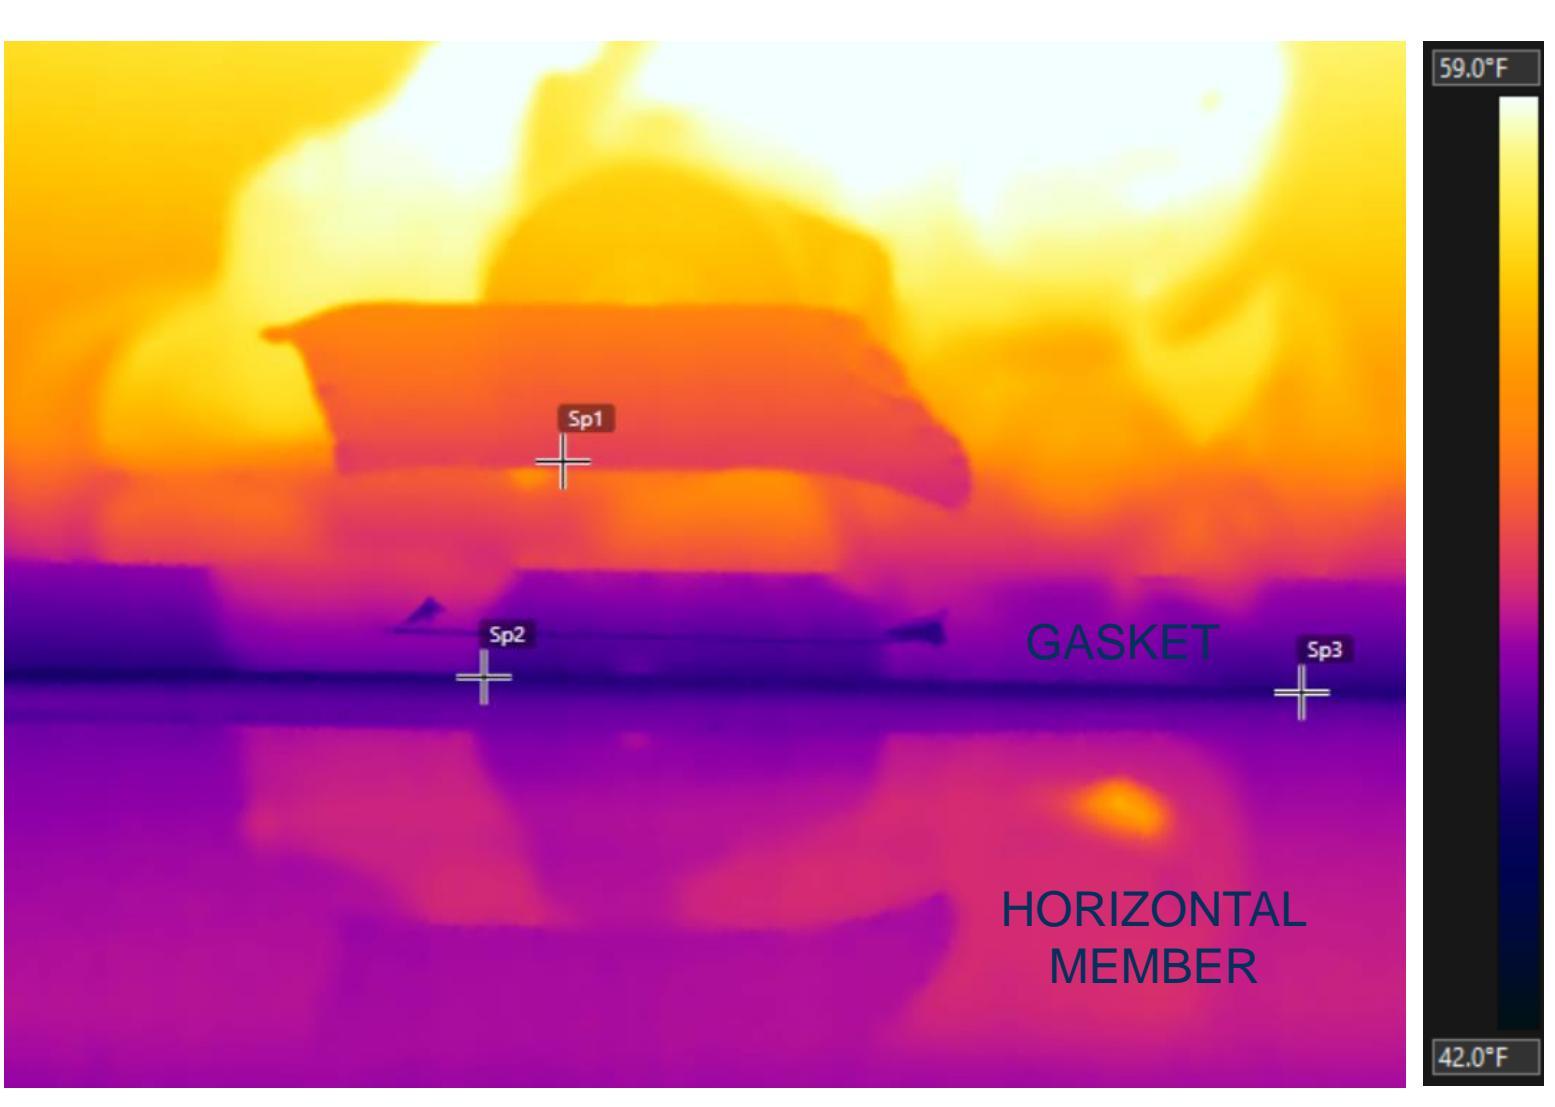
NICU Room 14 – Interior at Middle Tube

Note		
West side mid lite		
Measurements		
Sp1	61.1 °F	
Sp2	61.1 °F

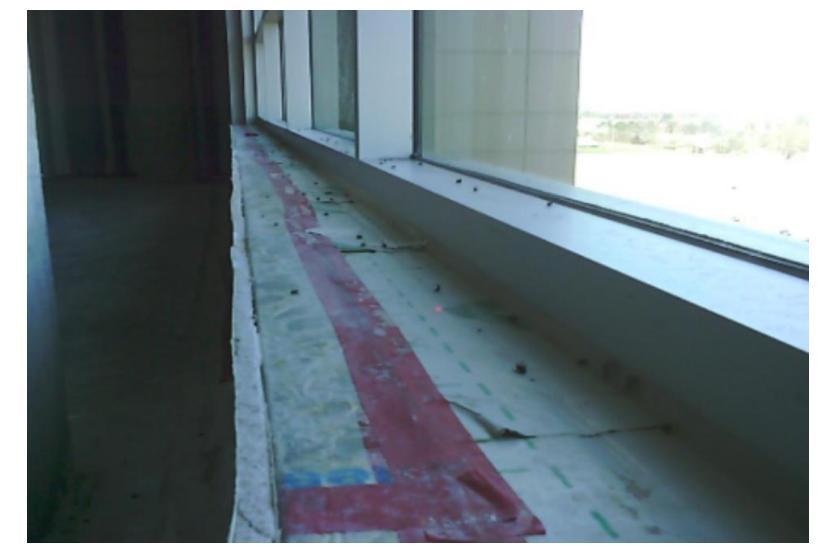
North wall 5th floor looking north, structural steel temperatures are lower than frame temperatures. This image was taken at 10:00 am when exterior ambient temperatures were approximately 22°F. This image shows the frame sitting on the cold side of the exterior wall, directly onto the steel member. The spot surface temperatures are as follows: Spot1 - 46.7°F, Spot2 - 60.0°F, Spot3 – 51.0°F, Spot4 – 51.0 °F, Spot5 – 51.8°F, Spot6 – 59.8°F.
