Invisible Improvement: Air Tightening an Office in a Historic Pier

4EA Building Science

Invisible Improvement: Air Tightening an Office in a Historic Timber Pier

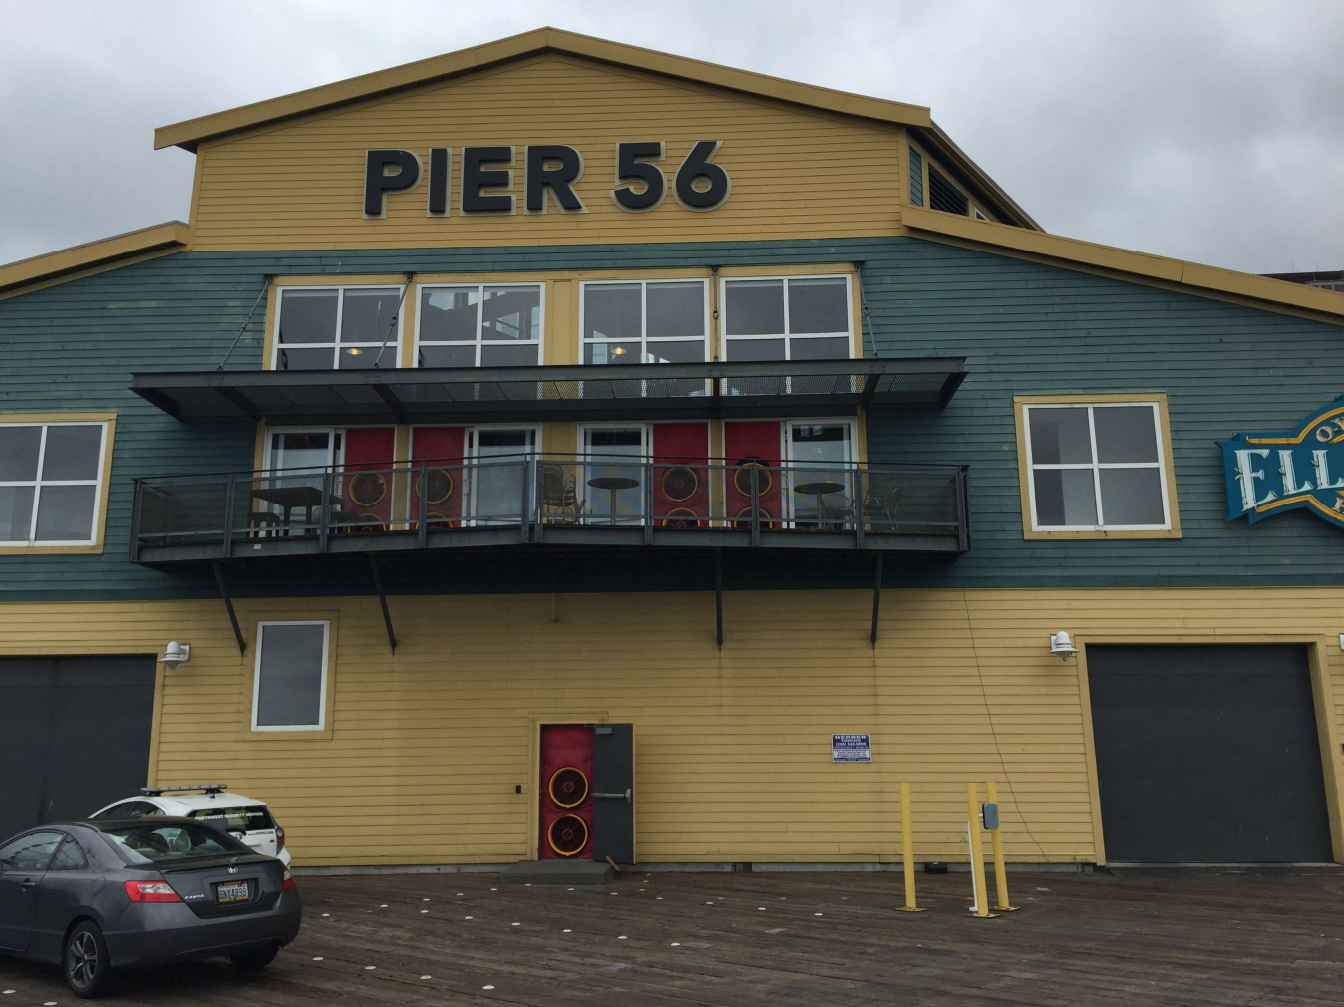
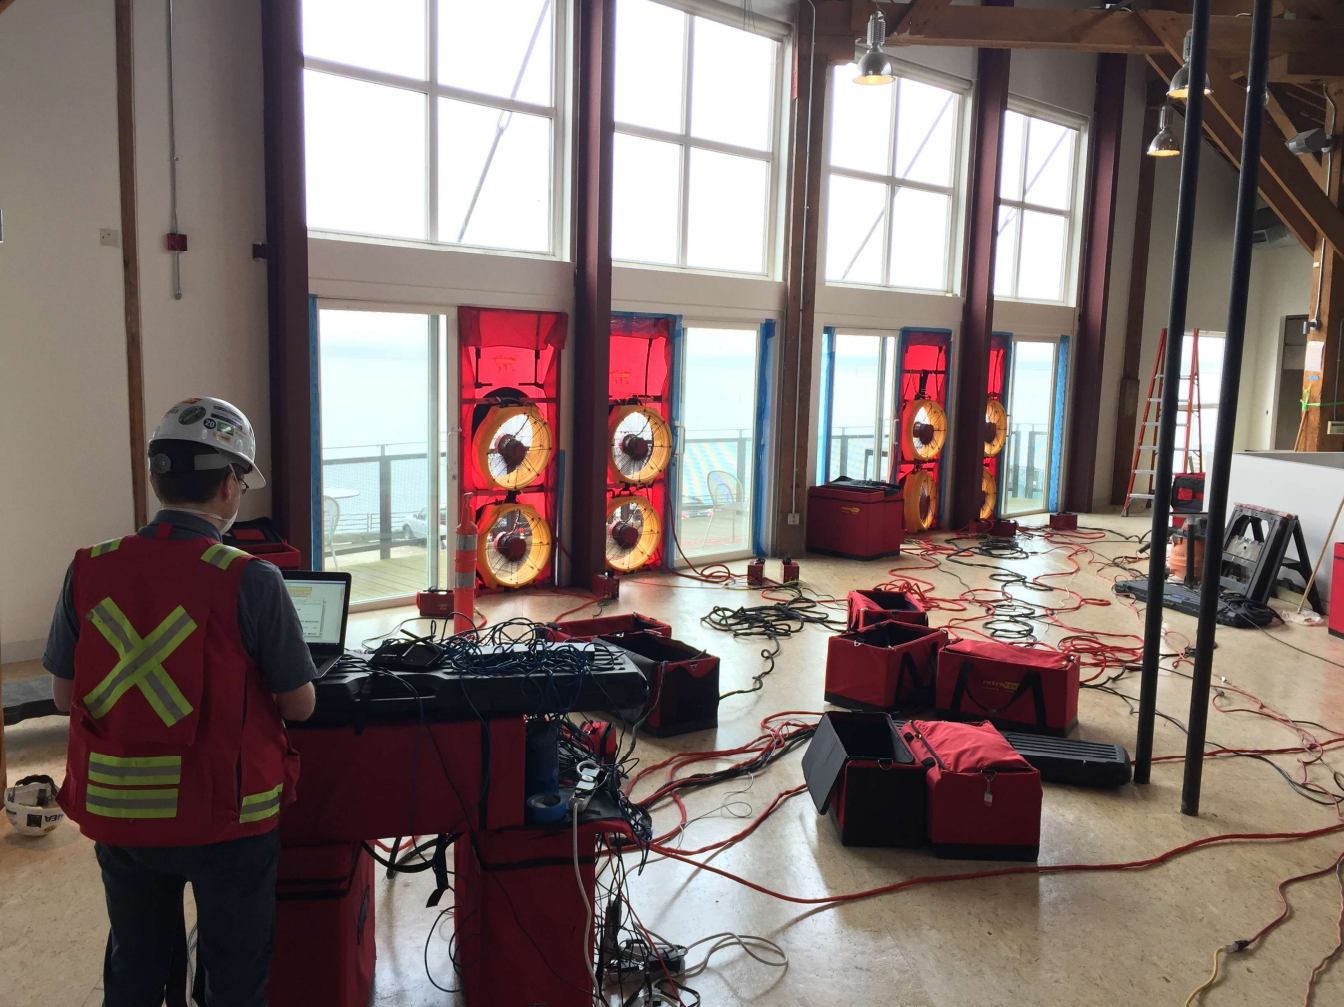
Re-Testing Setup

- All test conditions from the initial test were repeated, such as fan locations and temporary sealing
- Tested in May 2021

0.778 CFM/SF at 75 Pascals	Depressurization	4.863 ACH50
1.071 CFM/SF at 75 Pascals	Pressurization	7.030 ACH50
0.925 CFM/SF at 75 Pascals	Average	5.950 ACH50

Air sealing measures decreased leakage by 15%

- Still room for improvement
- Some locations were missed or were not accessible
- Sealing of blocking at rafters was a 3D problem (car decking to rafters could not be sealed).
