Energy Improvements to Existing Buildings Using Air Barriers and Insulation Upgrades

Brian H. Neely, AIA, CDT, BECxp

Gale Associates, Inc.

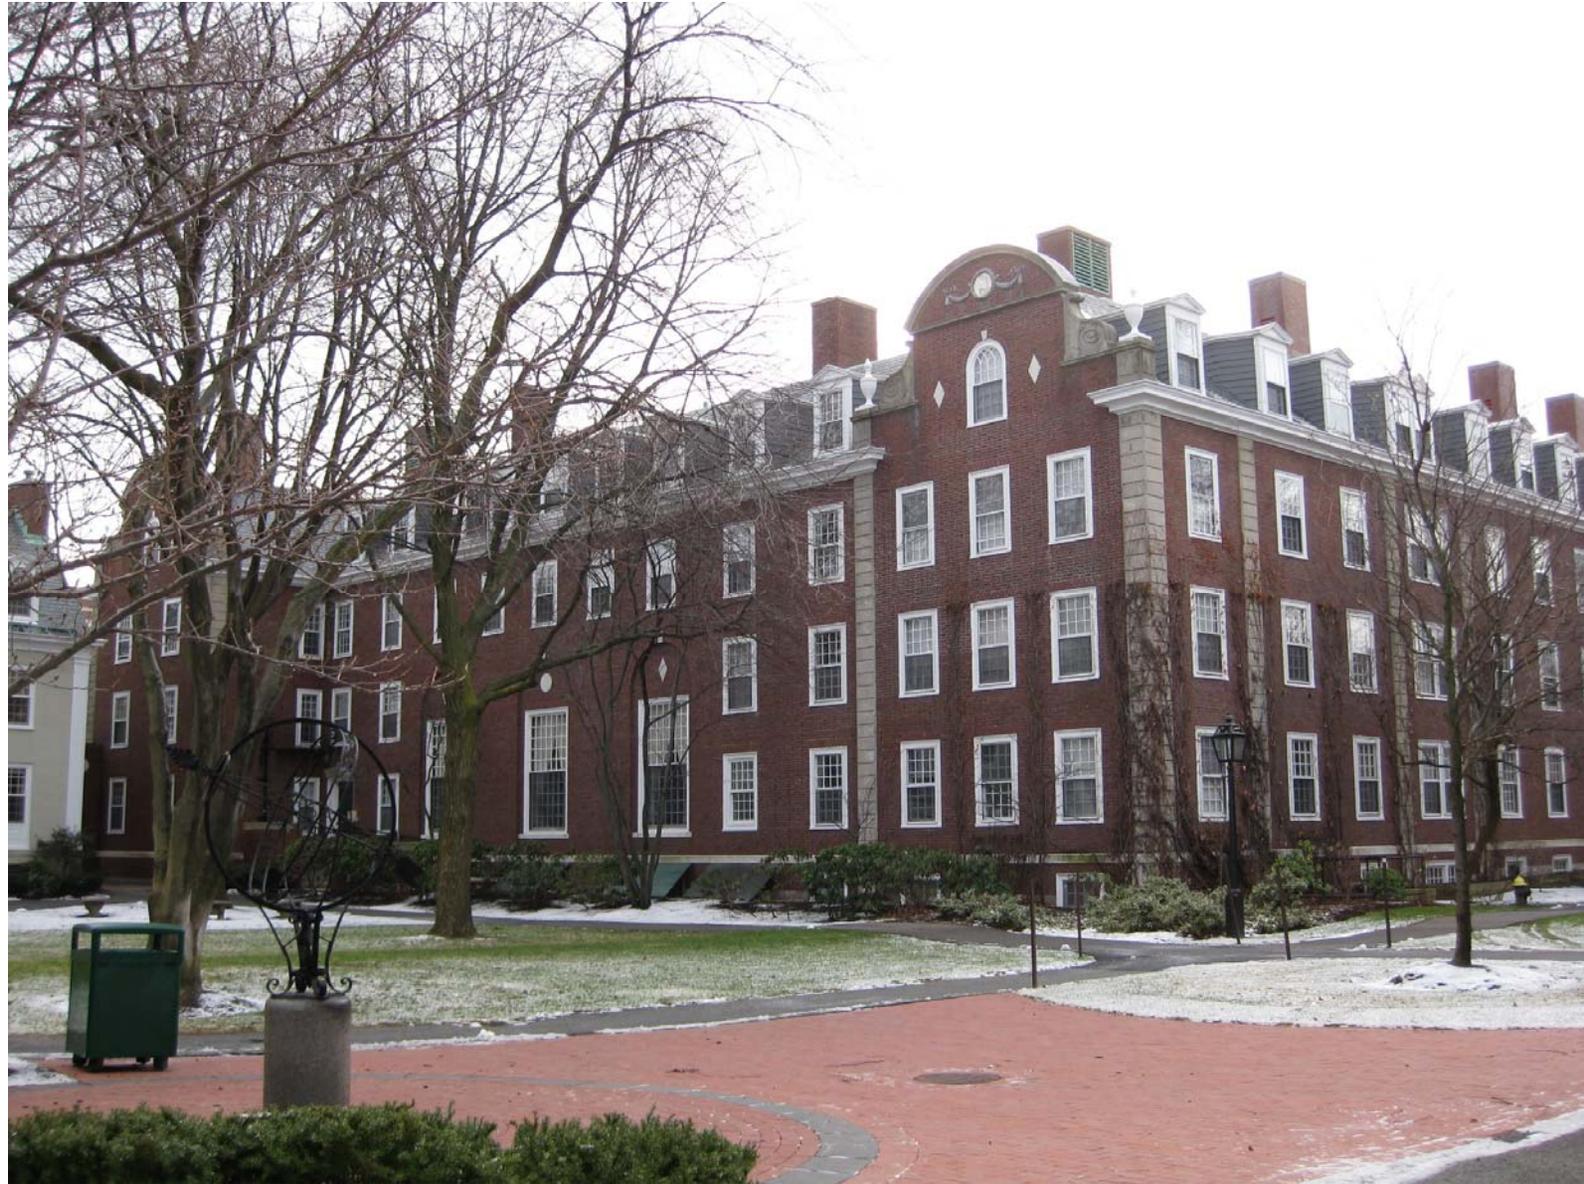
Unrenovated	Renovated SPF	Renovated FG Batt
Red Brick Exterior Wythe	P	P	P
Terra Cotta Block	P	P	P
Plaster	P	Removed	Removed
Insulation	—	1" closed cell polyurethane spray foam	3" fiberglass batt
Vapor Retarder	—	—	Polyethylene
Gypsum Sheathing	—		
Paint	Acrylic Latex	Acrylic Latex	Acrylic Latex

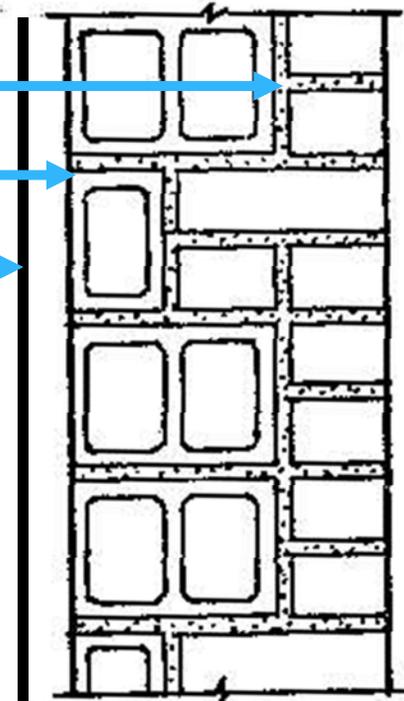
Original Building Construction

- Exterior Brick Masonry
- Terra Cotta Back Up Wall
- Interior Plaster Finish

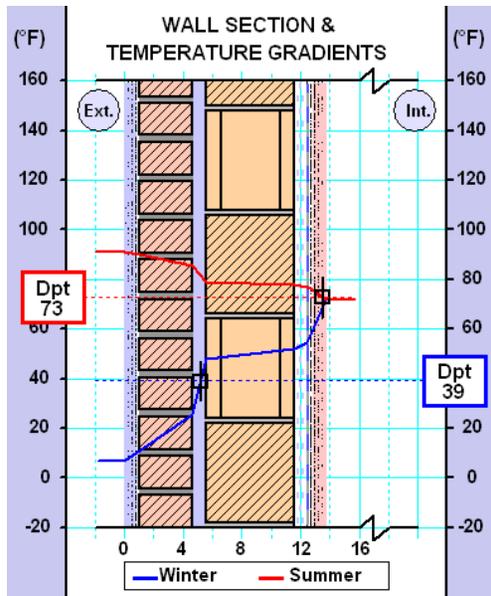
Unrenovated

Static Dewpoint Analysis

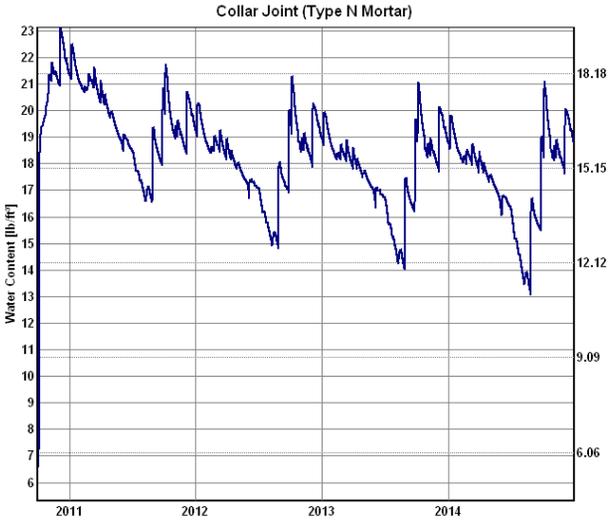
Unrenovated

Comparison: Collar Joint

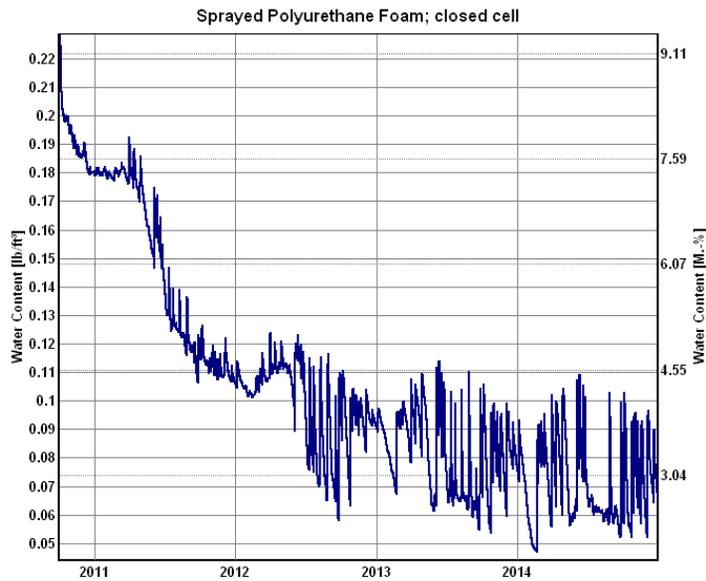
Renovated- SPF

Comparison: Insulation

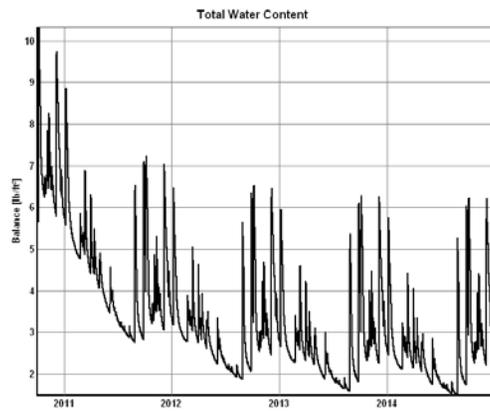
Unrenovated

Water Content of Wall Assembly

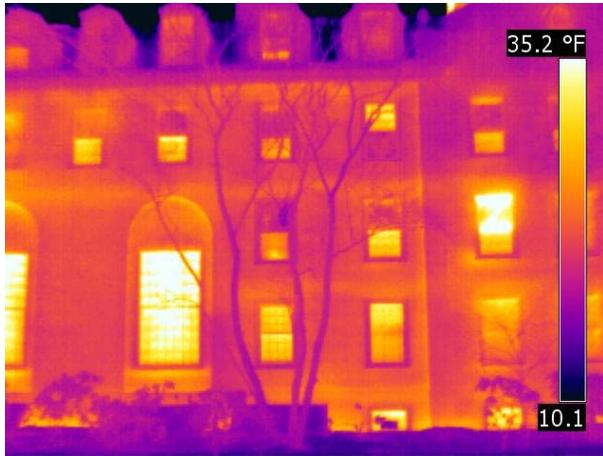
Unrenovated

Comparison: North Elevation

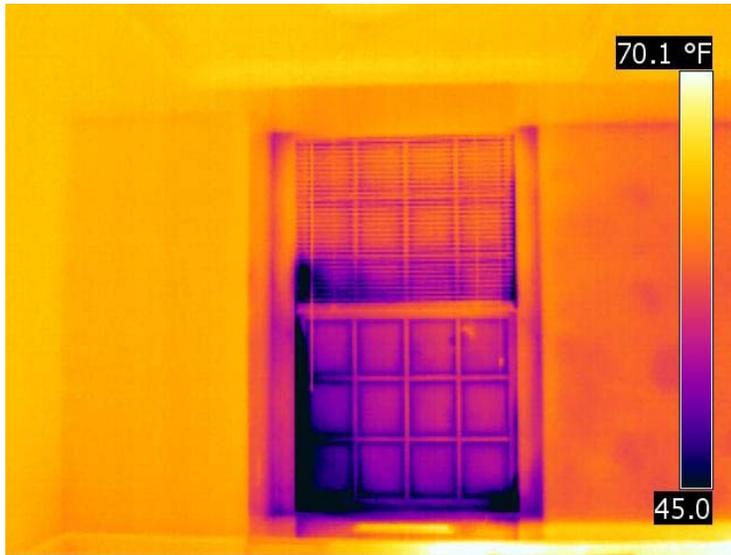
Unrenovated vs. Renovated SPF

Room Temp: 69 °F
Wall Temp: 58.6 °F

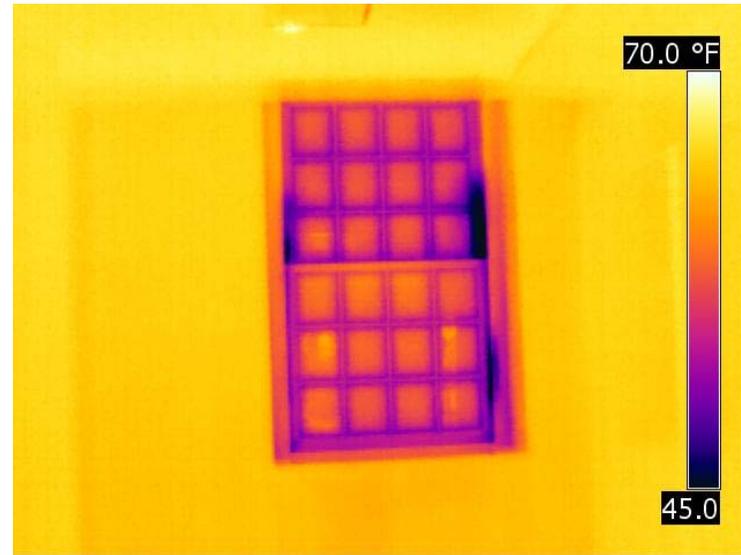
Renovated FG Batt

Room Temp: 65.4 °F
Wall Temp: 64.5 °F

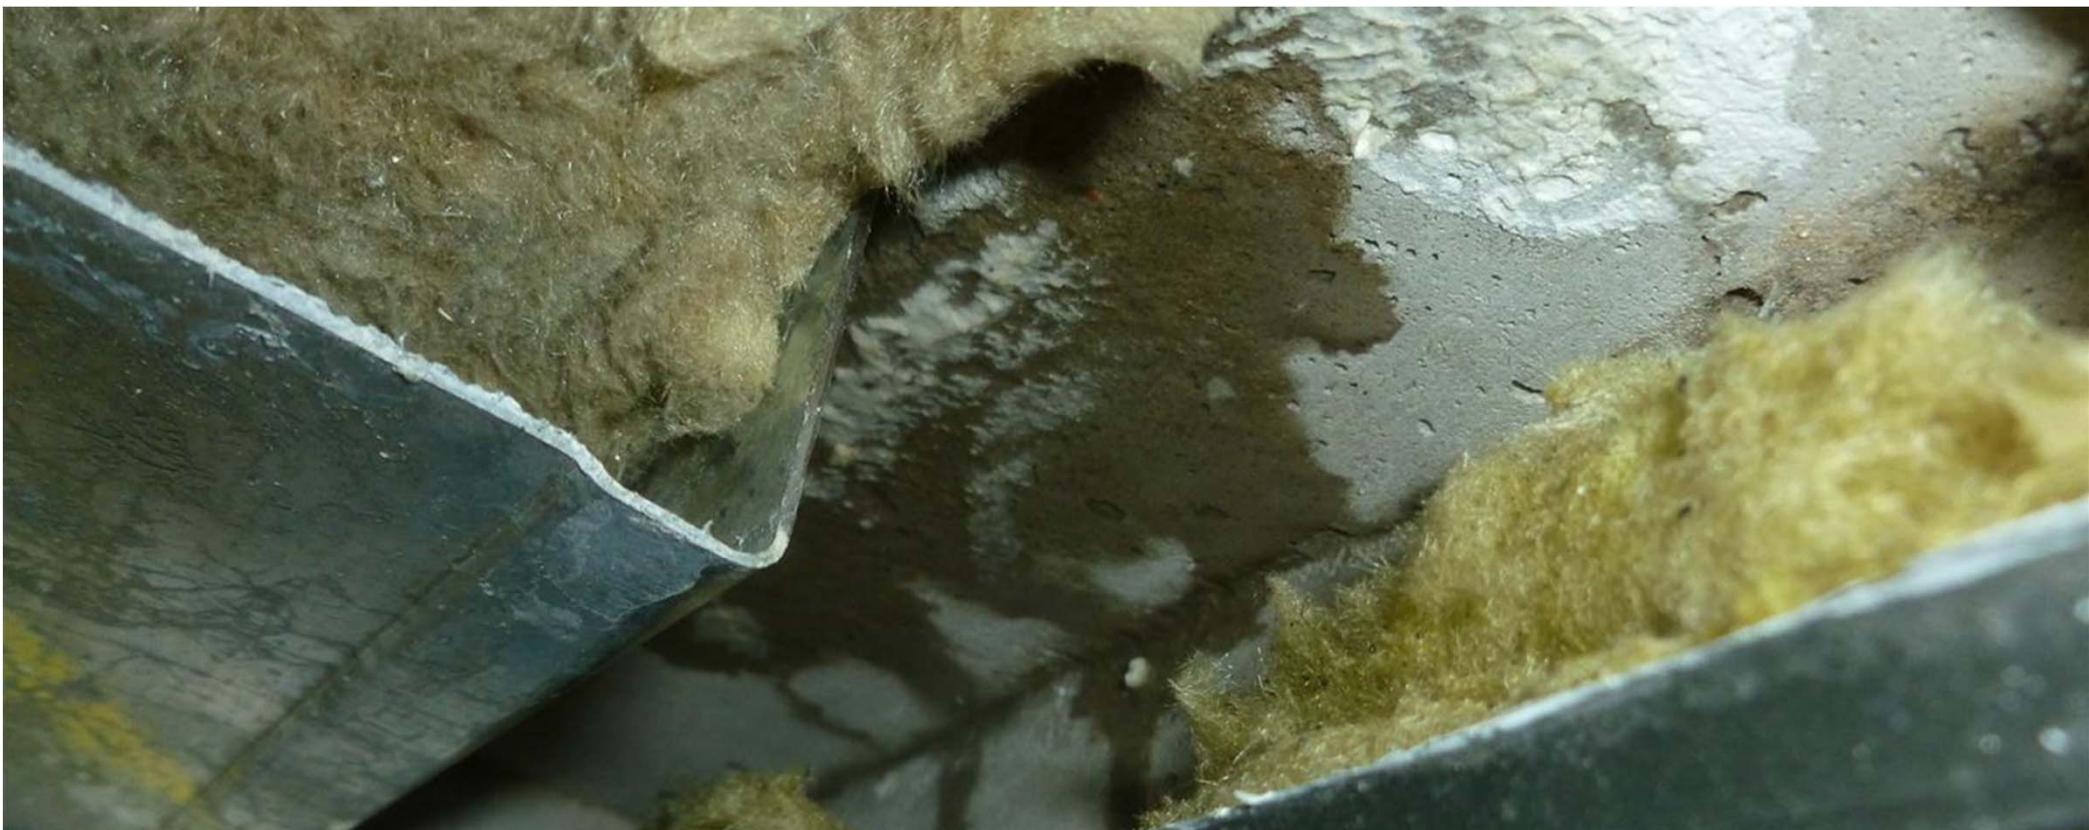
Condensation on exposed concrete

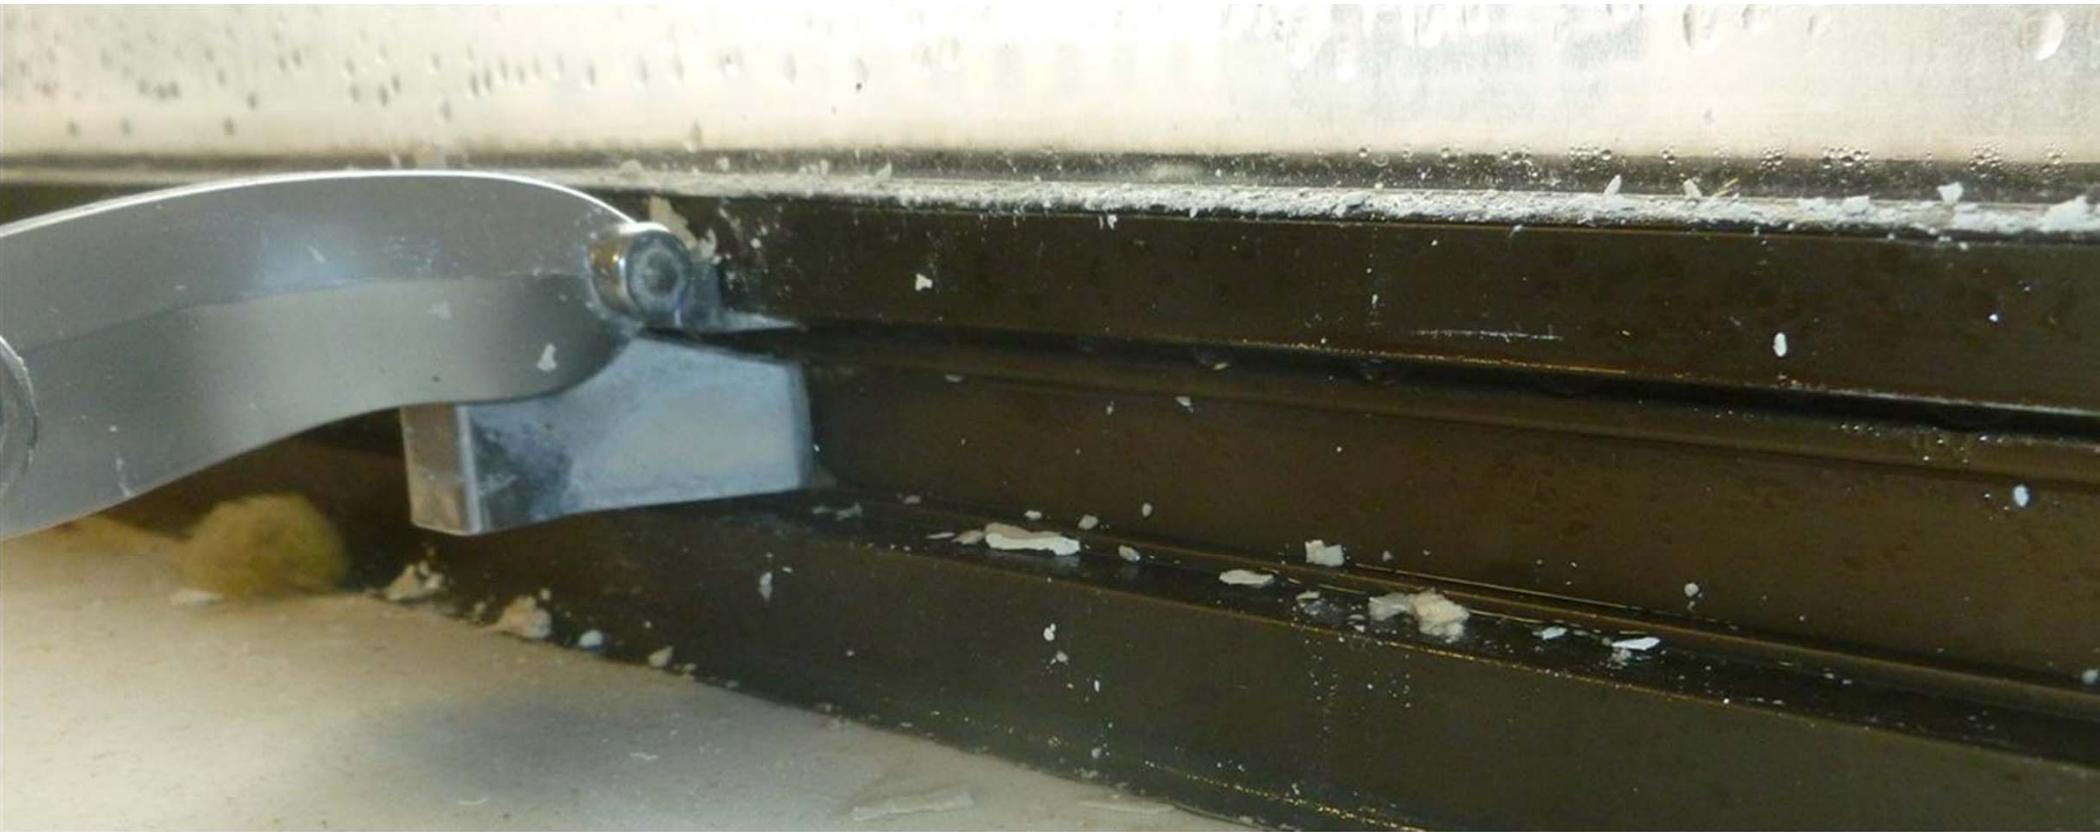
Condensation on window system

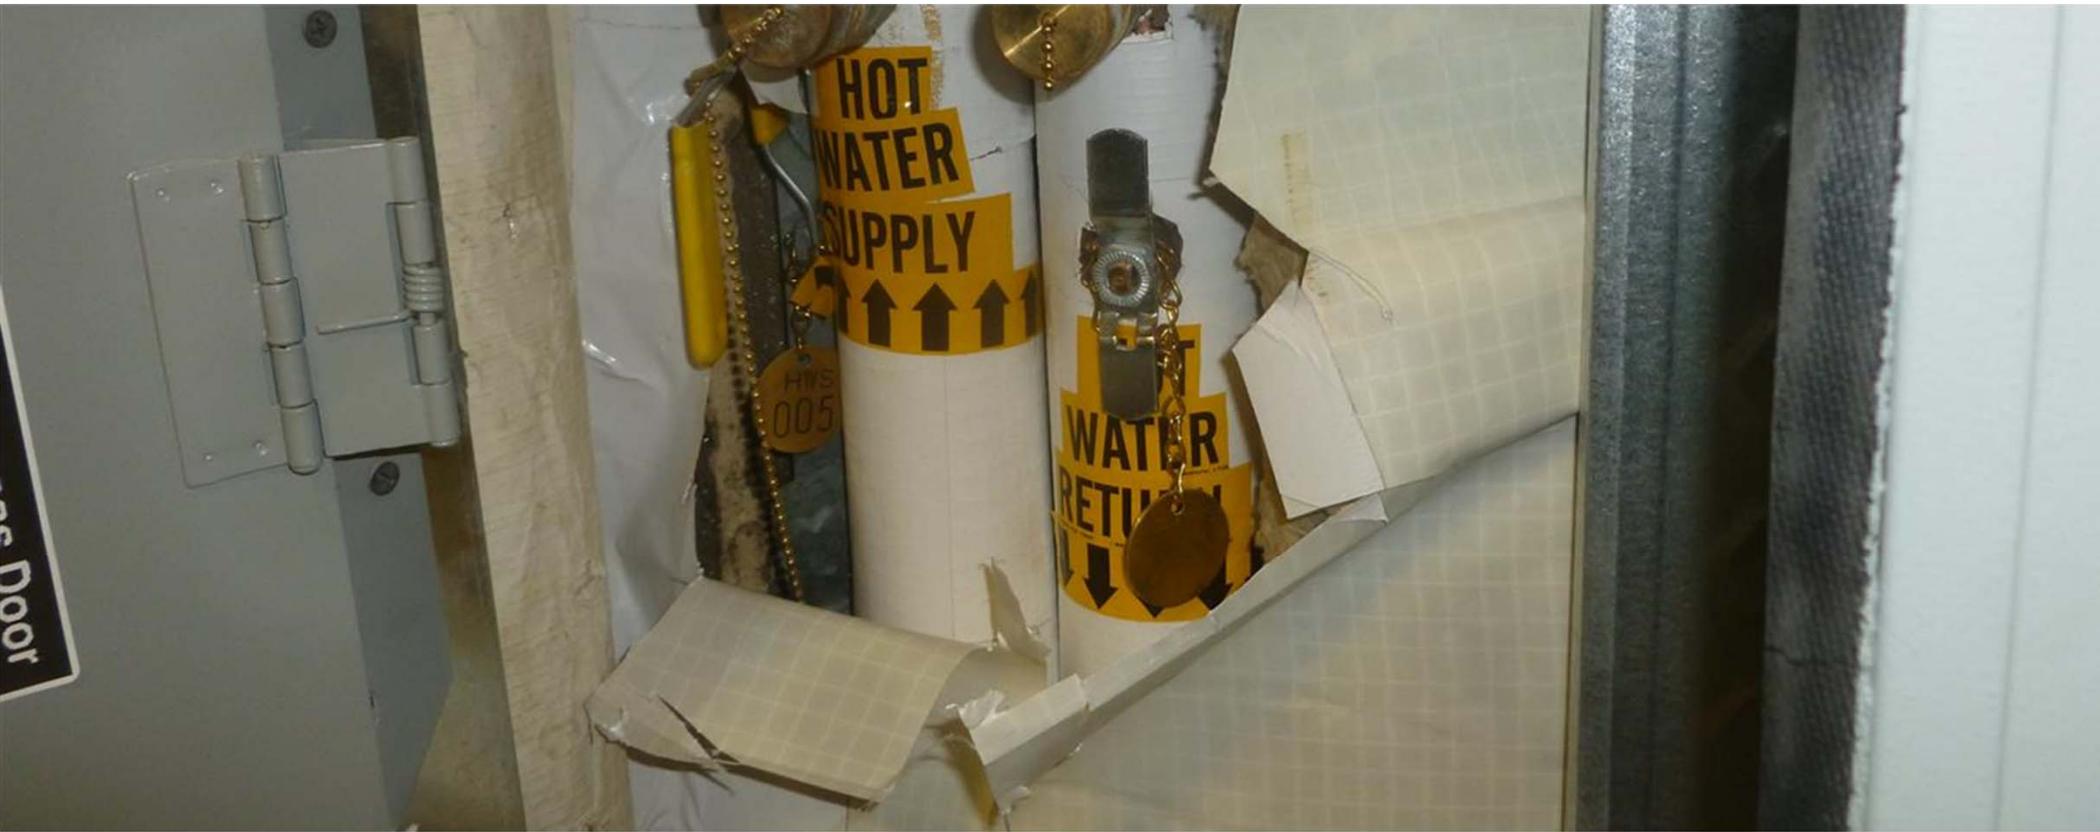
Non-continuous vapor barrier

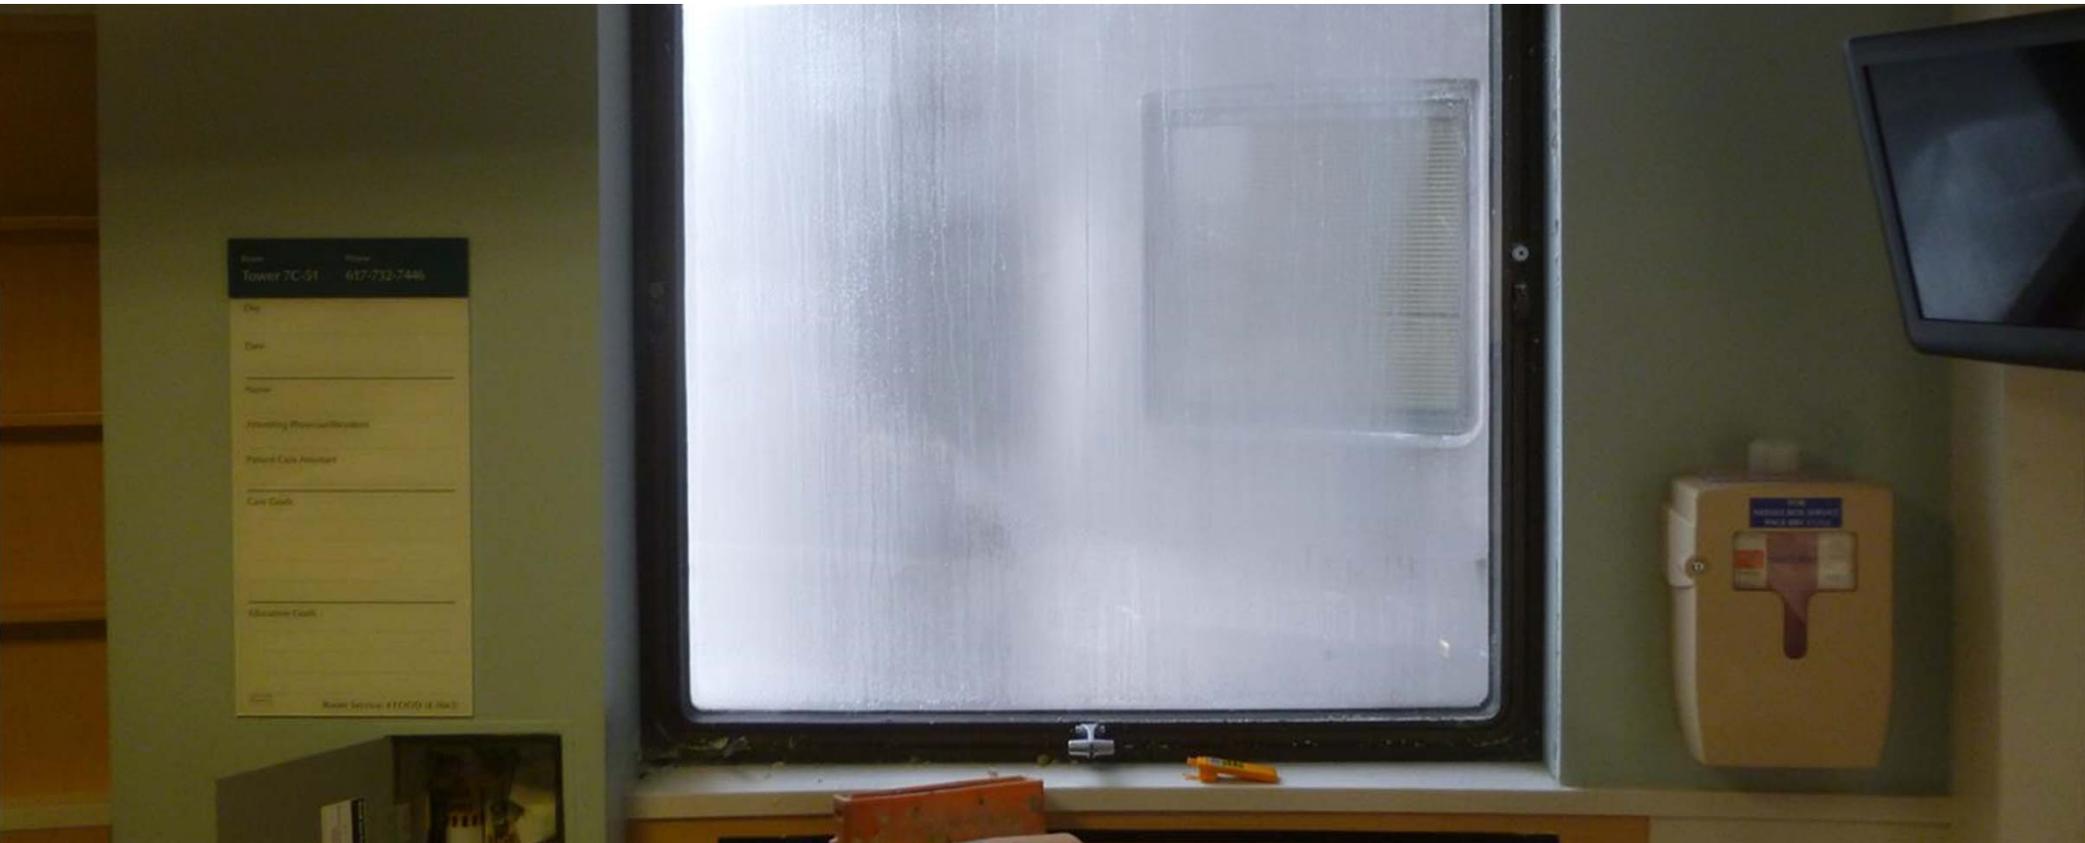
Condensation at exterior wall

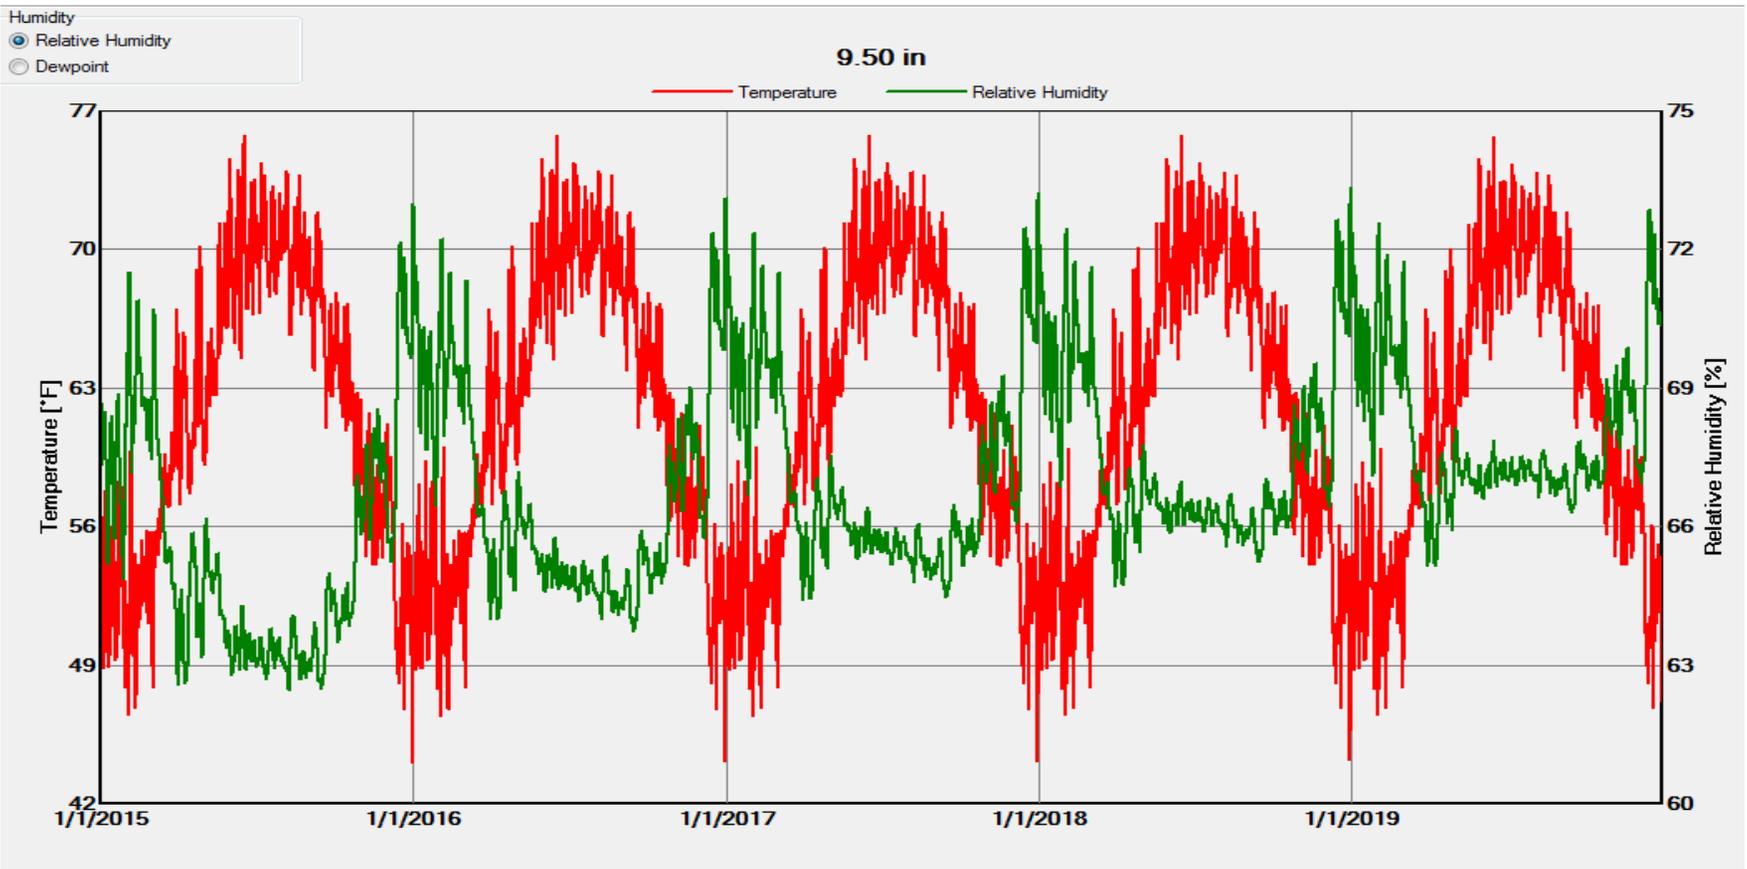
Temperature and humidity readings .75" into the SPF. Note several RH readings over 80%.

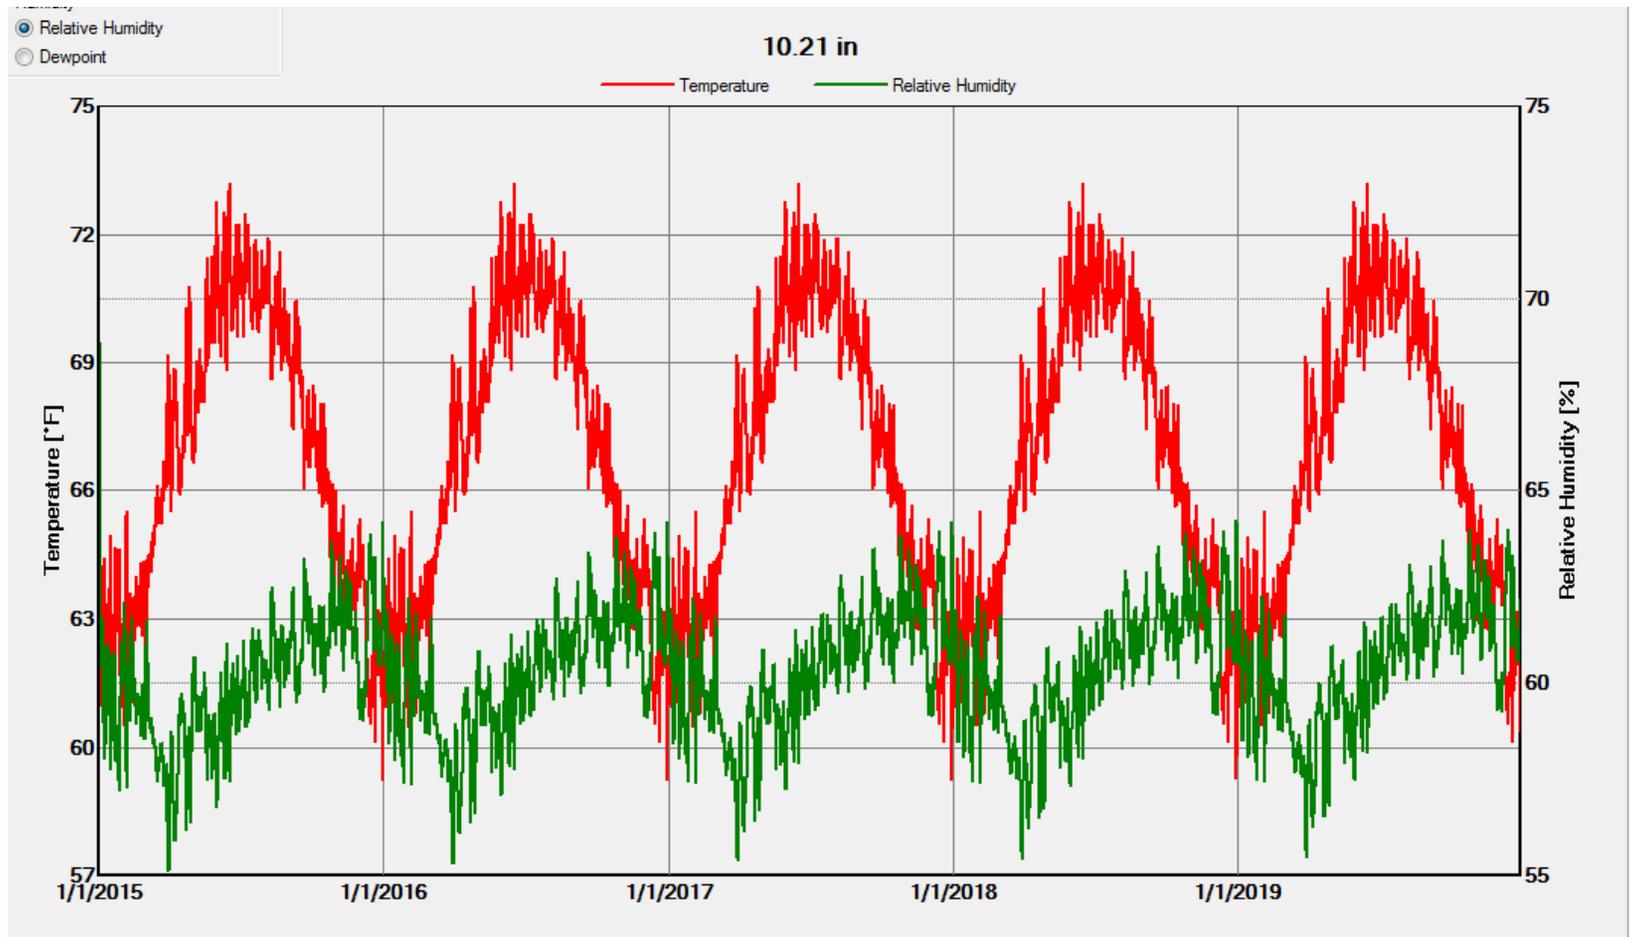
Temperature and humidity readings 1.5” into the SPF.
 Note no RH readings over 80% and very few over 70%.

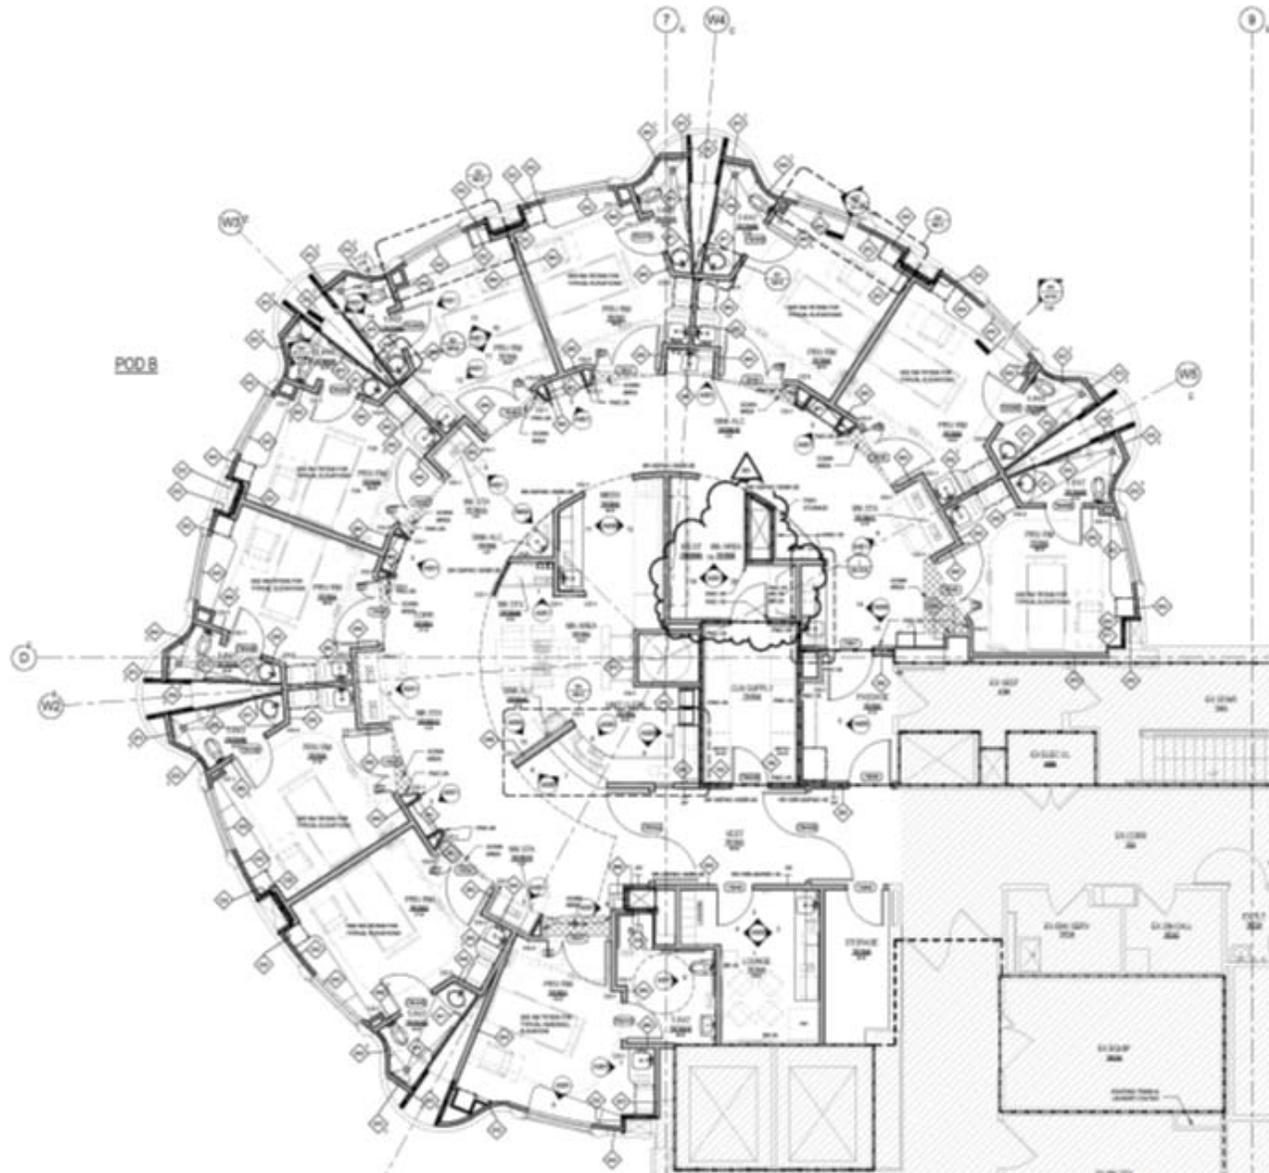
Thermal Probe Locations

Interior surface of the precast concrete panel

Interior surface of the interior gypsum wall board

Interior surface of glazing

Surface of steel support angle for the precast panels at the floor above

Interior surface of metal frame

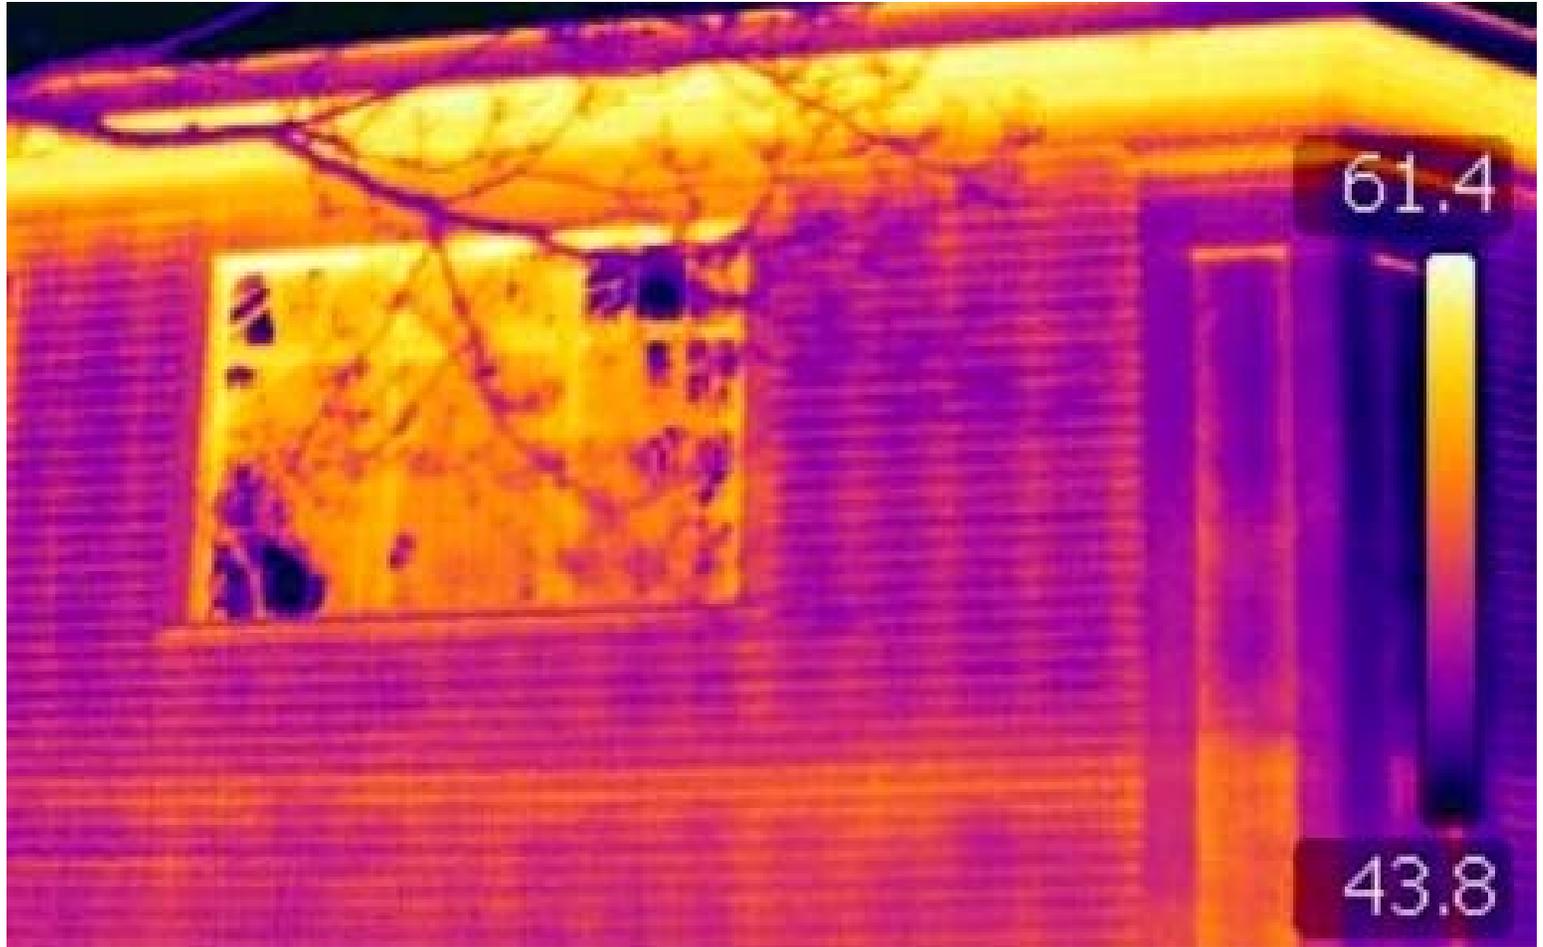
Metal Stud Framed Walls

Image 9: Infrared image highlighting the thermal bridging caused by the metal studs

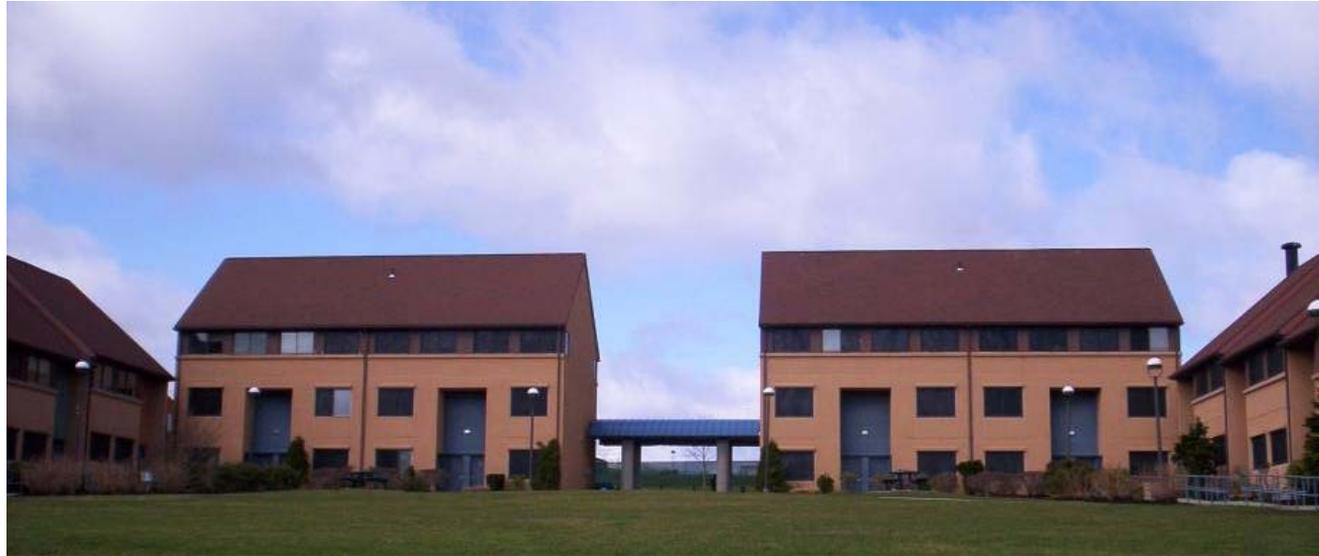
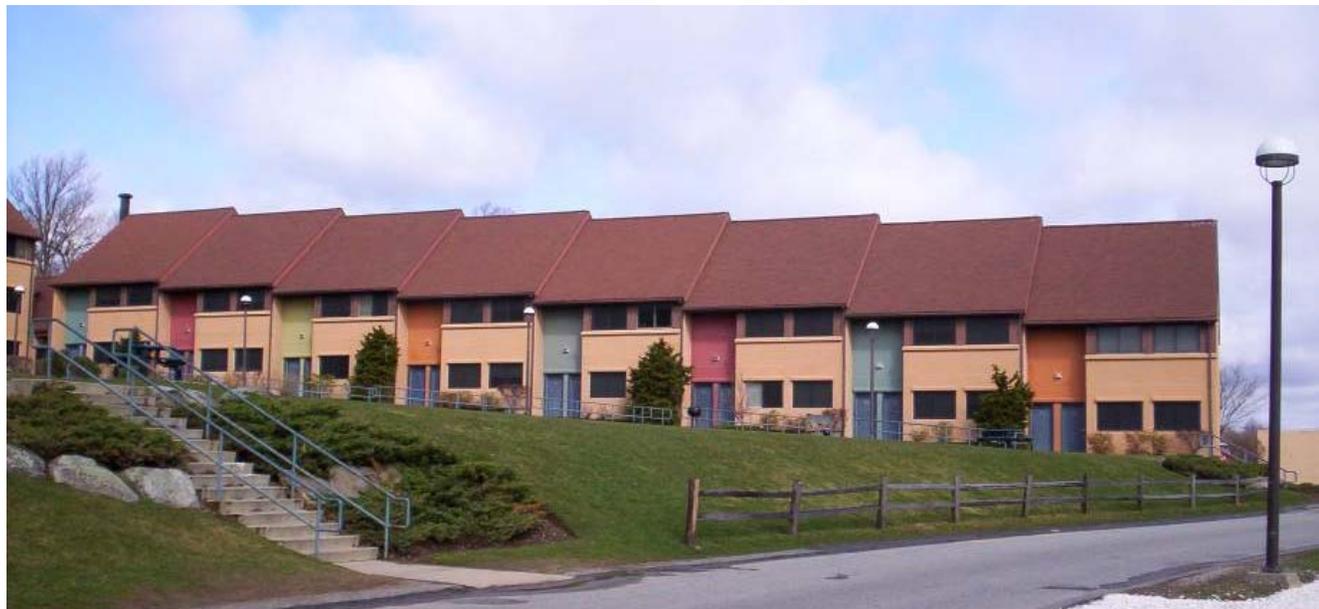
Background – History

- Typical three story dorm building – east / courtyard elevation.
- Typical two story dorm buildings, photo shows the south elevation of the north wing.

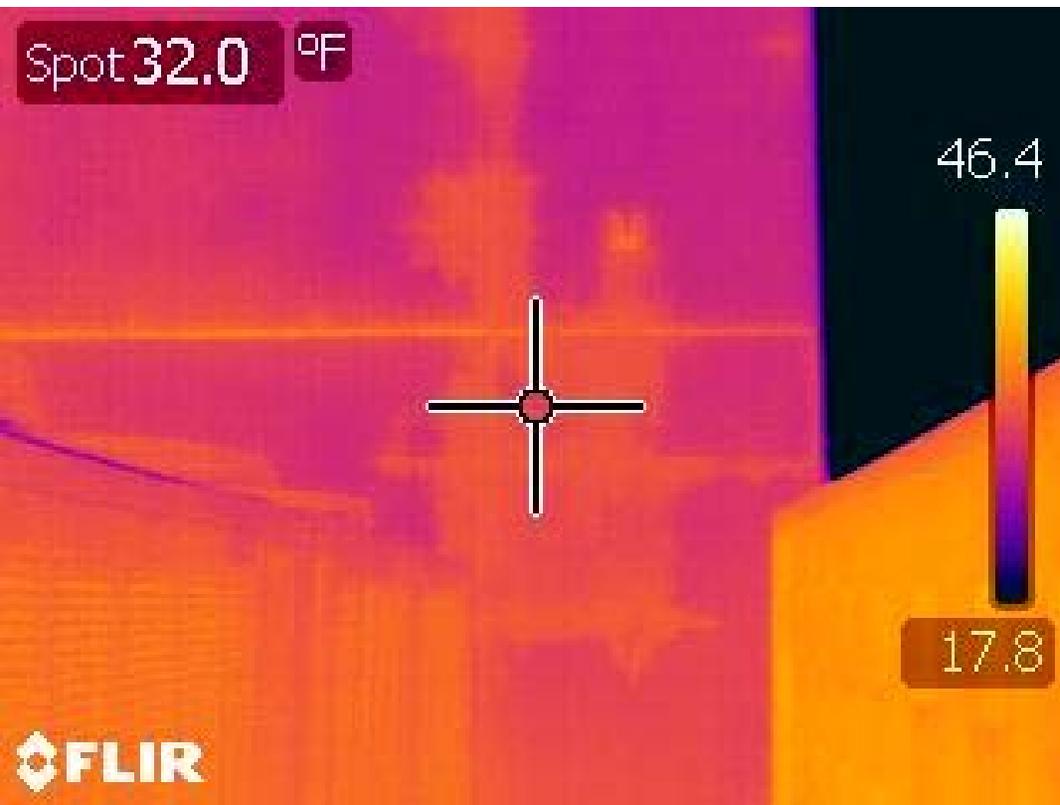
Background – History

- The EIFS panels are cracked at the vertical joints and are bowing
- Staining of EIFS under the window.
- Open joints were observed at the horizontal sealant line.
- The EIFS is not adhered to the wall at the foundation which is wet, note water running down behind the EIFS.

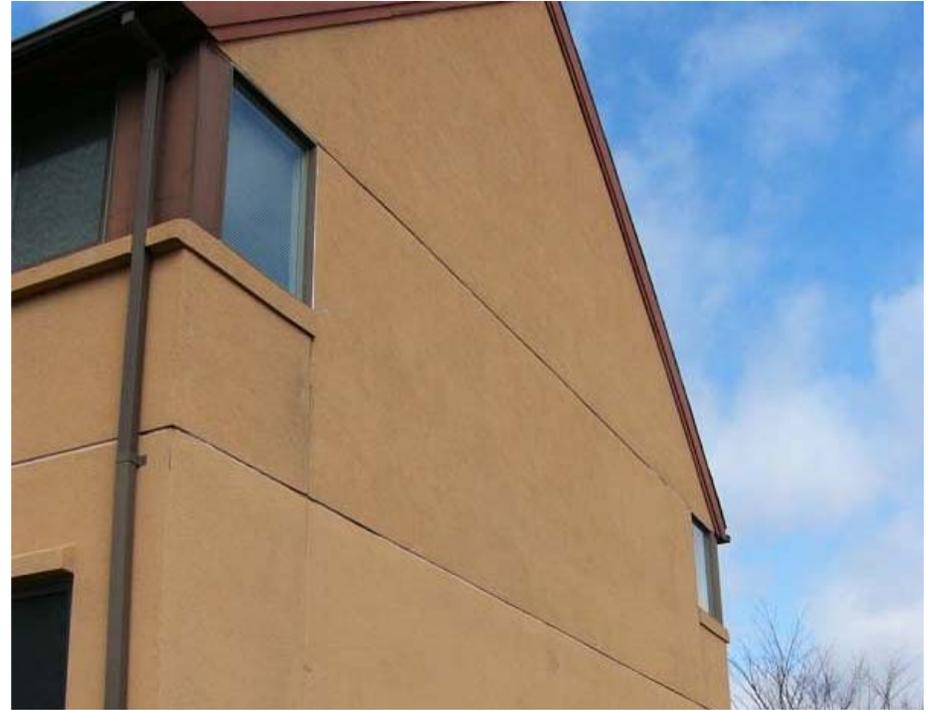
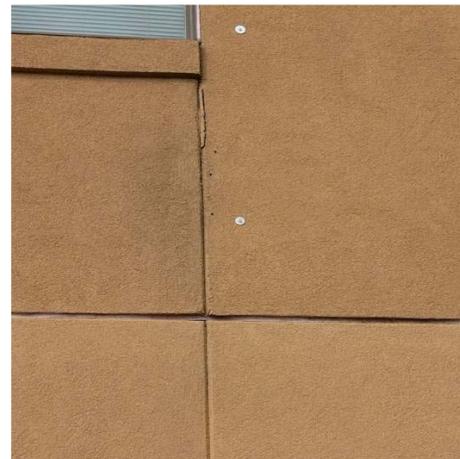
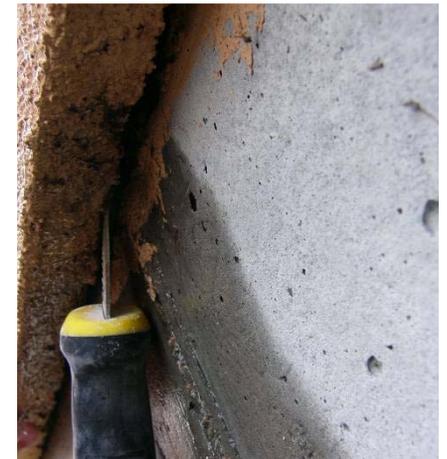
Background – History

- South wall of the south wing of Tidewater which blew off in the wind storm of April 15th and 16th, 2007.
- Prior to the storm, the EIFS wall was previously secured with fasteners by University staff.
- The EIFS is in direct contact with the shingles. Step flashing was observed behind the EIFS. The step flashing was not flashed or secured tightly to the substrate.

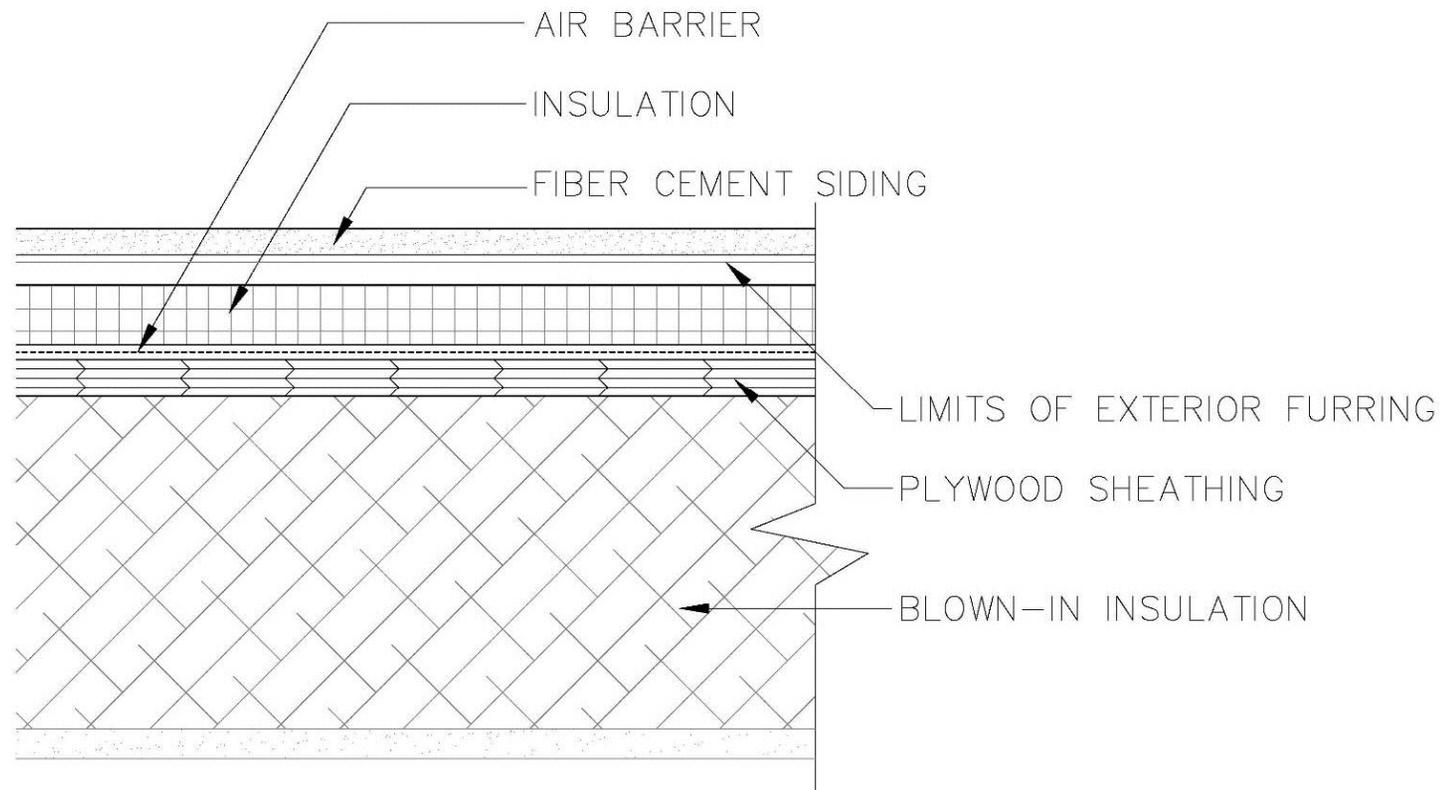
Wall System

- Siding attached through furring and into existing wood studs
- Insulation between furring members
