Energy Improvements to Existing Buildings Using Air Barriers and Insulation Upgrades

Brian H. Neely, AIA, CDT, BECxp

Gale Associates, Inc.

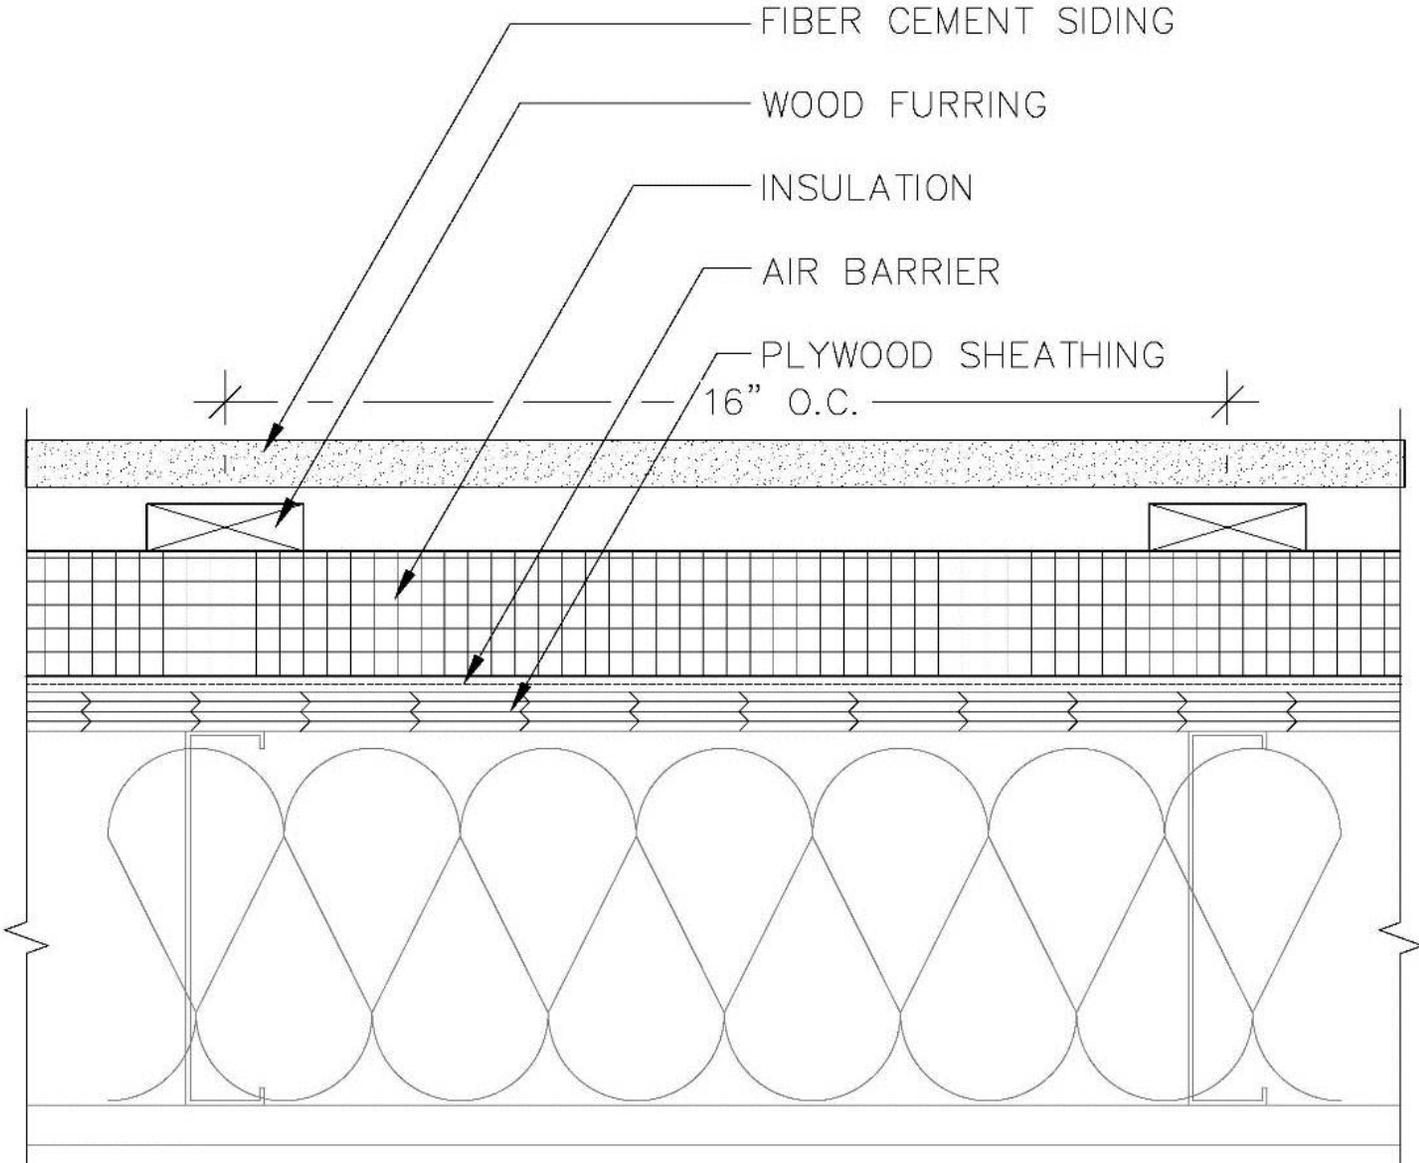
Preferred Design

- Siding attached through furring and into existing wood studs
- Insulation continuous behind furring members

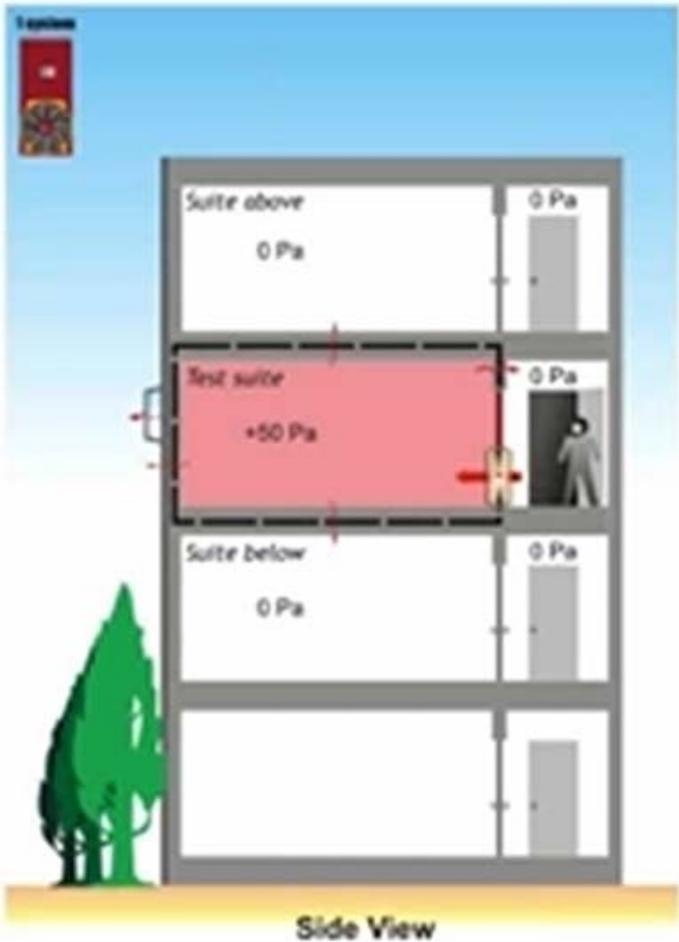
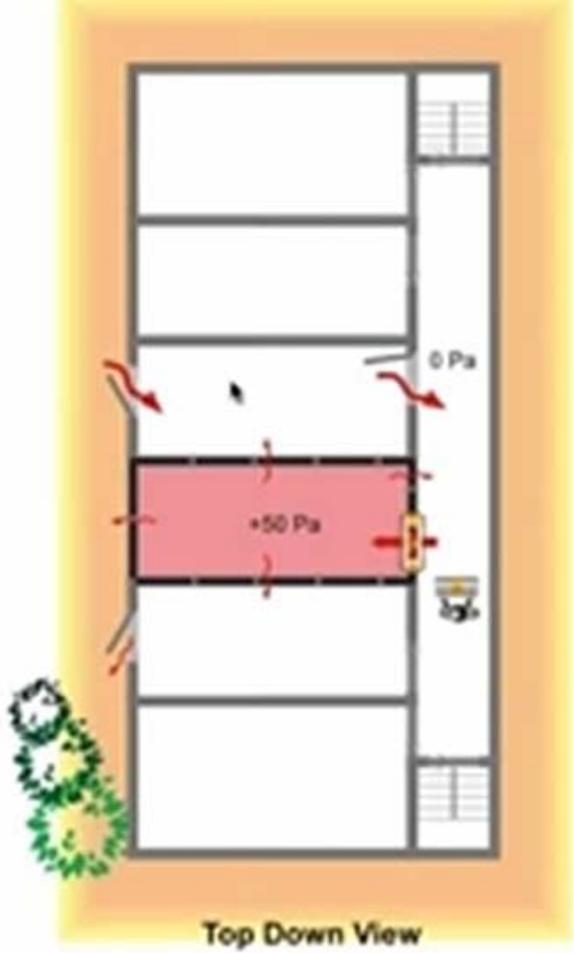
After Year 1 –
Phase 1

Complex 2
undergoing
renovations

Complex 1
renovations
complete

Complex 3
awaiting
renovations

Testing ASTM 779-10

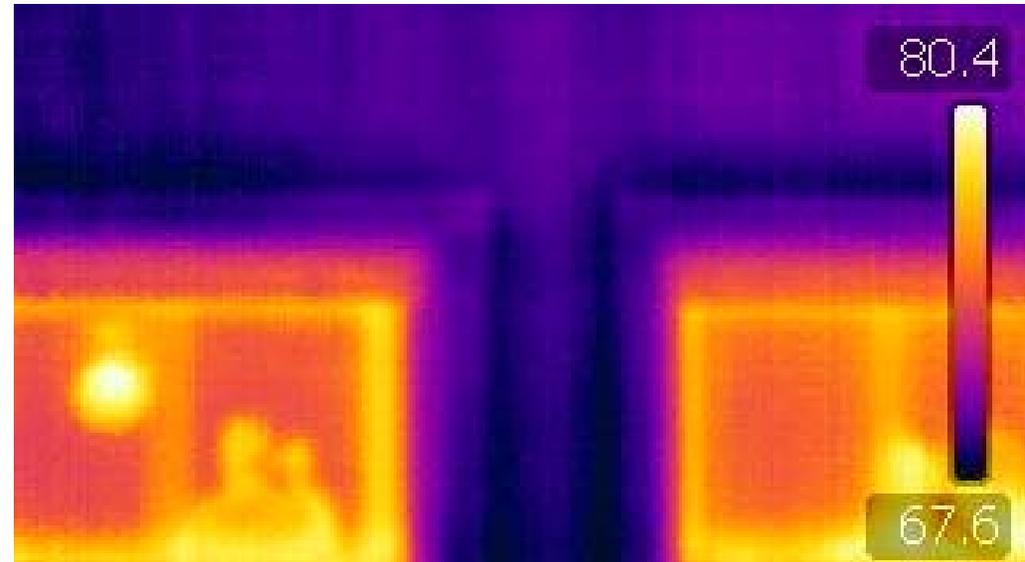
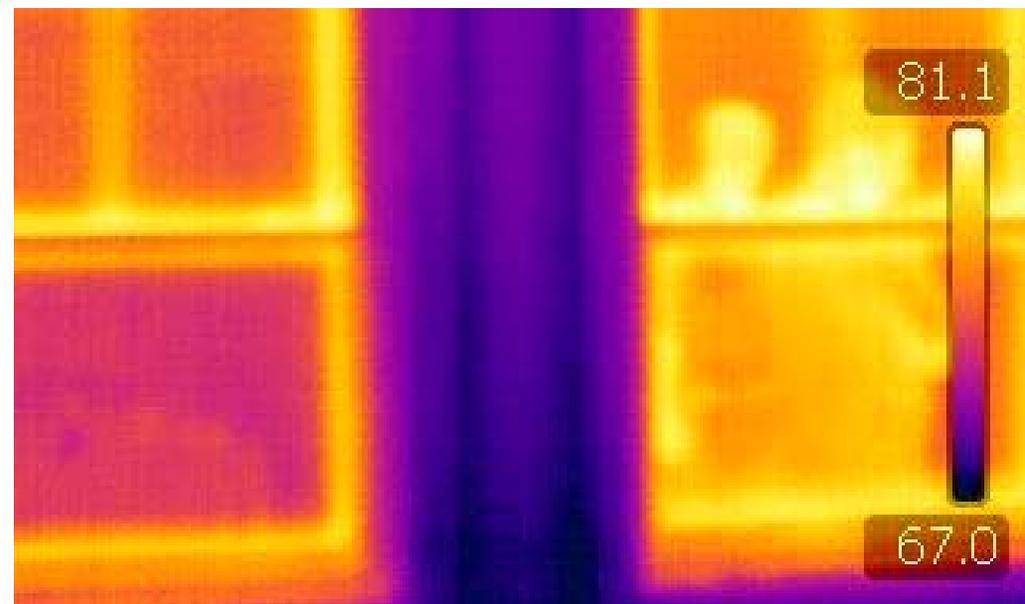
Testing

- ASTM 779-10 Blower Door Test
- Renovated Dorm

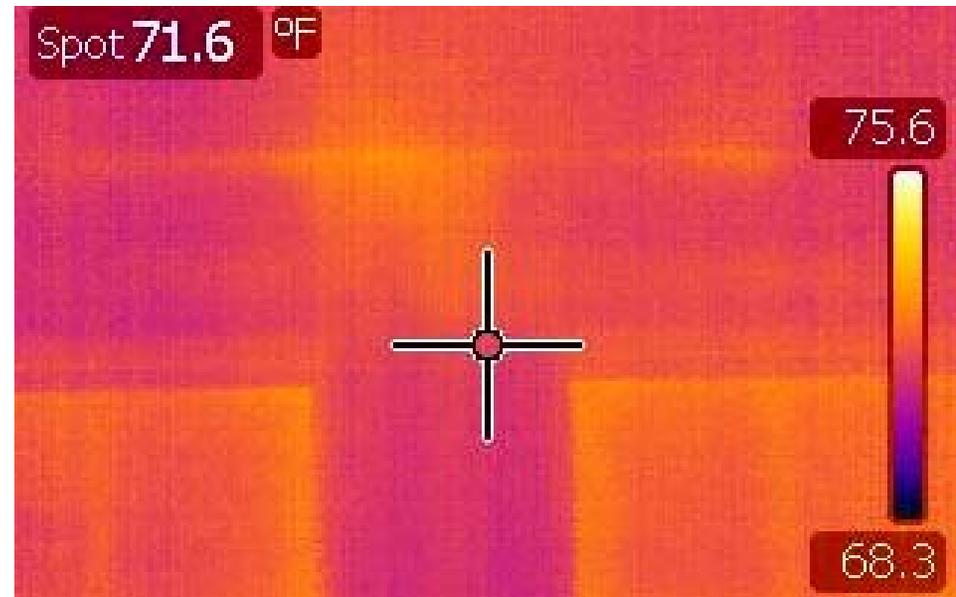
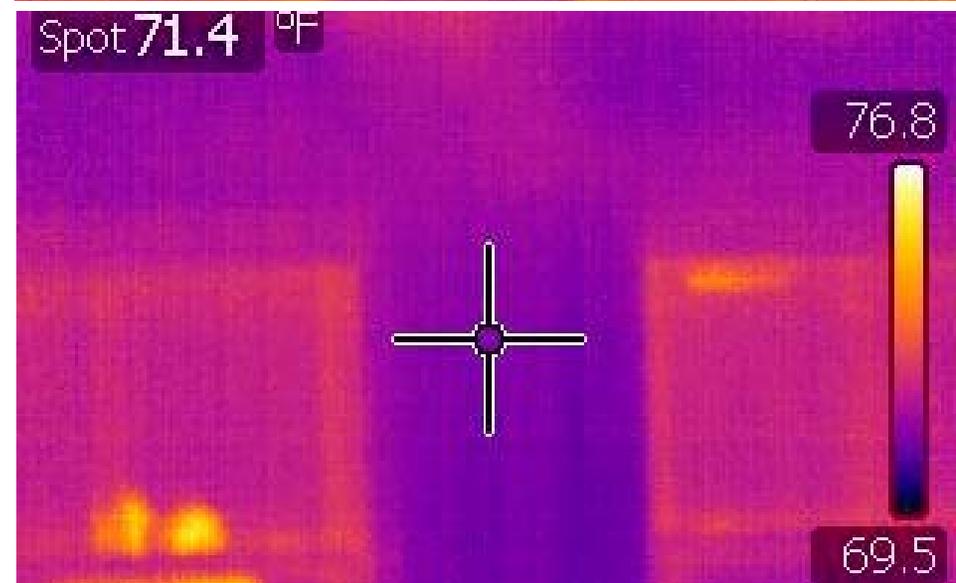
Testing

- ASTM 779-10 Blower Door Test
- Renovated Dorm

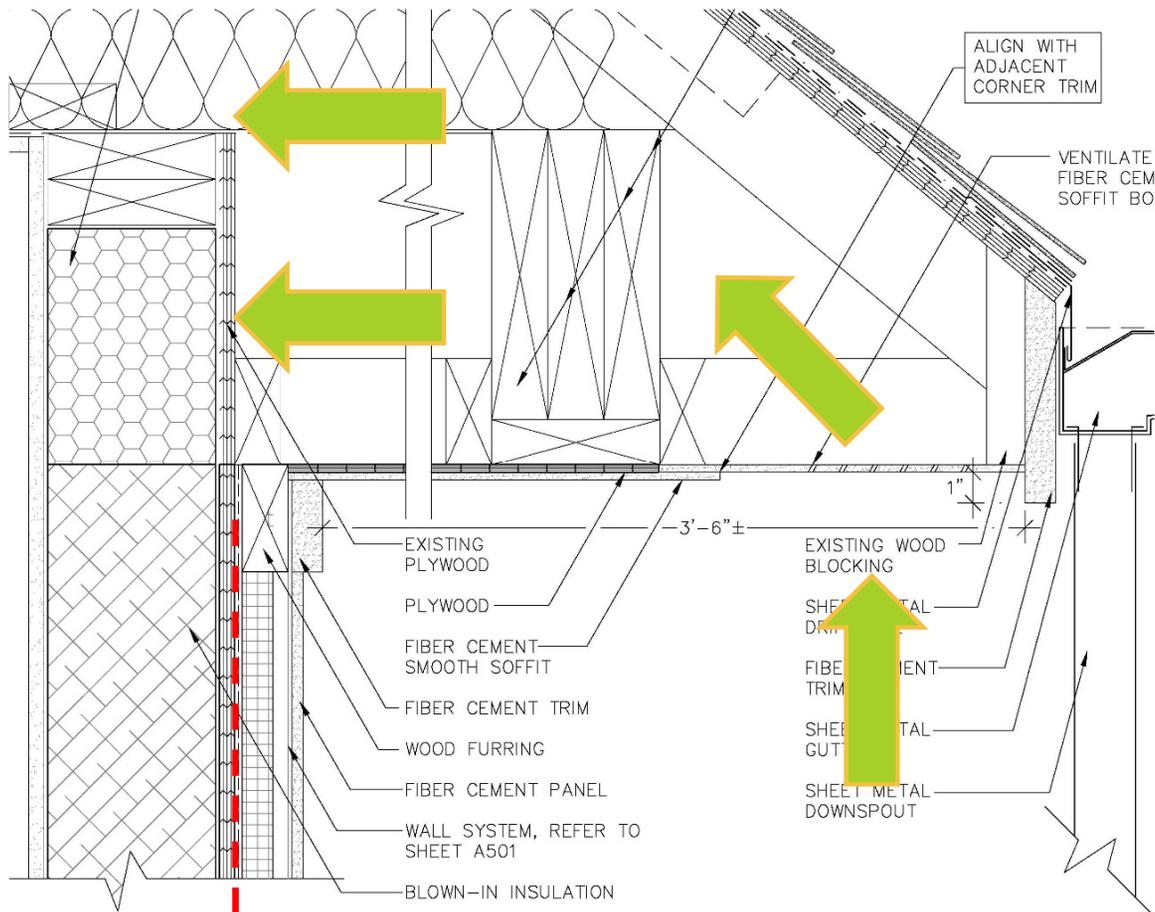
Potential Air Infiltration

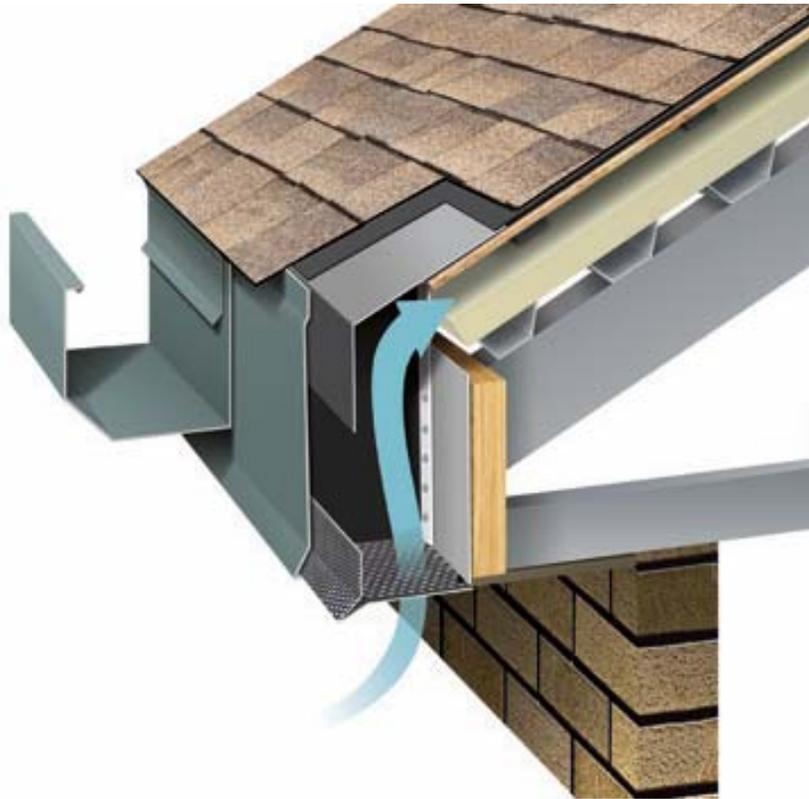
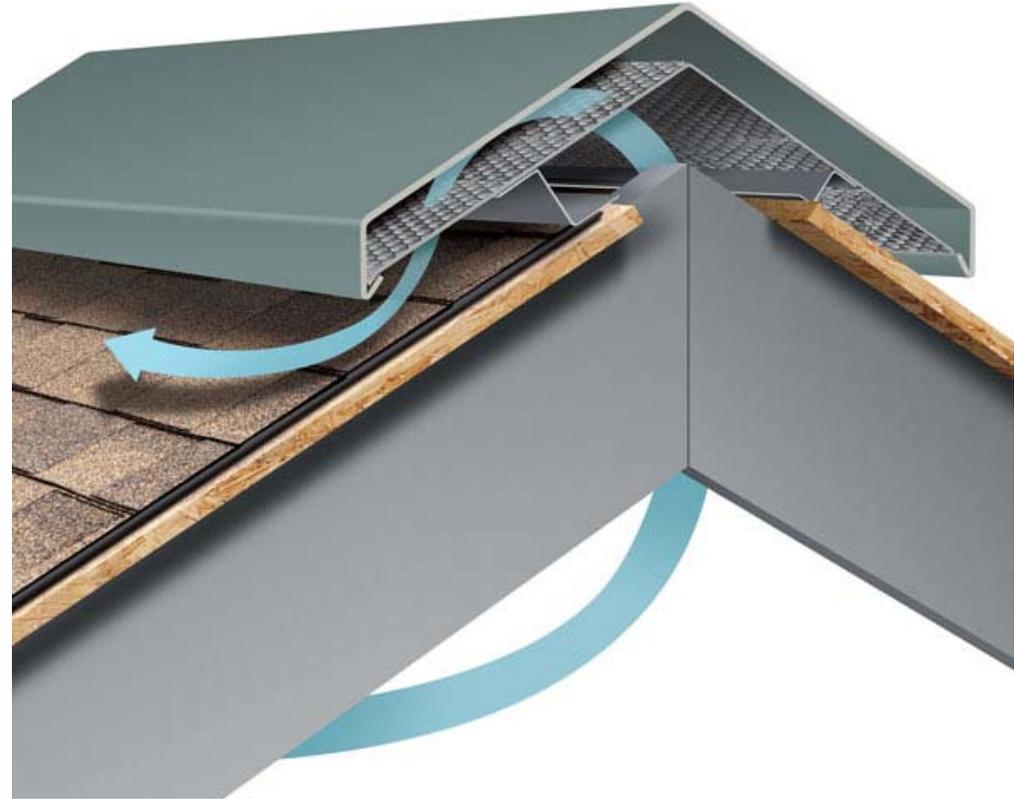
Preferred Design Detail

EPA Indoor airPLUS | MOISTURE CONTROL
www.epa.gov/indoorairplus
BEST PRACTICE TECHNIQUE

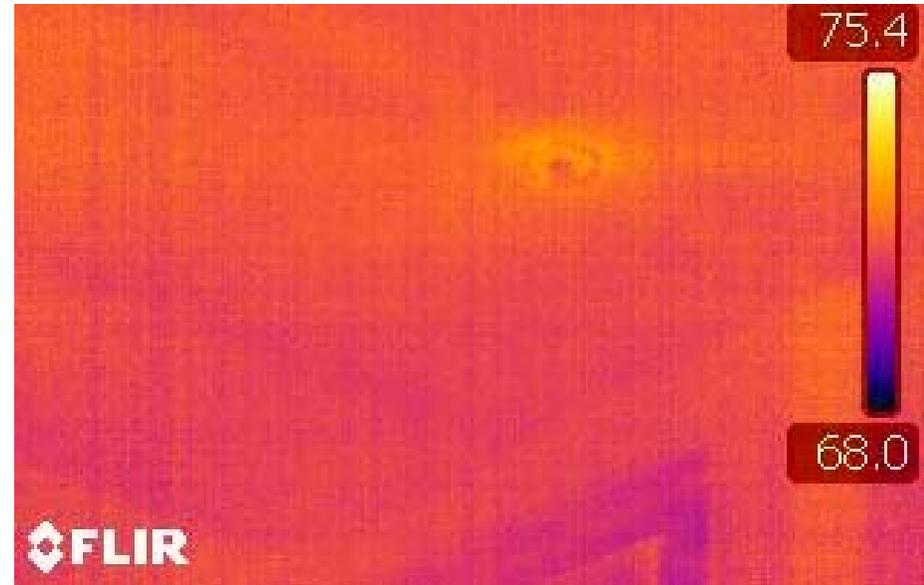
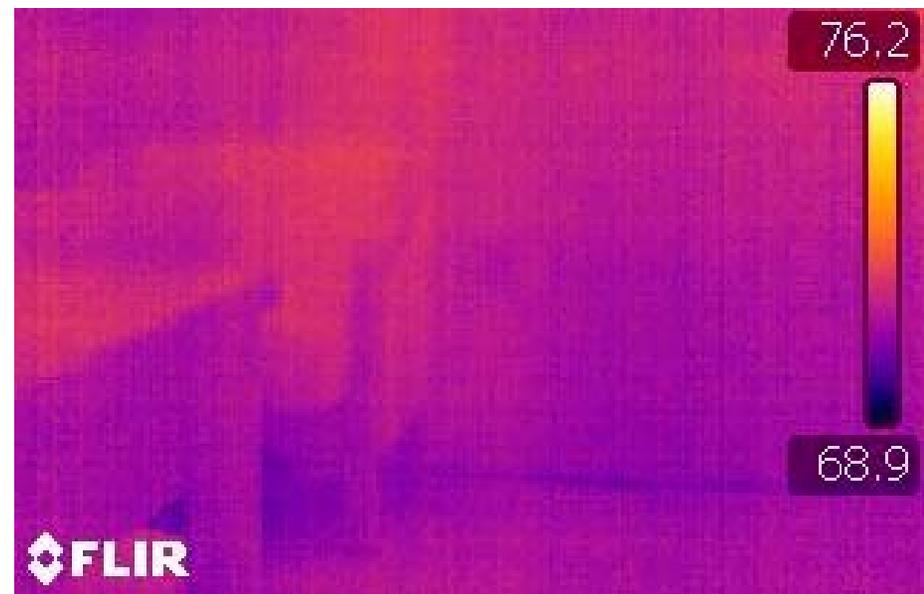
Testing

- ASTM E779-10 Blower Door Test
- Renovated Dorm
