Air Tightness Requirements of the Passive House Standard

Mike O'Donnell & Scott Pusey

Steven Winter Associates

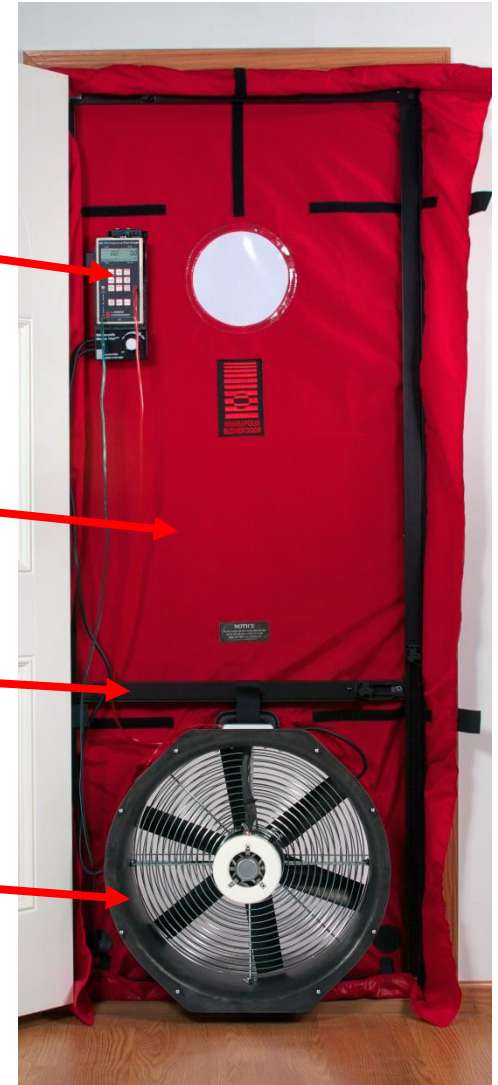
Blower Door Testing

- Basic Components
 - Gauge (manometer)
 - Shroud
 - Frame
 - Fan

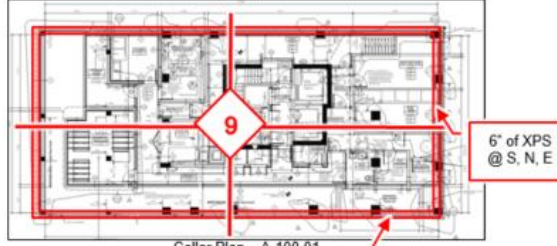
Cellar Plan – A-100.01

Item #	Inspection	Detail Date
U3	Below Grade Wall – Insulation	95% CD – 08/05/17

Description
See Wall Type 9: 6 1/2" or 5" of DOW HighLoad 40 XPS; insulation continuous at benched area; must be inspected before Preprufe is installed.

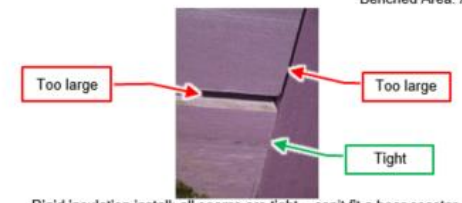
Rigid insulation install: all seams are tight – can't fit a beer coaster.

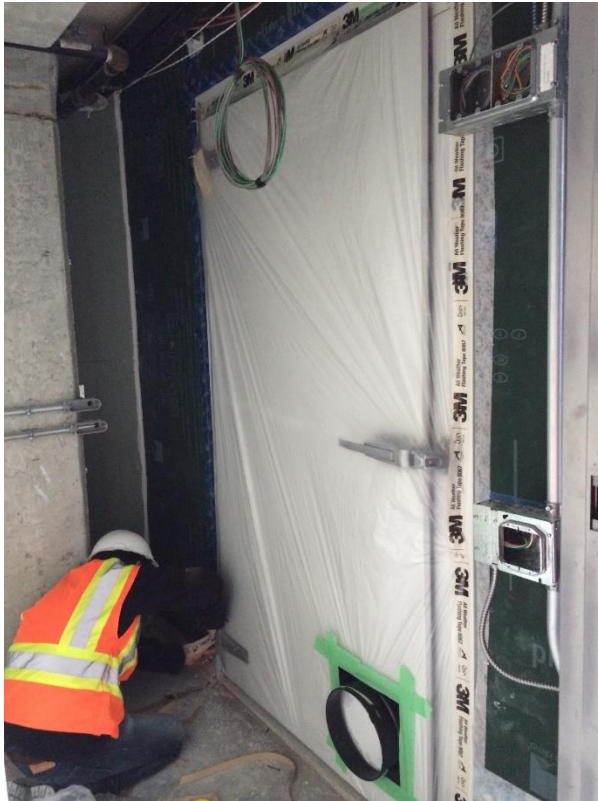
Other Tests

- Condenser porch doors
- Trash chute rooms / doors

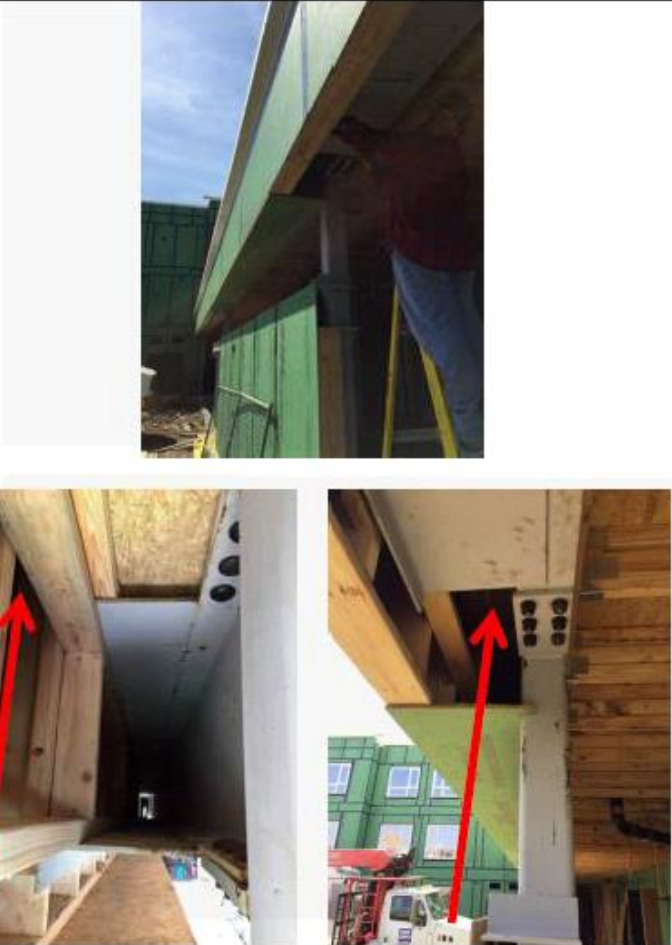
Item #	Description and Action Required	Images
1	<p>9" of OCSP needs to be sprayed on the ceiling of the canopy which is currently un-reachable due to the structural steel of the canopy. This may require temporary removal of the already installed exterior sheathing.</p> <p>After the sheathing is re-attached, OCSF needs to be applied to the interior of it.</p> <p>The condition needs to match Detail 1 on A6.3 shown below.</p>

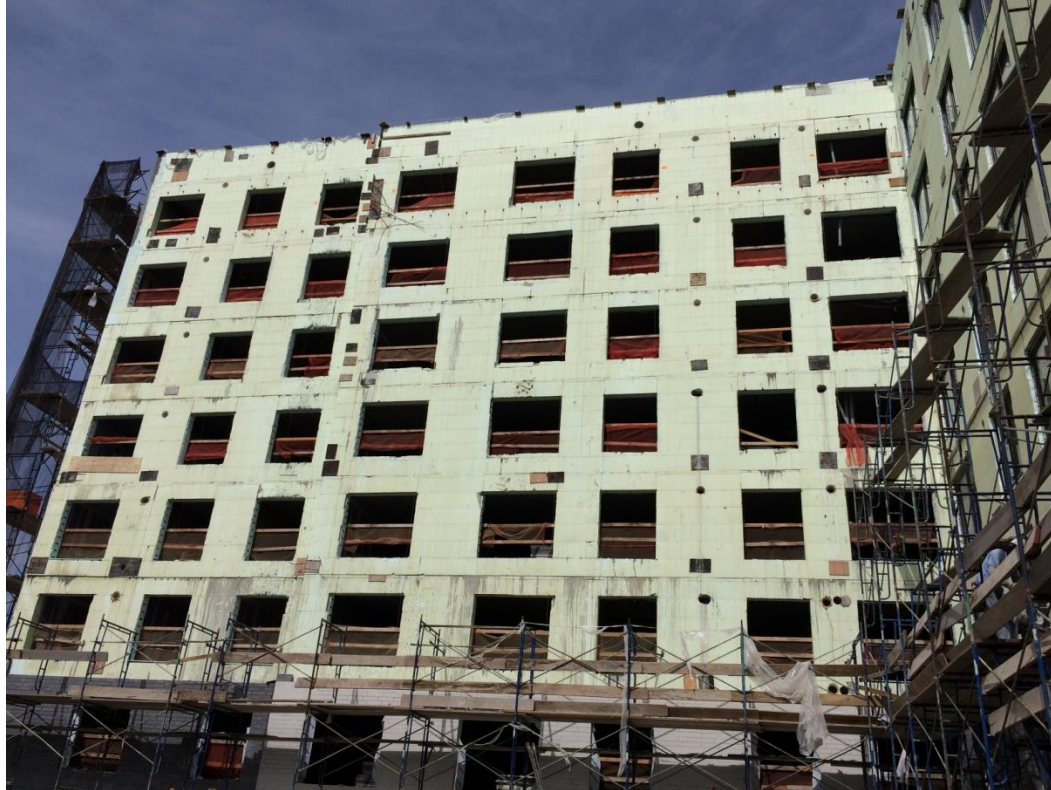
Wall Inspections

- ICF doesn't require as many inspections for insulation and air barrier

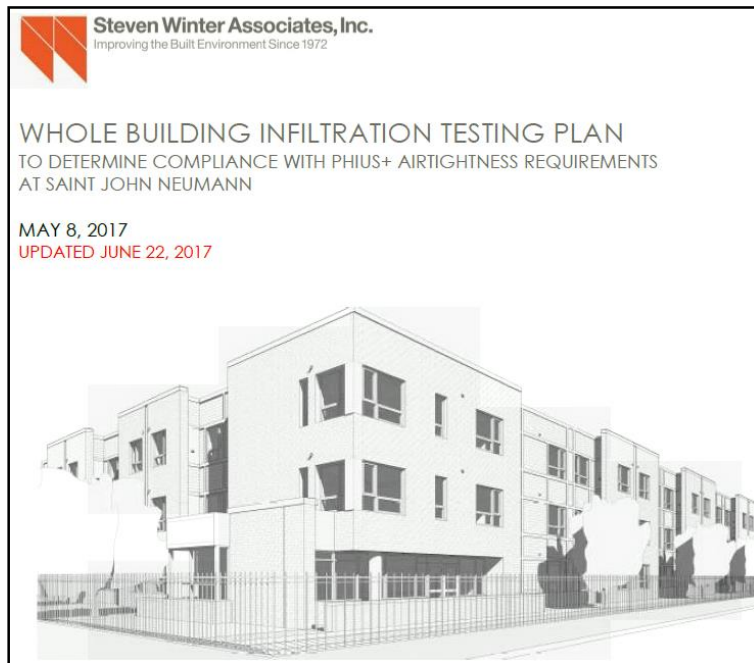
Blower Door Test Conditions

Intentional Opening	Test Setting	Notes
Windows, doors, skylights in the building enclosure	Closed and latched	
Doors and operable windows inside the test enclosure	Open	Use stairways to connect all zones of the building
Fire dampers	Remain as found	
Dryer doors	Closed and latched	
Gas meter room	Door to gas meter room closed and weather stripped	
Waste handling system	Trash chute termination at roof taped off. Door to trash rooms closed.	
ERVs (apartments)	Fan off, any dampers closed. Ducts to the outside sealed inside the ERV cabinet in each apartment.	Ventilation is continuous, so can remain taped off
Motorized dampers: ERV-4 (cellar)	Fan off, dampers closed. Taped off from the exterior	Ventilation is continuous, so dampers closed and sealed off
Motorized dampers: ERV-5 (1 st floor)	Fan off, dampers closed. Taped off from the exterior	Ventilation is continuous, so dampers closed and sealed off
Motorized dampers: ERV-2A (1 st floor)	Fan off, dampers closed. Taped off from the exterior	Ventilation is continuous, so dampers closed and sealed off

Motorized damper: Laundry Room (2 nd floor)	Fan off, dampers closed. Taped off from the exterior	<u>Untaped</u> for Method A test
Motorized damper: ERV-2 (2 nd floor)	Fan off, dampers closed. Taped off from the exterior	Ventilation is continuous, so dampers closed and sealed
Motorized dampers: EMR (1 st floor), Stair A, Stair B, Elevator, Boiler Room (roof)	Taped off from the exterior	<u>Untaped</u> for Method A test
ERV 2 (roof)	Fan off, dampers closed	Ventilation is continuous, so

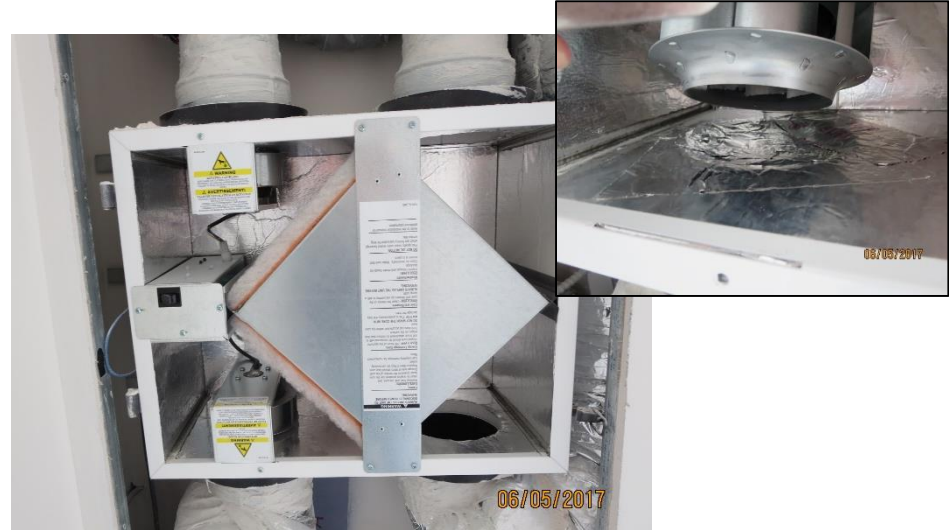
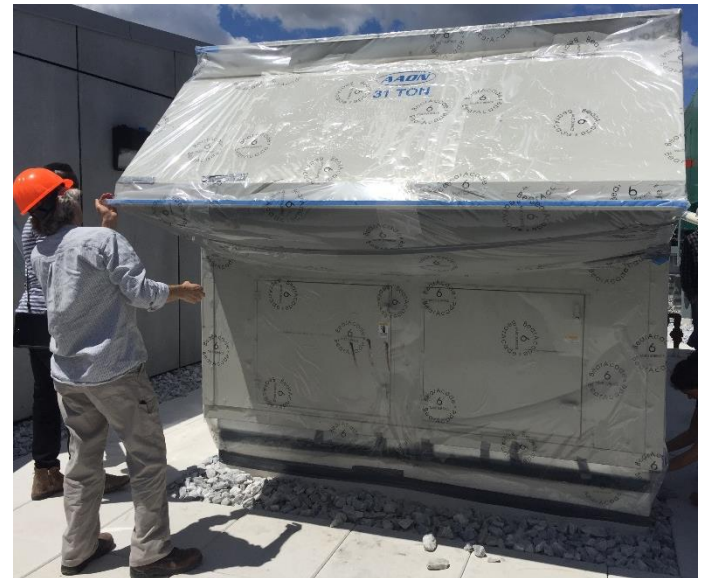
ERVs & Blower Door

- Need to seal off ERVs for final test
- Can't seal off vents from outside for individual ERVs
- Tape off both outdoor connection ports inside every ERV
- Wrap rooftop ERVs
