Non-Visible Energy – Decoding Electromagnetic Energy and Thermodynamics

Case Study 1 – CoxHealth Patient Tower Addition

Case Study 2 – Primatara Mansion

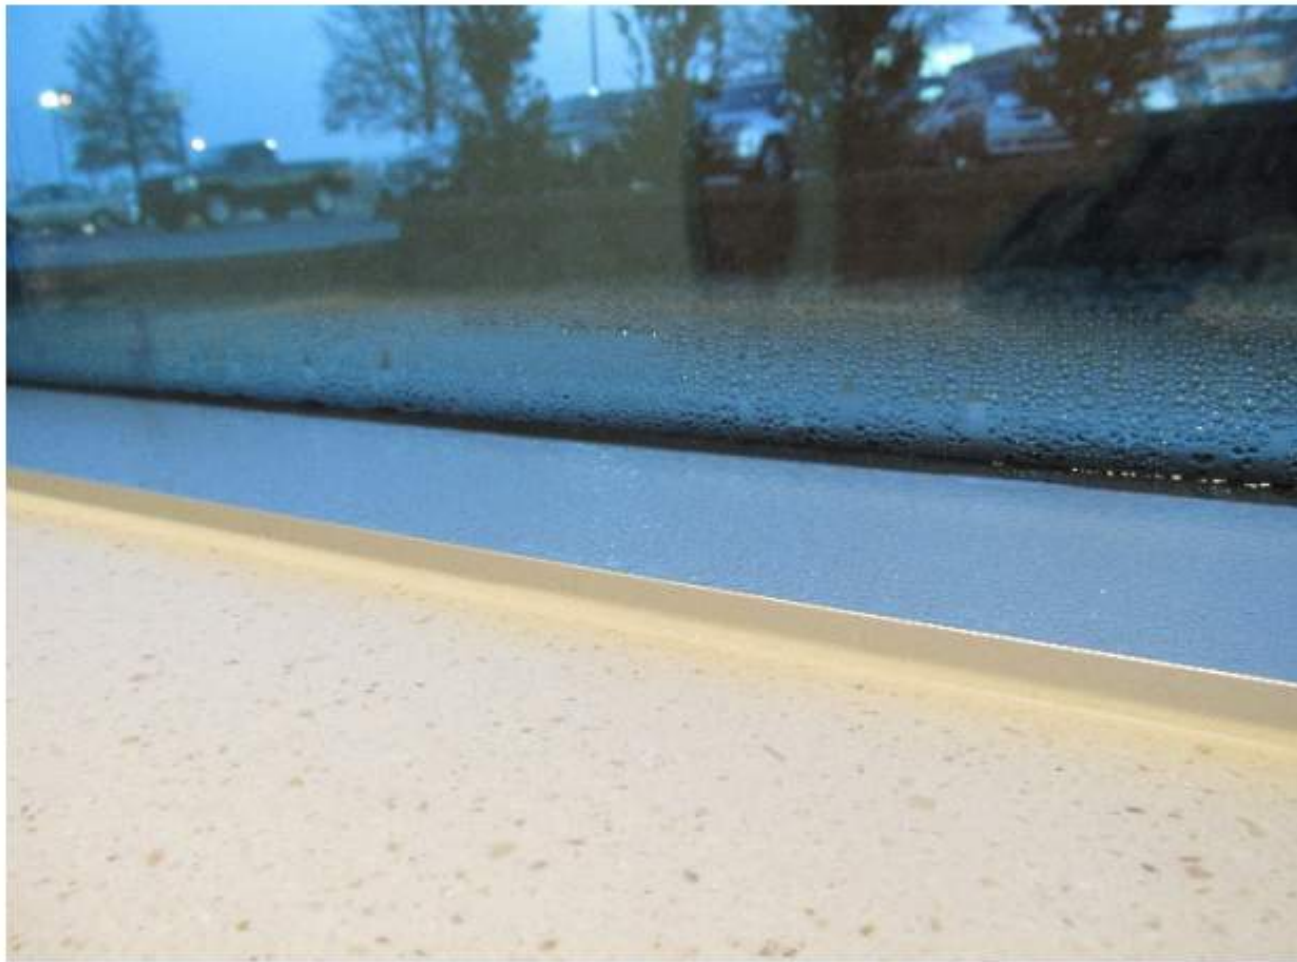
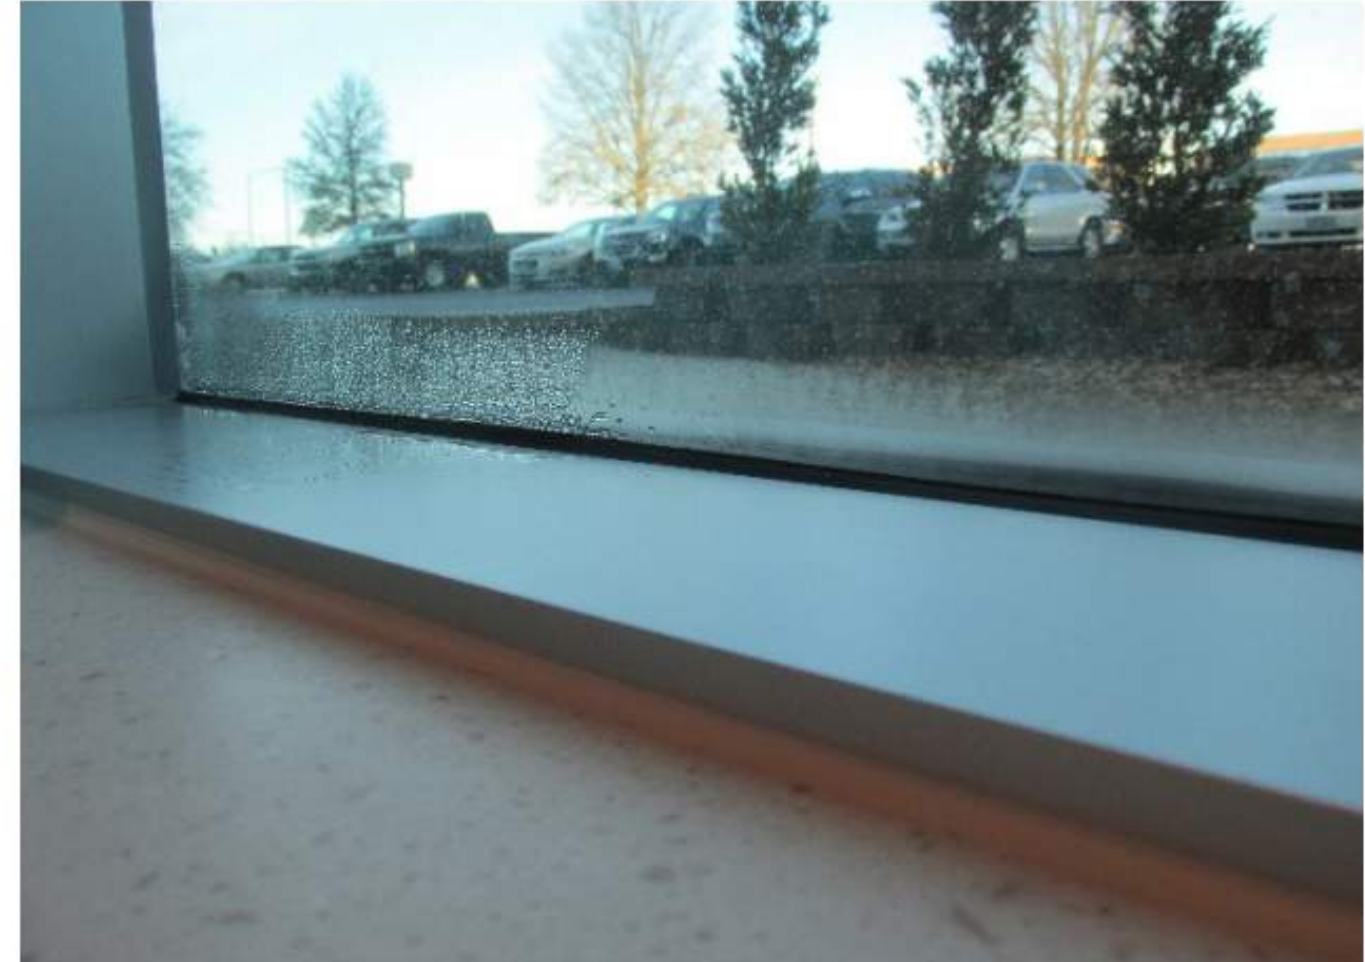
NICU Room #14: Image on left was taken upon arrival at 7:15am on 2/2/18. Image on the right was taken to document the reoccurrence of condensation within 30 minutes of drying glass and tube.

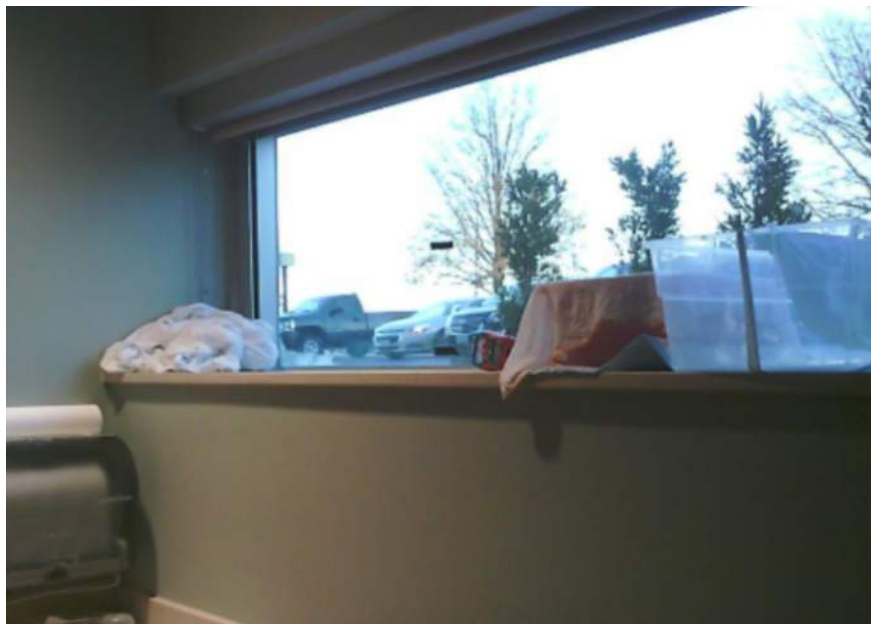
NICU Room 14 – North Elevation

Note: According to the design criteria used of: 3°F exterior temp, 72°F interior temp, wind velocity of 15 mph, relative humidity at 35% and dew point temperature of 42.9°F the projected surface temperatures of the frames above would result in surface condensation.

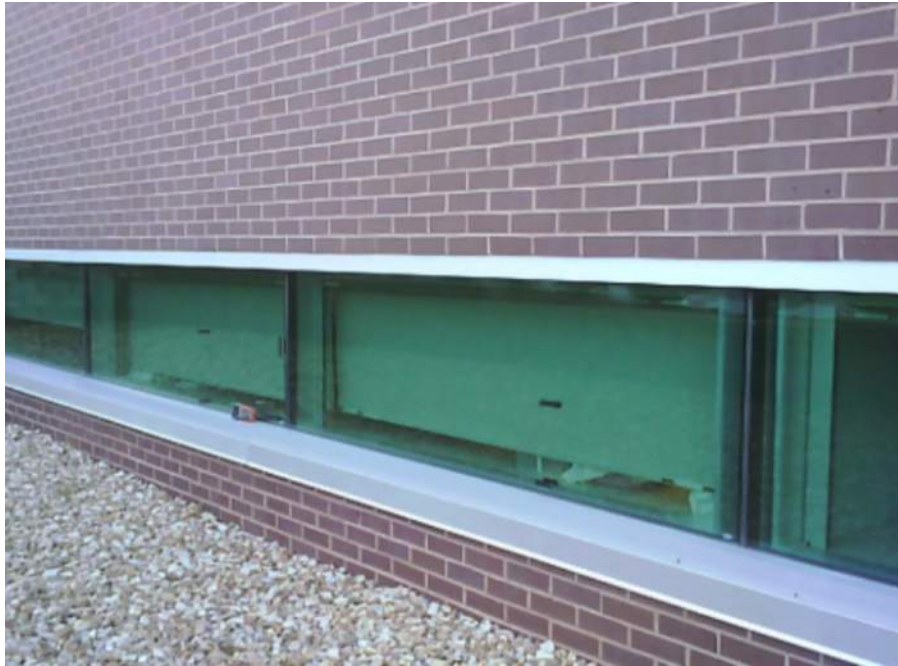
NICU Room 14 – Exterior at Sill Tube

Bx1	Max	23.9 °F
	Min	22.3 °F
	Average	23.2 °F

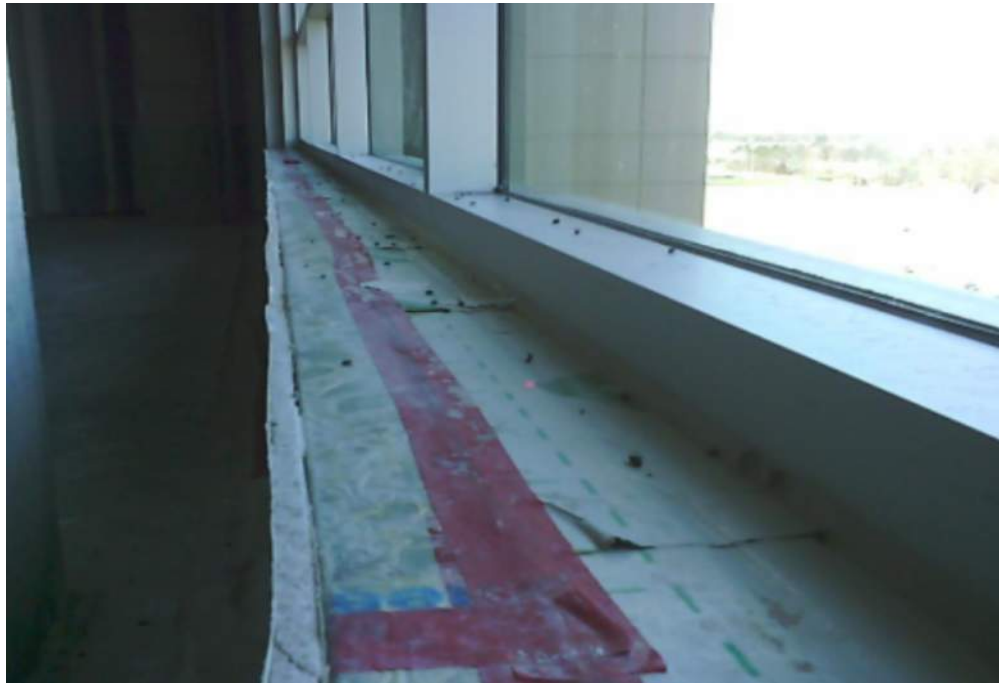
North wall 5th floor looking north, structural steel temperatures are lower than frame temperatures. This image was taken at 10:00 am when exterior ambient temperatures were approximately 22°F. This image shows the frame sitting on the cold side of the exterior wall, directly onto the steel member. The spot surface temperatures are as follows: Spot1 - 46.7°F, Spot2 - 60.0°F, Spot3 - 51.0°F, Spot4 - 51.0 °F, Spot5 - 51.8°F, Spot6 - 59.8°F.

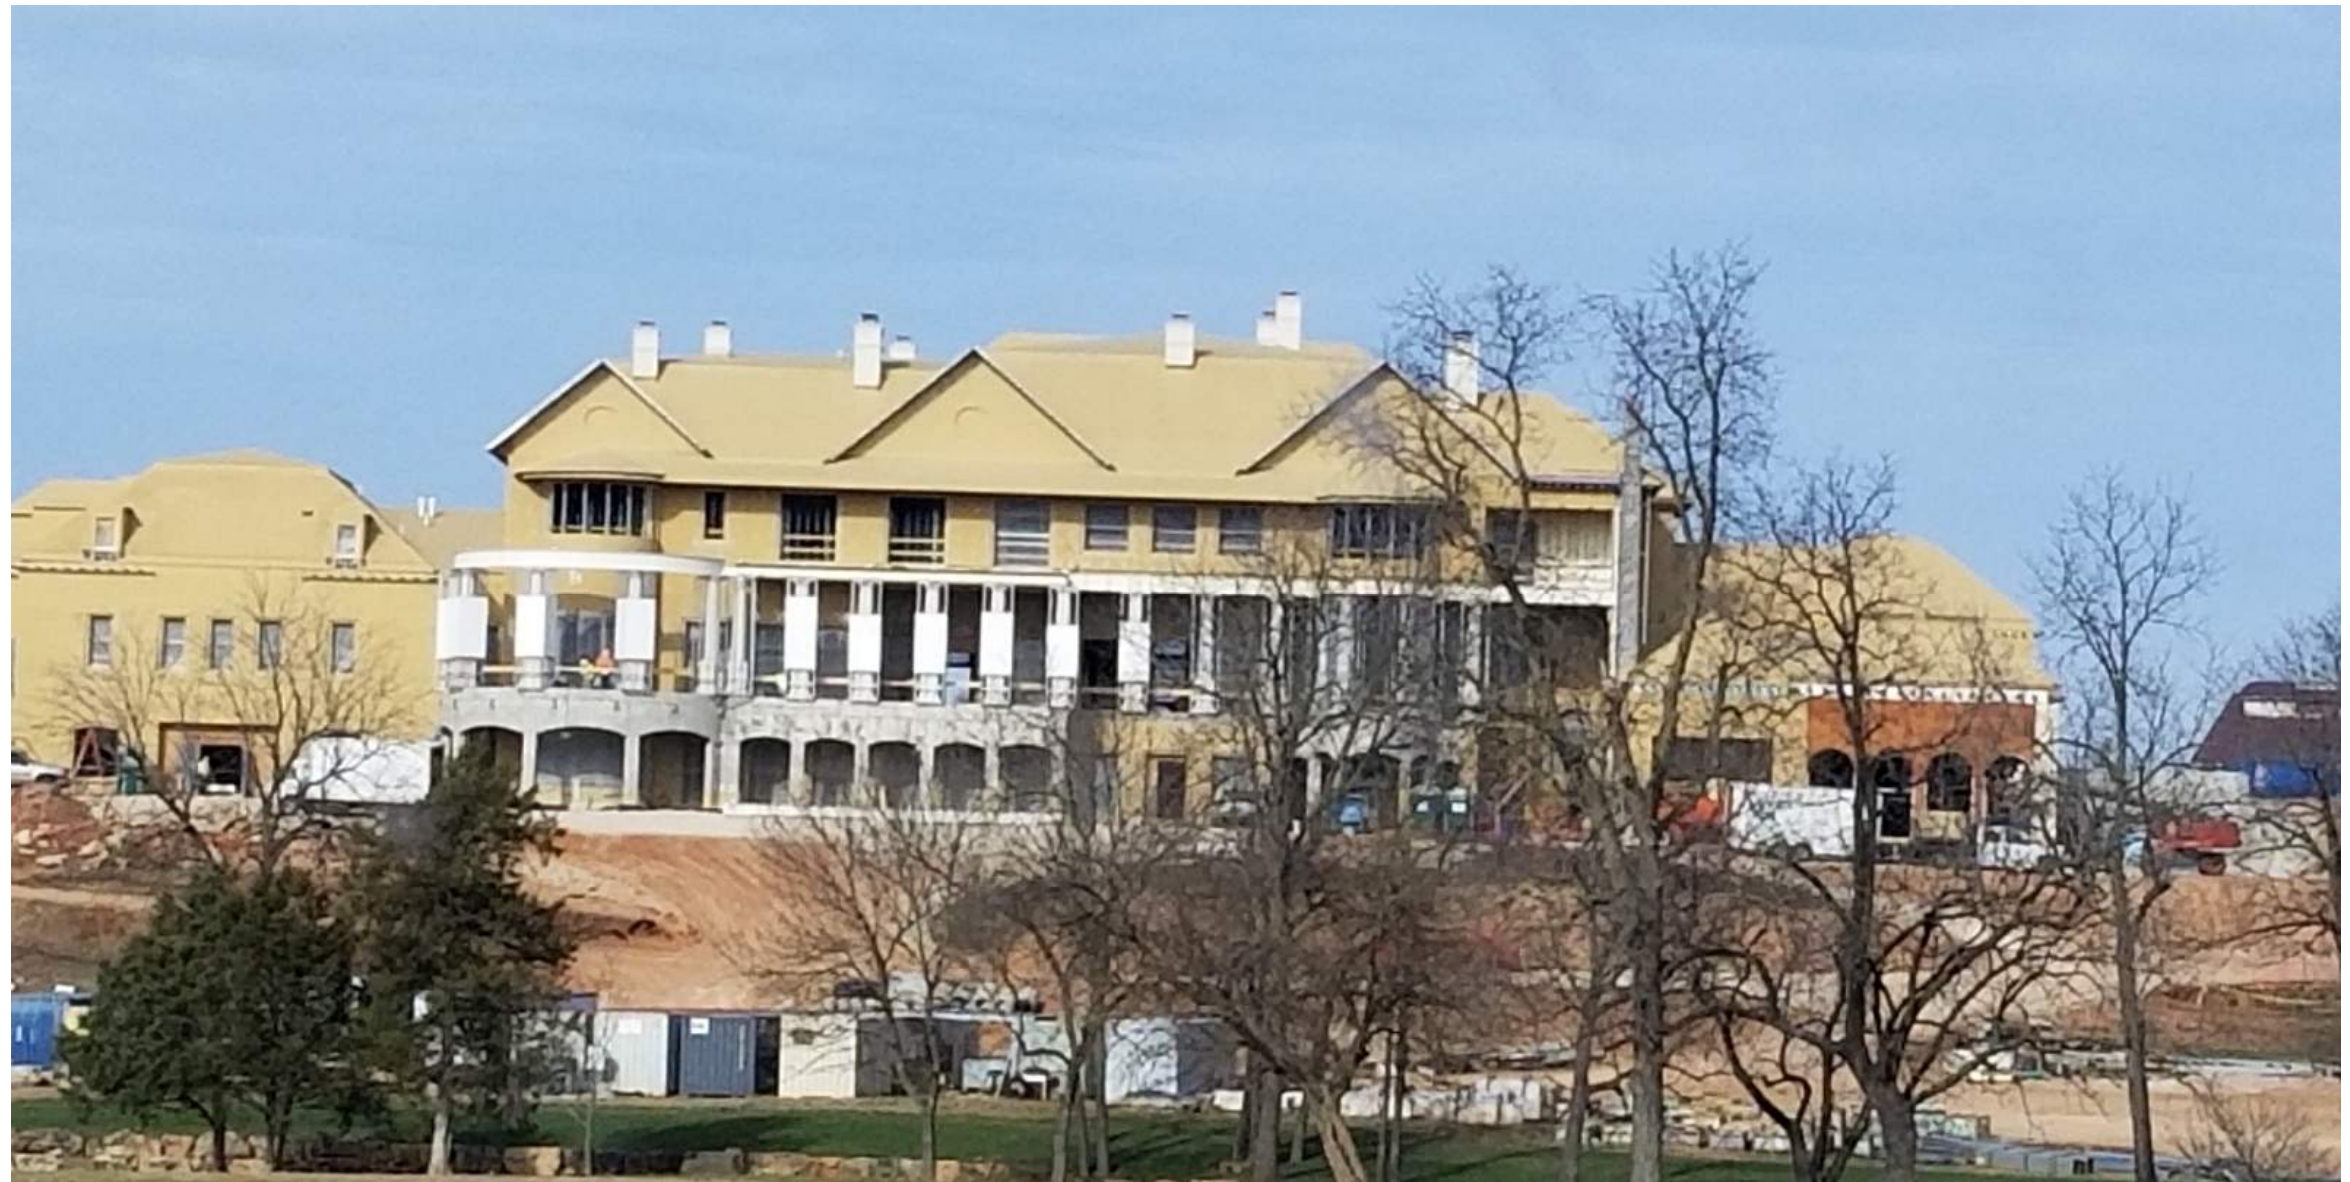
Leak Point at every window identified at the stainless clips at both the head and jambs.

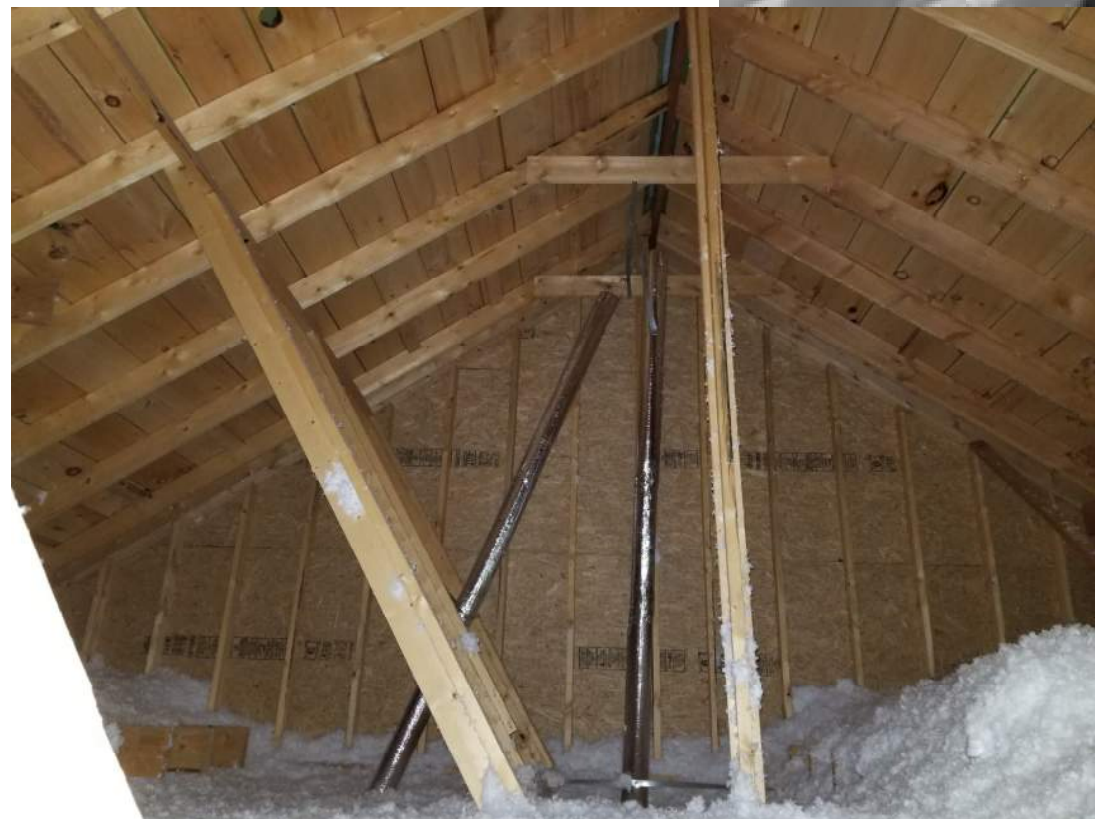
Mechanical duct temperature drop of 10°F

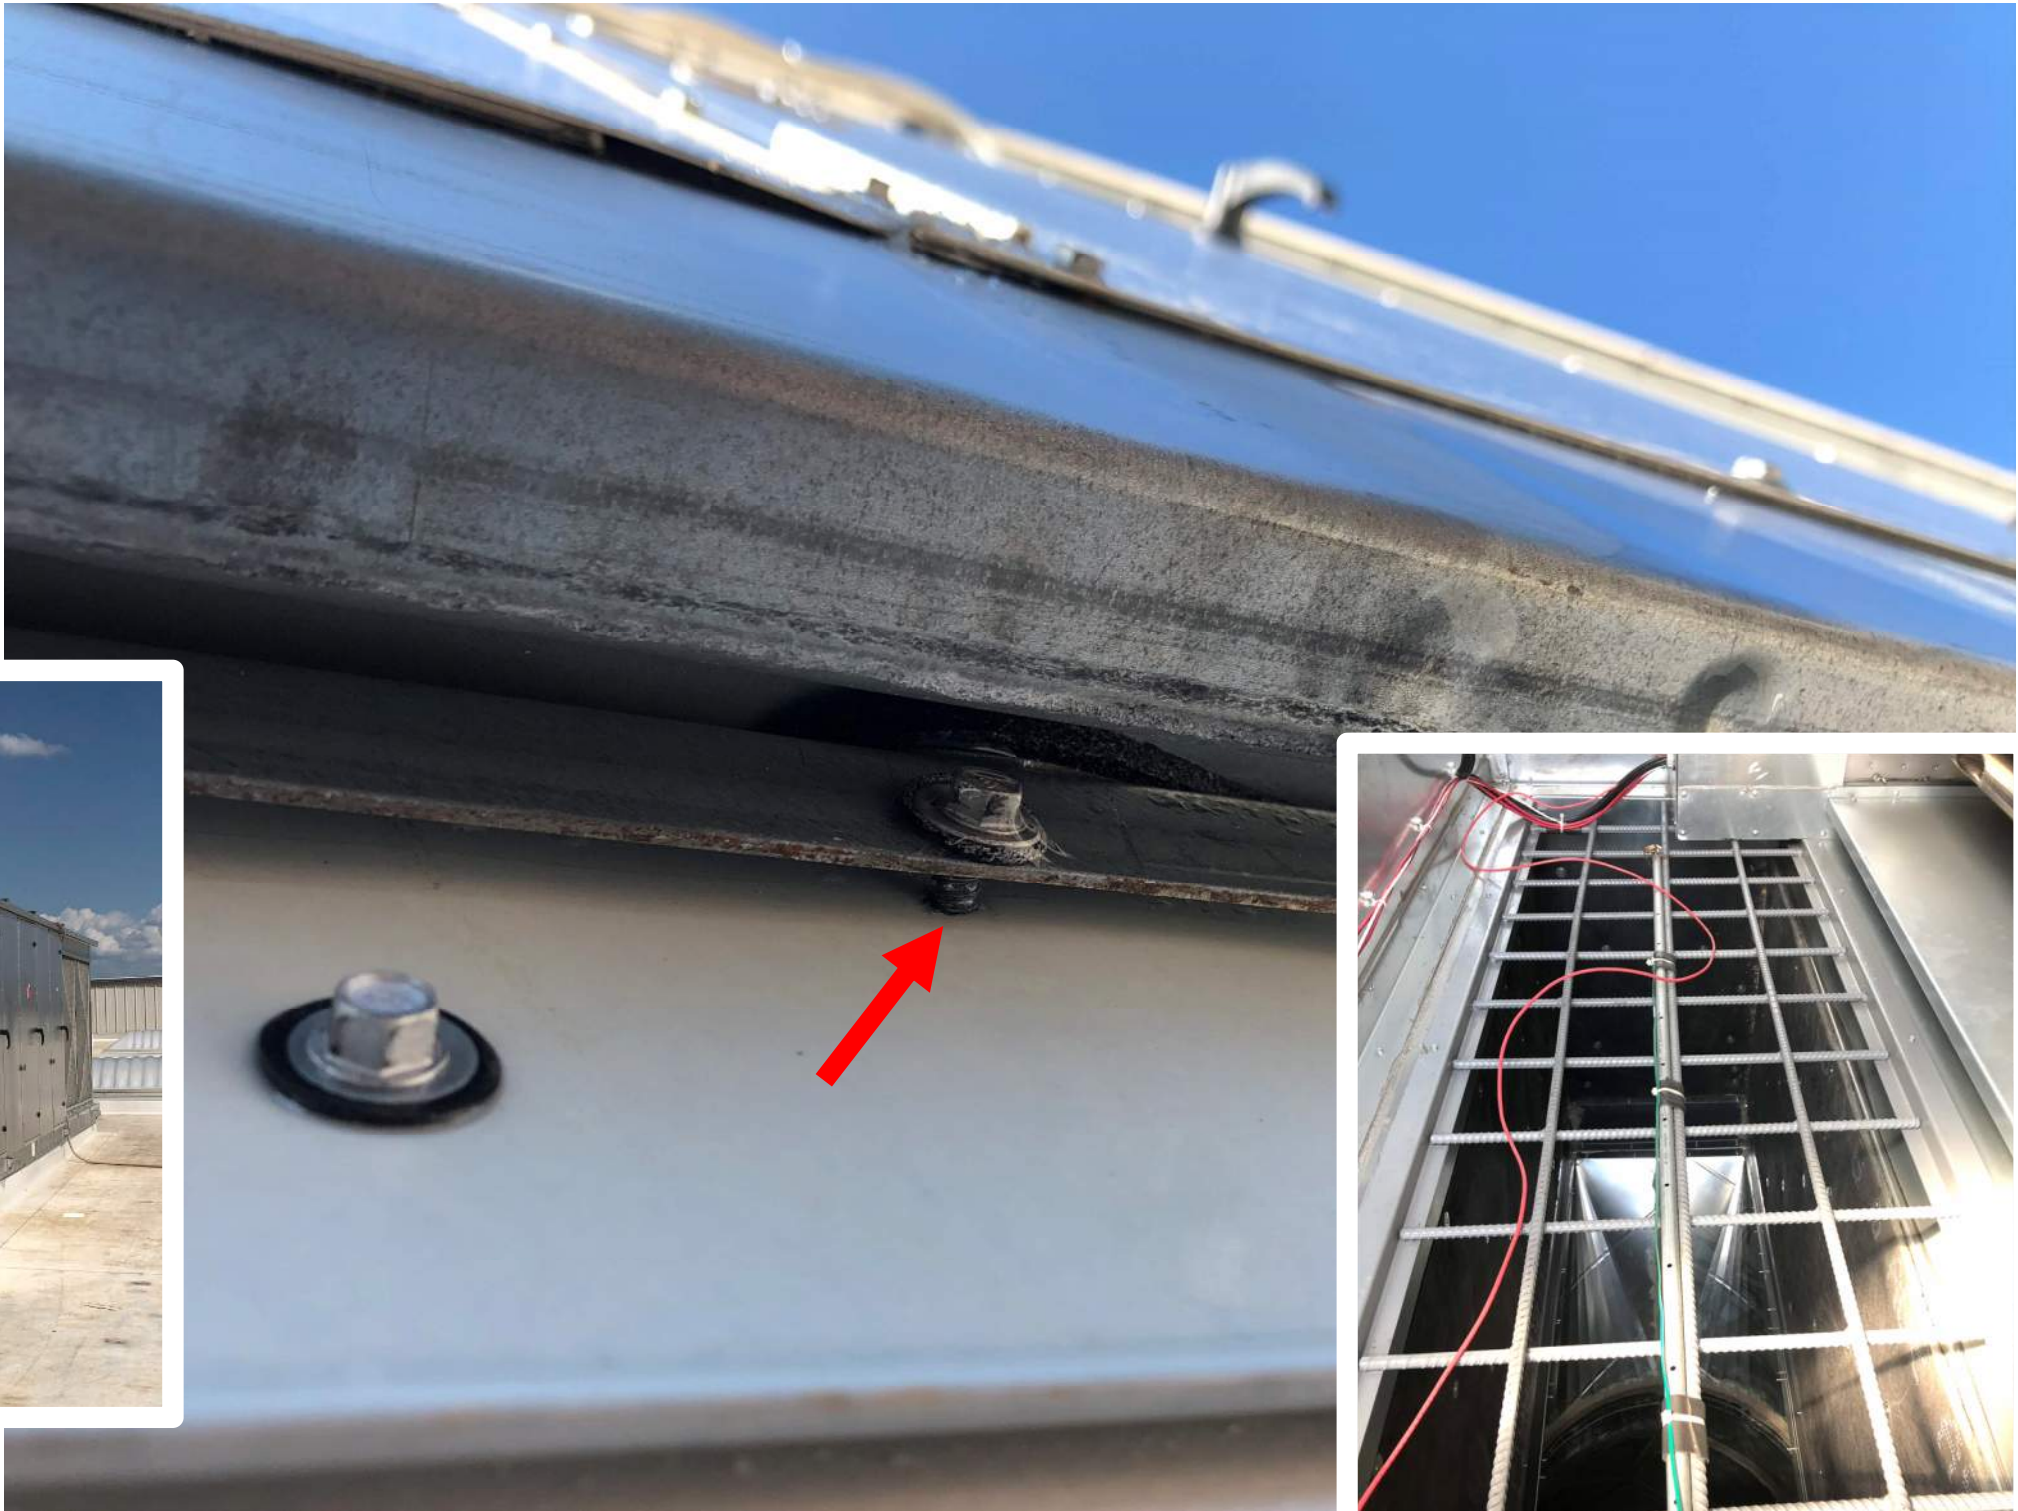
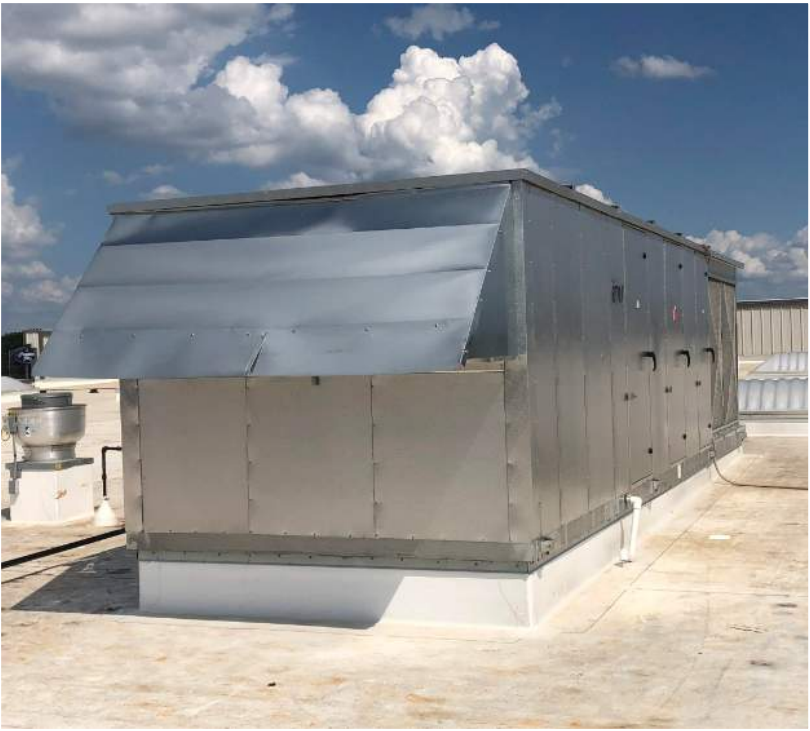
Non-standard Used to Narrow Down Point of Infiltration
